The Hall Senior School Development Project

Design & Access Statement
March 2019

This **Design & Access Statement** accompanies a Section 73 planning application to vary planning permission 2016/06319/FUL for the redevelopment of The Hall Senior School site located on the east side of Crossfield Road opposite the junction with Adamson Road.

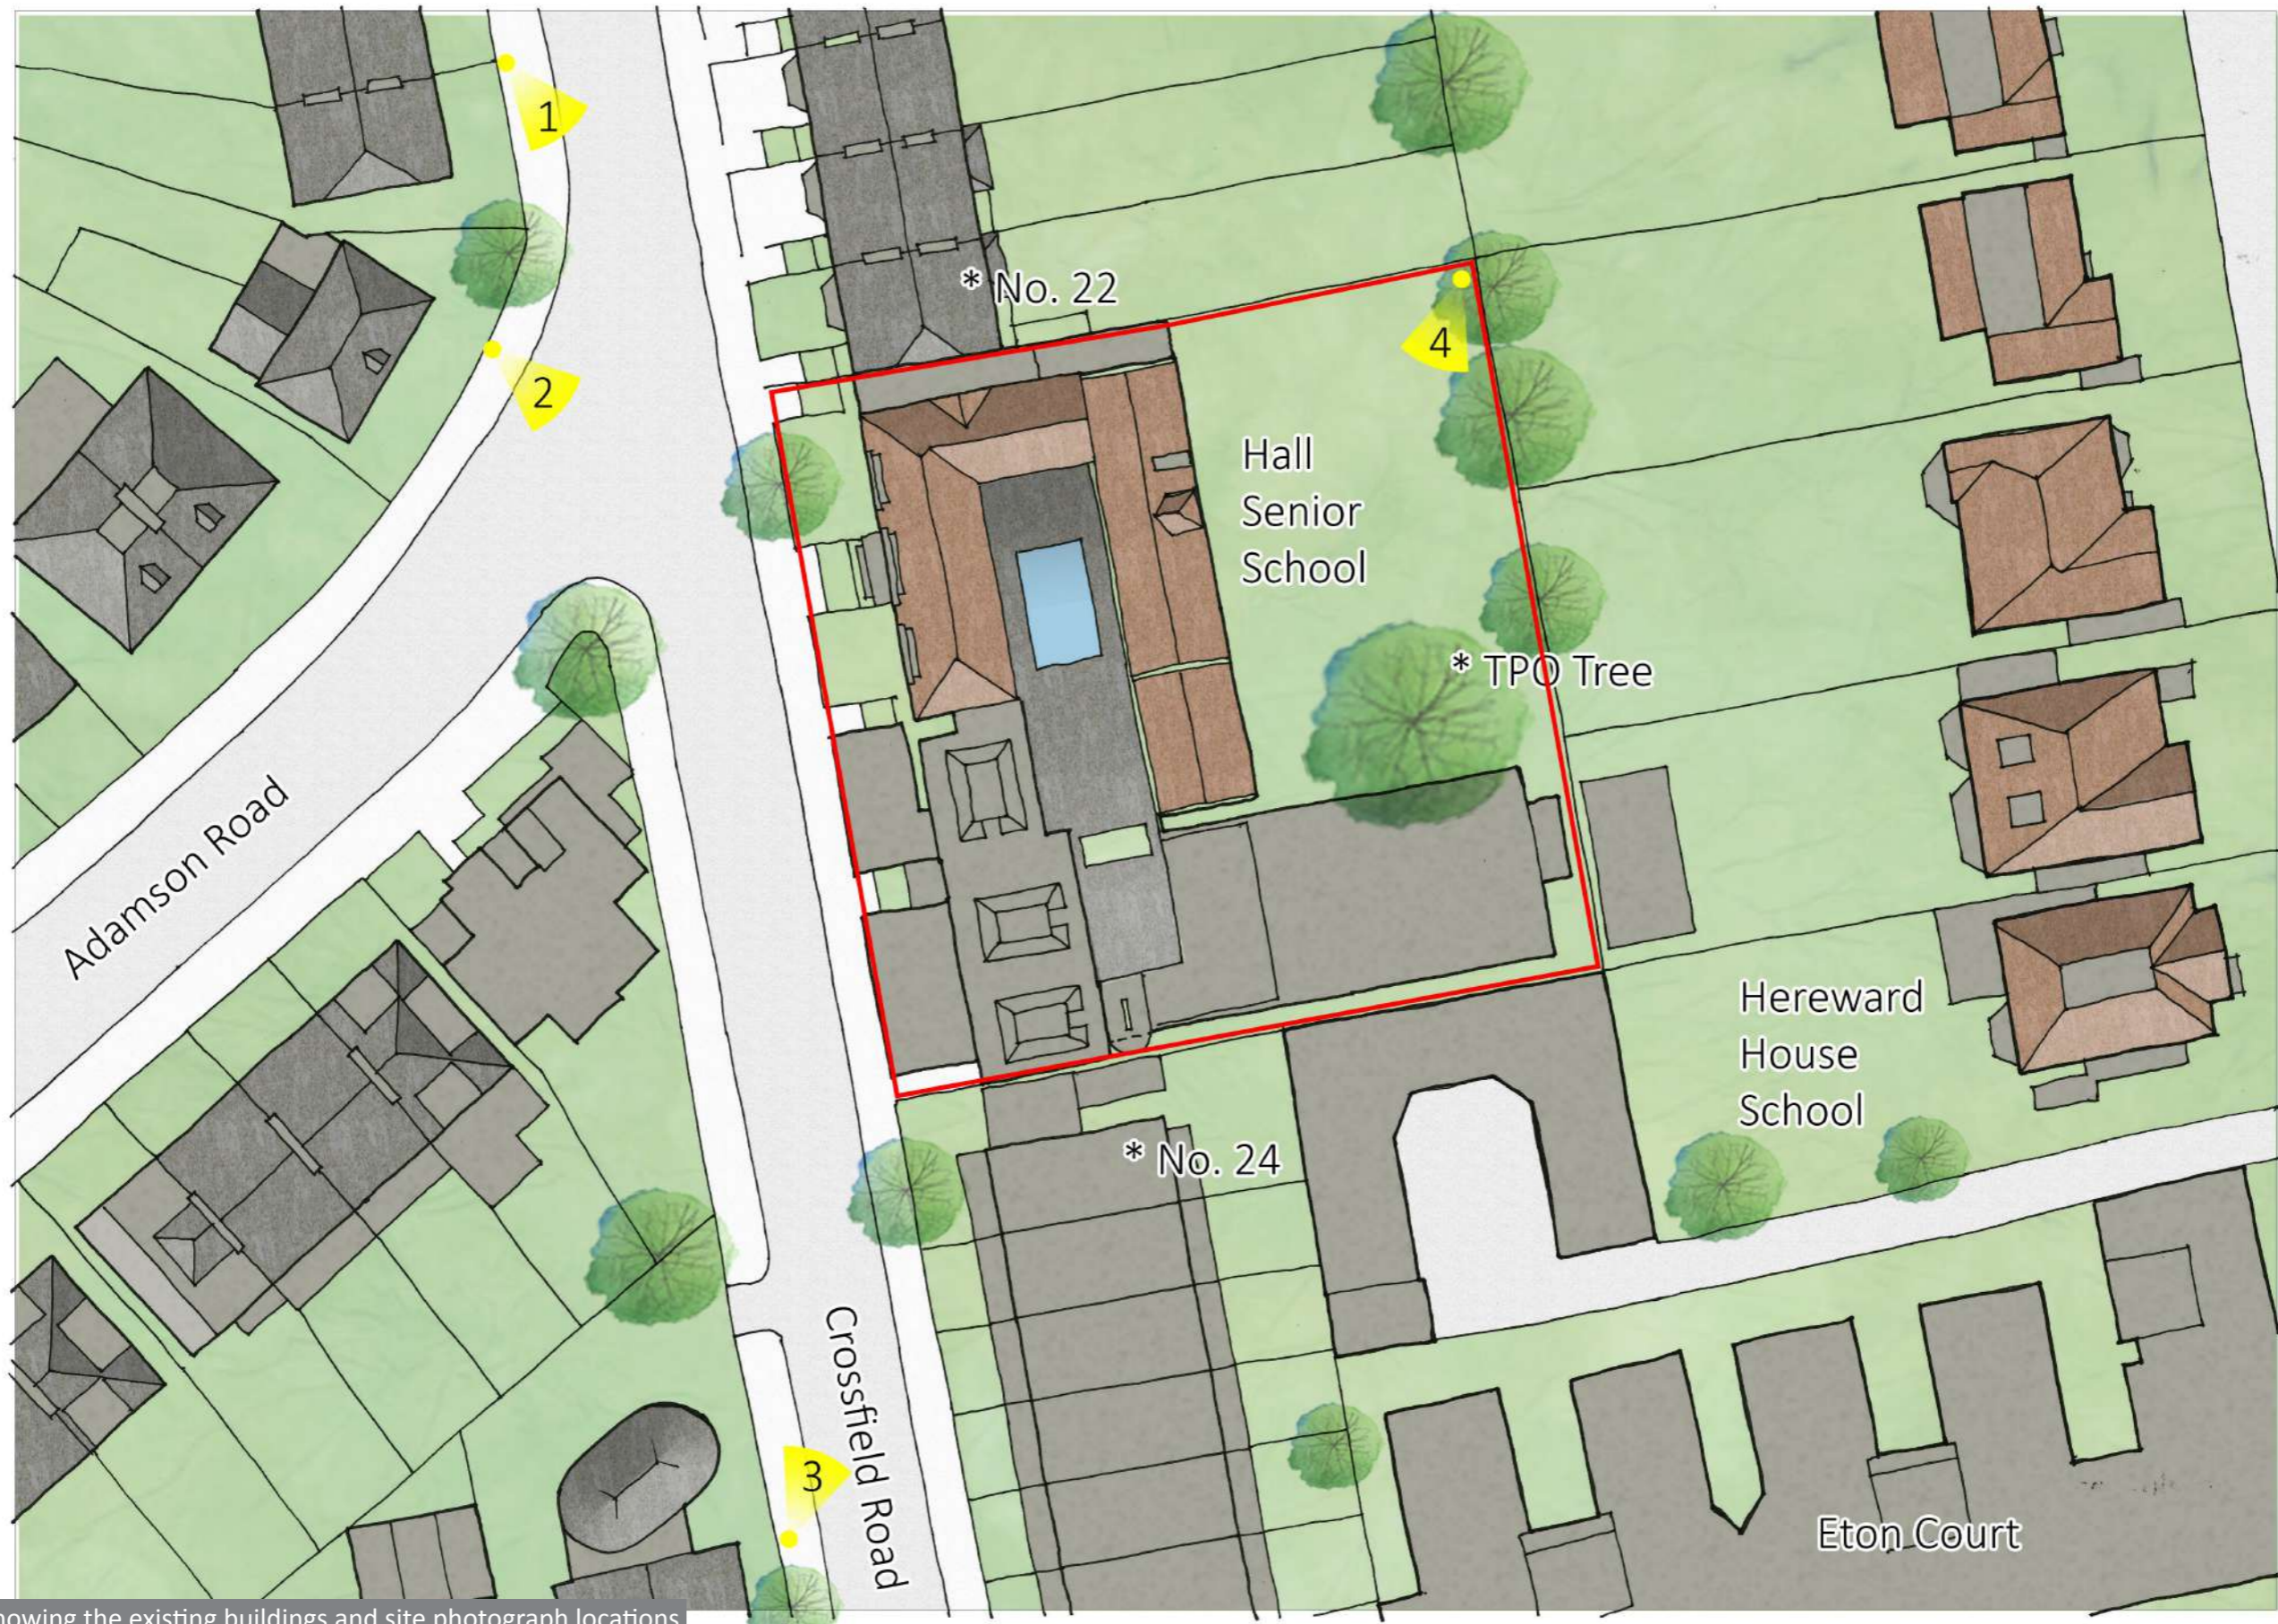
Site plan showing the existing buildings and site photograph locations

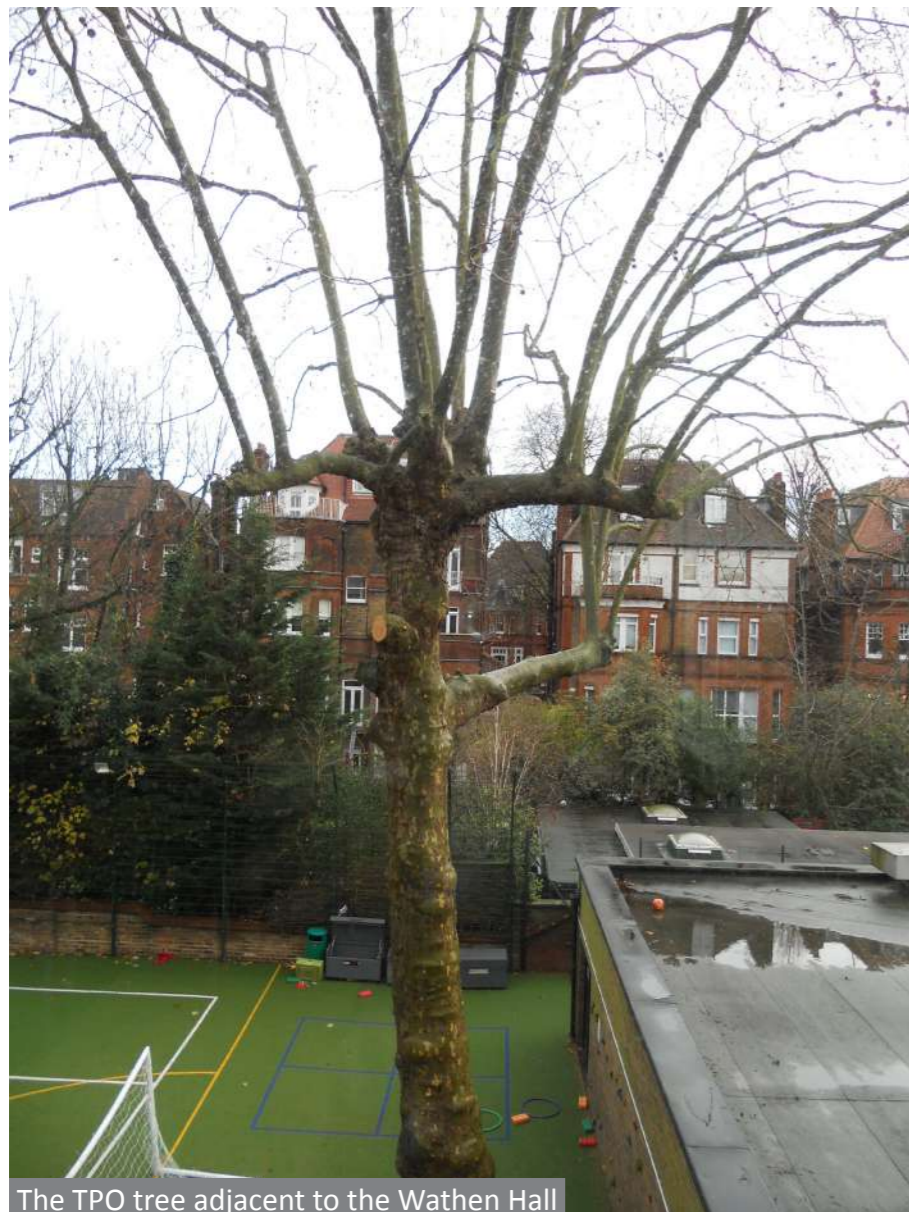
The TPO tree adjacent to the Wathen Hall

This tree has been pollarded earlier in its life but since then has formed a full crown. The tree is carefully maintained and the crown periodically reduced. Indications are that it is in good condition and is many decades from decline. It is in the School's interests for this tree to be retained as removal could be detrimental to the buildings foundations.

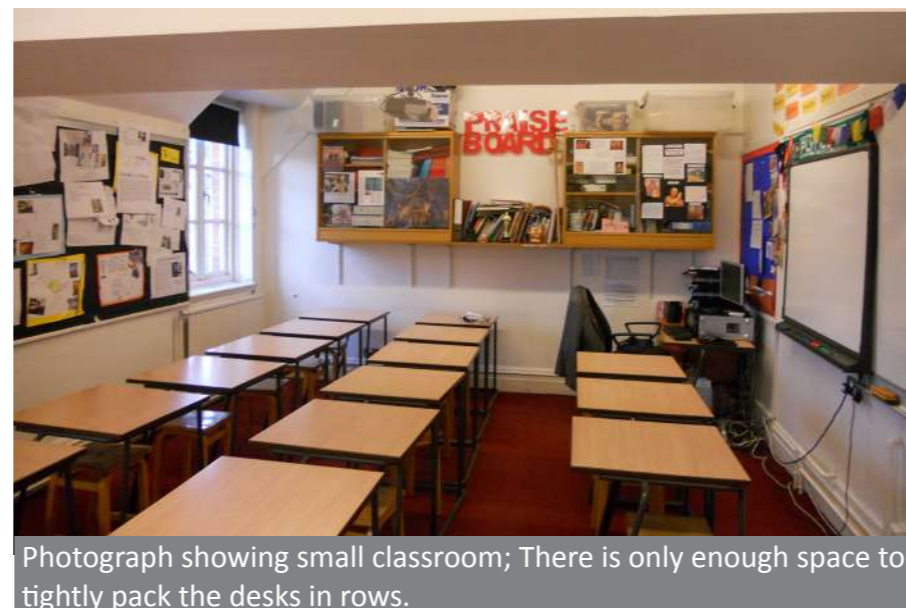
Photograph showing small classroom; There is only enough space to tightly pack the desks in rows.

2. Several of the classrooms are too small. Of the current 21 teaching spaces only 6 meet the recommended floor area for a group of up to 20 when assessed against relevant standards. Of the remainder 4 are so small they are better suited to a half class group.

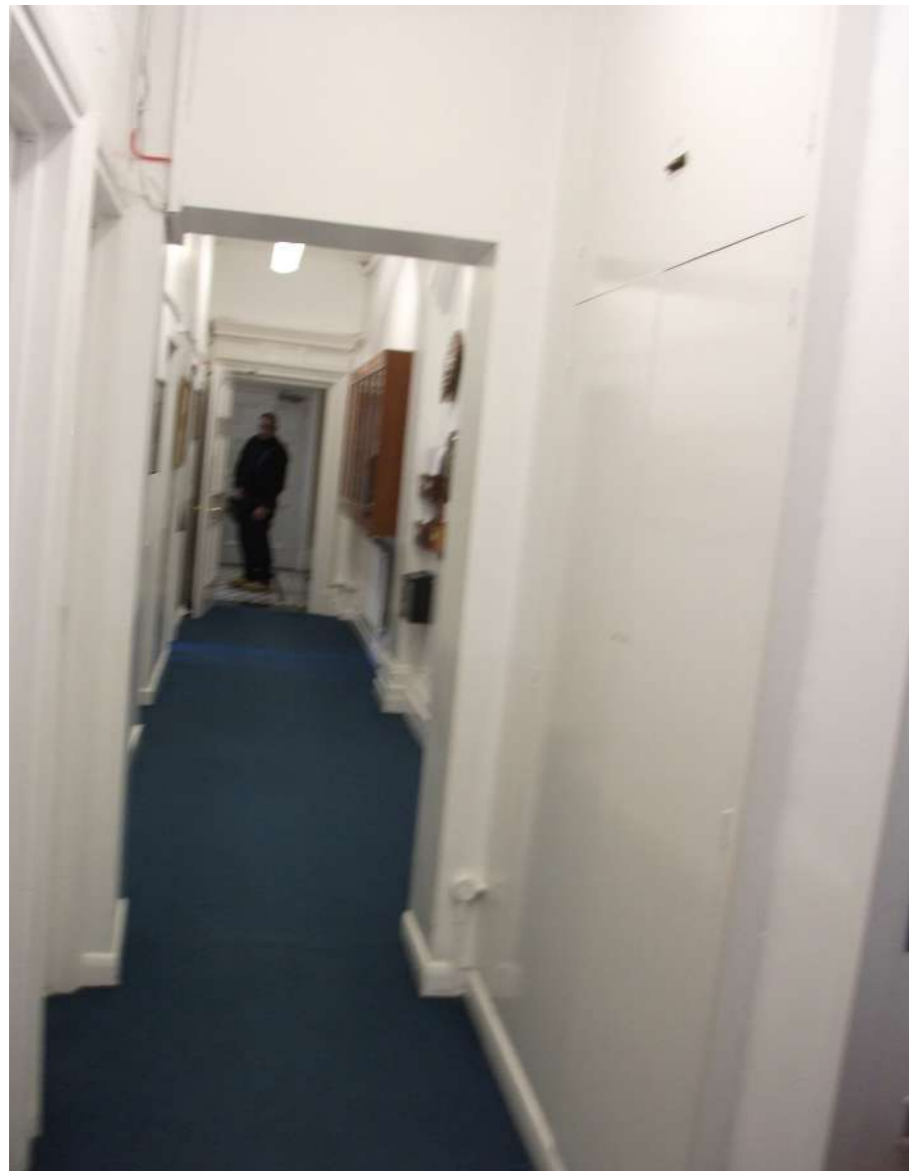
Photograph showing a corridor in the Centenary Building; The layout is a warren of tight corridors with little natural daylight.

4. The building layout is chaotic and disconnected due to piecemeal development and excessive density, and this results in a disruptive atmosphere.
5. Currently not all teachers have their own subject specific classroom adding to timetable pressure. In order for this to be rectified four additional classrooms are required.
