Landmark Trees

Re: Addendum to Arboricultural Report MAA/9GG/AIA/01a

I write following the excavation of a trial pit at 9 Grange Gardens, London NW3 7XG as part of a planning application 2017/2445/P, as recommended within our initial report on the potential impacts of the development on trees on and adjacent to the site.

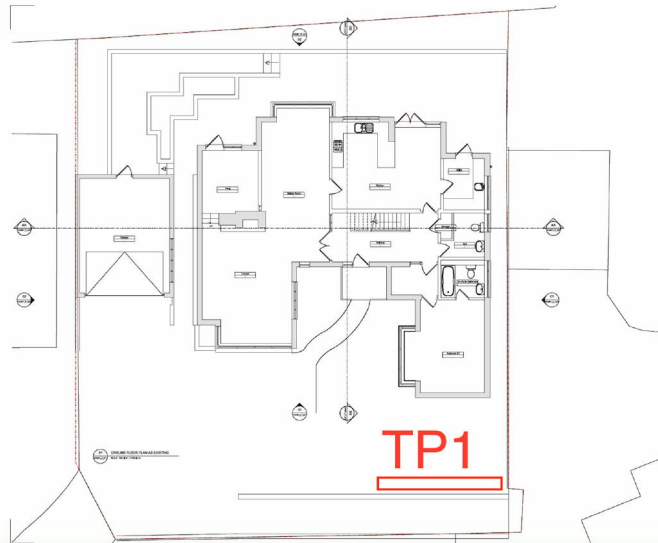
Extract 1: Location of trial pit on plan

The trial pit was excavated in the position detailed in Extracts 1 and 2 below, to a depth of some 800mm. I visited the site on the 29th January 2019 in order to inspect the trench and can confirm no roots from the adjacent high quality oaks T1 and T6 were present (see Photograph 1) and it is worthy of note that the wall foundations extended below the bottom of the trench. Photograph 2 shows a root from an adjacent Viburnum shrub that has grown towards the wall, found it to be an impenetrable barrier and adjusted its course accordingly. Oak roots possess no especial faculty for breaking through obstructions and thus I do not think it unreasonable to conclude that if a trial trench were excavated the far side of the wall that similarly deflected oak roots would be found.

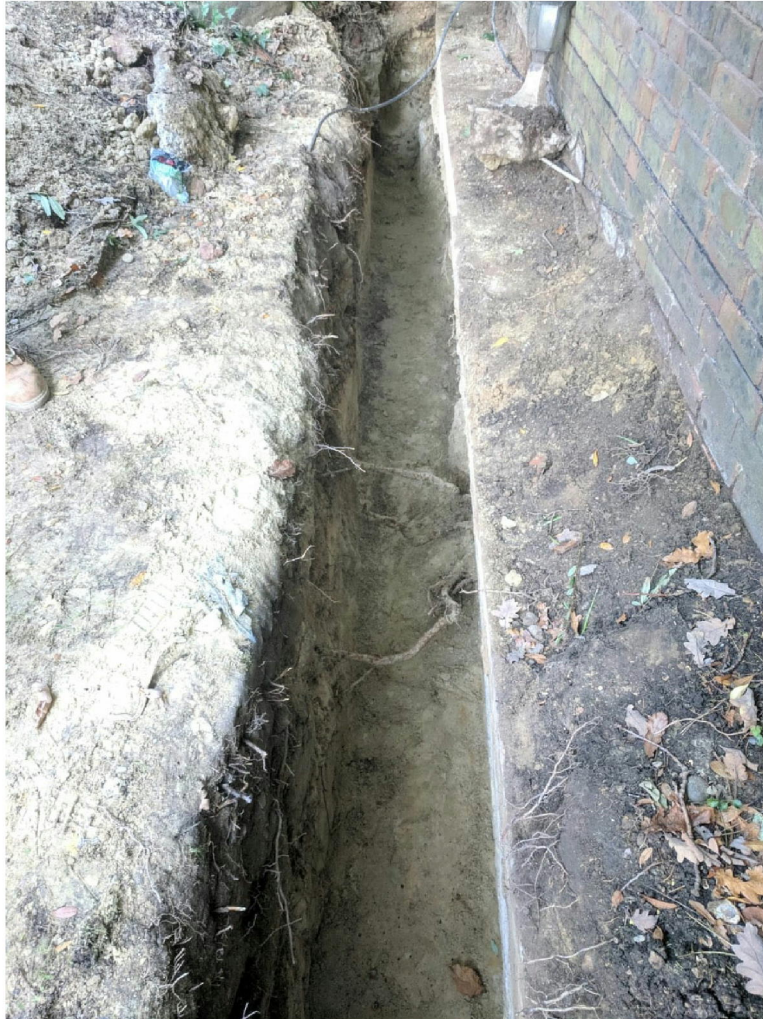
Photograph 1: No rooting from adjacent oak T1 within trial trench / beyond boundary wall foundations

I therefore conclude that, as per the enclosed updated Arboricultural Impact Plan, the proposals will have no impact on T1 or T6.

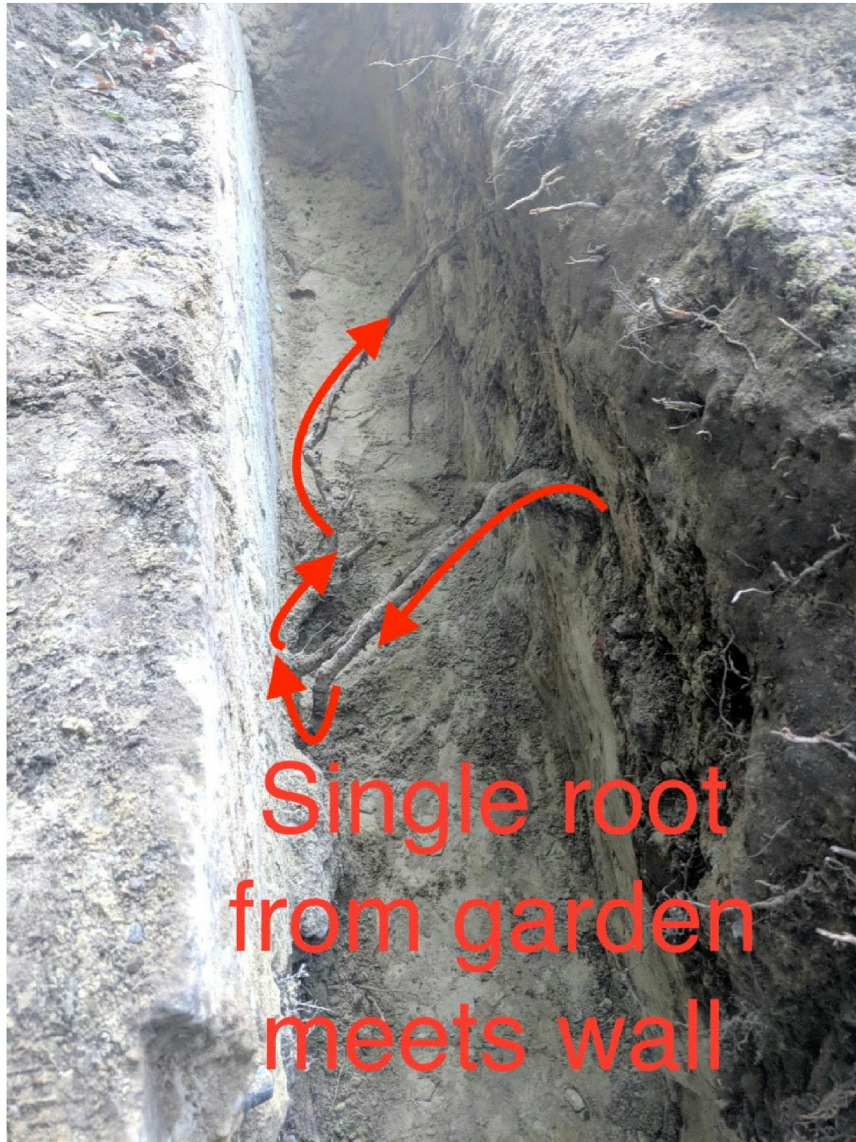
Photograph 2: Viburnum root deflected by wall
