**VIEWS ALONG THE HIGHWAY**

South End Road towards St Crispin's Close

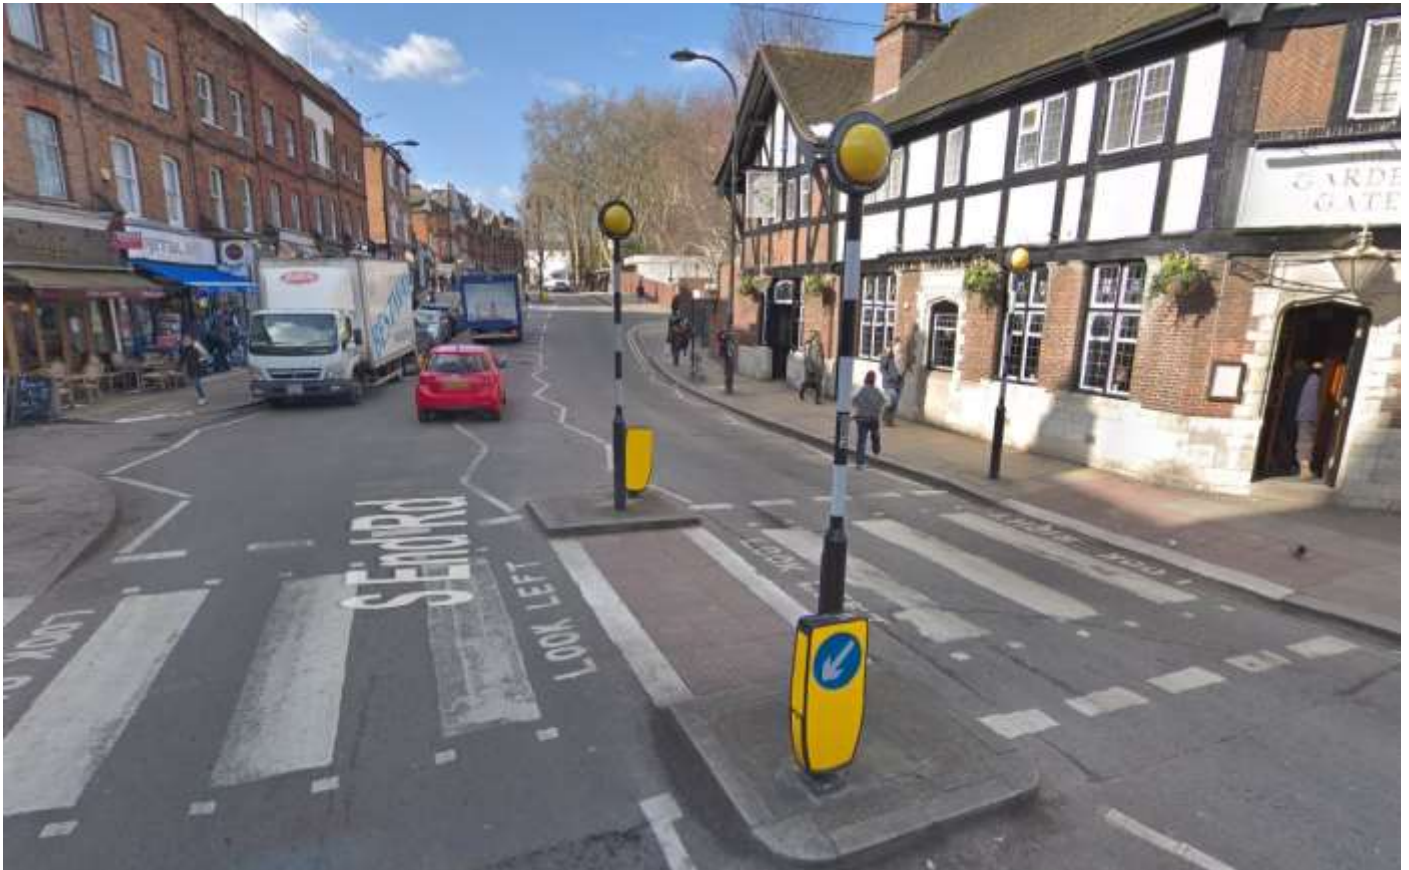
Figure 1: View heading north

The entrance to St Crispin's Close is clearly visible up on the right. There is a pelican crossing, and traffic calming measures such as reflective bollards. There are also frequently staged street lights and a wide central reservation in the road.

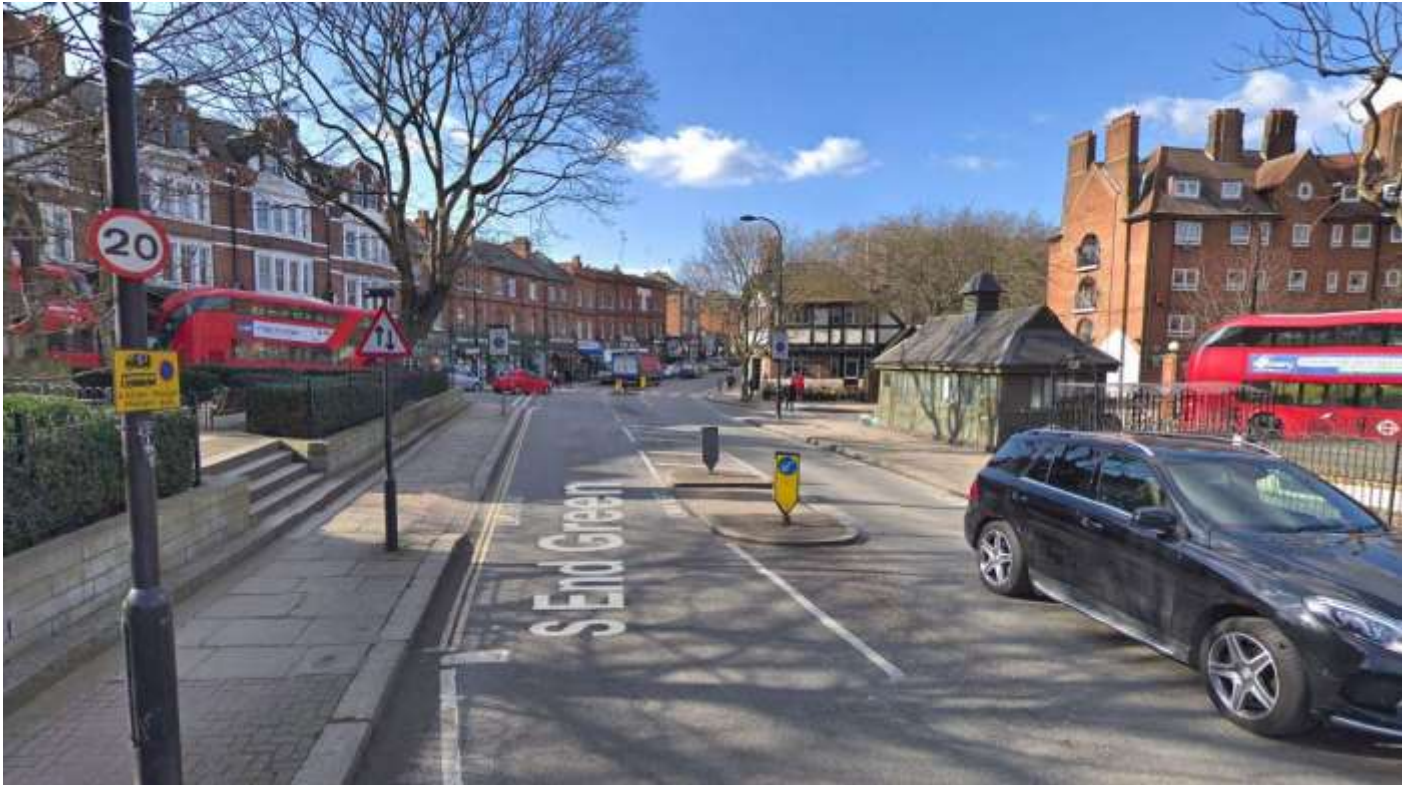
Figure 2: View north - from further

The view north from further back. Further traffic calming measures (pedestrian islands and bollards). Note the 20 mph sign.

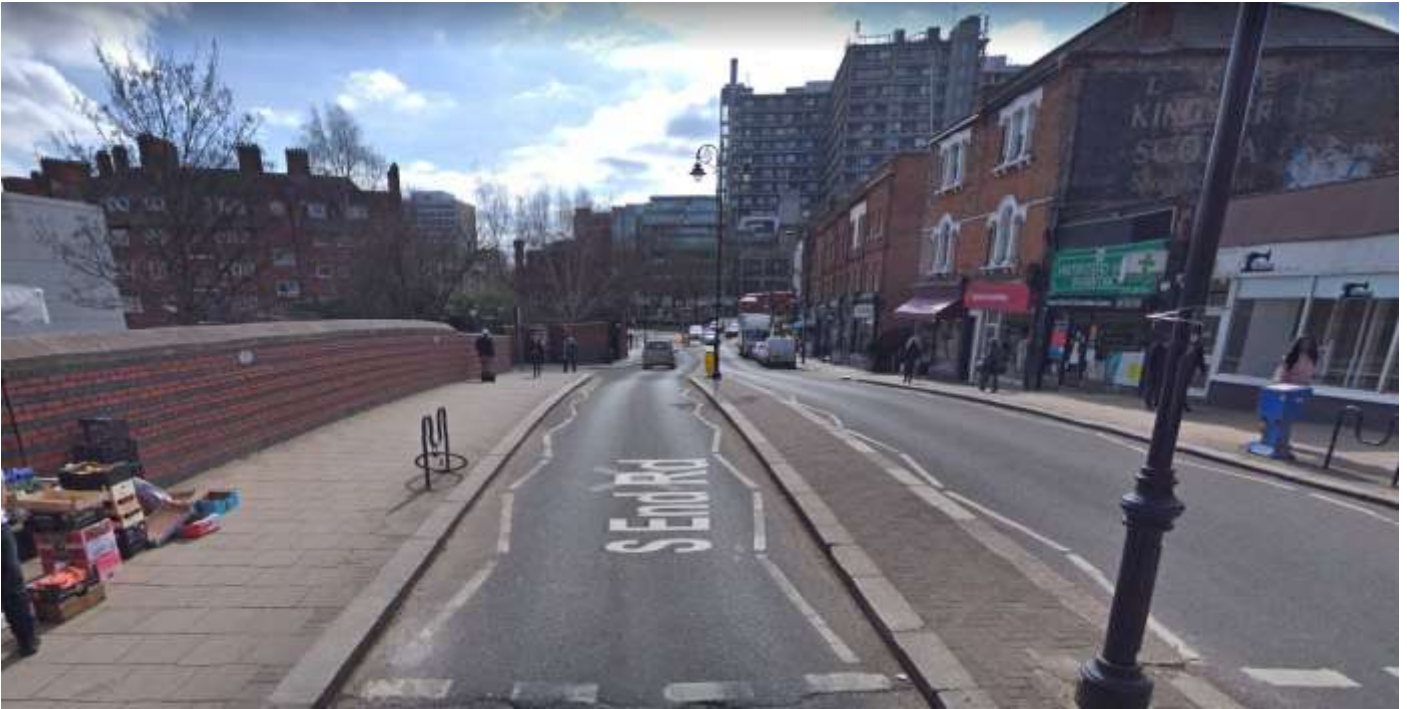
Figure 3: View heading south

The entrance is clearly visible owing to the wide pavement, which provides clear visibility splays. Not the traffic bollards immediately opposite the entrance and the regularly spaced streetlights. In the immediate foreground are road markings showing the pelican crossing (from where this image was taken). Further evidence of crime is to be seen in the single bike wheel left chained to the bike rack to the left (following, presumably, the theft of the rest of the bike).
