EXISTING SHOPFRONT BAY ELEVATION

IUE,			DRAWING THE EXISTING SHOPFRONT BAY ELEVATION		
).				bad	architecture & interior design
EB 19	DWG BY SF	REV.		7549 2133	2nd Floor
- PA .25			E: info@gr W: www.	padlondonltd.com gpadlondonltd.com	130 Old Street London EC1V 9BD

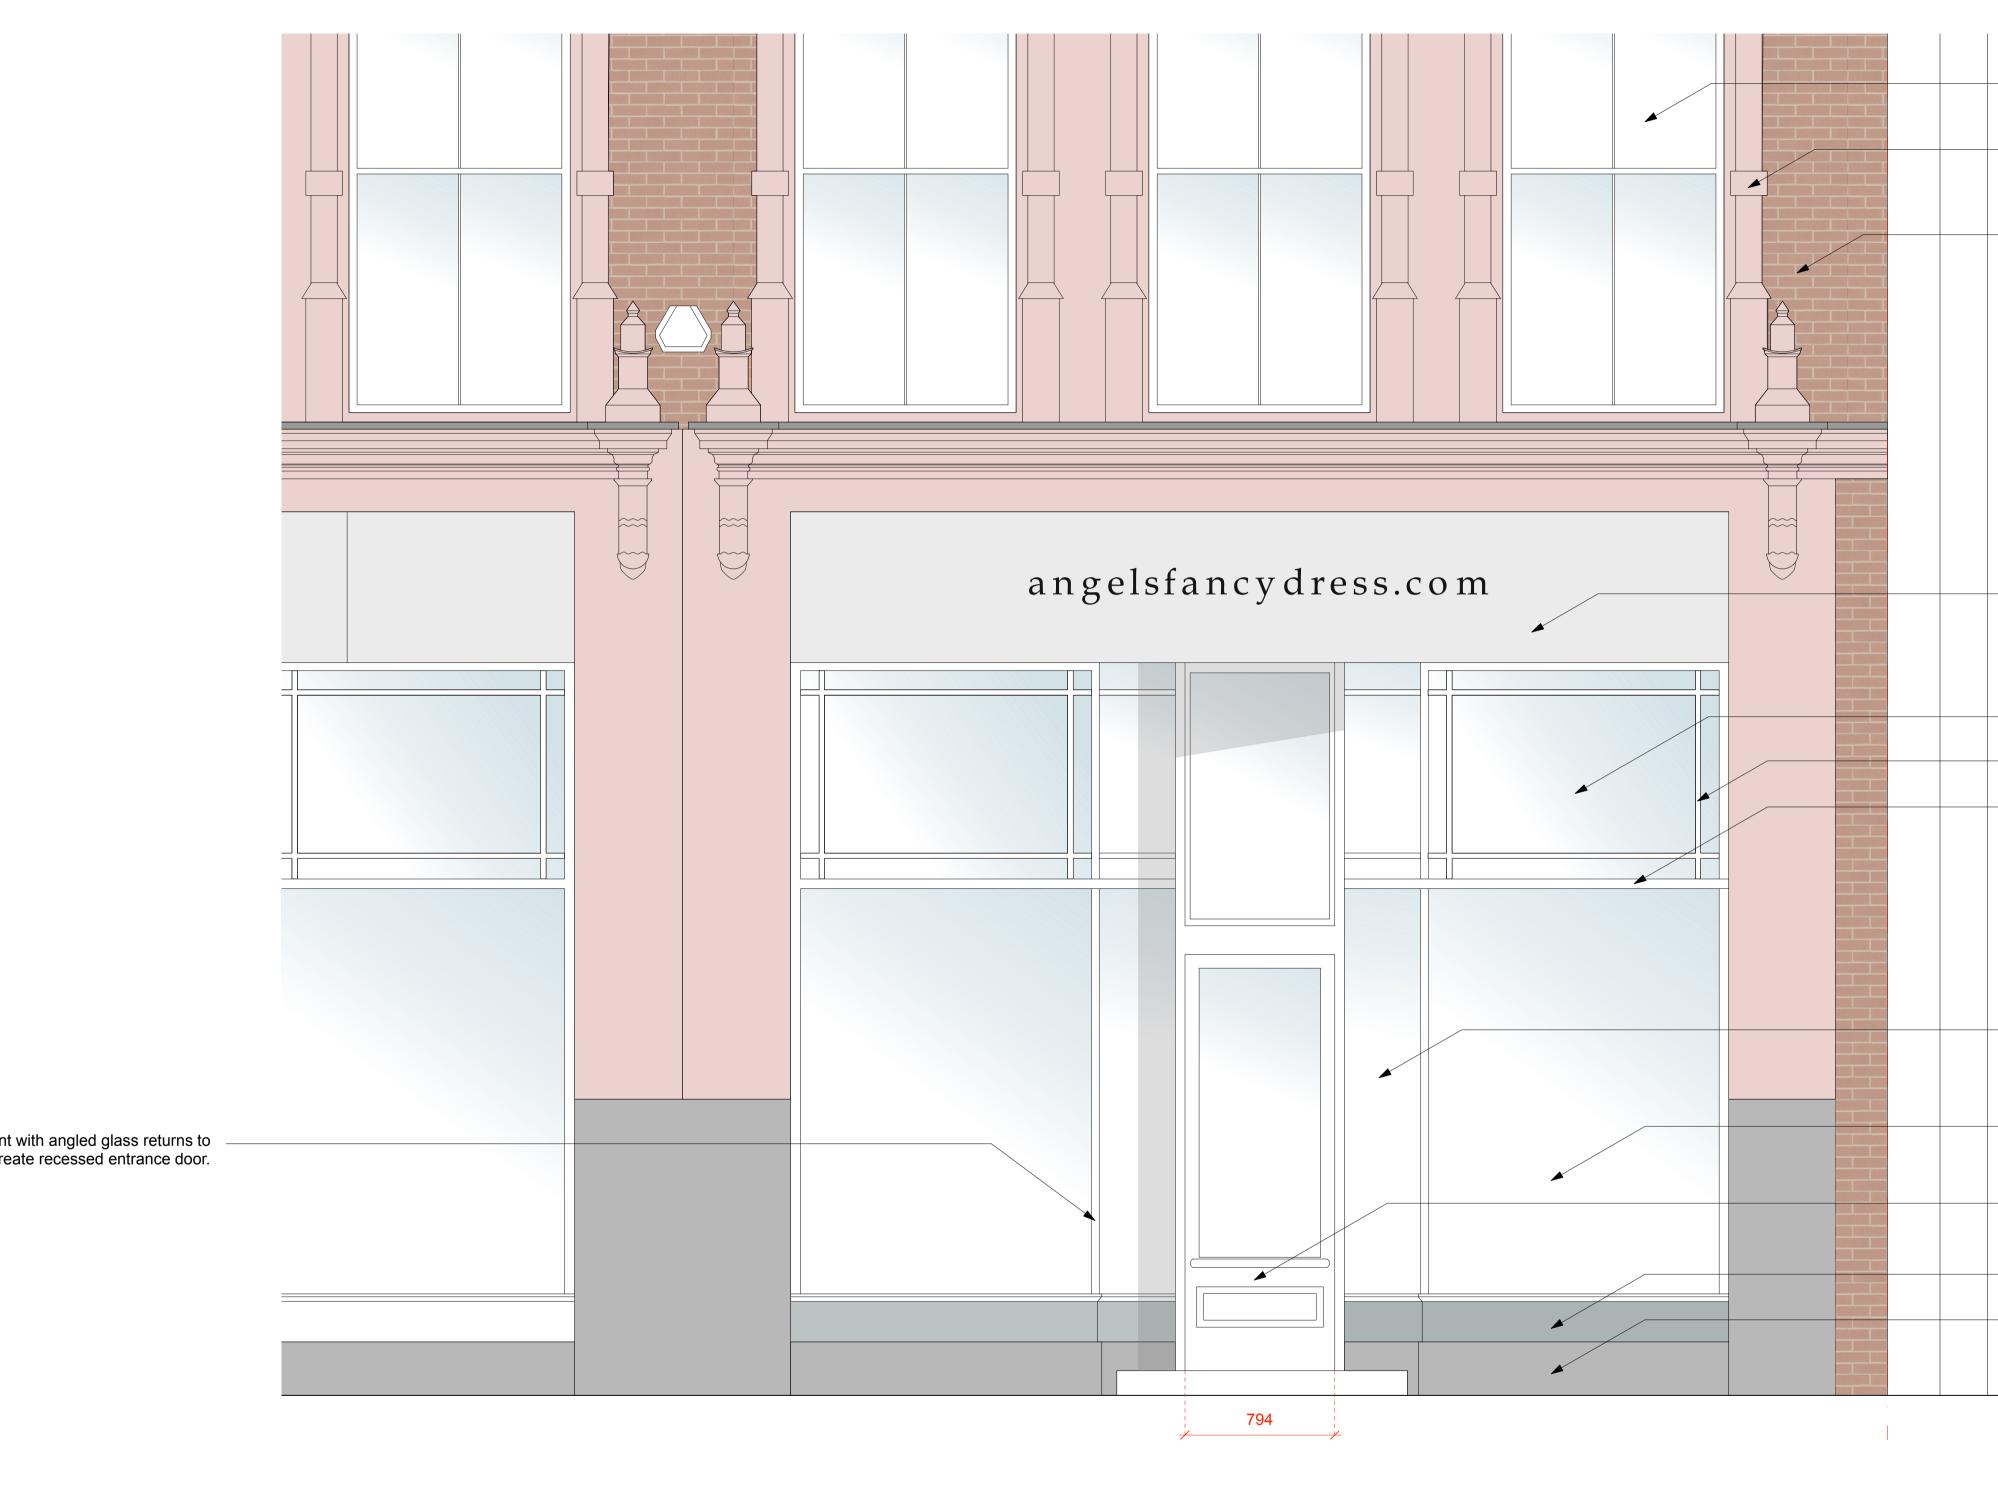
Existing shopfront with angled glass returns to create recessed entrance door.

Existing timber single glazed sash windows painted white.
 Existing ornate red sandstone external window surround detailing.
 Existing red brick external façade.
 Existing shopfront fascia of current building tenant Angels Costumes.
 Existing shopfront transom light
 Existing shopfront window mullion.
 Existing shopfront window transom.
 Existing timber shopfront with chamfer angled glass returns to create recessed entrance door.
 Existing timber shop front single glazed windows.
 Existing timber shopfront door with 794mm clear opening.
 Existing timber painted shop front stall riser.
 Existing grey sandstone shopfront plinth.
