DESIGN AND ACCESS STATEMENT
FOR
REPLACEMENT OF ROOF AND UPGRADE OF LAUNDRY CORRIDOR
BELOW
AT

St Dorothy's International Student Residence
99 Frognal
London
NW3 6XR

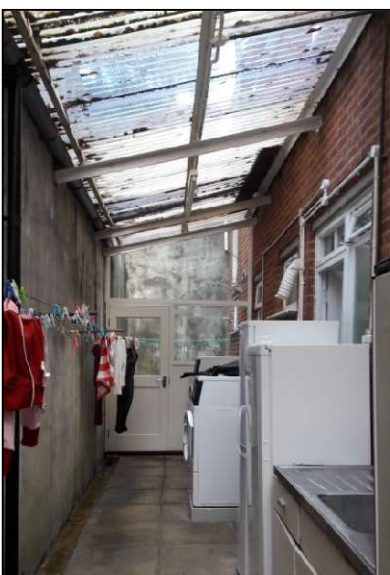
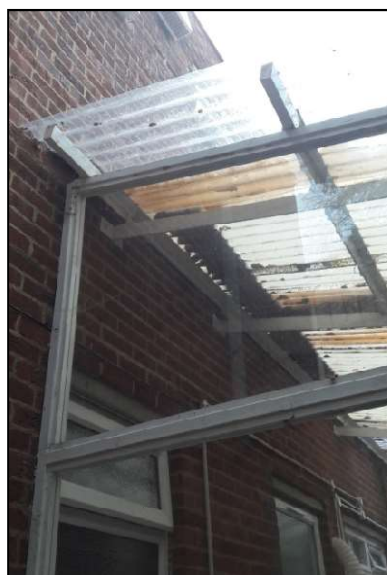
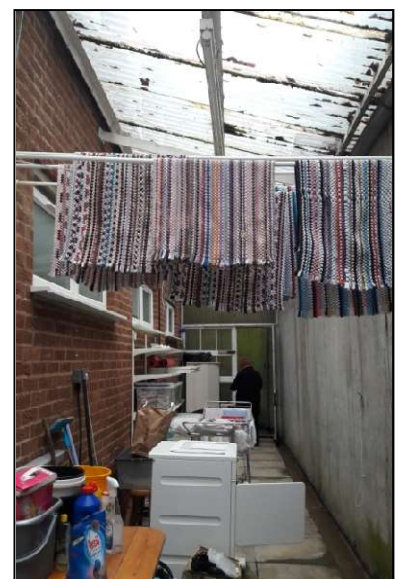
The photos below show the rear lower yard / corridor area that is presently covered by a very much DIY structure incorporating a Perspex roof covering. This leaks when it rains and the whole facility that this creates at present is very sub – standard and needs to be upgraded.

As can be seen from the photos this is the main laundry area, and whilst its size is suitable for the need required it is quite apparent that the conditions of this semi external space are not.
