5 Gainsborough Gardens

Design and Access Statement: 25th April 2019

This document is to accompany the Listed Building, Conservation Area and Planning Application for replacement of two modern French Doors at No 5 Gainsborough Gardens, a Grade II listed semi-detached house located within the Hampstead Conservation Area.

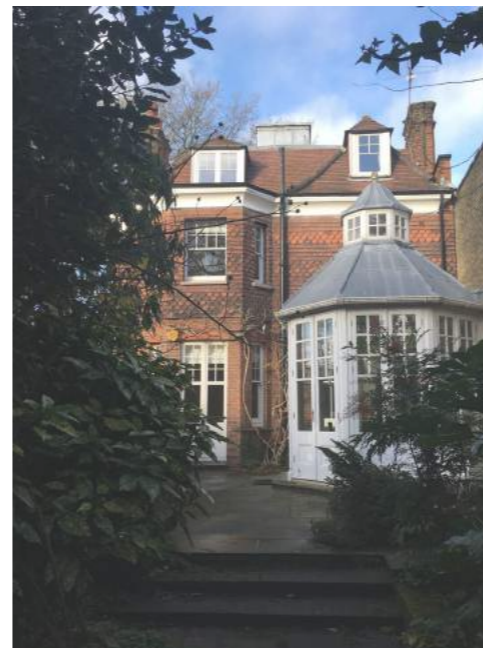
South East Elevation

The South East elevation has a two storey broad canted bay. On the ground floor there is a modern pair of French doors in poor condition, leading from the drawing room into the garden. On each side there are smaller sash windows which appear original. The existing conservatory is being demolished and replaced with modern single storey rear extension (Planning consent granted 2018/3493/L and 2018/2629/P)

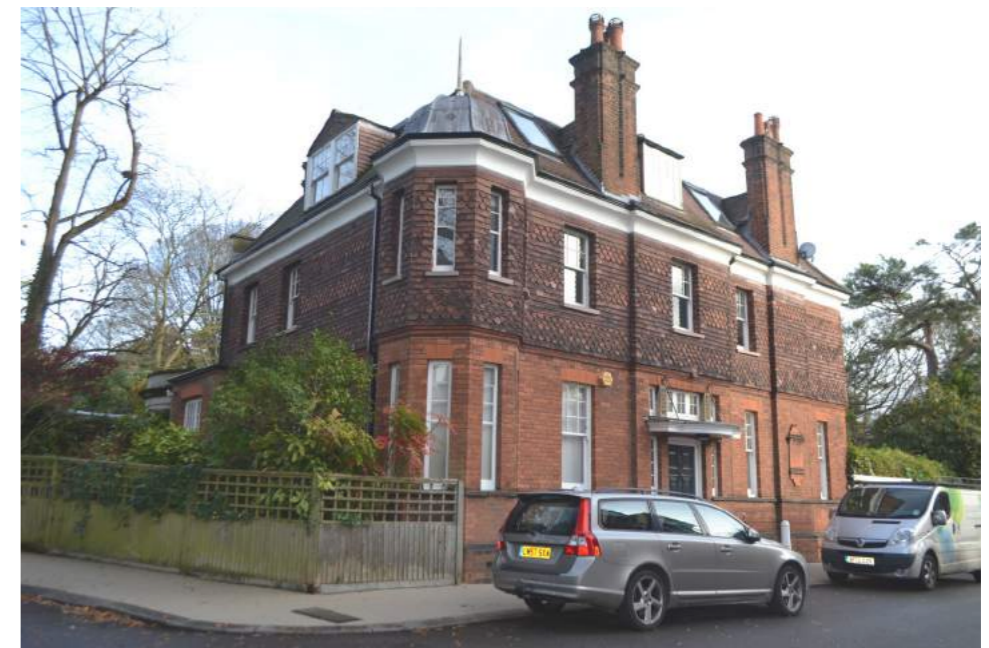
South West Elevations

The windows to the first floor and attic show signs of repair and many have replacement sashes with horns and glazing bars that vary from the original. The upper sashes also vary in their pattern (6 pane and 8 pane), which is partially a result of replacement over time.

The roof lights are clearly modern.

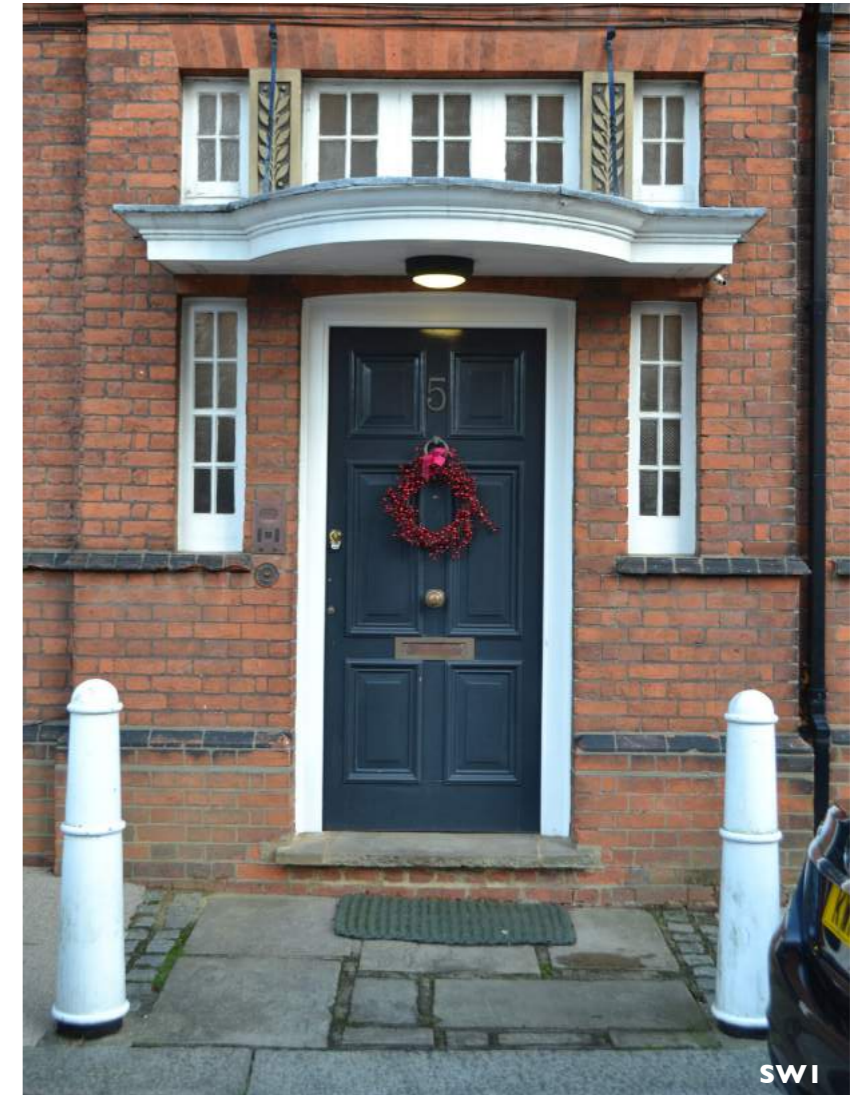
*Photo SW1
Existing main entrance on
South -West Elevation. The door
is relatively modern however
the side windows and the fan
windows above canopy appear to
be original.*

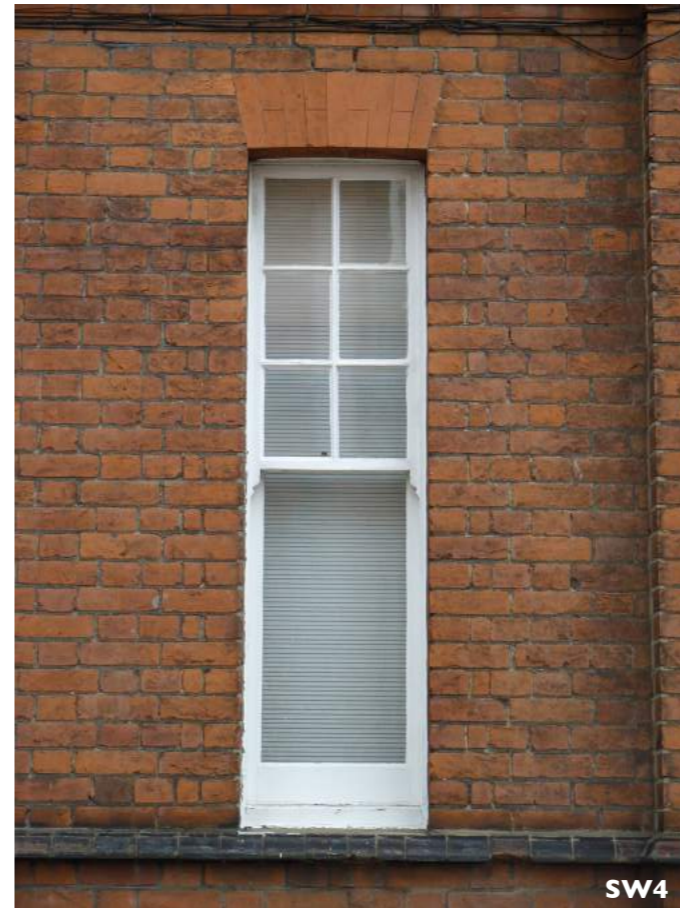
SW4

*Photos SW4-SW7
Typical windows on ground floor of South -West Elevation. The windows seem to be original with some replacement hinges to the casement window in the corner bay.*

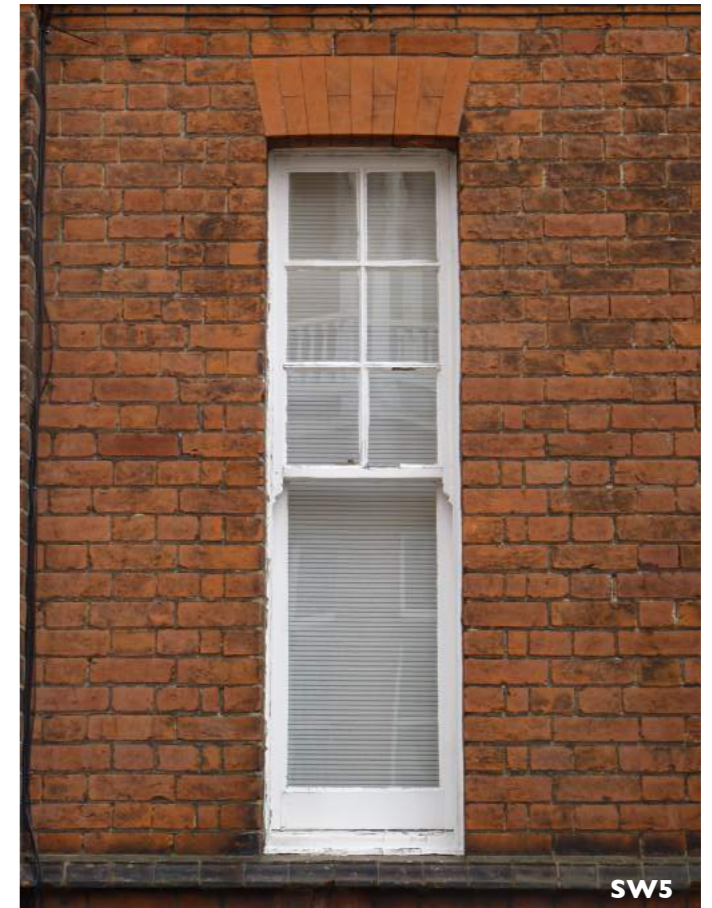
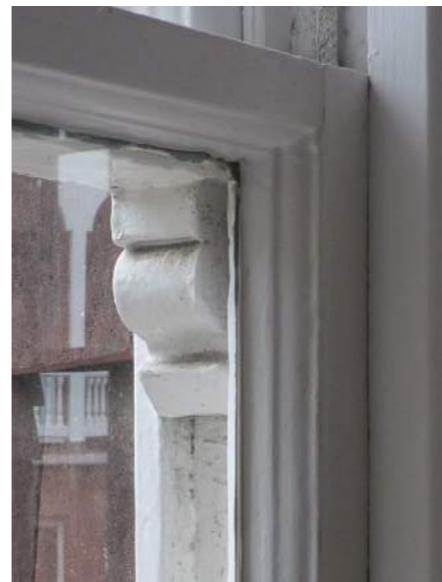
The horn detail shown is typical of the sashes to the ground floor and would appear to be original.

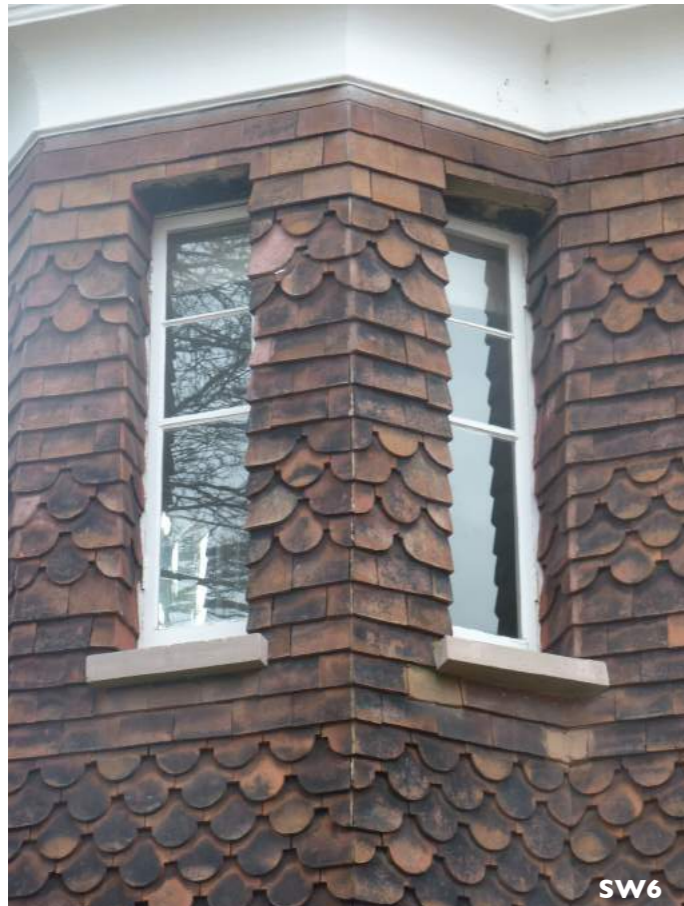
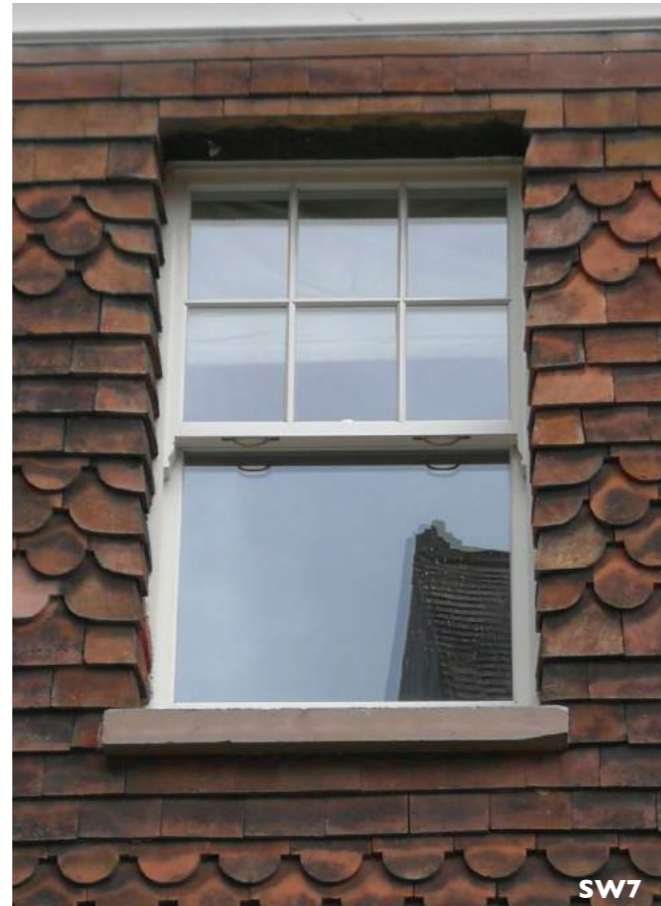
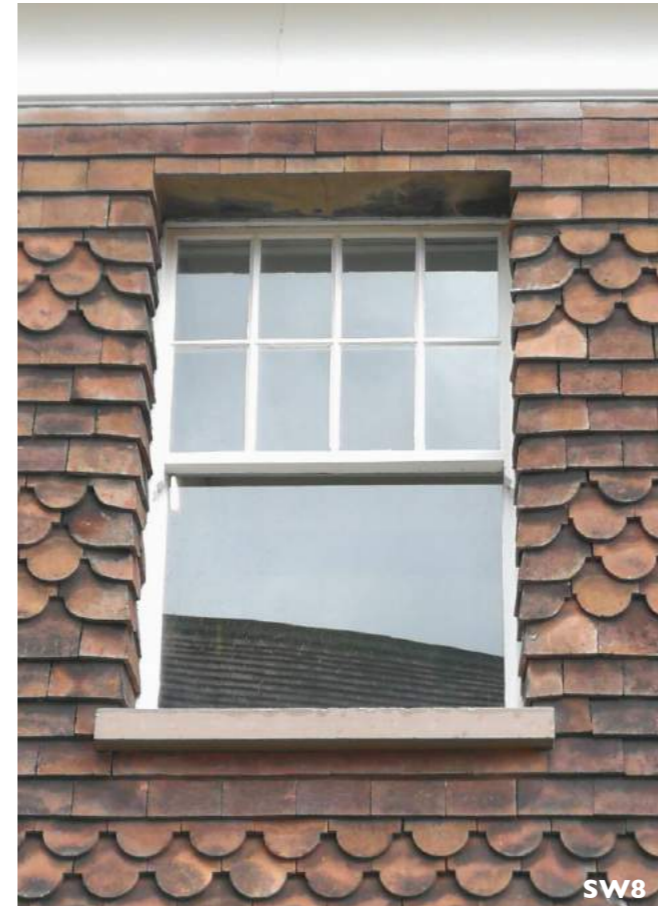
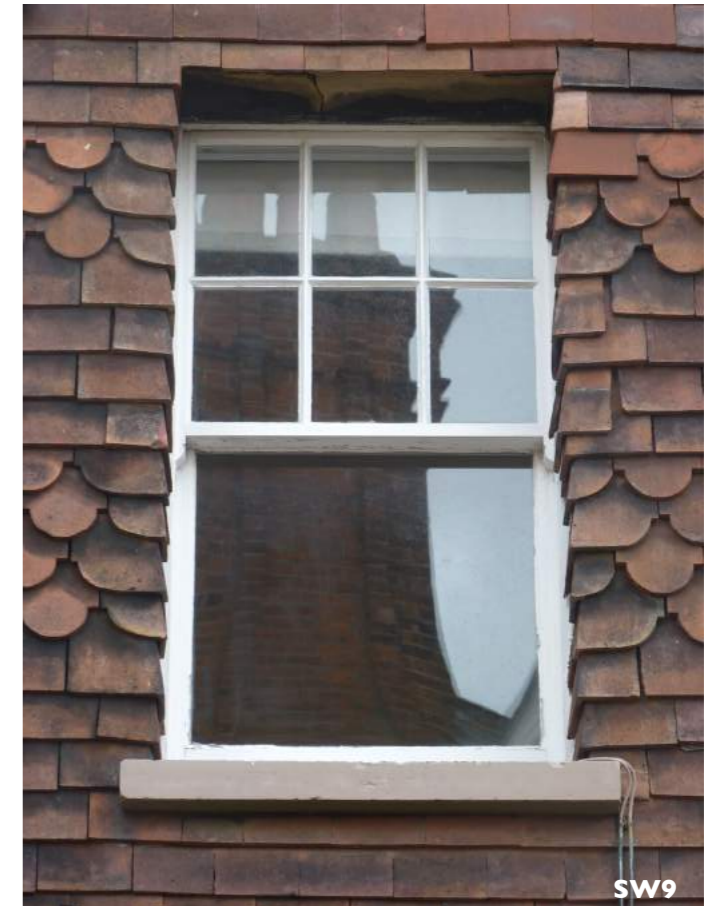
*Photos SW6-SW9
Typical windows on first floor
of South-West Elevation. The
windows have been either
replaced or refurbished- SW7 is a
relatively modern double glazed
sash window.*

*The horn details to the upper
floors vary from those at the
ground floor. It is likely that
either whole windows have been
replaced or replacement sashes
fitted within the existing sash
boxes.*

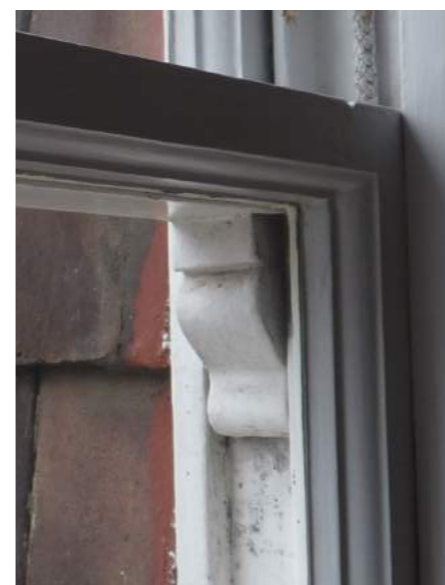
*Photos SW10-SW12
Typical windows on second
floor of South -West Elevation.
The roof lights are relatively
new and the dormer window
is replacement double glazed
casement window.*

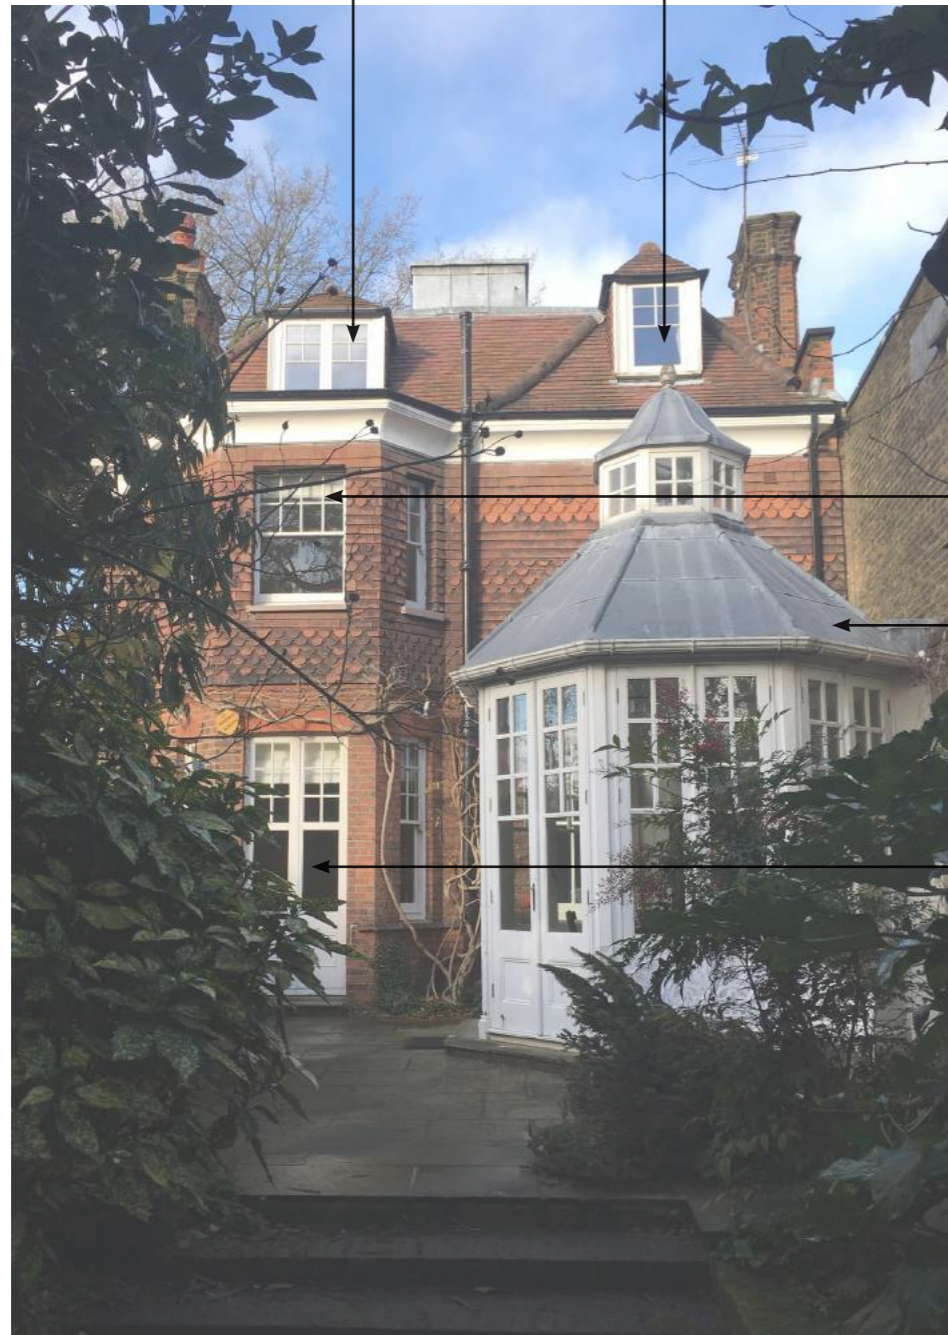
Modern double glazed timber casement windows

Non-original sash windows

Modern conservatory to be demolished and replaced with new. Planning application 2018/3493/L and 2018/2969/P

Modern French style door

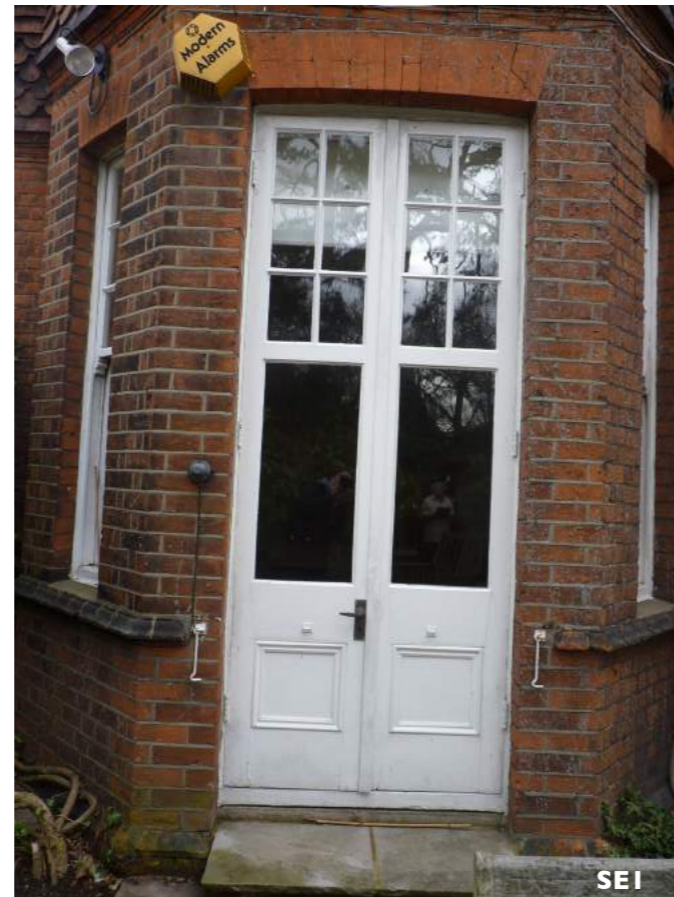
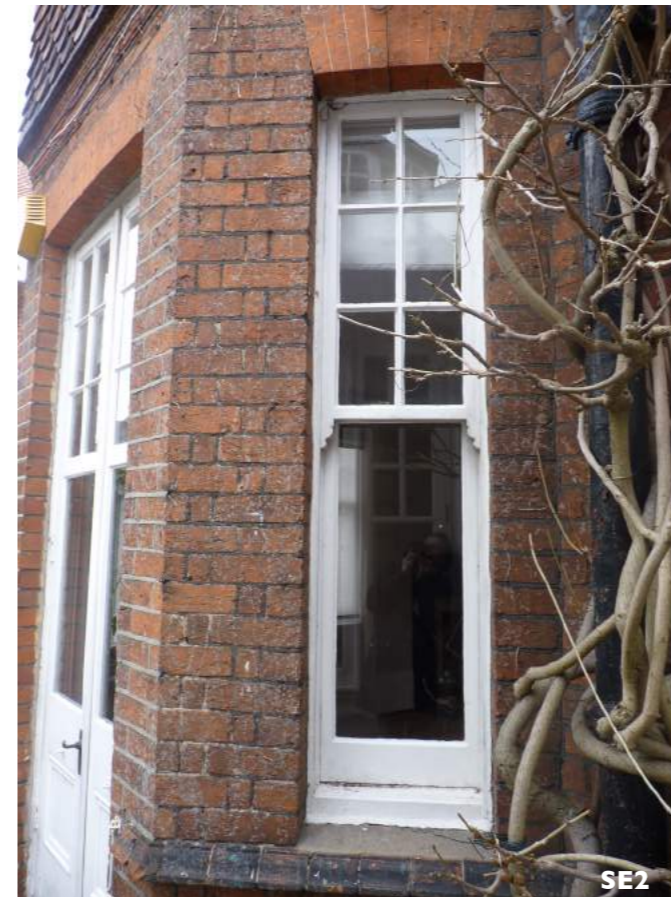
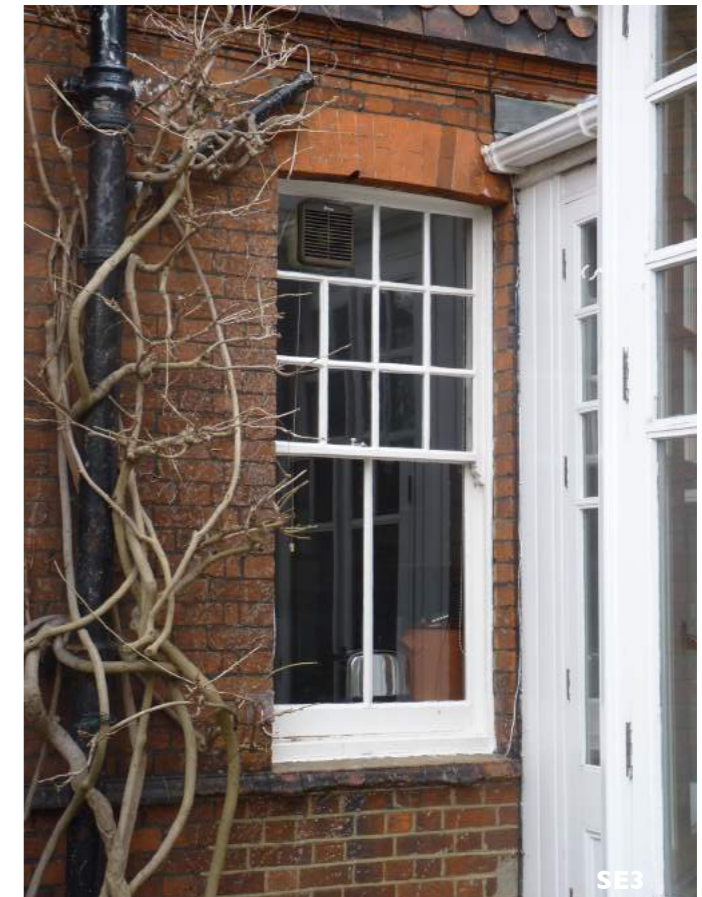
Externals : South East Elevation Ground Floor

*Photos SE1-SE4
Existing garden doors are
modern in construction, however
both windows to its sides seem to
be original.*

It is proposed to install new French Doors to the Rear and Front Gardens with slimline 10mm double glazing. Currently both doors constitute a high security risk due to their poor condition and insufficient locking systems.

Replacement of the relatively modern French doors will be undertaken using the moulding and patterns taken from the existing original windows where appropriate and from the existing doors.

- Replace existing hinges to French doors to match diameter and lengths of the originals
- 10mm Vacuum glazing to be incorporated in new door
- New glazing bars to accommodate IGU
- Moulding and patterns to be taken from the existing doors and original windows
- Locking bolts to be incorporated within frame

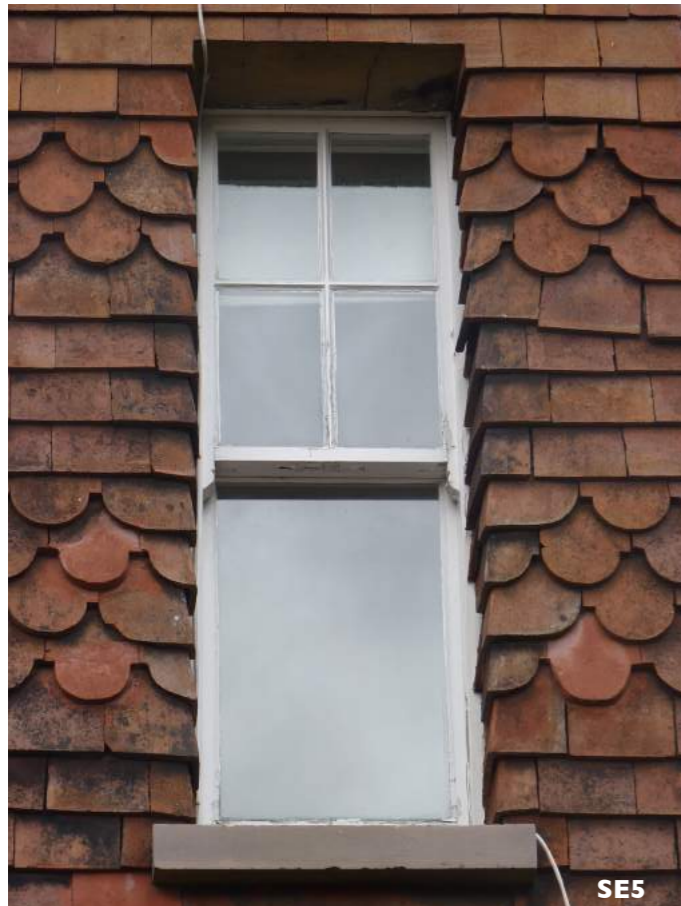
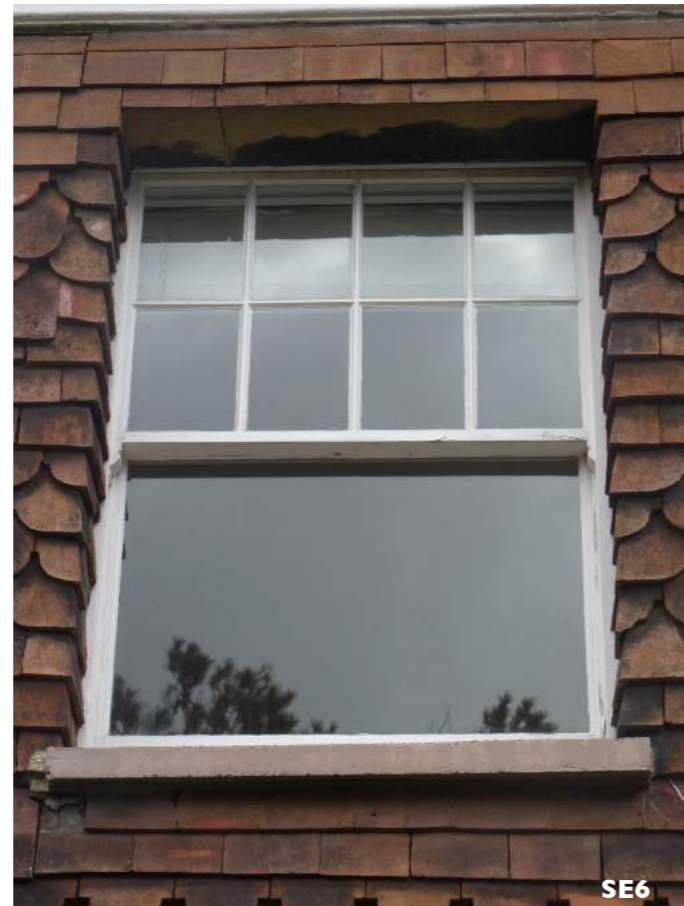
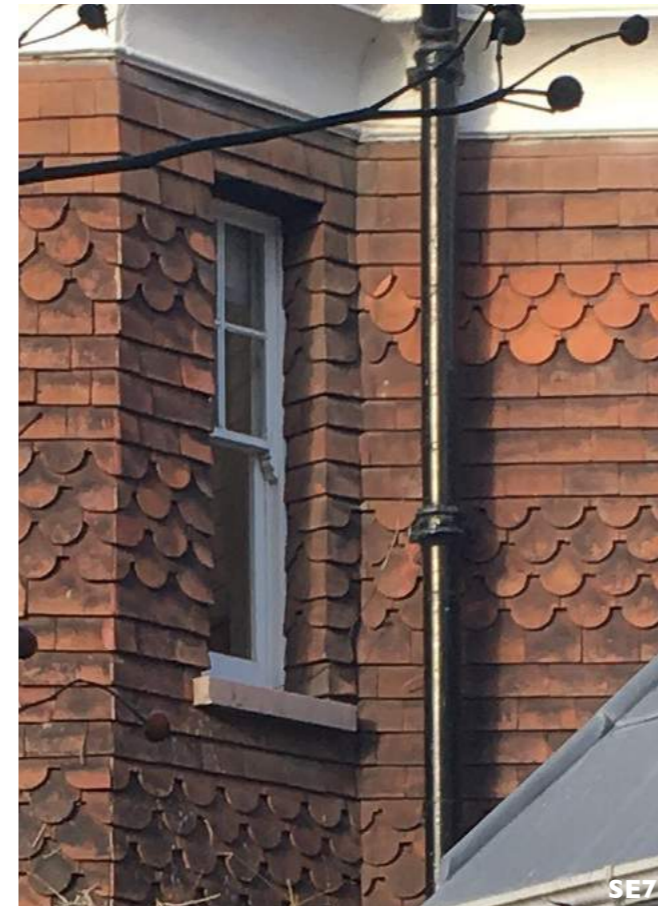
Externals : South East Elevation First Floor

*Photos SE5-SE8
Typical windows on first floor of
South-East Elevation. Windows
SE5, SE6 and SE8 are non-
original windows with different
horn details to window SE7 which
seems to date from the time of
original building.*

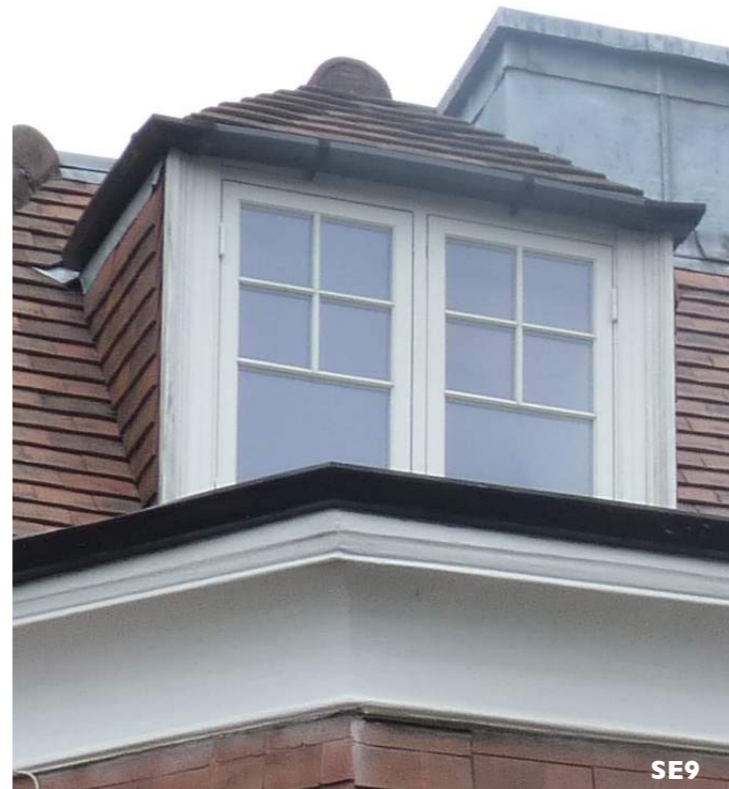
Externals : South East Elevation Second Floor

*Photos SE9-SE10
Existing second floor dormer
windows on South -East
Elevation. These are modern
timber casement windows.*

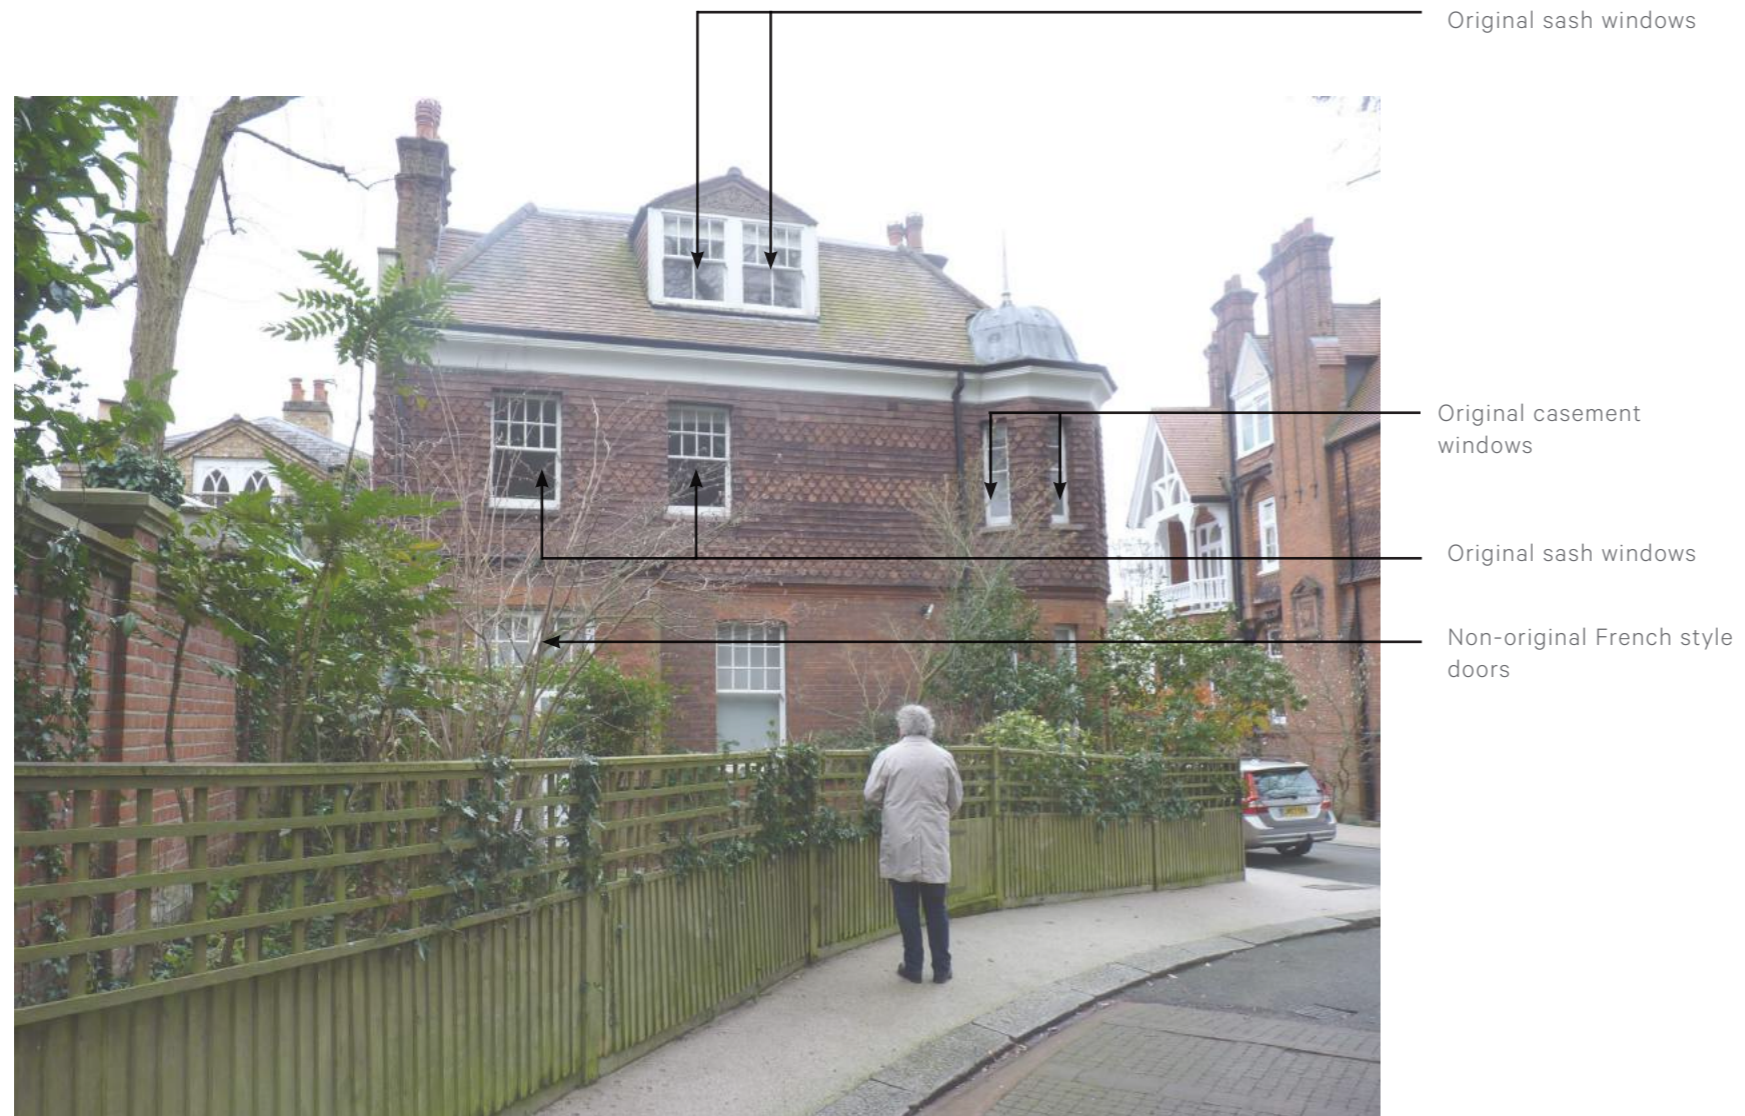
The North West elevation has a single storey square bay on the ground floor and a canted double storey corner bay finished with an ogival lead roof with tall finial.

There is a flat roofed square bay giving garden access via replacement french doors. This bay may be an early addition to the original form of the house. A sash window facing the boundary wall to the left is fitted with decorative stained glass, possibly to prevent overlooking.

The upper floor is decorated with alternating bands of plain and fish scale tiles. The upper sashes are smaller in size and the canted bay has narrow casement windows.

There is a gabled, half-hipped, two-light dormer with tile-hung flanks and gables with a decorative motif.

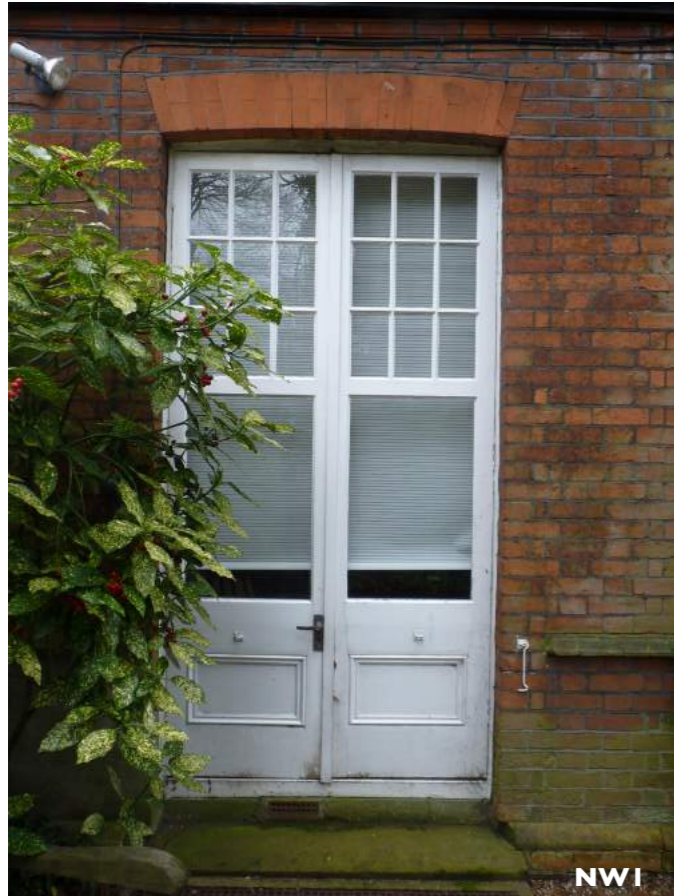
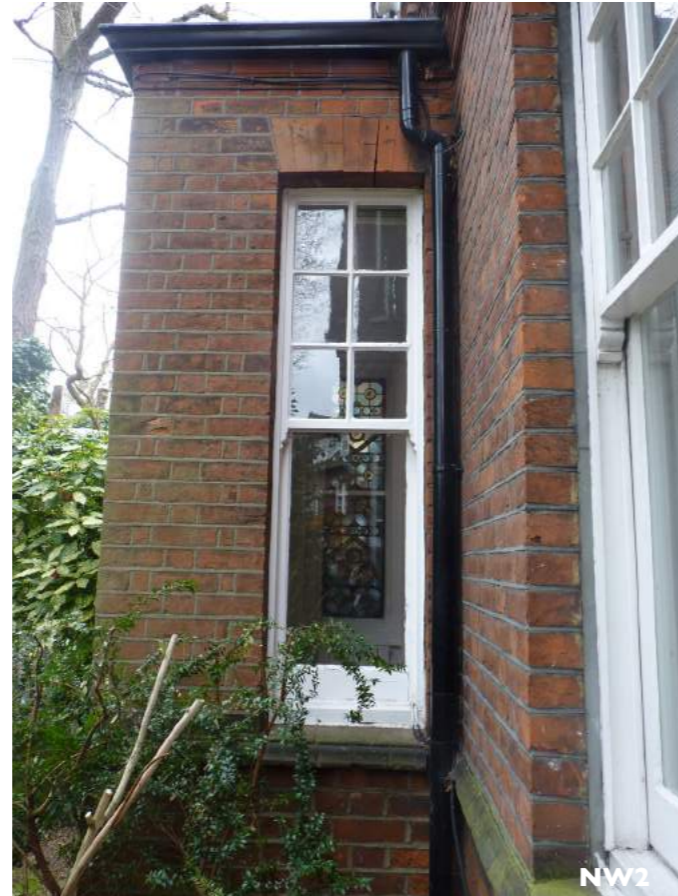
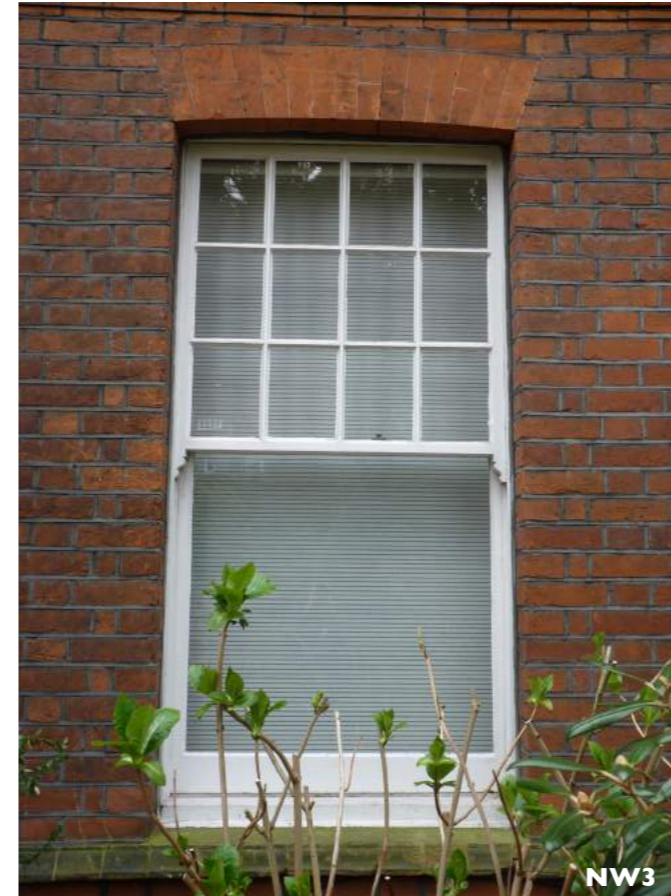
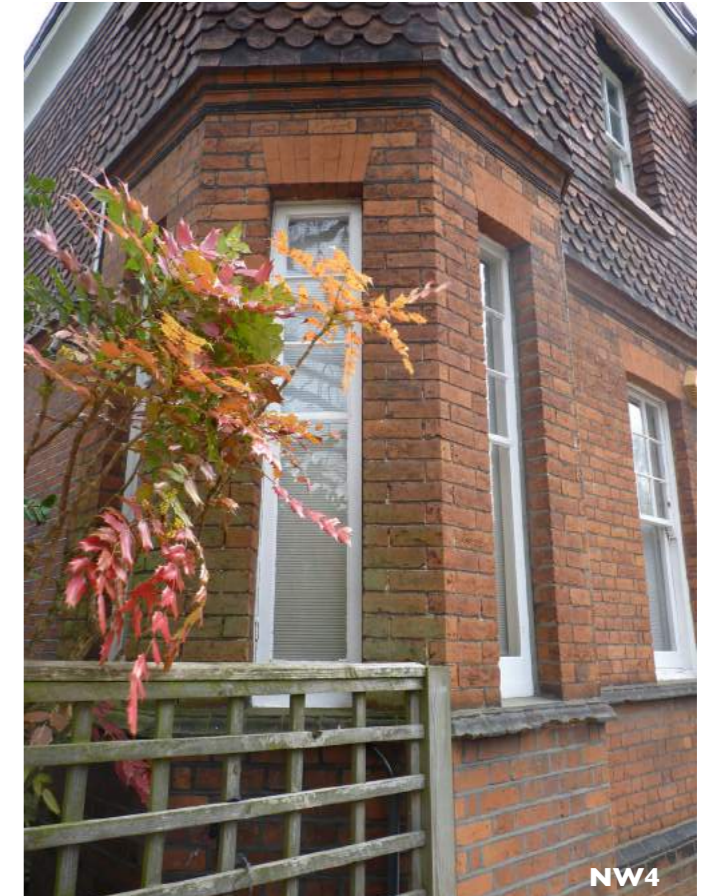
*Photos NW1-NW4
Typical ground floor windows and
door on North -West Elevation.
The sash windows are original
with some drought proofing work
done to the window on photo
NW3. The door to the ground
floor reception room however
is relatively modern and in very
poor condition.*

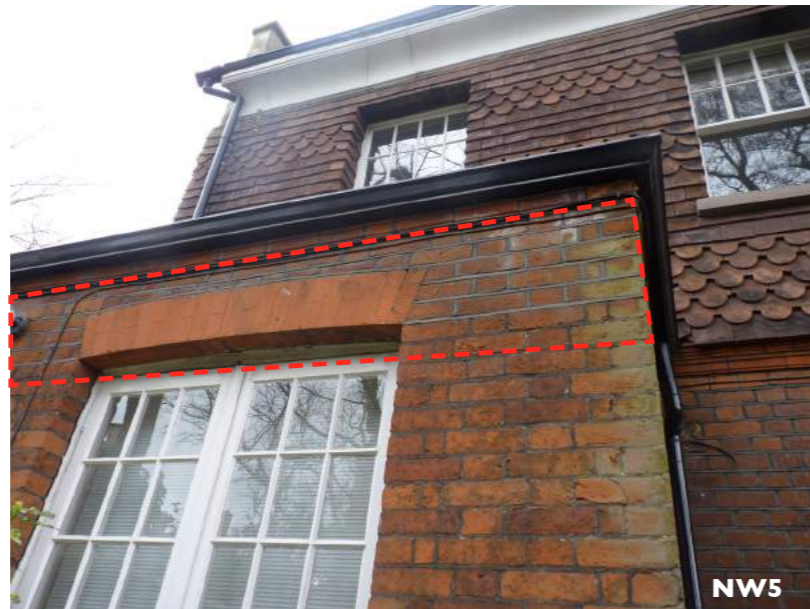
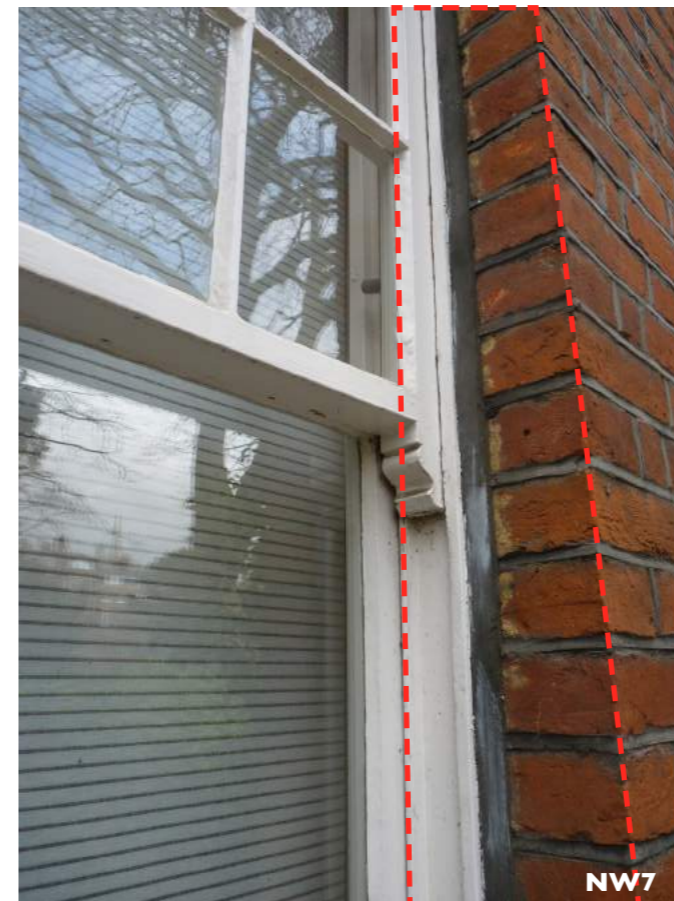
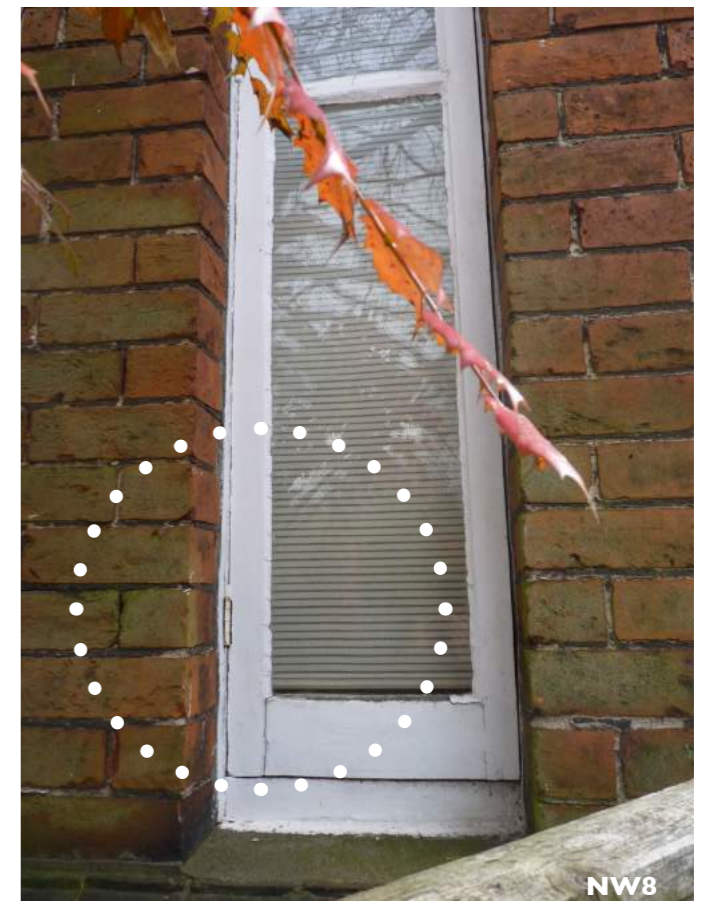
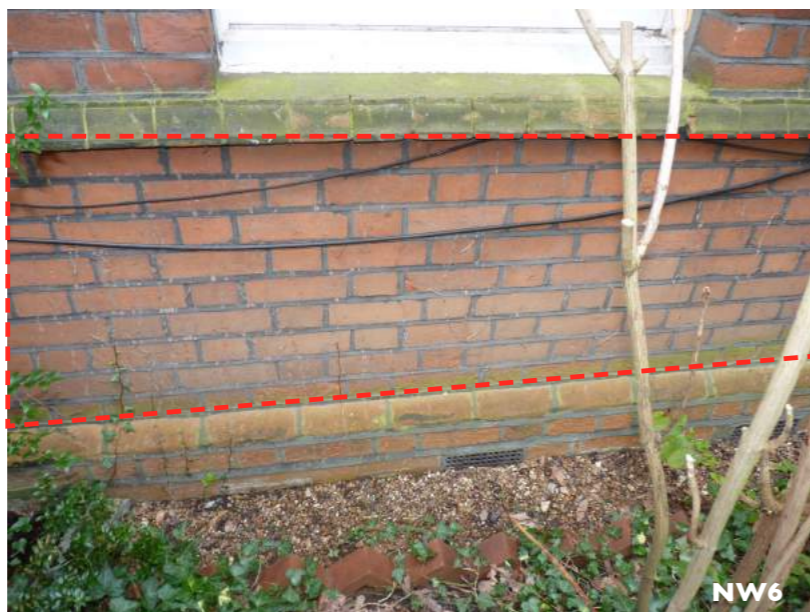
Photos NW5-NW6
Red dashed line denotes the repointing work that was carried out to the ground floor walls. Some of the windows were drought proofed with caulk which is visible on photo NW7

Photo NW8
Circled replacement hinges to some of the casement windows on ground floor of corner bay.

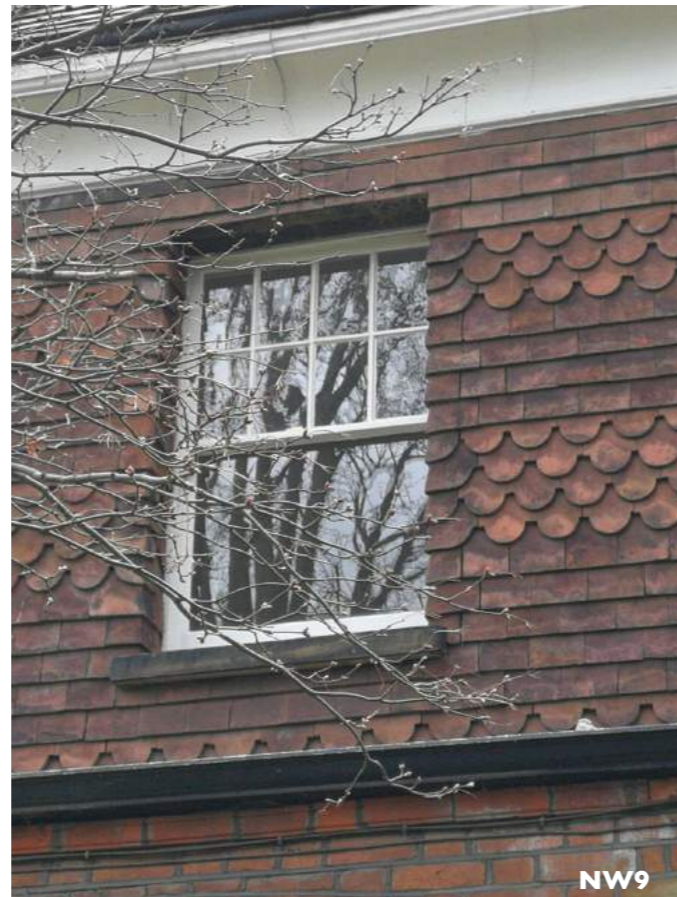
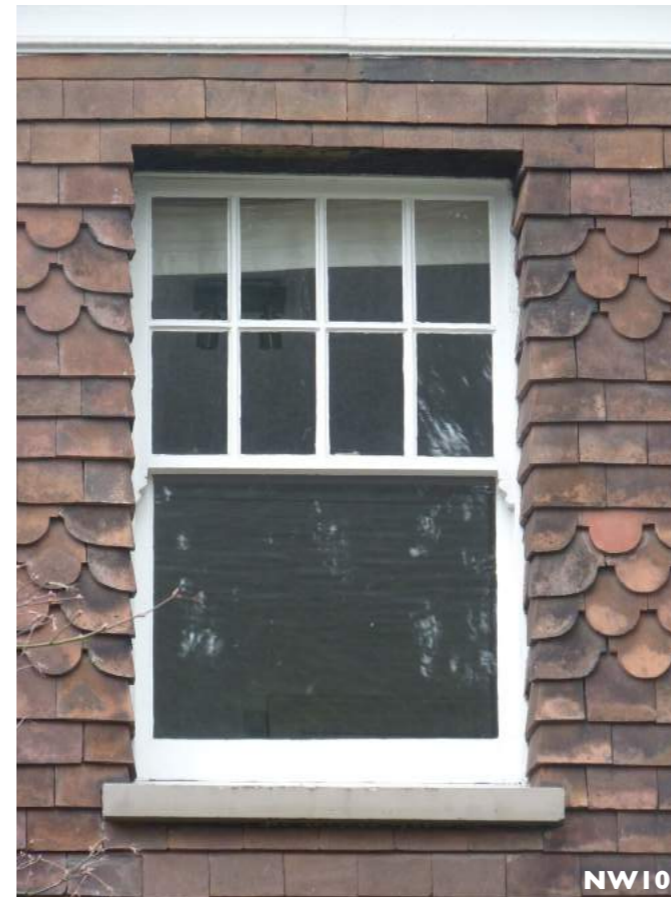
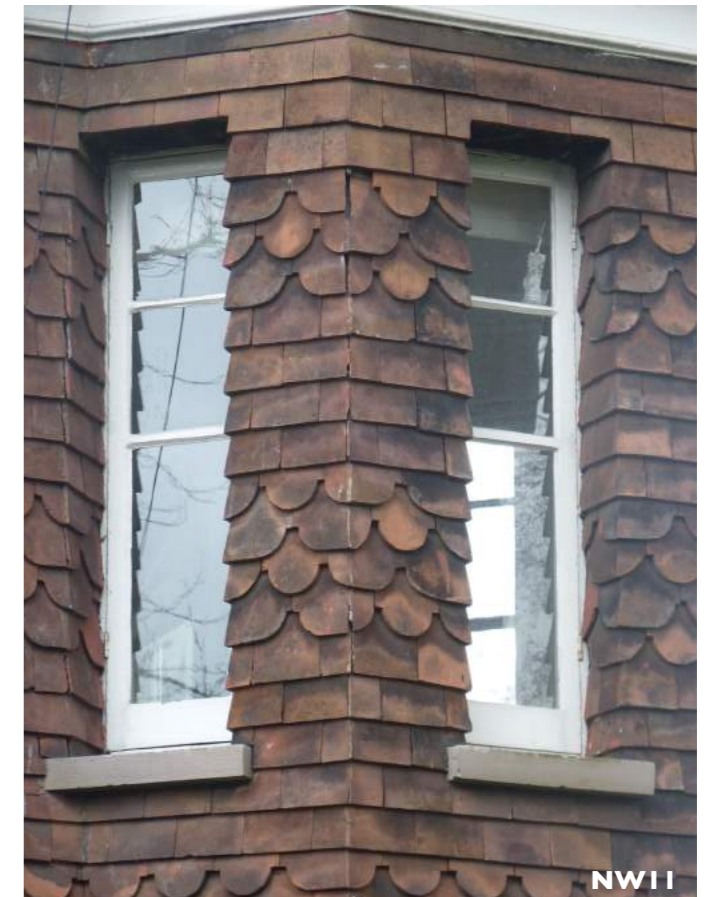
Externals : North West Elevation First Floor

*Photos NW9-NW11
Existing first floor windows on
North -West Elevation. The sash
windows seem to be original. The
casement windows in the corner
bay seem to be original as well.*

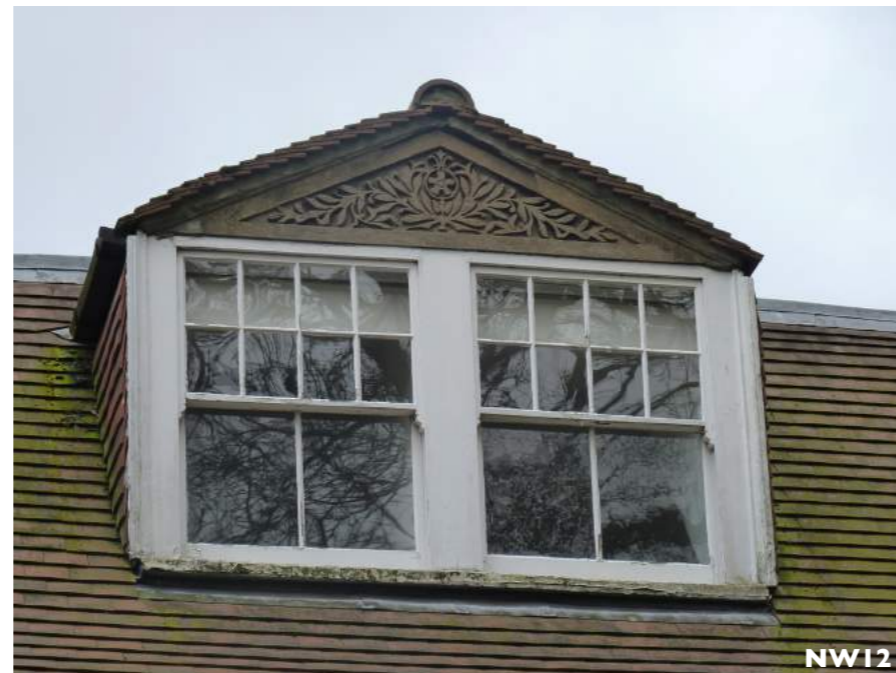
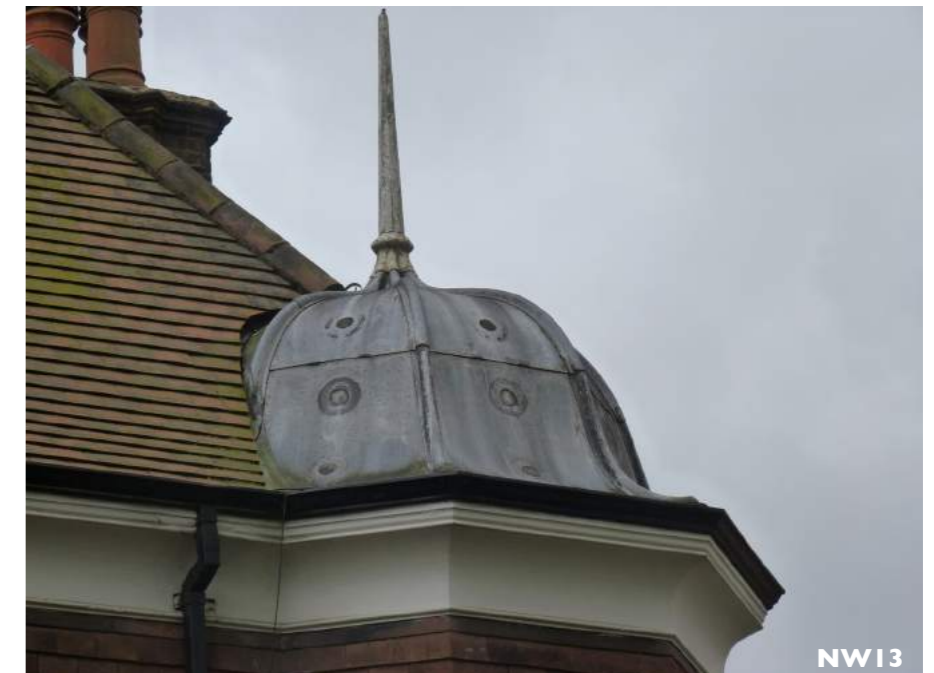
Externals : North West Elevation Second Floor

*Photo NW12-NW13
Photo NW12 shows gabled two-
light dormer with sashes with
decorative gable. Photo NW13
shows the ogival leaded roof with
tall finial to corner bay.*
