5 Gainsborough Gardens

Design and Access Statement: 25th April 2019

This document is to accompany the Listed Building, Conservation Area and Planning Application for replacement of two modern French Doors at No 5 Gainsborough Gardens, a Grade II listed semi-detached house located within the Hampstead Conservation Area.

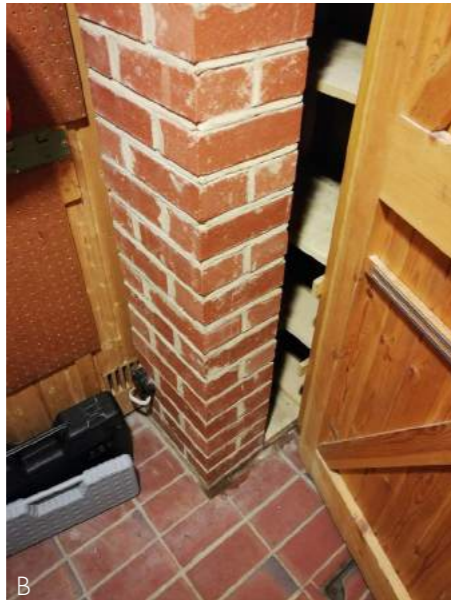
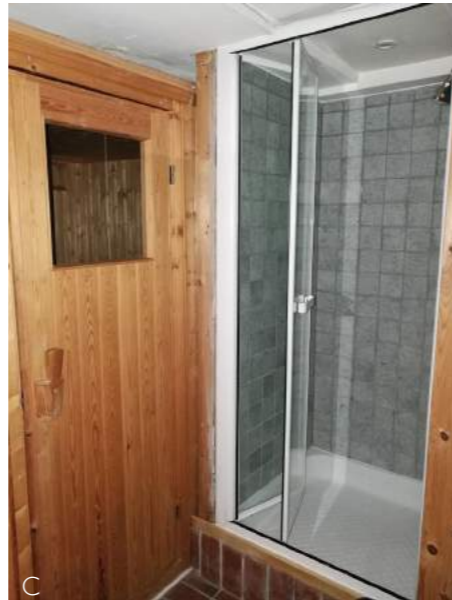
Internals : Basement

Photos A-C
Photo A shows the staircase.
Photo B shows new pier column which supports new beam.
Photo C shows timber partition between the sauna and shower.

The plan shows structural alterations, which were carried out some time ago, with new steel and brick columns supporting new beam.

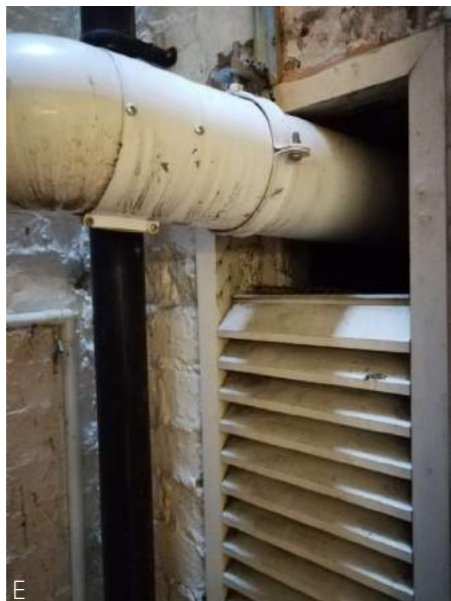
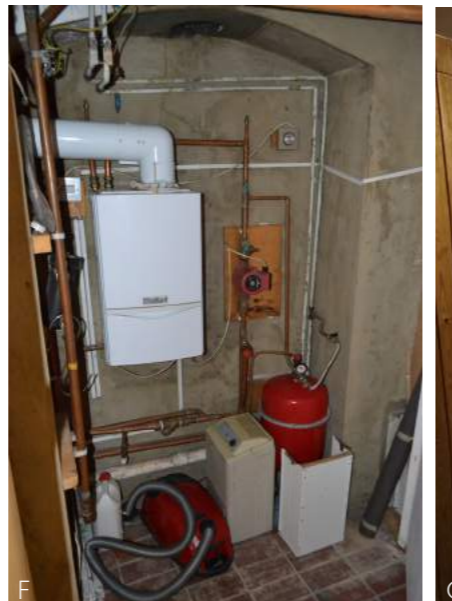
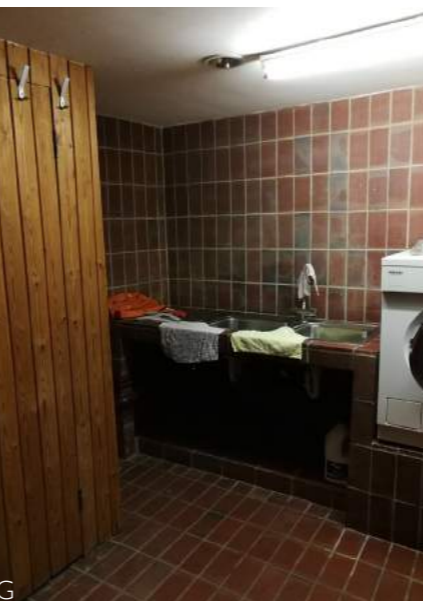
The external lightwell appears to date from the time of the construction of the original building, however it has been modified over time to allow for various pipe work connections.

Photos D-G
These photos show boxing in to the original lightwell windows as well as the remains of an original arch to the kitchen hearth which now holds new boiler. Photo G shows utility area to the back of the basement.

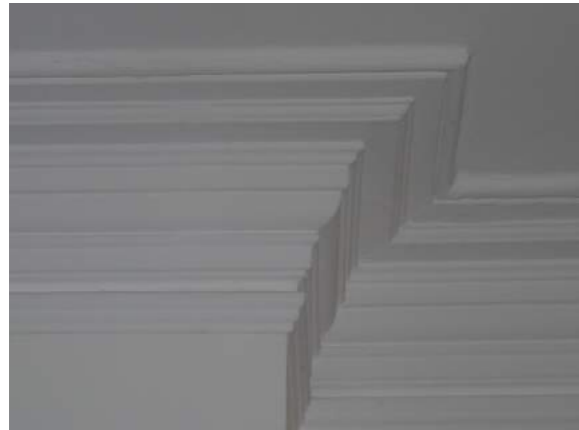
Moulded cornice detail to the ceilings

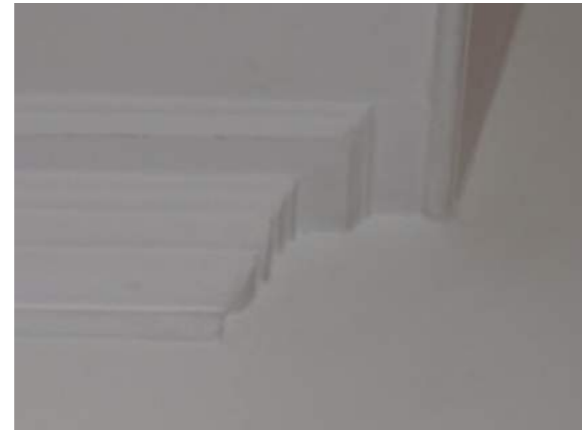
Moulded cornice detail abutting stair

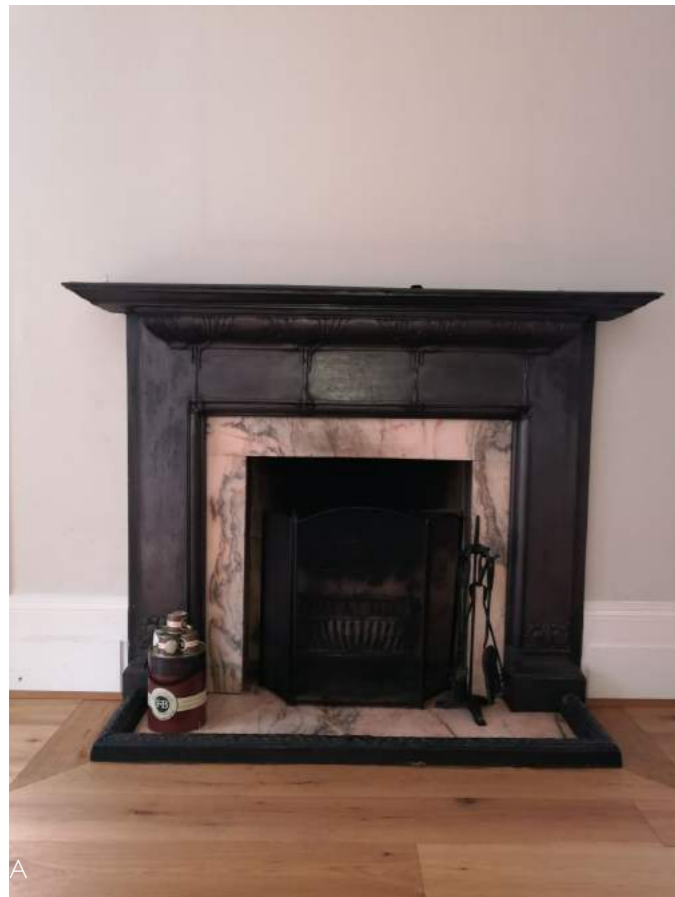
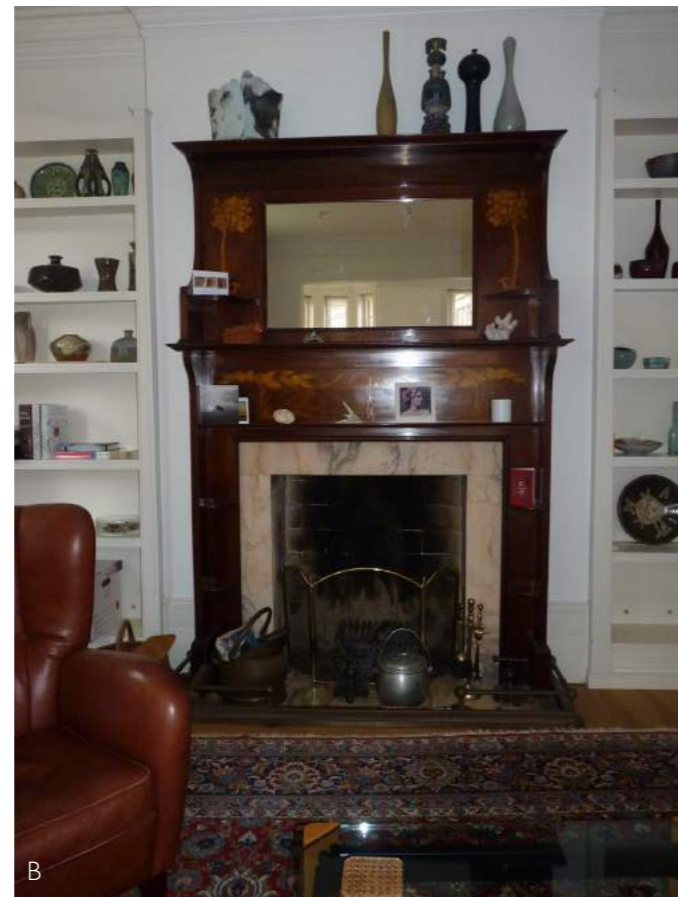
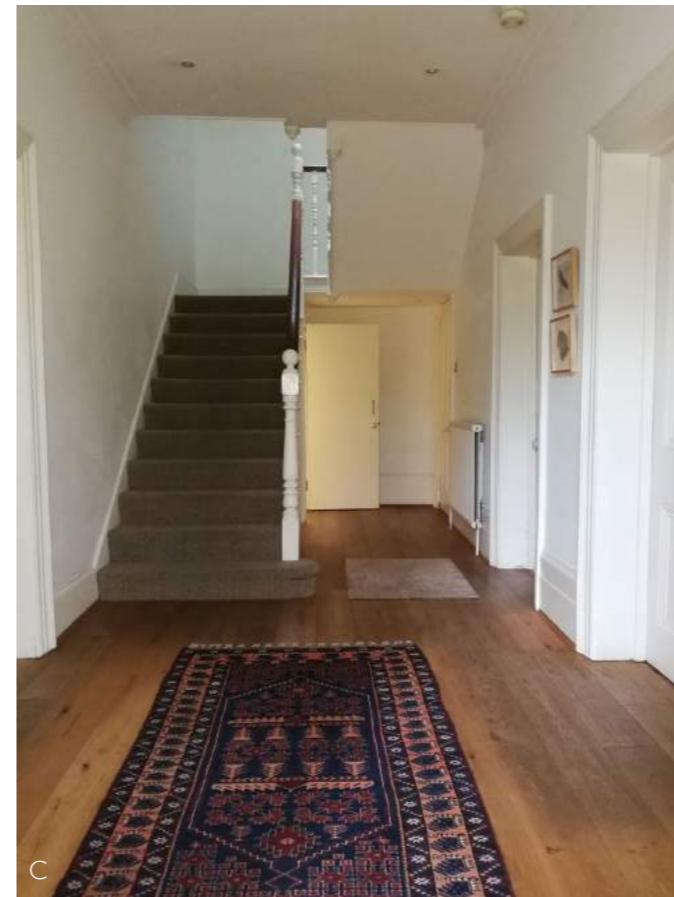
*Photos A-B
These photos show ornamental fireplaces to dining and drawing rooms, typical window surrounds and stained glass sash window to side bay. It should be noted that the fireplaces were installed by the current owners before the building being listed and are not original to the building*

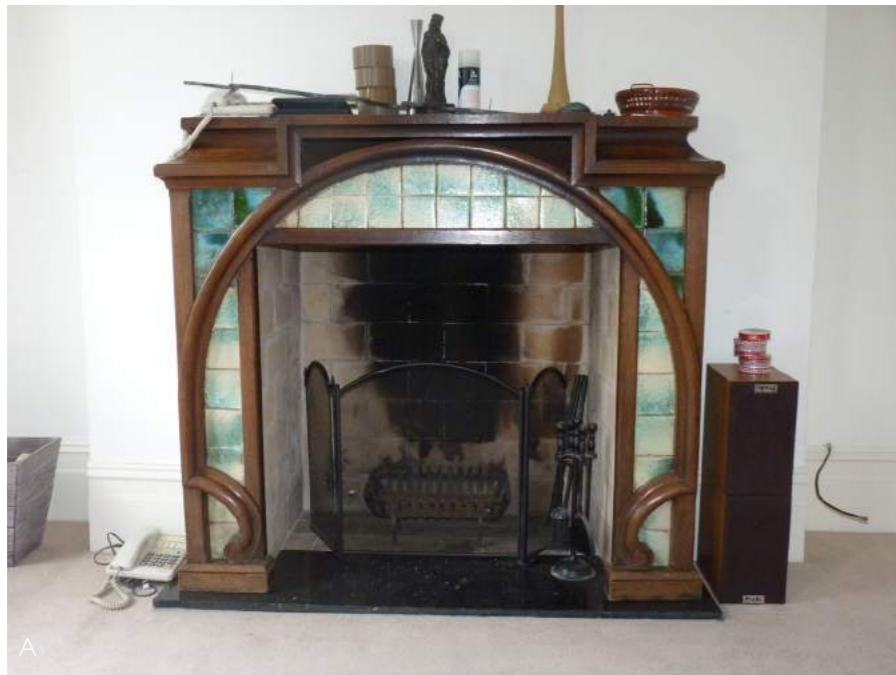
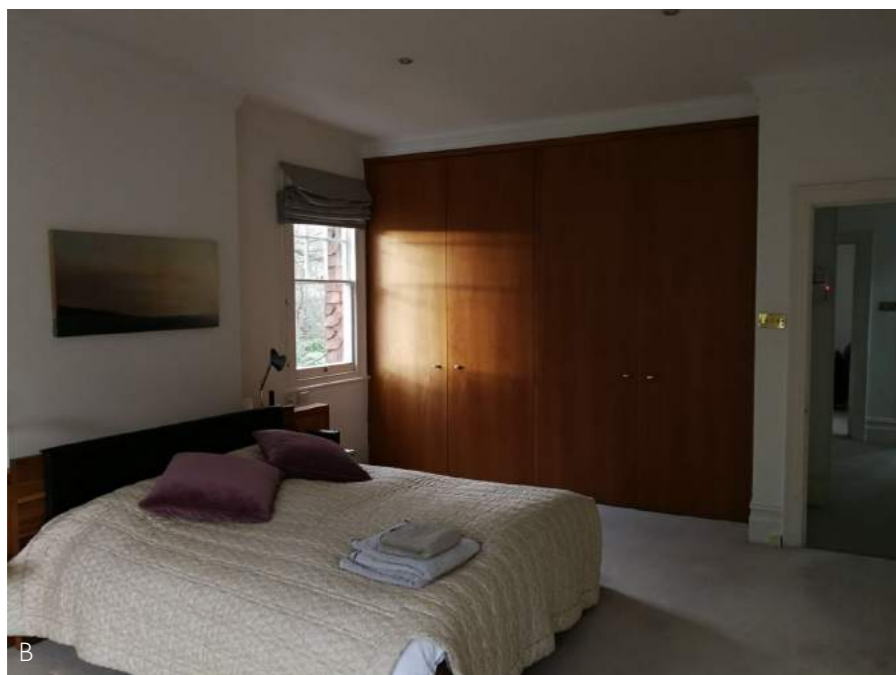
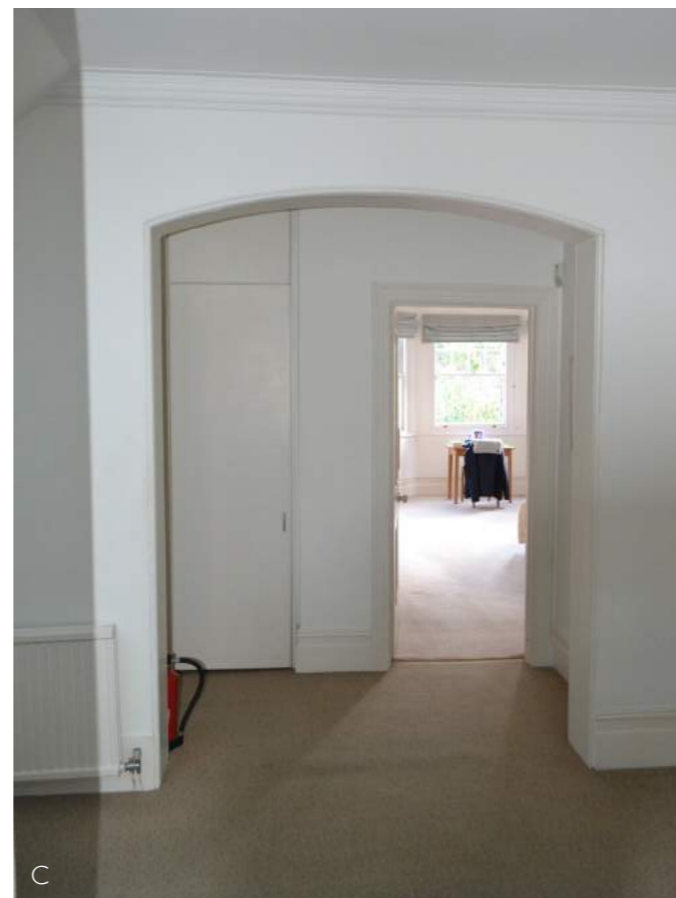
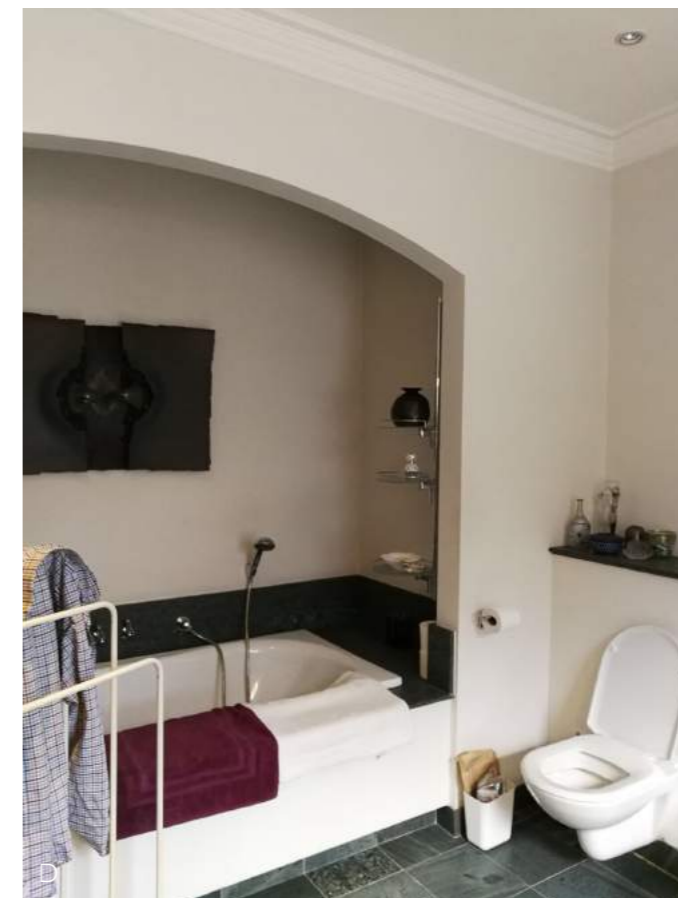
*Photos A-D
These photos show typical door
architrave detail, art nouveau
fireplace, modern joinery within
the bedrooms and en-suit
bathroom.*

The first floor was refurbished by the current owners prior to the building being listed. Master bedroom was fitted with walk in wardrobe hidden behind joinery units. A number of rooms have decorative cornicing with mixture of new and original patterns.

What now is a en-suit bathroom could once be an internal room and is not of any historical value.

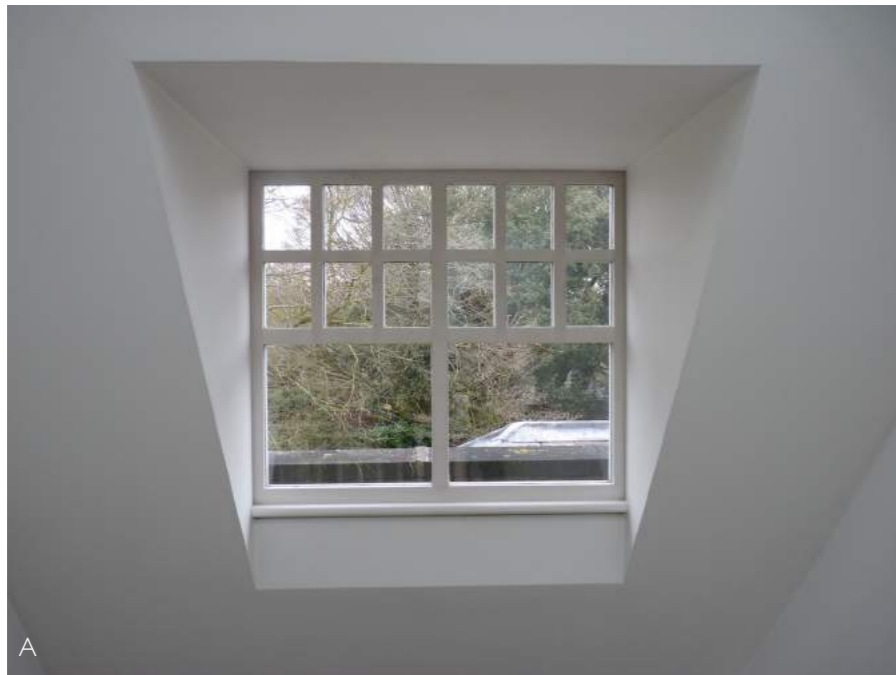
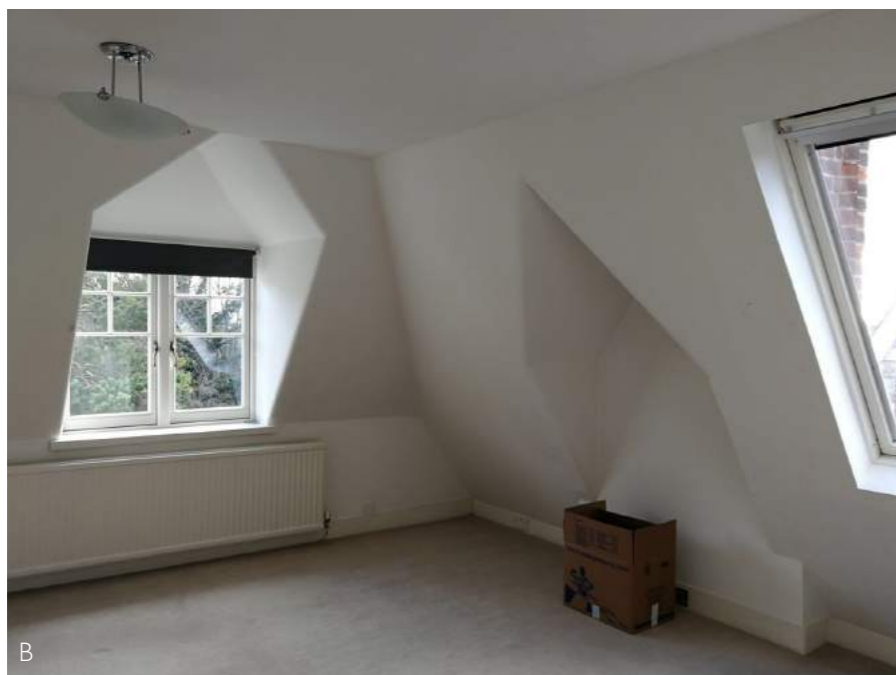
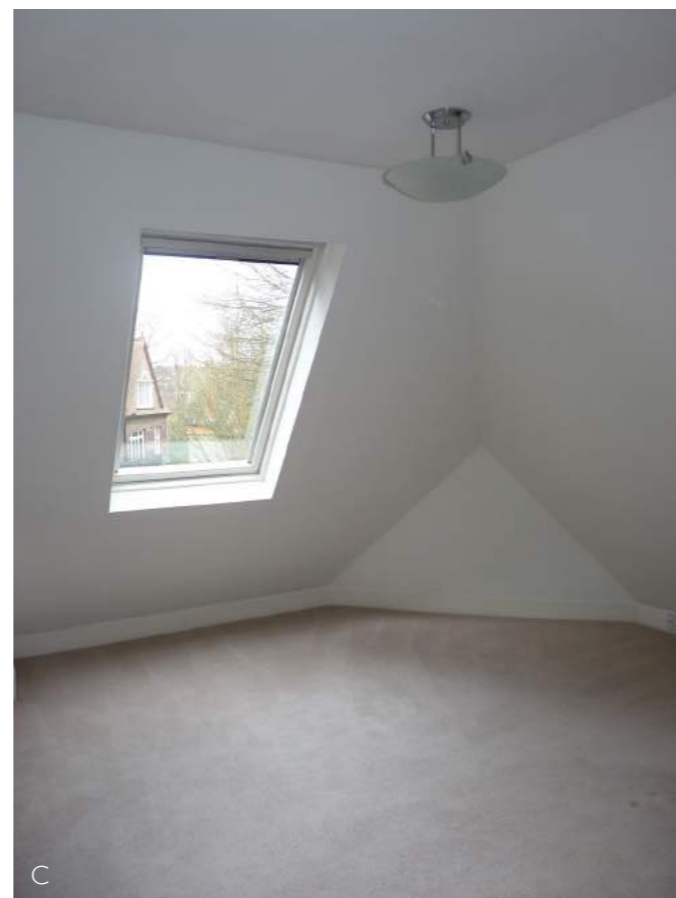
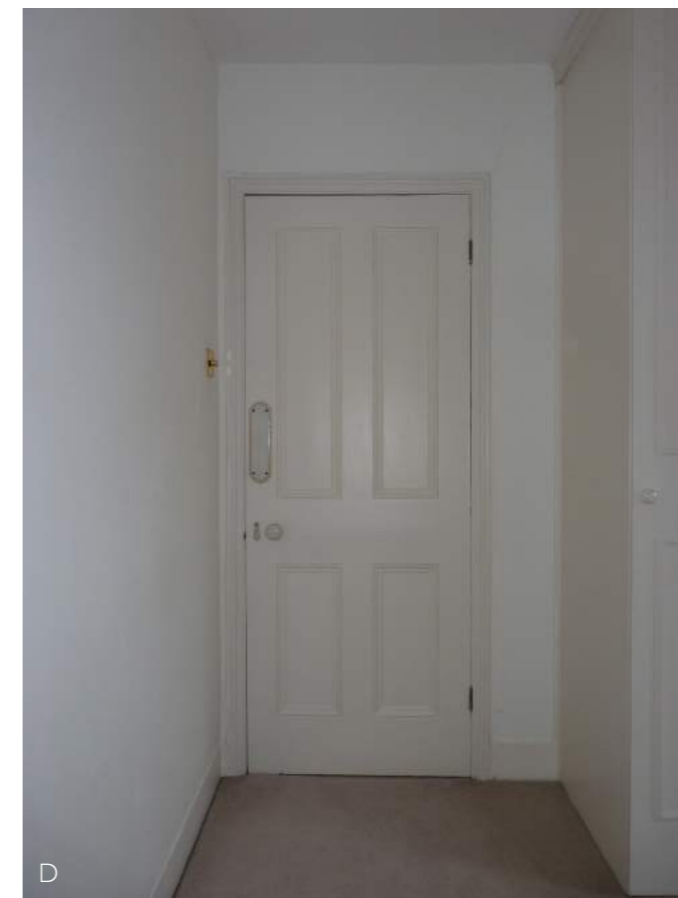
*Photos A-D
These photos show typical door
architrave detail, simple skirting
boards to all rooms and various
modern dormer windows.*

Besides the two windows to north west elevation all windows are modern timber windows.

There is a new dormer to the North-East elevation with fixed glazing and heavy glazing bars. There are number of new rooflights.

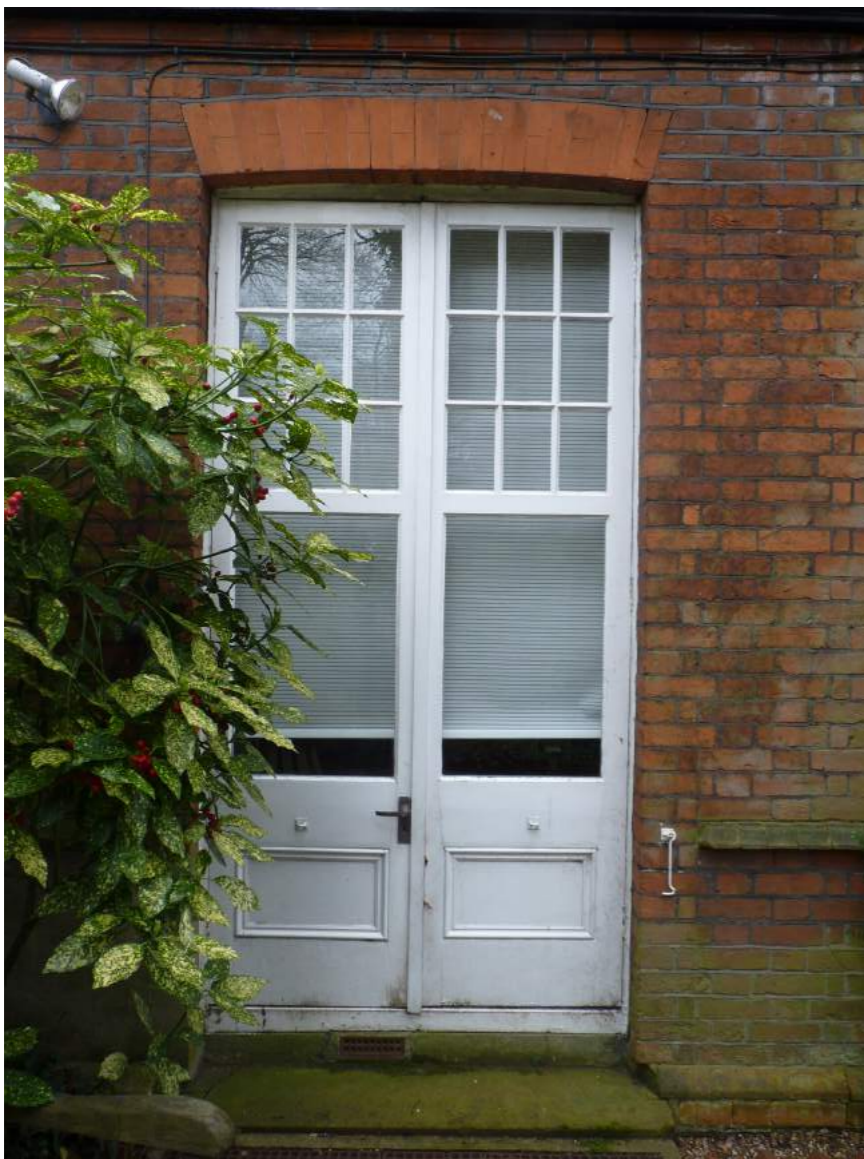
Existing Front Garden French Door

It is proposed to install new French Doors to the Rear and Front Gardens with slimline 10mm double glazing. Currently both doors constitute a high security risk due to their poor condition and insufficient locking systems.

Replacement of the relatively modern French doors will be undertaken using the moulding and patterns taken from the existing original windows where appropriate and from the existing doors.

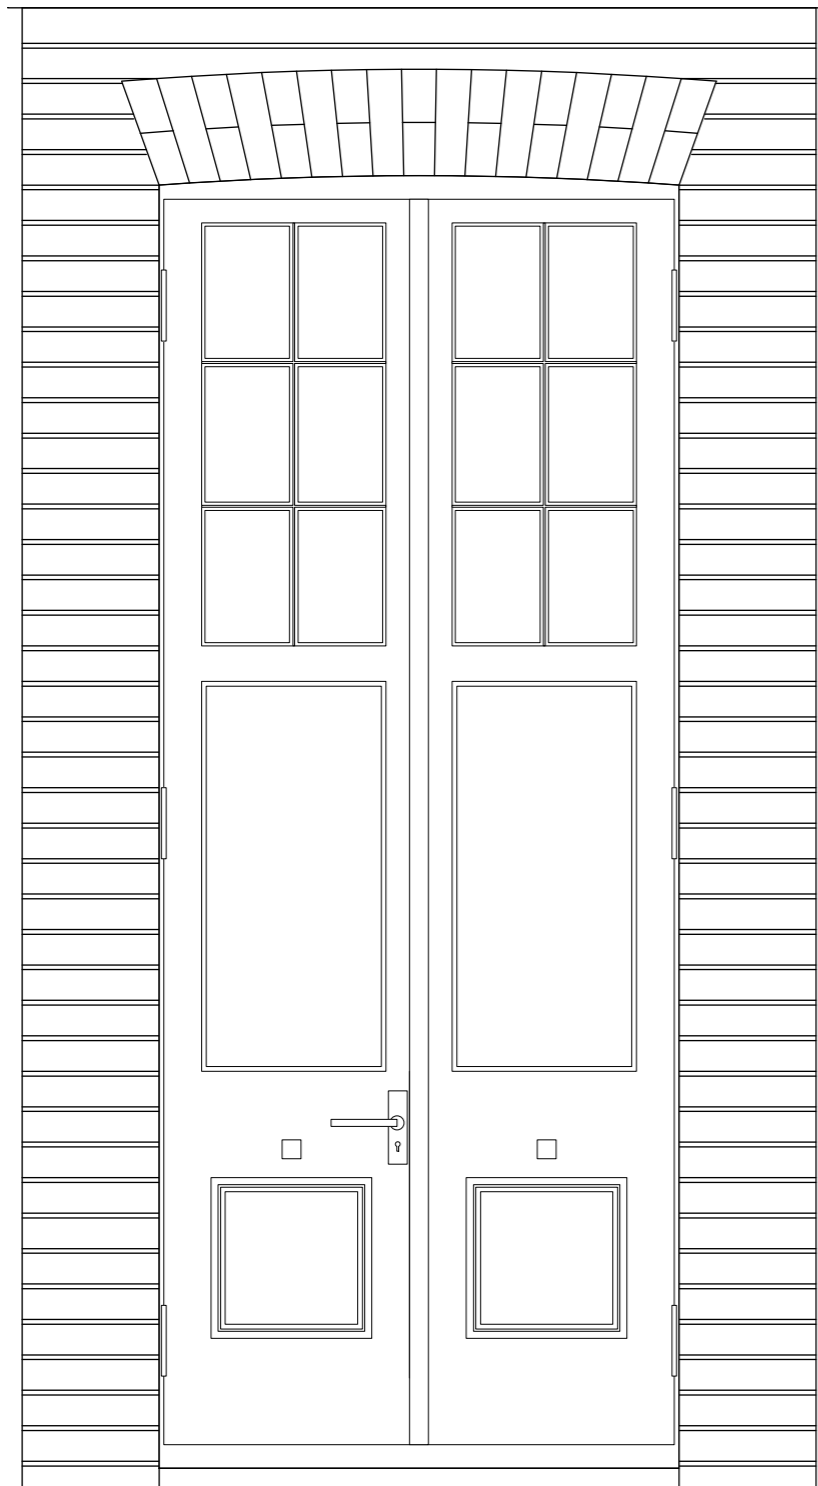
1 French Door External Elevation
Scale: 1:8

These doors are relatively modern replicas.

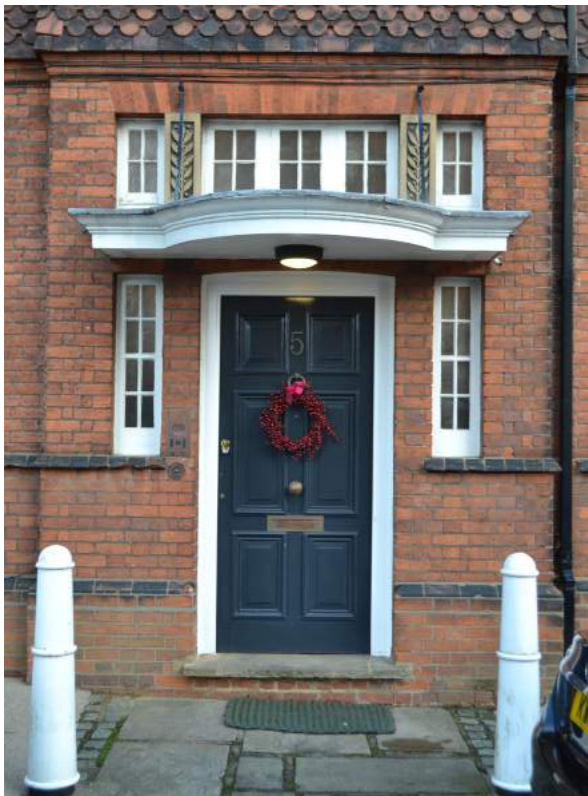
Existing stepped access to the property

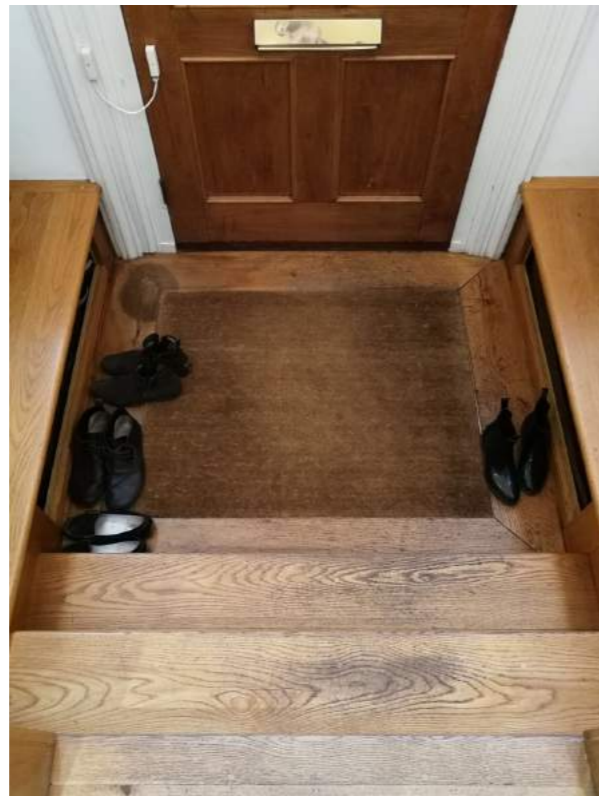
Existing Internal stairs to the front entrance lobby
