**DESIGN, ACCESS AND
CONSERVATION AREA STATEMENT**

The balustrading to the front steps at

**4 Compayne Gardens,
London NW6 3DH**

11 April 2019

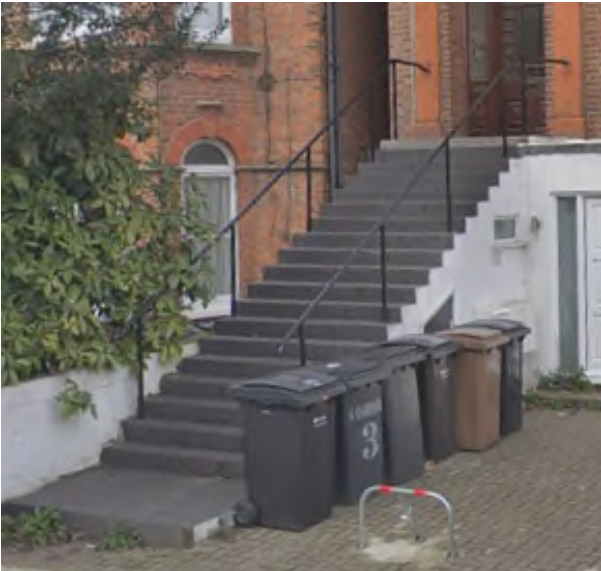
The existing staircase is supported of masonry walls on both sides with threads and risers similarly of masonry.

The original style handrail is in place. There is however no balustrading.

The absence of balustrading constitutes a danger and a fall hazard, particularly to children.

There is no dwarf walls are removed.

There is no balustrading of any description.

Existing Front Steps

The design of the steps will incorporate dwarf walls to be stucco rendered. The type of render will be sand and cement continuously in line on the external faces with the masonry beneath and will match same. There will be a coping over to match others in the area. Both sides of the dwarf walls and the coping will be painted white in a masonry paint to match others in the area.

Our preference is the second form of balustrading however we have offered both for your consideration.

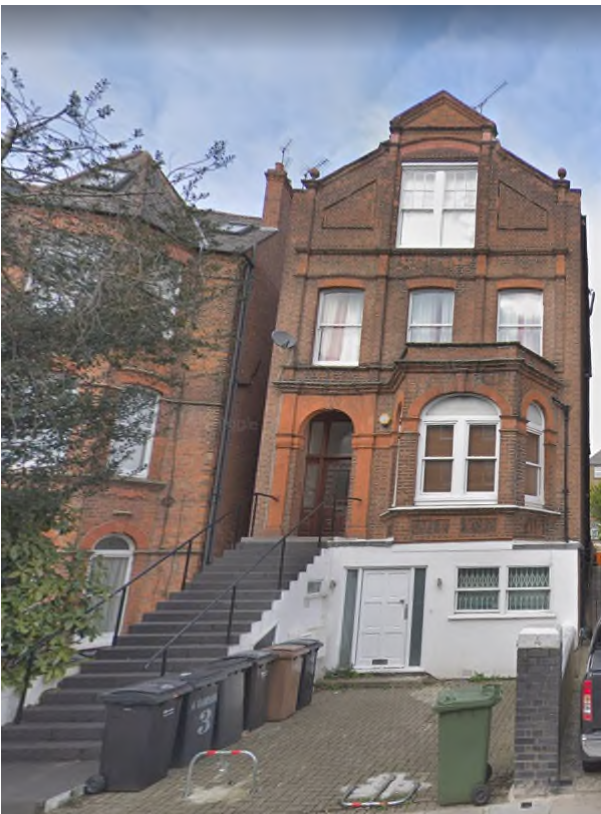
The façade is of solid brickwork. The brickwork is in Flemish bond with the original sand and cement jointing between exposed brick faces.

There is a Roman style arch with central key bricks over the hall door with the arch springing points are supported on corbel brickwork. There are front brick columns projecting a half brick which continue up to support a 3 brick corbel which forms part of a horizontal band extending over the entrance and continuing over all 3 sides of the front splay bay. There are similar Roman style arches over the bay windows with projecting key bricks over the display bay central arch.

The ground floor façade is stucco rendered in smooth finish with no architectural merit.

Existing Façade

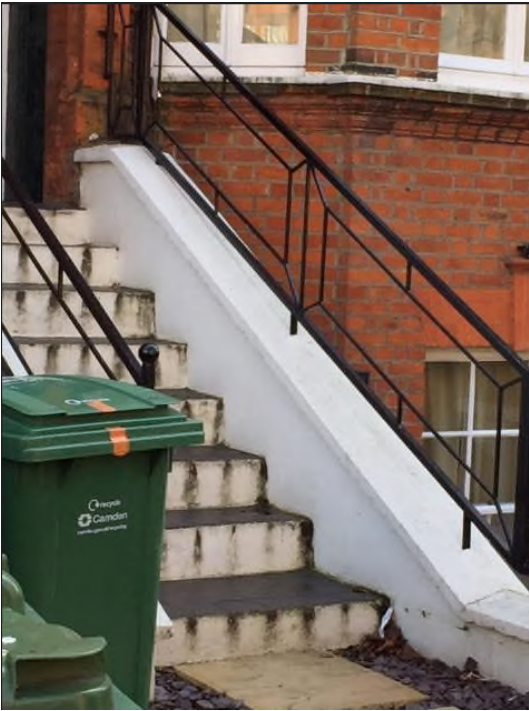
A second type of balustrading found in the opposite side of the road and which appears to be quite old, though perhaps not original is that of reducing rectangles with spaces of not more than 100 mm between same. Either balustrade would be in mild steel with face dimensions not

Rectangular Balustrading found on Compayne Gardens

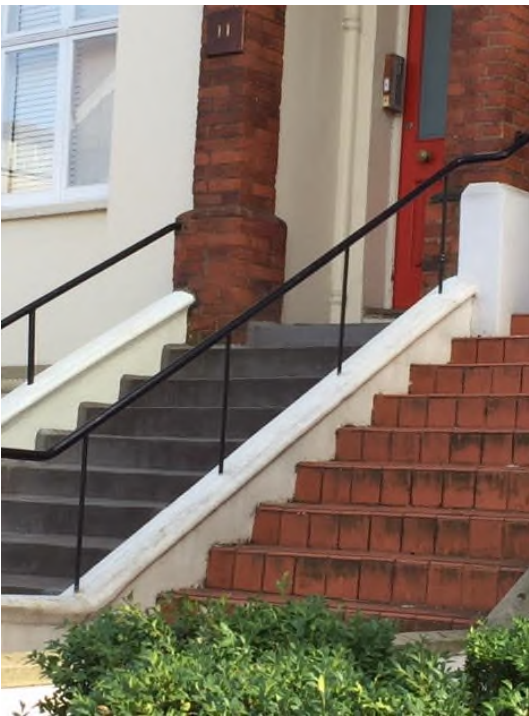
The original stairs in the area have dwarf walls with a handrail over. The area between the top of the dwarf walls and the handrail is un-protected in original and un-altered buildings.

Original open balustrading

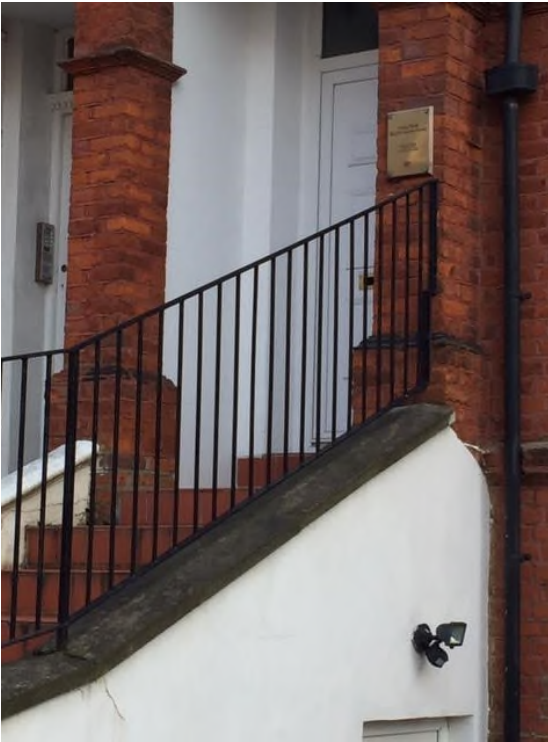
There are two types of balustrading locally. The more common provides vertical rails with a gap of not more than 100 mm between same.

Modern Vertical Rail Balustrading.
