Internal Repairs & Conservation Key

Drawings to be read in conjunction with Outline Conservation Strategy - Key Areas **CTH-PUR-MP-00-SP-A-00005**

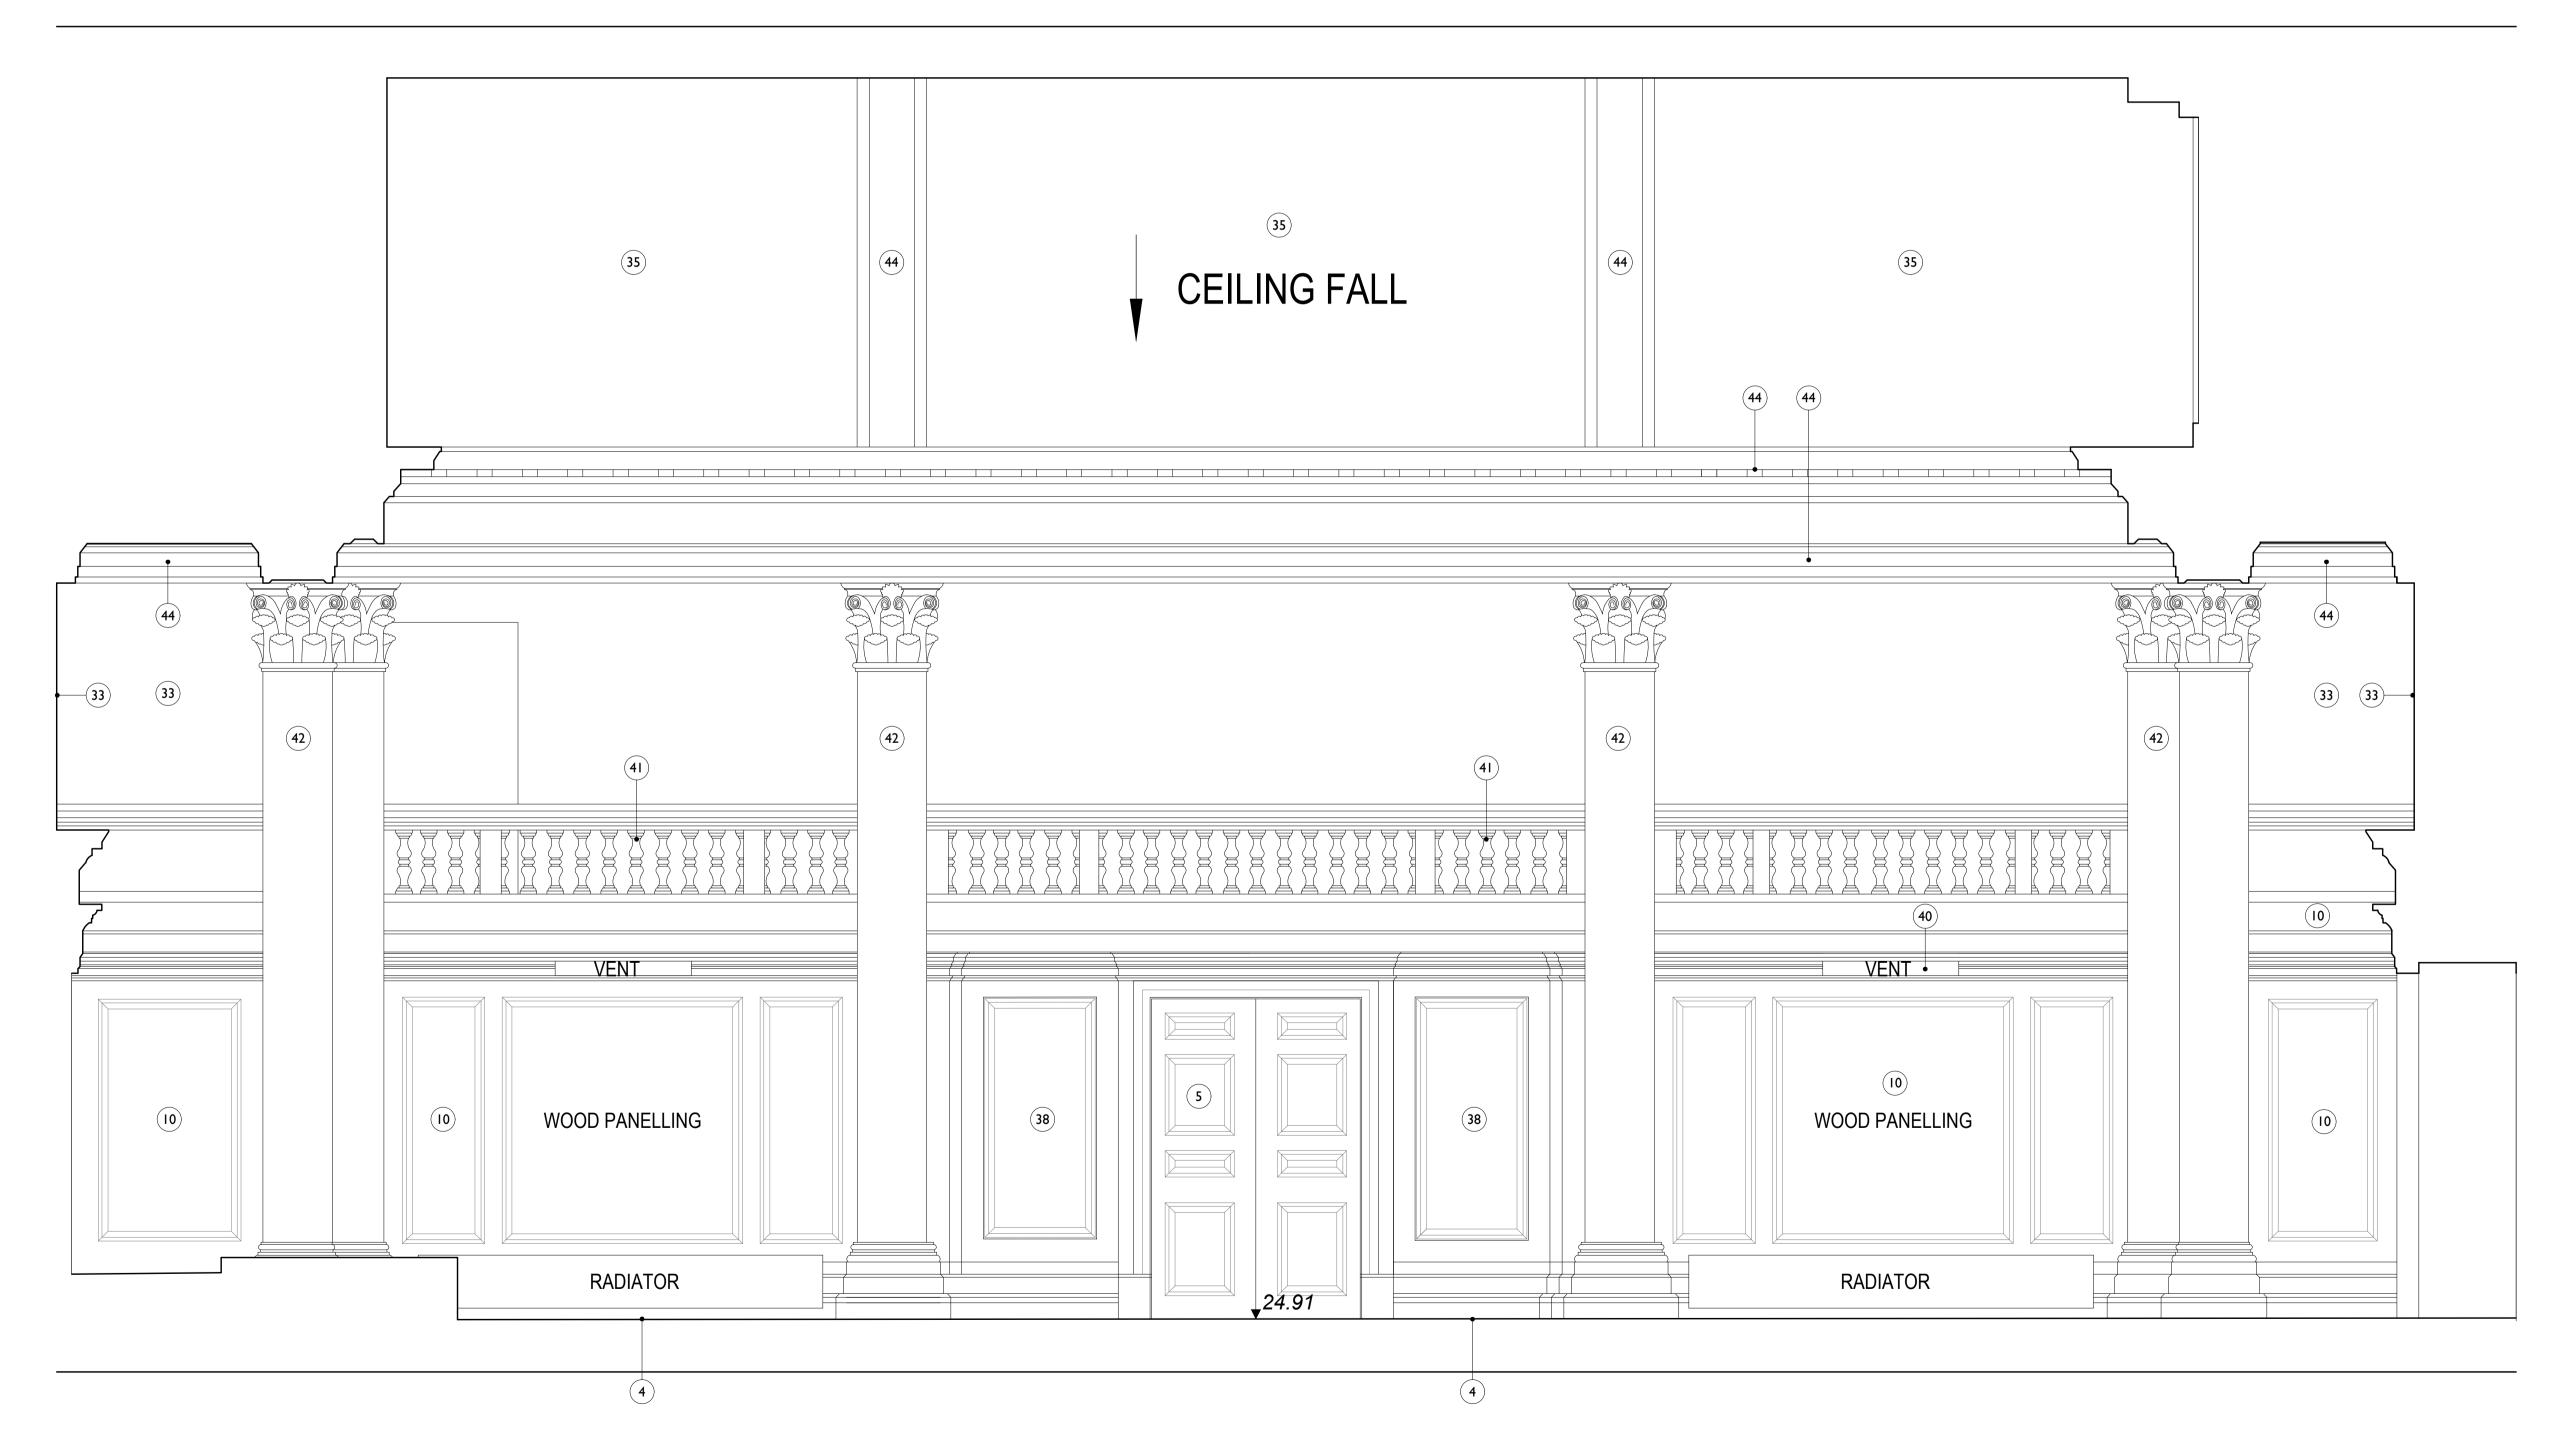
FIDOR BOX - Indicative location of proposed floor box. Cabling to be fed from below; openings located on site. FIDOR boxes to include bespoke joinery lid to allow for integration into heritage floor finishes

Area of structural opening - refer to (91)000 series drawings for dimensions

Section of timber panelling to be carefully removed for installation of electrical cabling from below. To be kept secure during works and reinstated following electrical installation. Maximum extents of removal shown - on site confirmation of panel division required Item of removal - Original Fabric

Overhead - 300mm wide opening to ceiling for high level concealed cable distribution - make good after installation

Overhead - Whole bay of vaulted ceiling to be removed for cabling distribution and reinstated

High level opening in wall for services distribution

Area of panelling/skirting removed for new grille installation for supply/return air flow. Extent of opening to services engineer's requirement.
