DRAWING TITLE	Int Elevations - EI.40 Proposed Internal Conservation Repairs			
----------------------	--	--	--	--

DRAWING NO.	CTH-PUR-MB-01-DR-A-93404			
--------------------	--------------------------	--	--	--

PROJECT	Camden Town Hall			
----------------	------------------	--	--	--

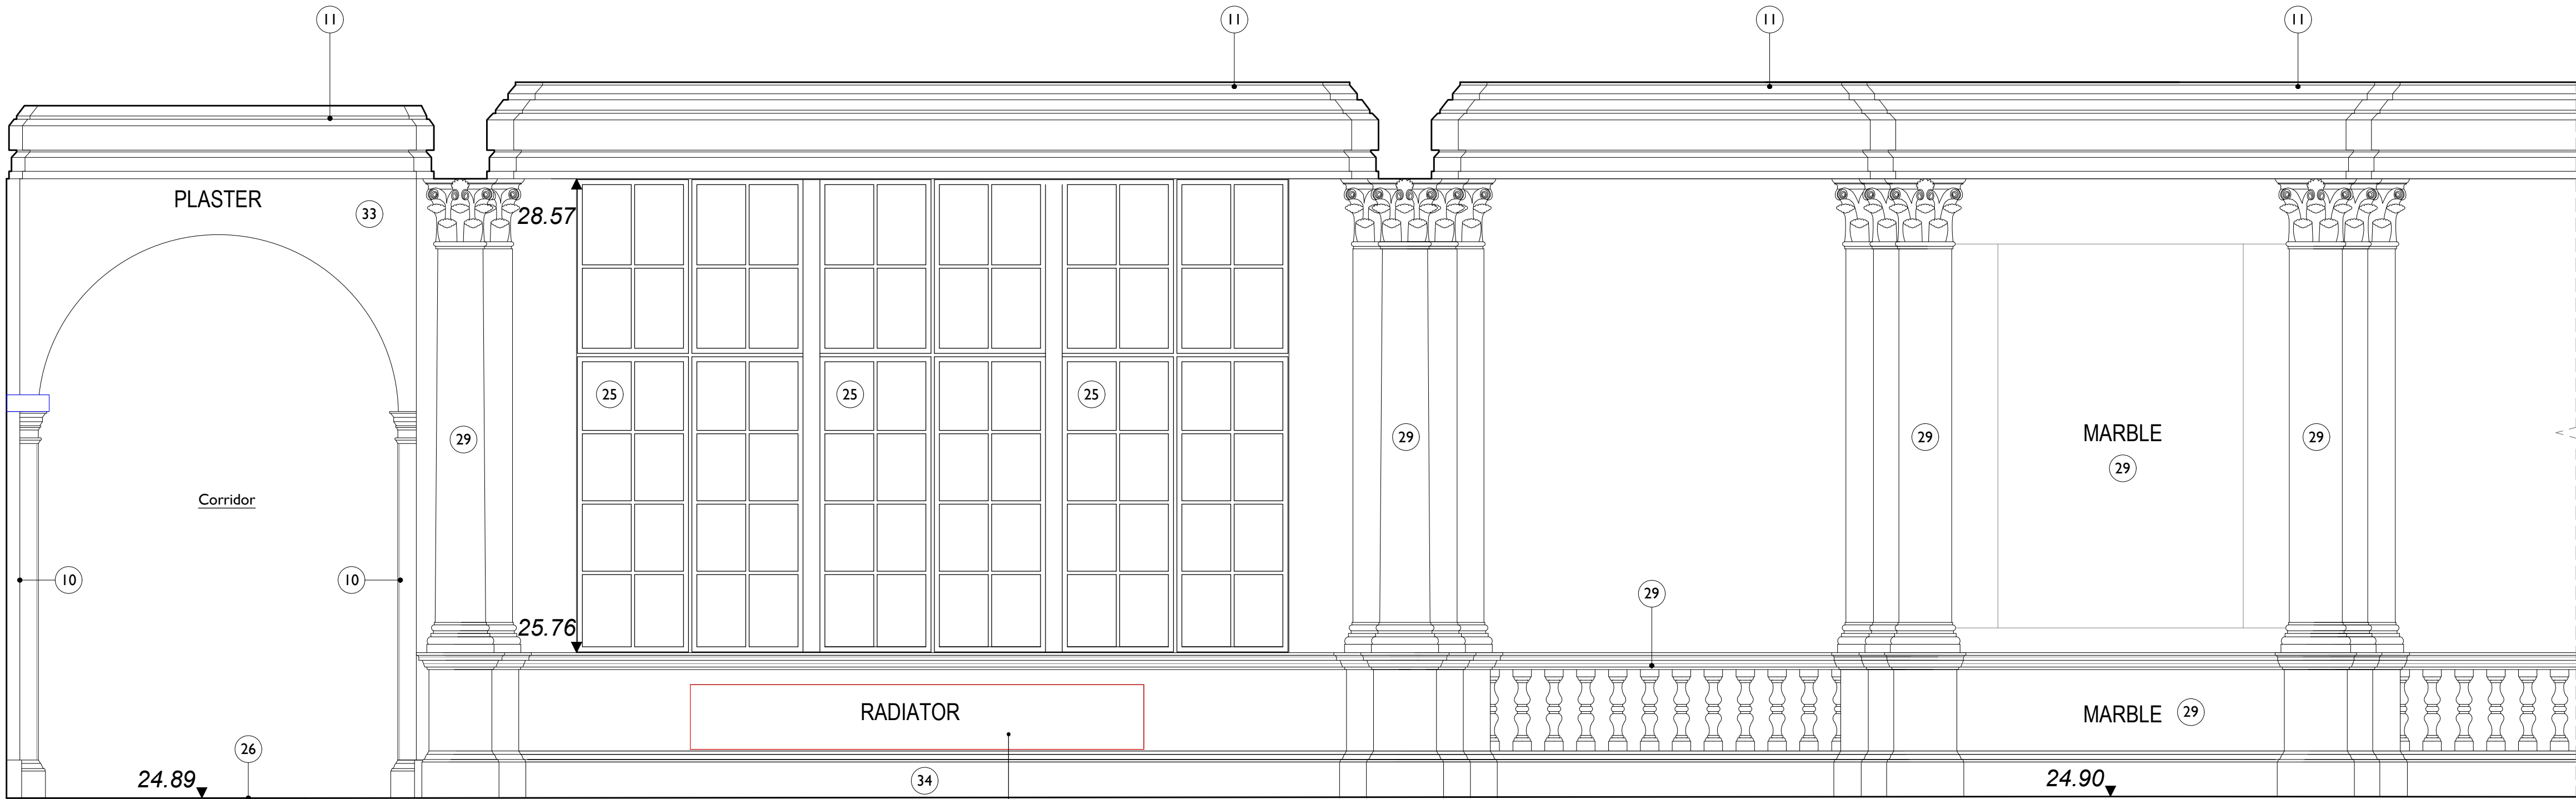
Remove radiator and locally repair variegated marble panels as required, including cleaning, polishing and sealing as advised by specialist

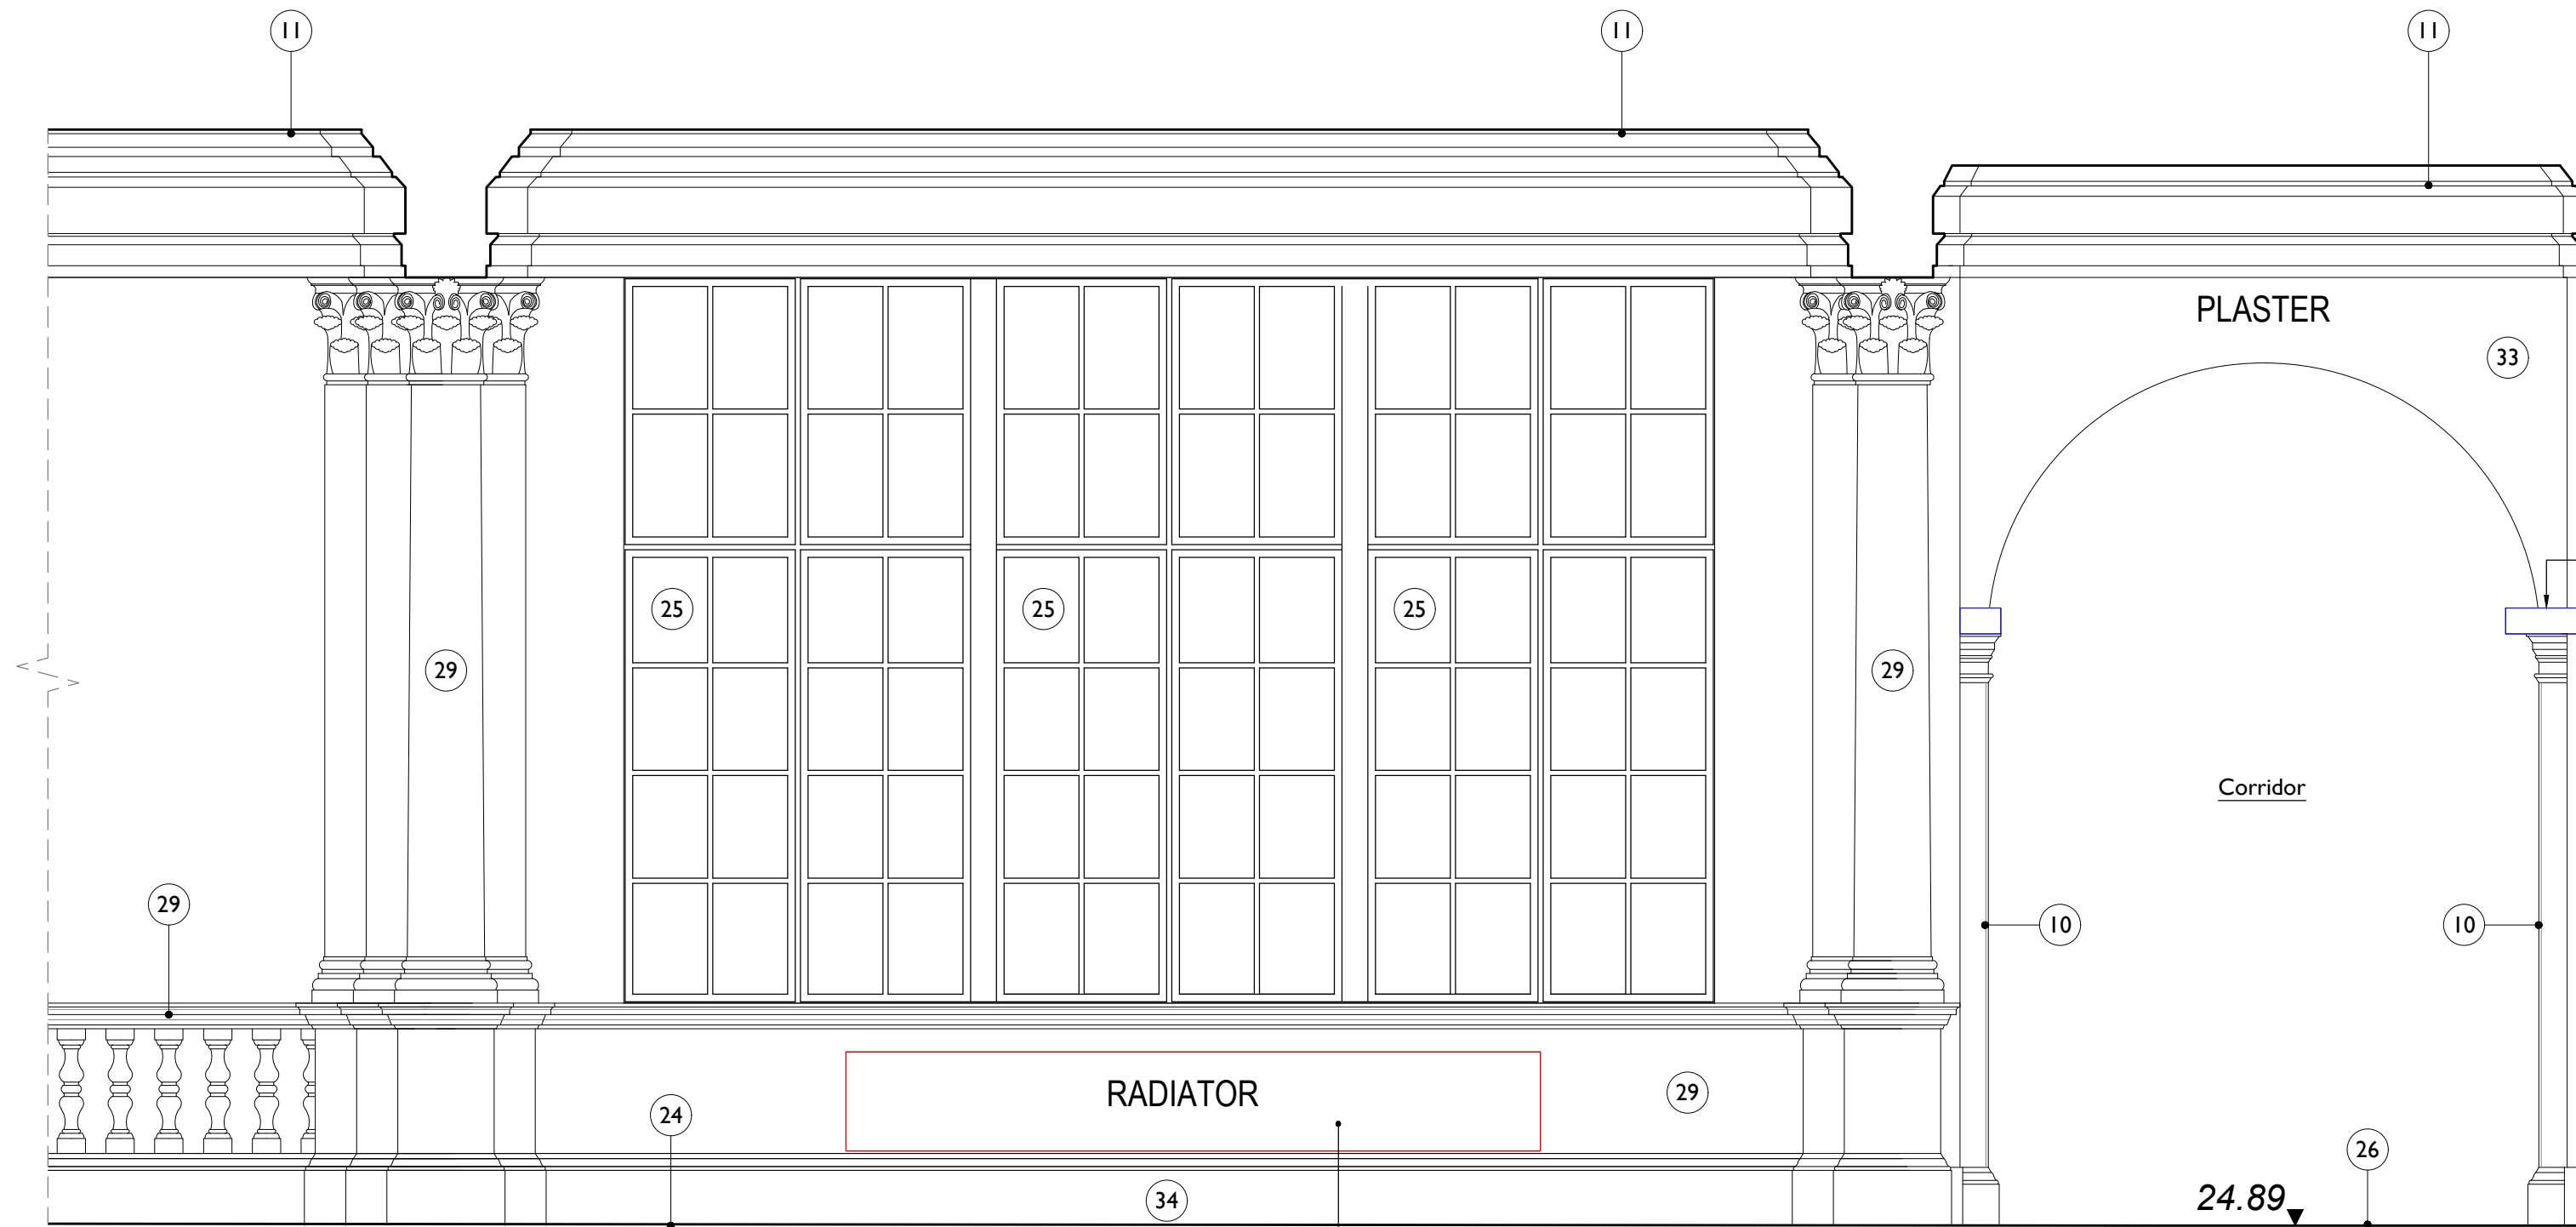
Remove radiator and locally repair variegated marble panels as required, including cleaning, polishing and sealing as advised by specialist

Existing white plastic trunking to be removed and cabling stripped out. To be replaced with sensitively integrated concealed lighting and cabling containment
