ISSUE	DATE	DRAWN	CHECKED	DESCRIPTION
DRAWING TITLE	Plan - E1.40 Proposed Internal Conservation Repairs			
DRAWING NO.	CTH-PUR-MB-01-DR-A-93401			
REVISION	S5 P00			
SIZE & SCALE	A1L 1:50			
DRAWING STATUS	S5 SUITABLE FOR PLANNING

PROJECT Camden Town Hall

I 93041 **E1.40 Existing Room Plan**
1:50 @ A1

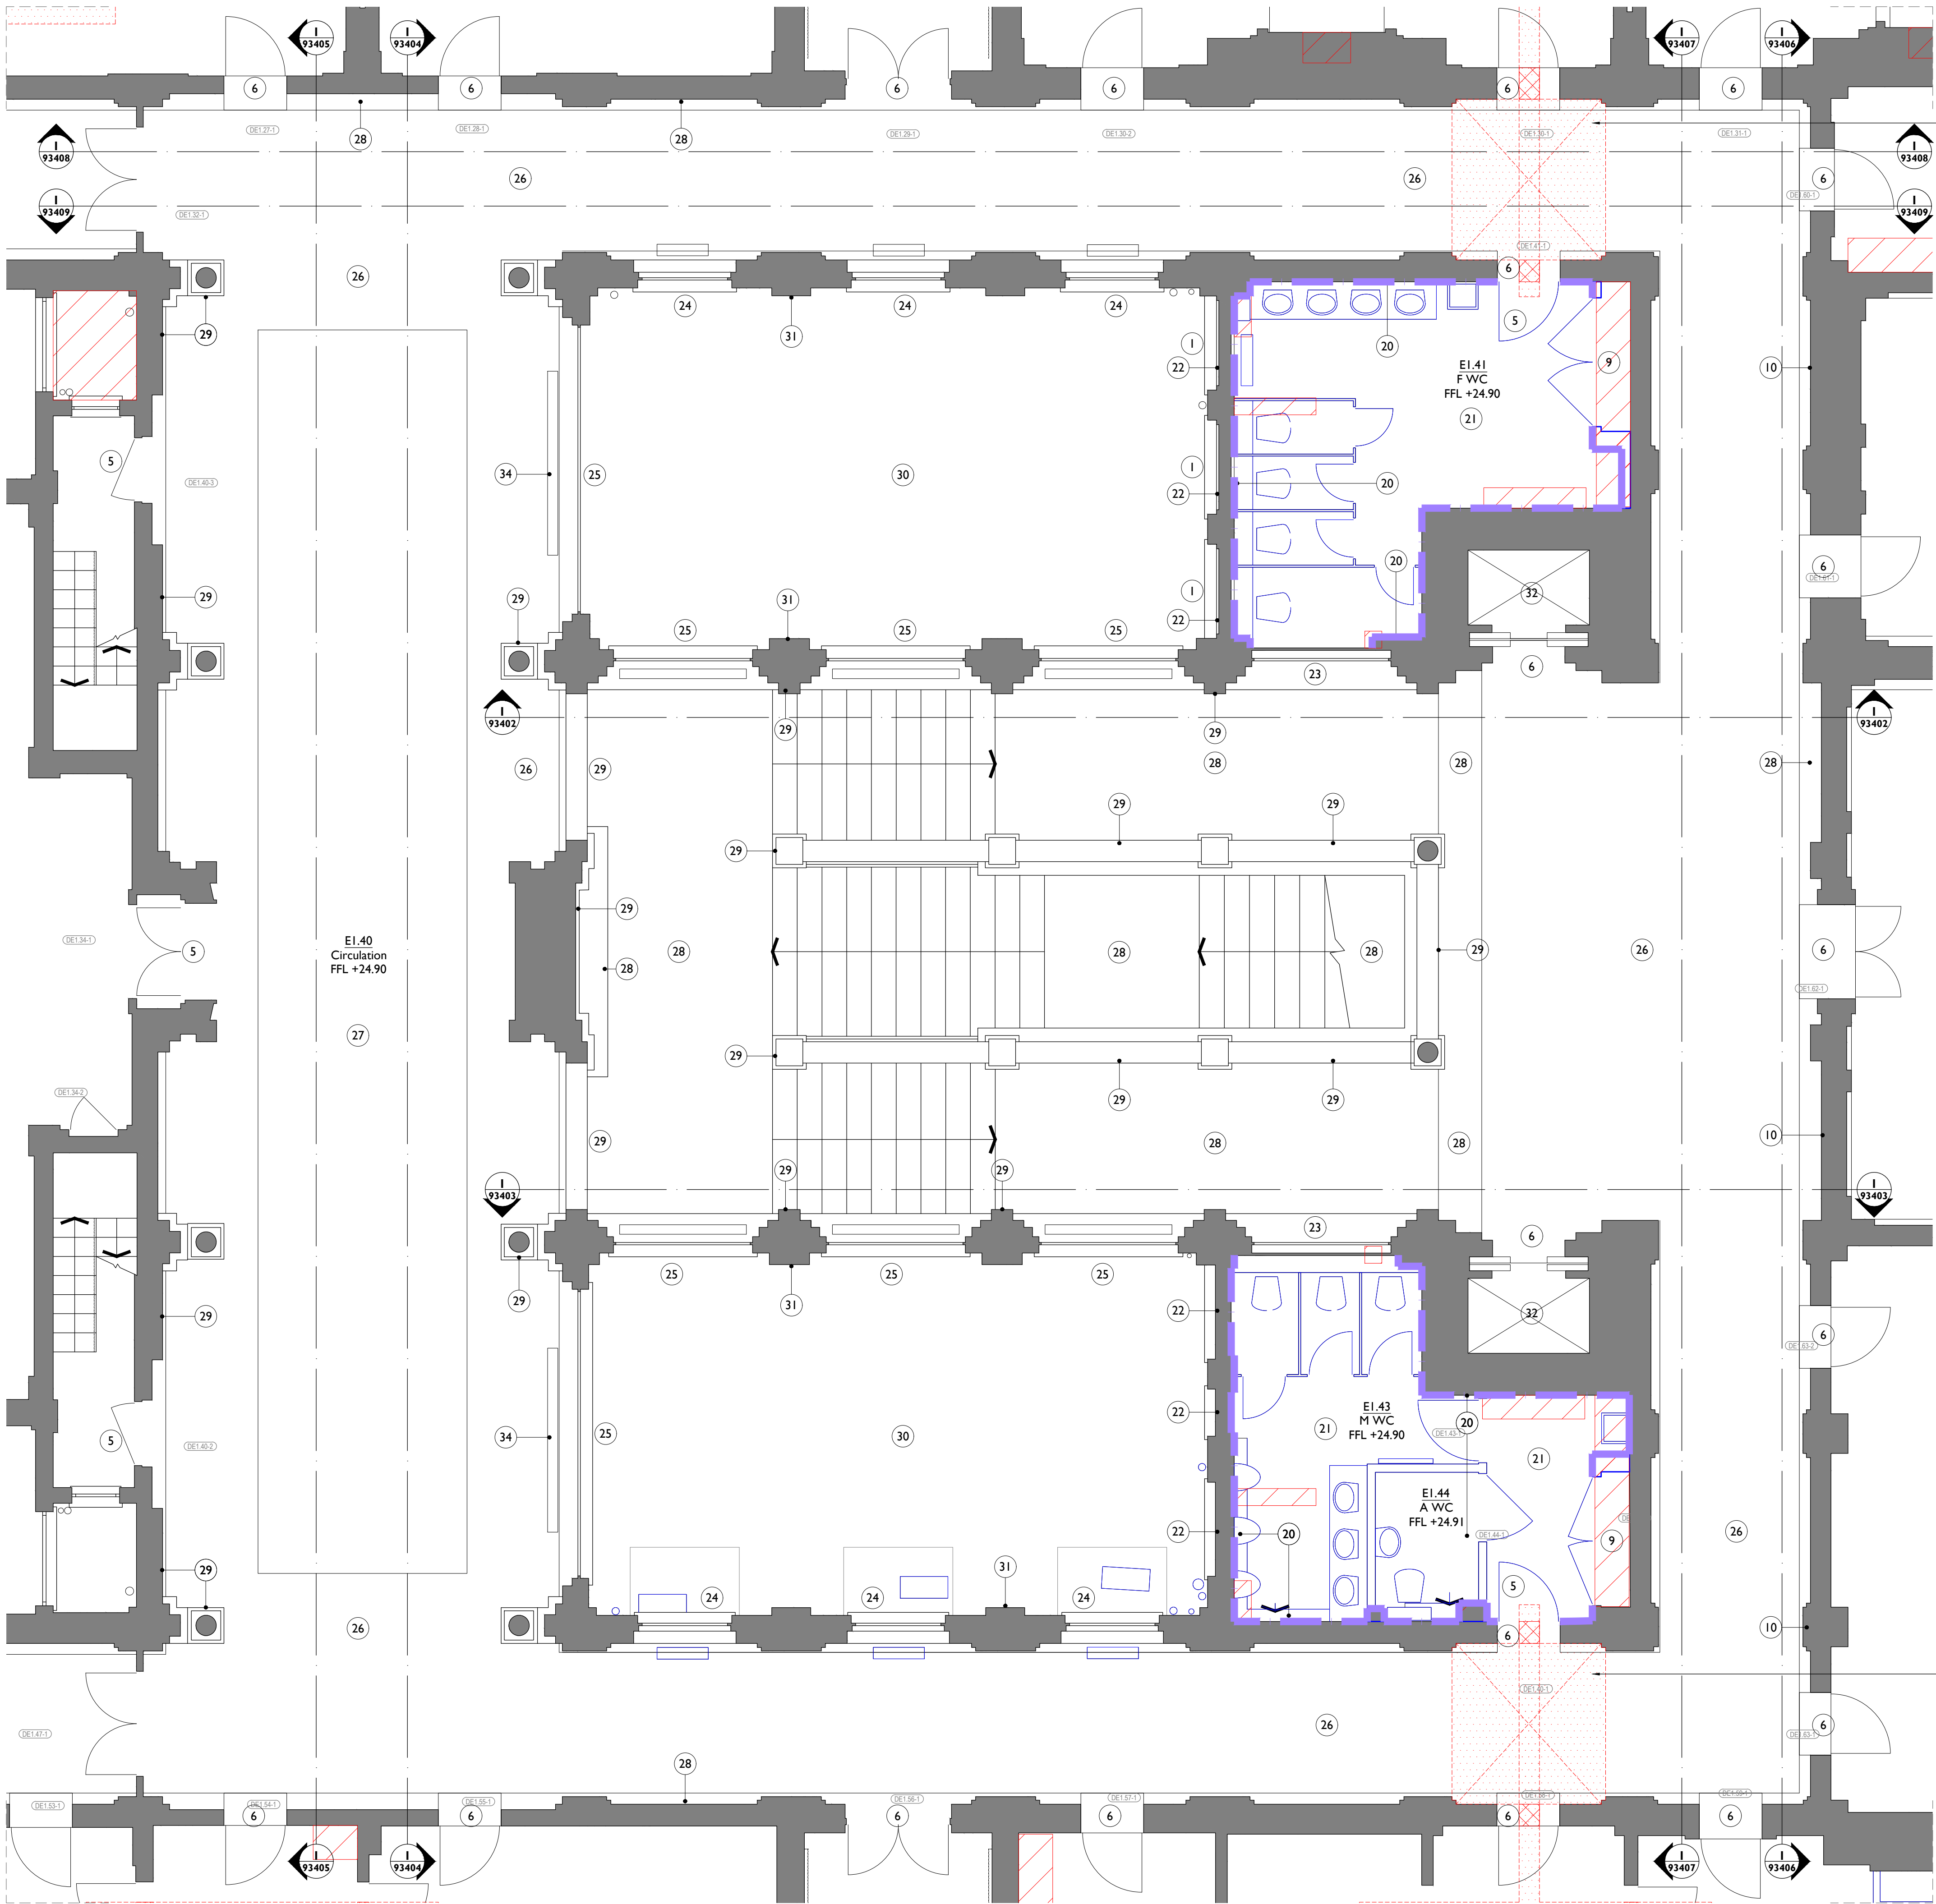
Area of vaulted ceiling to be removed for electrical cabling distribution. To be reinstated to match existing following installation works

Floor Box - Indicative location of proposed floor box. Cabling to be fed from below; openings located on site. Floor boxes to include bespoke joinery lid to allow for integration into heritage floor finishes

Section of timber panelling to be carefully removed for installation of electrical cabling from below. To be kept secure during works and reinstated following electrical installation. Maximum extents of removal shown - on site confirmation of panel division required

Overhead - 300mm wide opening to ceiling for high level concealed cable distribution - make good after installation

Overhead - Whole bay of vaulted ceiling to be removed for cabling distribution and reinstated

High level opening in wall for services distribution

Area of panelling/skirting removed for new grille installation for supply/return air flow. Extent of opening to services engineer's requirement.
