91 GOWER STREET DEVELOPMENT

Design, Access & Heritage Statement

University College London (UCL)

Date: April 2019

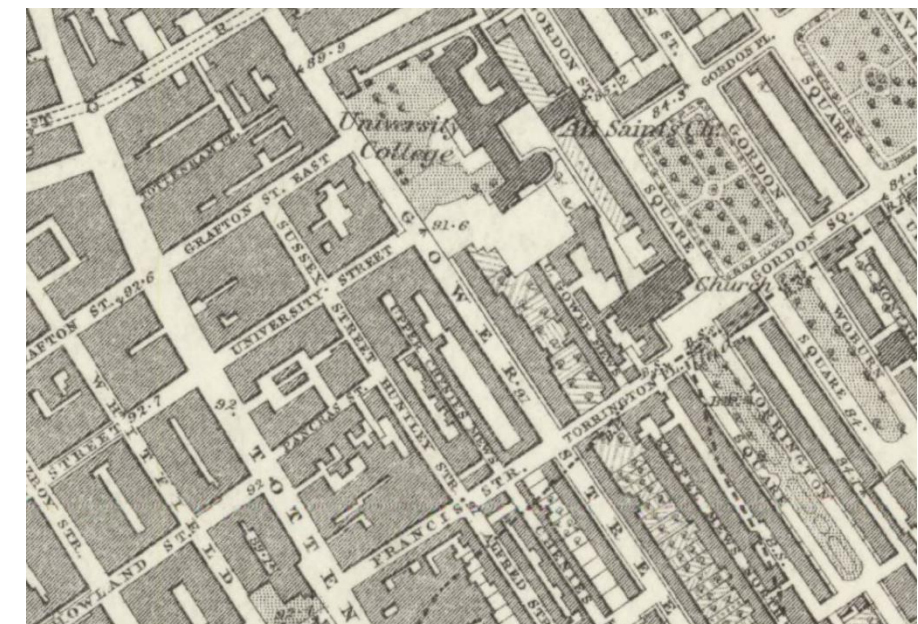
Fig 3.1 Middlesex XVII OS Map (Surveyed 1868-1873)

Fig 3.2 London (First Editions c1850s) XXV – OS 25 Inch England and Wales (1870)

- 3.2.5 The Middlesex XVII OS Map (Surveyed 1868-1873) and London XXV OS Map (1870) shows the UCL Wilkins building with generous front gardens opposite the UCL Hospital building. No. 91 Gower Street is shown as a terrace of houses opposite similar buildings, with smaller mews structures at the rear.

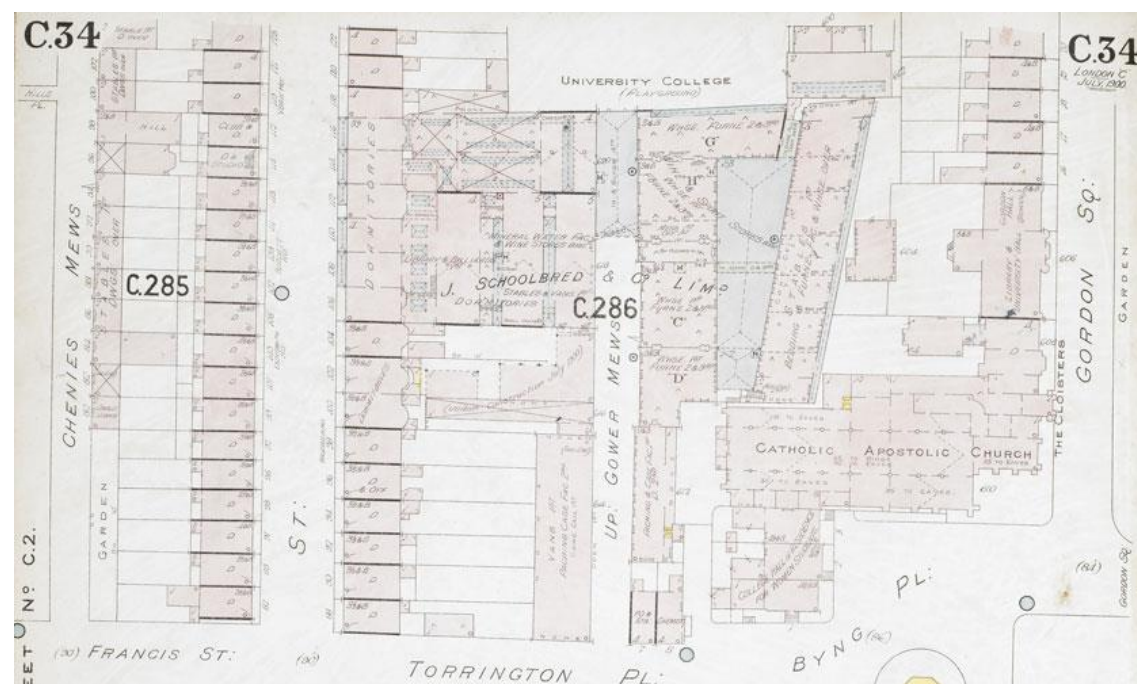
Fig 3.3 Insurance Plan of London North West District Vol C Sheet 34 (1900)

- 3.2.6 The Insurance Plan of London North West District Vol C Sheet 34 from 1900 shows a garden at the rear of Nos. 87-97 Gower Street, in place of stables or mews houses. The map also shows the expansion of the university with dormitories infilling an area of land between Gower Street and Upper Gower Mews.

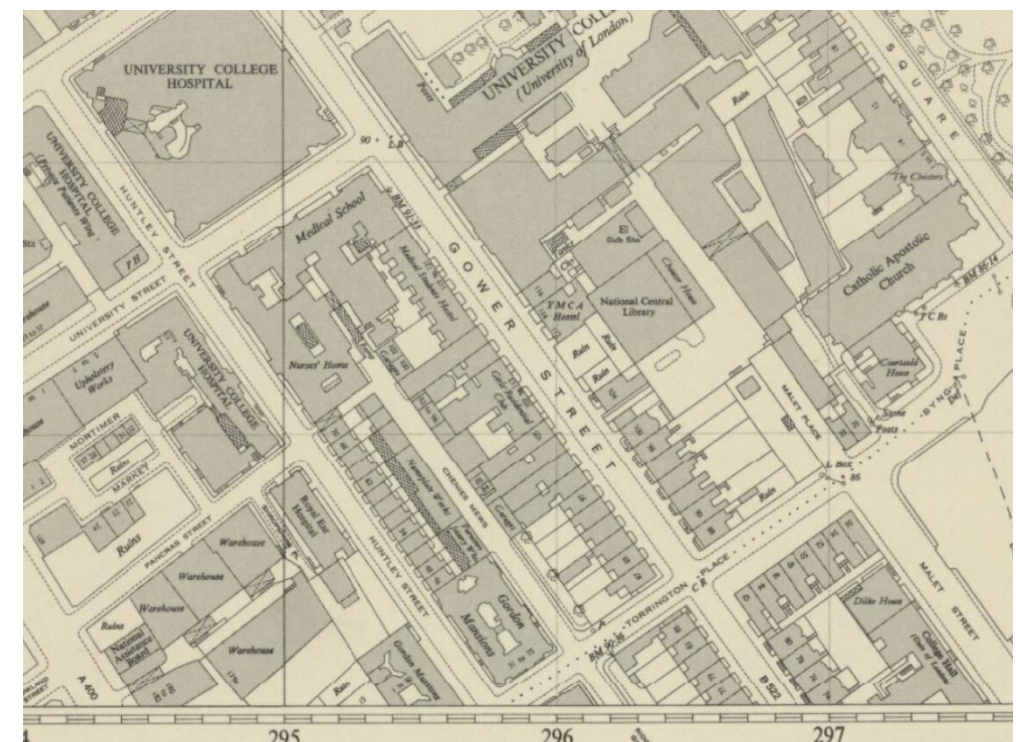
Fig 3.4 OS 6 Inch England and Wales (1938)

Fig 3.5 OS National Grid Map (1954)

- 3.2.7 The 1938 OS Map continues to show gardens at the back of 91 Gower Street, whereas the 1954 OS Map depicts the annexe building at the rear of the property. It is therefore assumed the annexe building was added to the site in the years following WWII.
