Site Investigation Report

Rhyl Primary School, Camden

S2218-002, Rev. A

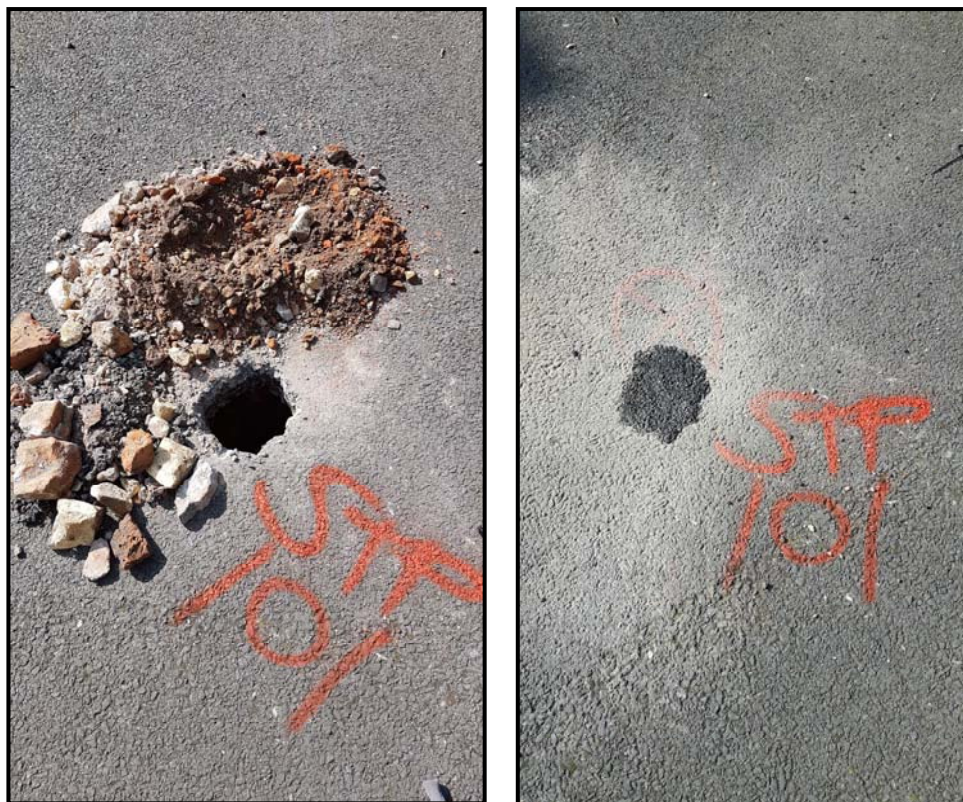
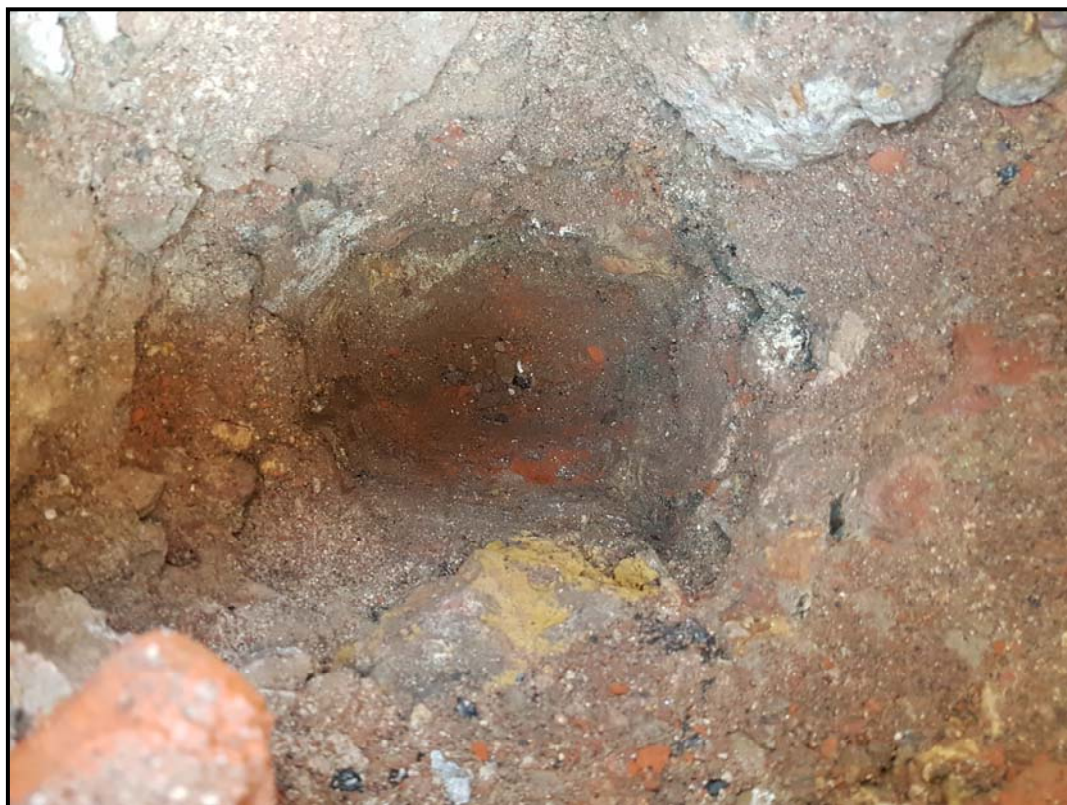
In all three locations, the surface comprised tarmacadam, 0.13-0.15m thick, and was noted to contain approximately 2-3 separate layers suggesting the area had been resurfaced at some point in the past.

Underlying the Tarmacadam, Made Ground was encountered and comprised a mixed aggregate of gravel and cobble sized fragments of brick and concrete, with occasional sandstone boulders. As the trial pits were advanced, clay content was noted to increase with depth although gravels of brick and concrete were still abundant.

Figure 1. Excavation, arisings and reinstatement of STP101

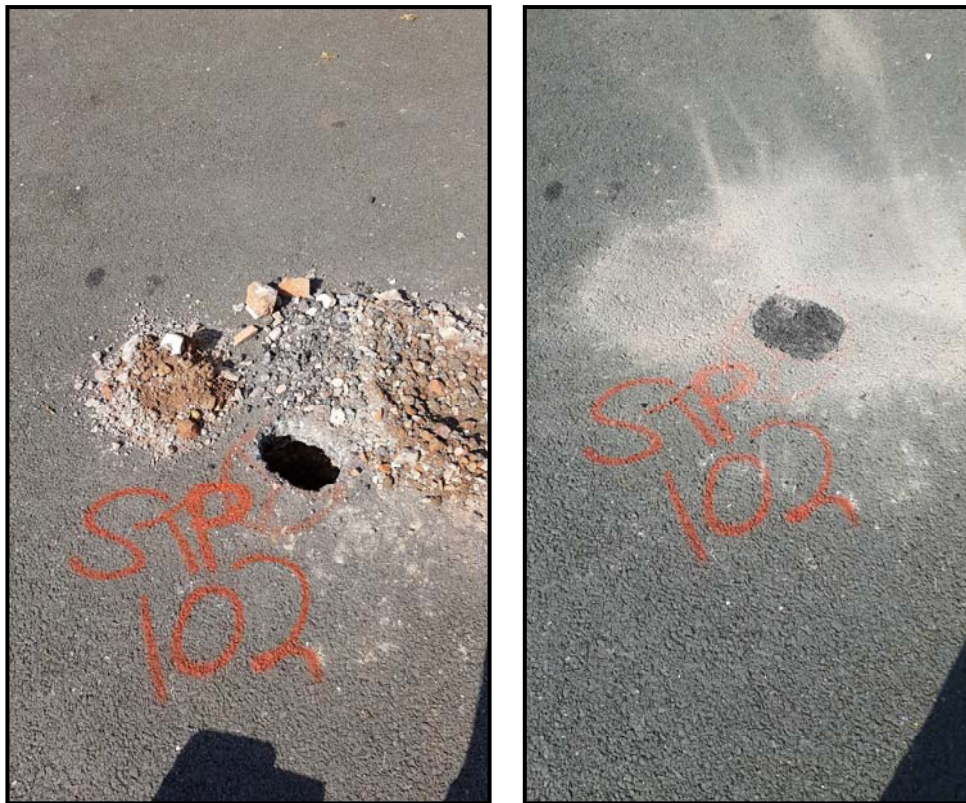
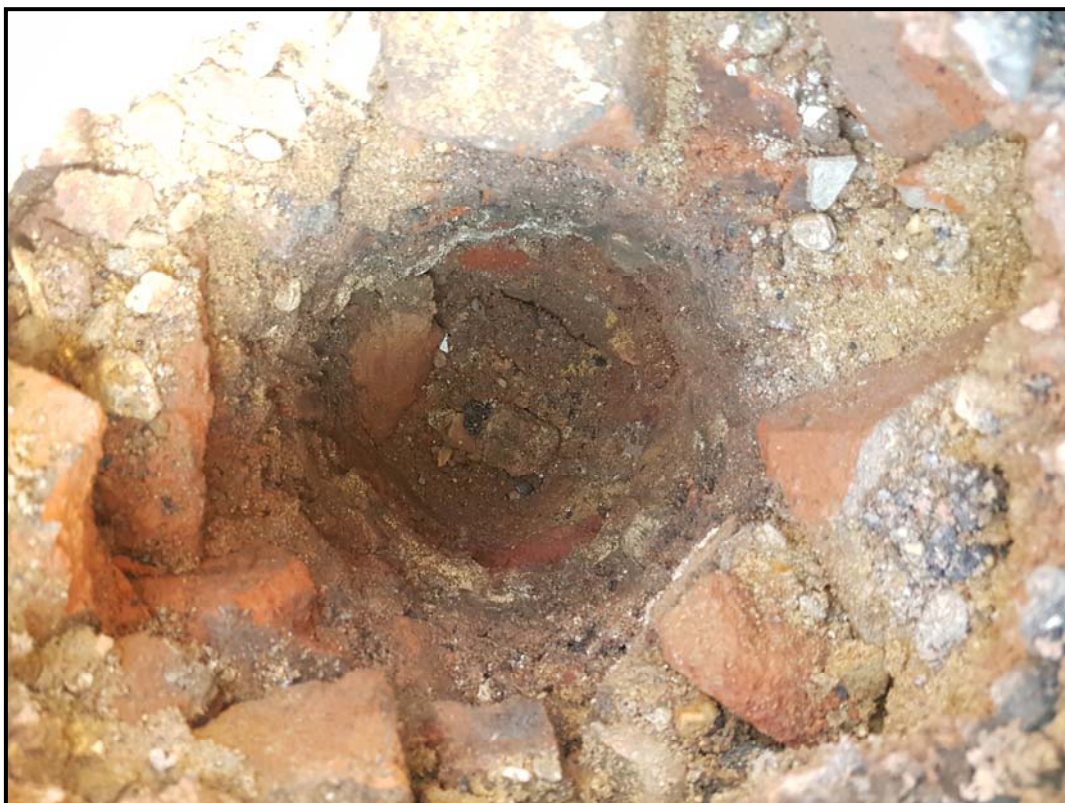
Figure 2. Excavation, arisings and reinstatement of STP102.

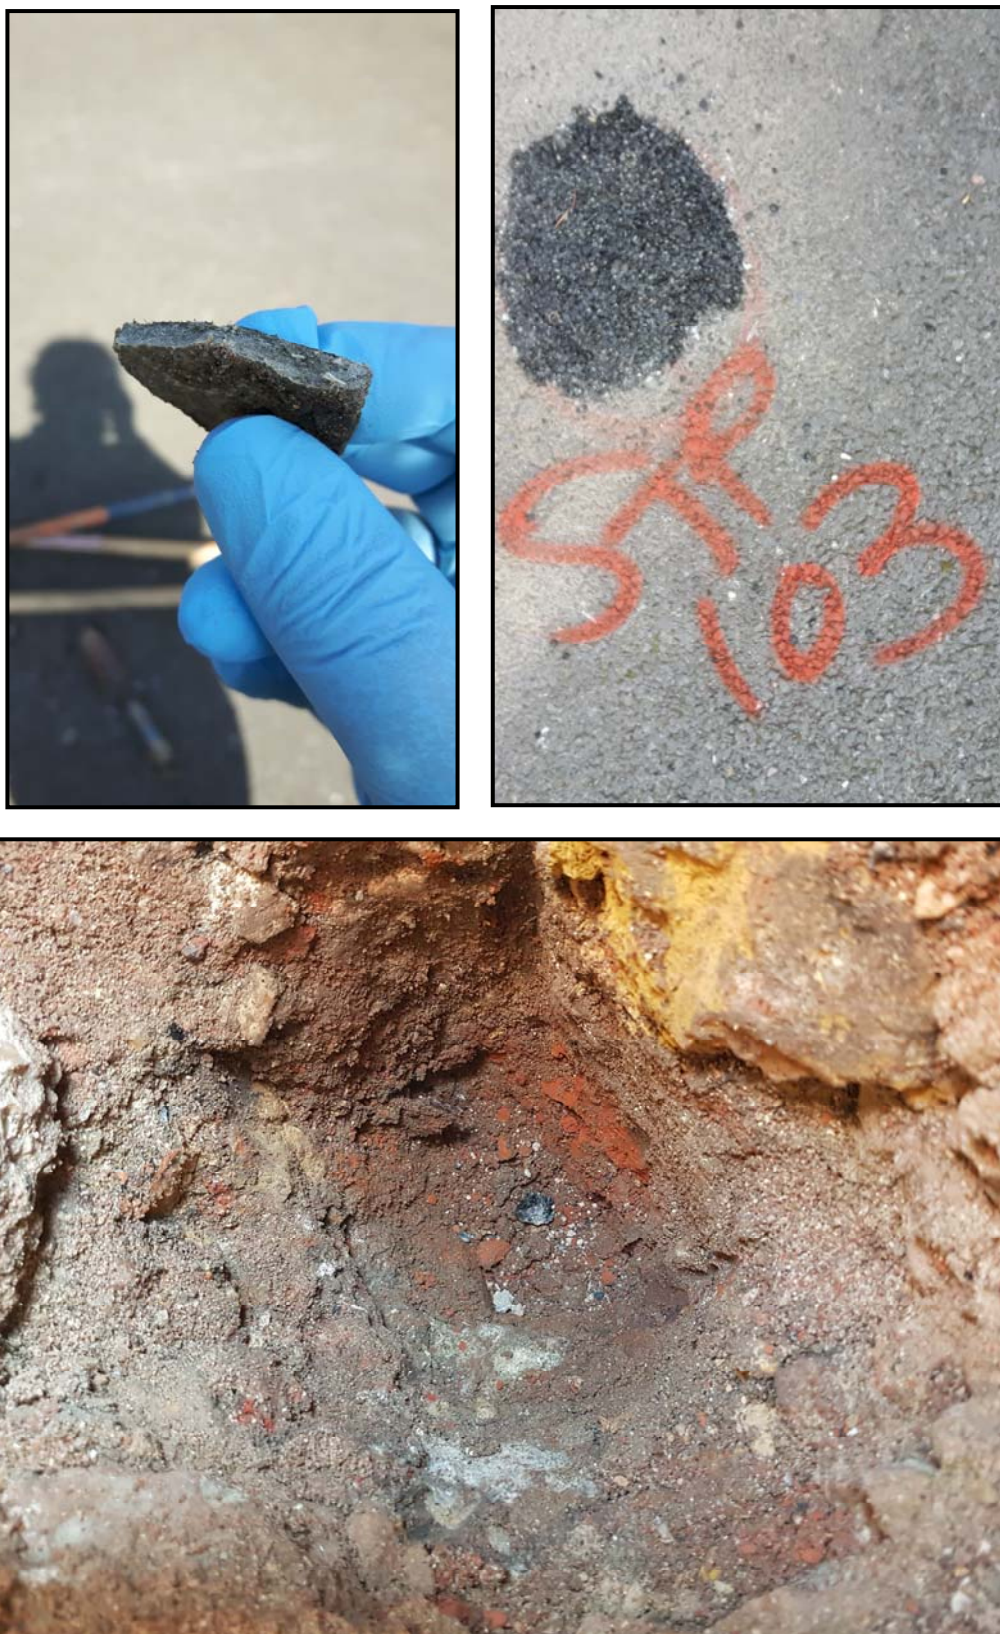
During the works, Sanctus identified a fragment of suspected asbestos roof tile in STP103 at a depth of a sample of 0.37m bgl. This was noted to partially comprise a fibrous material along the broken edge. This was photographed and was collected as a sample in addition to the soil samples for analysis.

Figure 3. Excavation, reinstatement and Asbestos Cement Board identified in STP103.

Due to the presence of both free fibres and visible fragments of asbestos in the materials underlying the hardstanding Sanctus recommends that any future excavations be undertaken under controlled circumstances to minimise risk to site users. Due to the identification of asbestos in fragmental and free fibre form, Sanctus would classify the enabling works as Notifiable Non-Licensed Work (NNLW).
