369 – 377 Kentish Town Road, Camden, London NW5

Archaeological Desk-based Assessment

Project: 369 – 377 Kentish Town Road, Camden, London, NW5

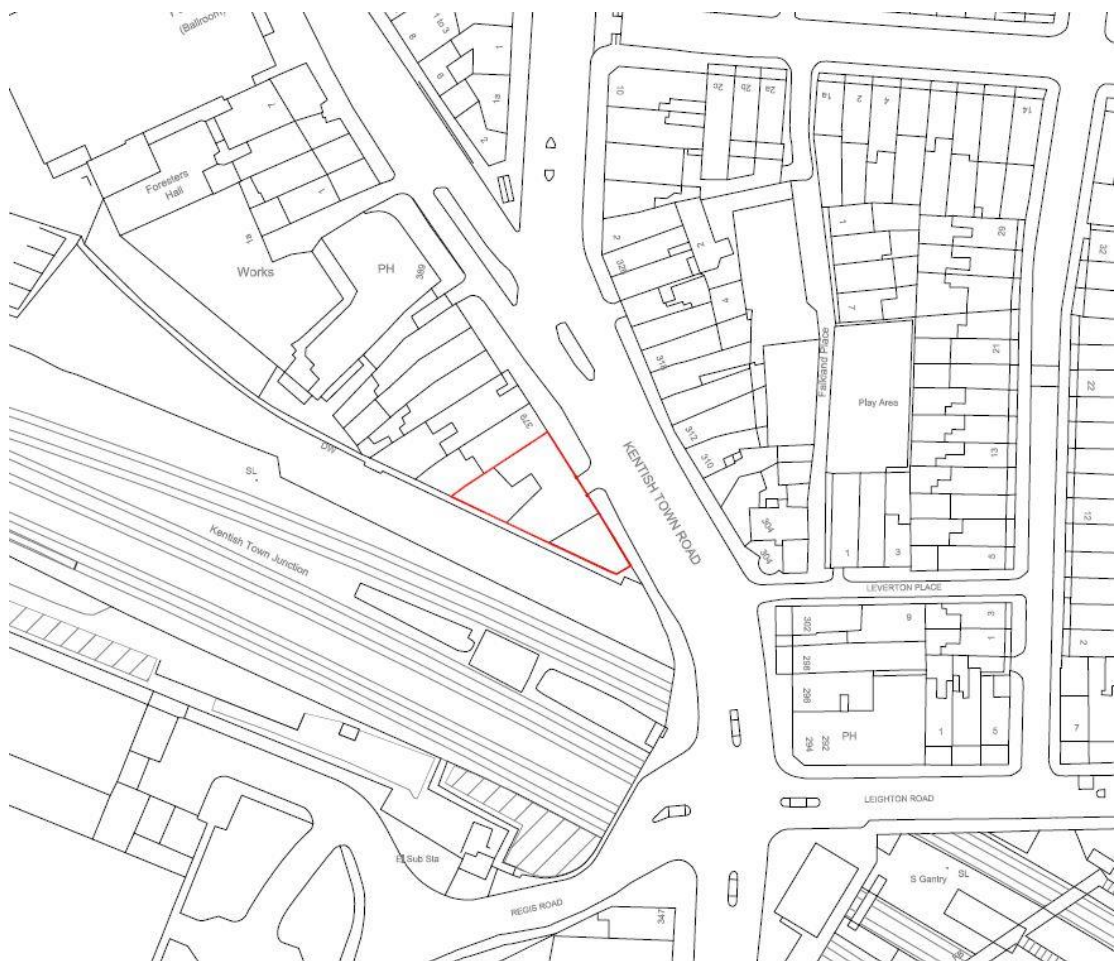
Figure 1 Site Location Plan with site outlined in red. OS mapping © Crown Copyright. All rights reserved. Licence No. AL100024244 .

- 1.1.1. This Archaeological Desk-based Assessment has been researched and prepared by Savills Heritage Planning on behalf of KTR Carwash Project Ltd (hereafter 'the Client') to assess the potential for and possible impact on buried heritage assets (archaeological remains) on land at 369 – 377 Kentish Town Road, Camden, London (hereafter 'the Site'), located at NGR 528971 185253, Fig. 1.

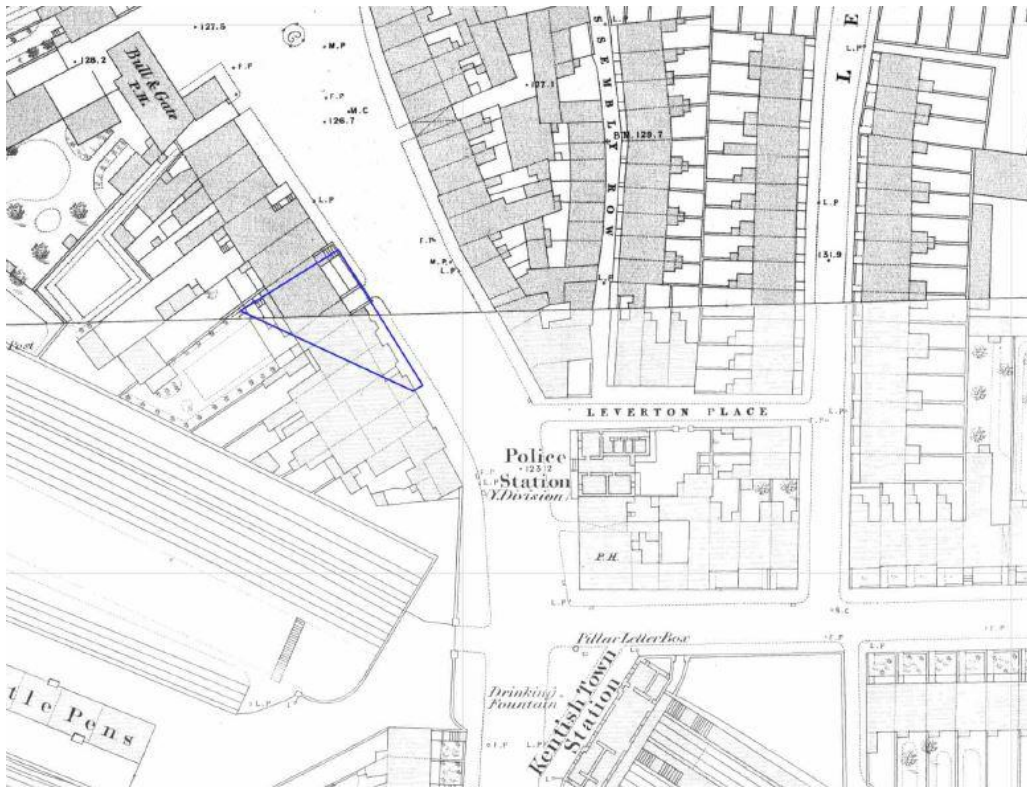
Plate 1 Ordnance Survey maps of 1871 – 3 with the Site outlined in blue.

- 2.8 The 1871 – 1873 Ordnance Survey maps (Plate 1) show the area of the Site to the north of the railway line. The Site is shown with a number of buildings fronting Kentish Town Road with gardens and outbuildings to the rear. Prior to the construction of the railway the area had been middle class in social character, but the needs of the railway transformed it into a more working class district with numerous small scale industries (Weinreb and Hibbert 1995). No changes are shown on the 2nd edition Ordnance Survey map of 1894 (not illustrated), but by the time of the 3rd edition Ordnance Survey map of 1915 (Plate 2) Kentish Town Junction has expanded to the north and the buildings shown within the Site on the earlier maps appear to have been demolished.

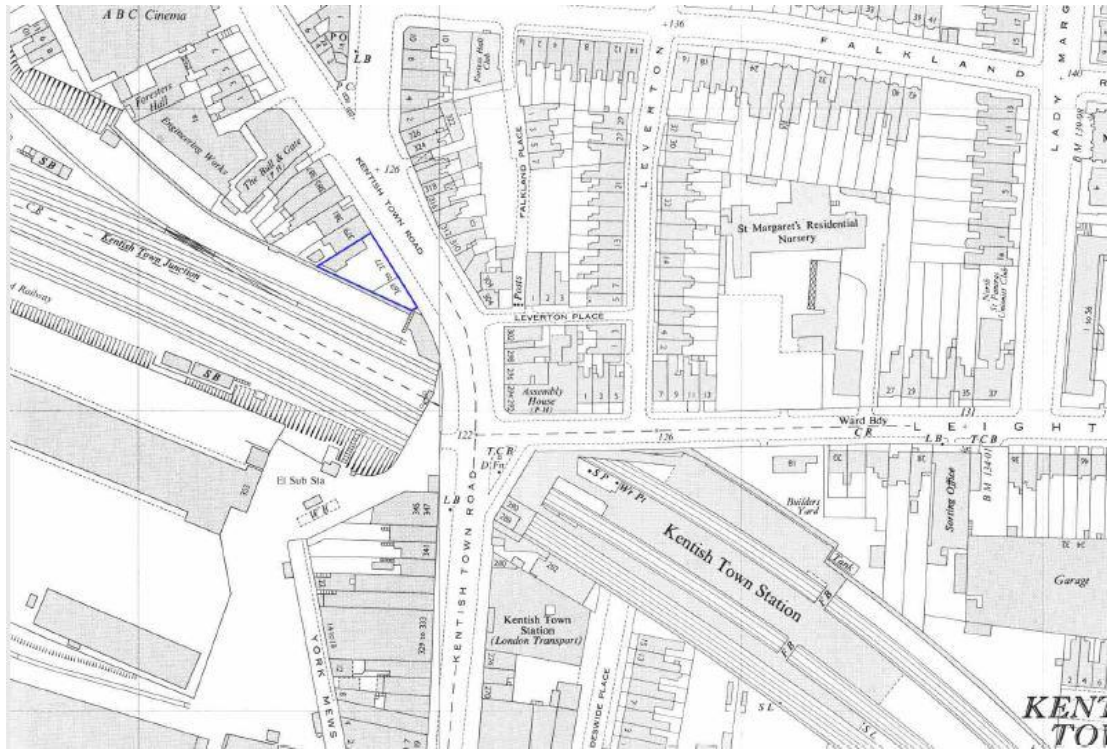
Plate 4 Ordnance Survey maps of 1963 – 68 with the Site outlined in blue

2.8.2 The central structure is no longer shown on the Ordnance Survey maps of 1963 – 8 (**Plate 4**), and no structure is shown in the south-eastern part of the Site; though the area is still demarcated as a separate area to the north-western end of the Site.

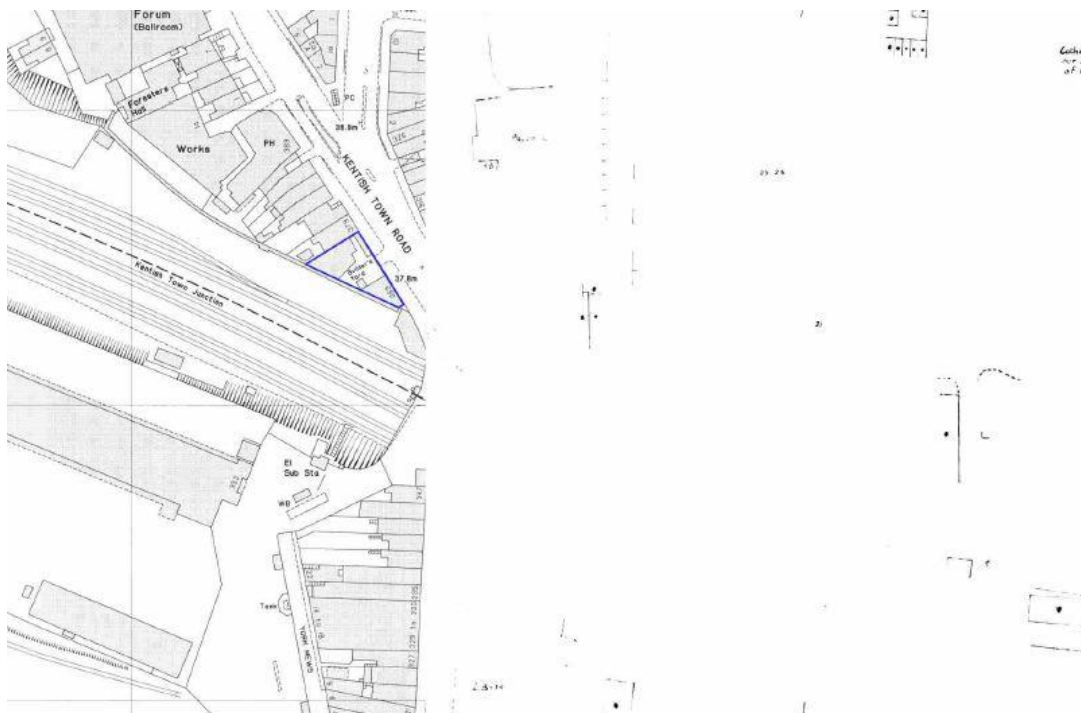
Plate 5 Ordnance Survey maps of 1976 – 1980 with the Site outlined in blue

2.8.3 By 1976 – 1980 (**Plate 5**) additional structures are again shown in the south-east and north-east corners of the Site, along with a small square structure on the western side. The whole of the Site is annotated 'Builders Yard'.

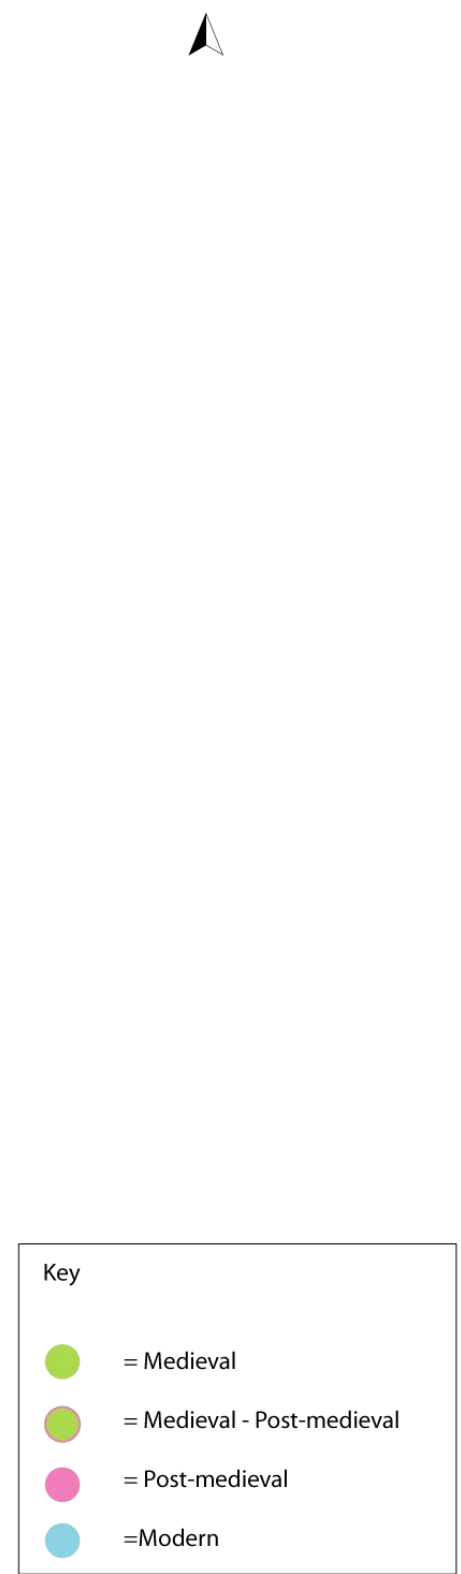
Figure 3 Non-designated heritage assets recorded on GLHER in the Sites Wider Study Area

2.1.2 Baseline conditions were established through consideration of all recorded heritage assets within a 500m Study Area buffered from the Site (Fig. 3) and a desk-based review of existing sources of publicly accessible primary and synthesised information, comprising:

2.6.2 The Archaeological Priority Area (Fig. 3) shows the possible extent of the linear settlement at this time although this is hard to confirm given the lack of archaeological investigations in the area. During the medieval period the land surrounding Kentish Town is likely to have consisted of farmland.

- Cantlowes Manor House (MLO18066) is not accurately located and the location point given by the GLHER lies on the east side of Kentish Town Road, c. 90m to the north of the Site (Fig. 3).
- Moated Farmhouse, Toll House, pound, moat, and drawbridge at Wolsey Terrace (MLO17812, MLO17813, MLO17814, MLO18055, MLO46418 & MLO46608) is recorded 330m to the south the Site and although the record is a little vague it appears to relate to Cantlowes Manor House and may have been associated with the chapel of ease (see above) (Fig. 3).
