3.2 RECENT PROJECT HISTORY 2017 HOTEL SCHEME BY DEXTER MOREN ASSOCIATES

4 SITE ANALYSIS

5 CARLISLE HOUSE RESTORATION

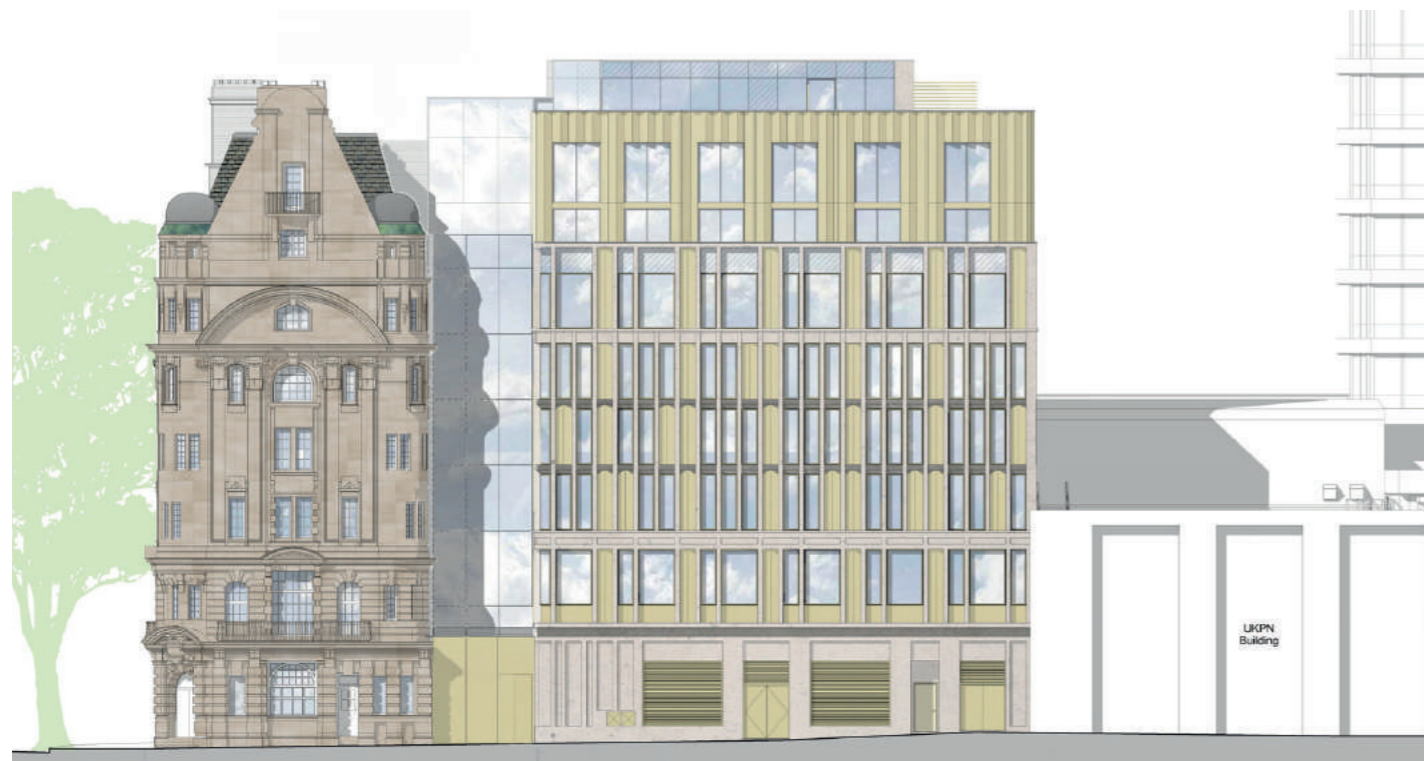
South Elevation - Submitted Planning Elevation July 2017

This planning application incorporated both Carlisle House and the headhouse site itself. The application was withdrawn in 2018.

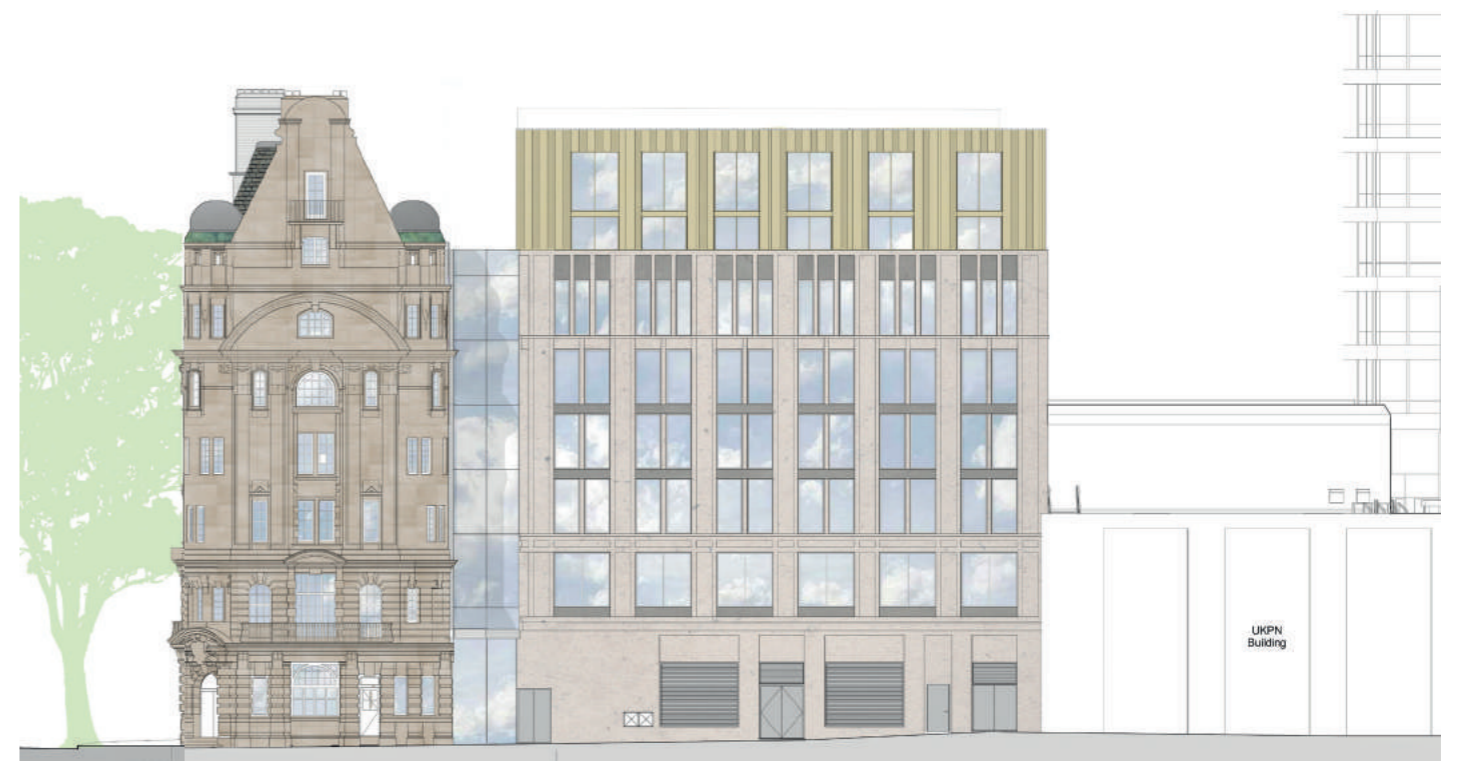
South Elevation - Revised Facade September 2017

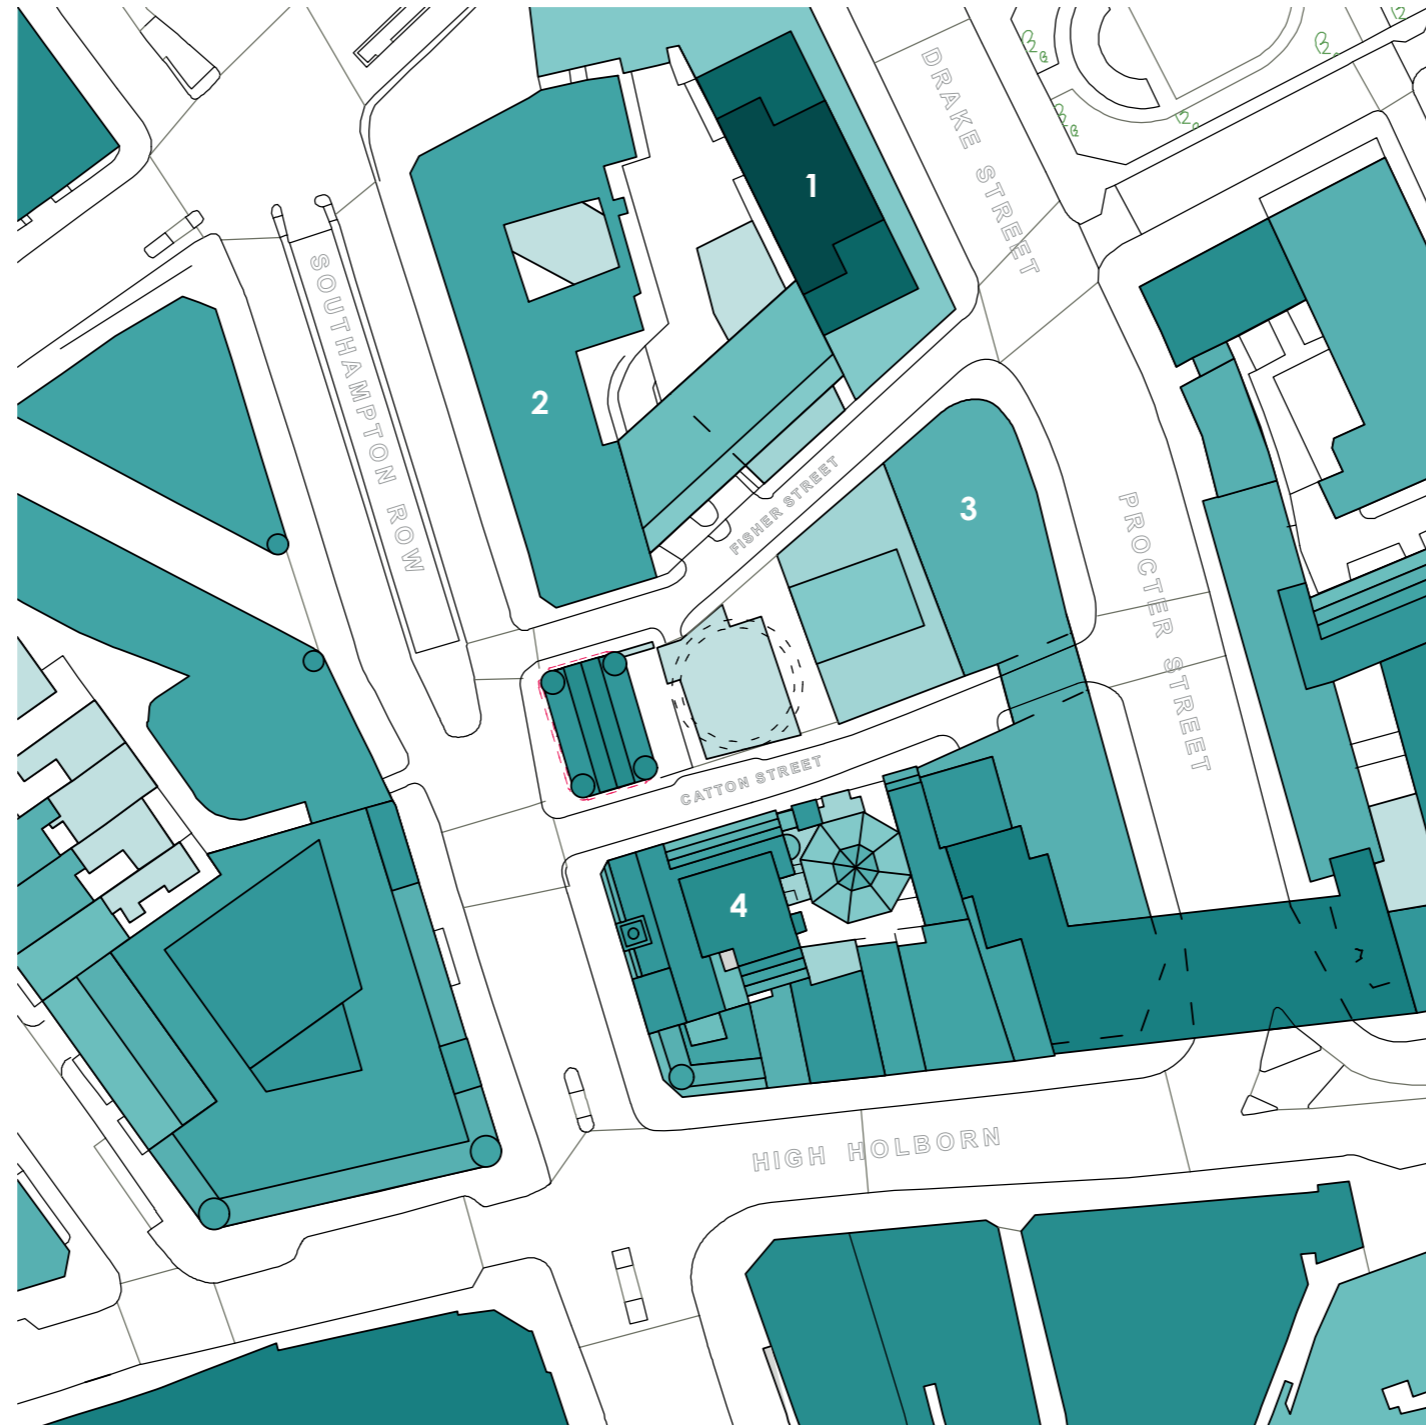
Storeys lowest to highest

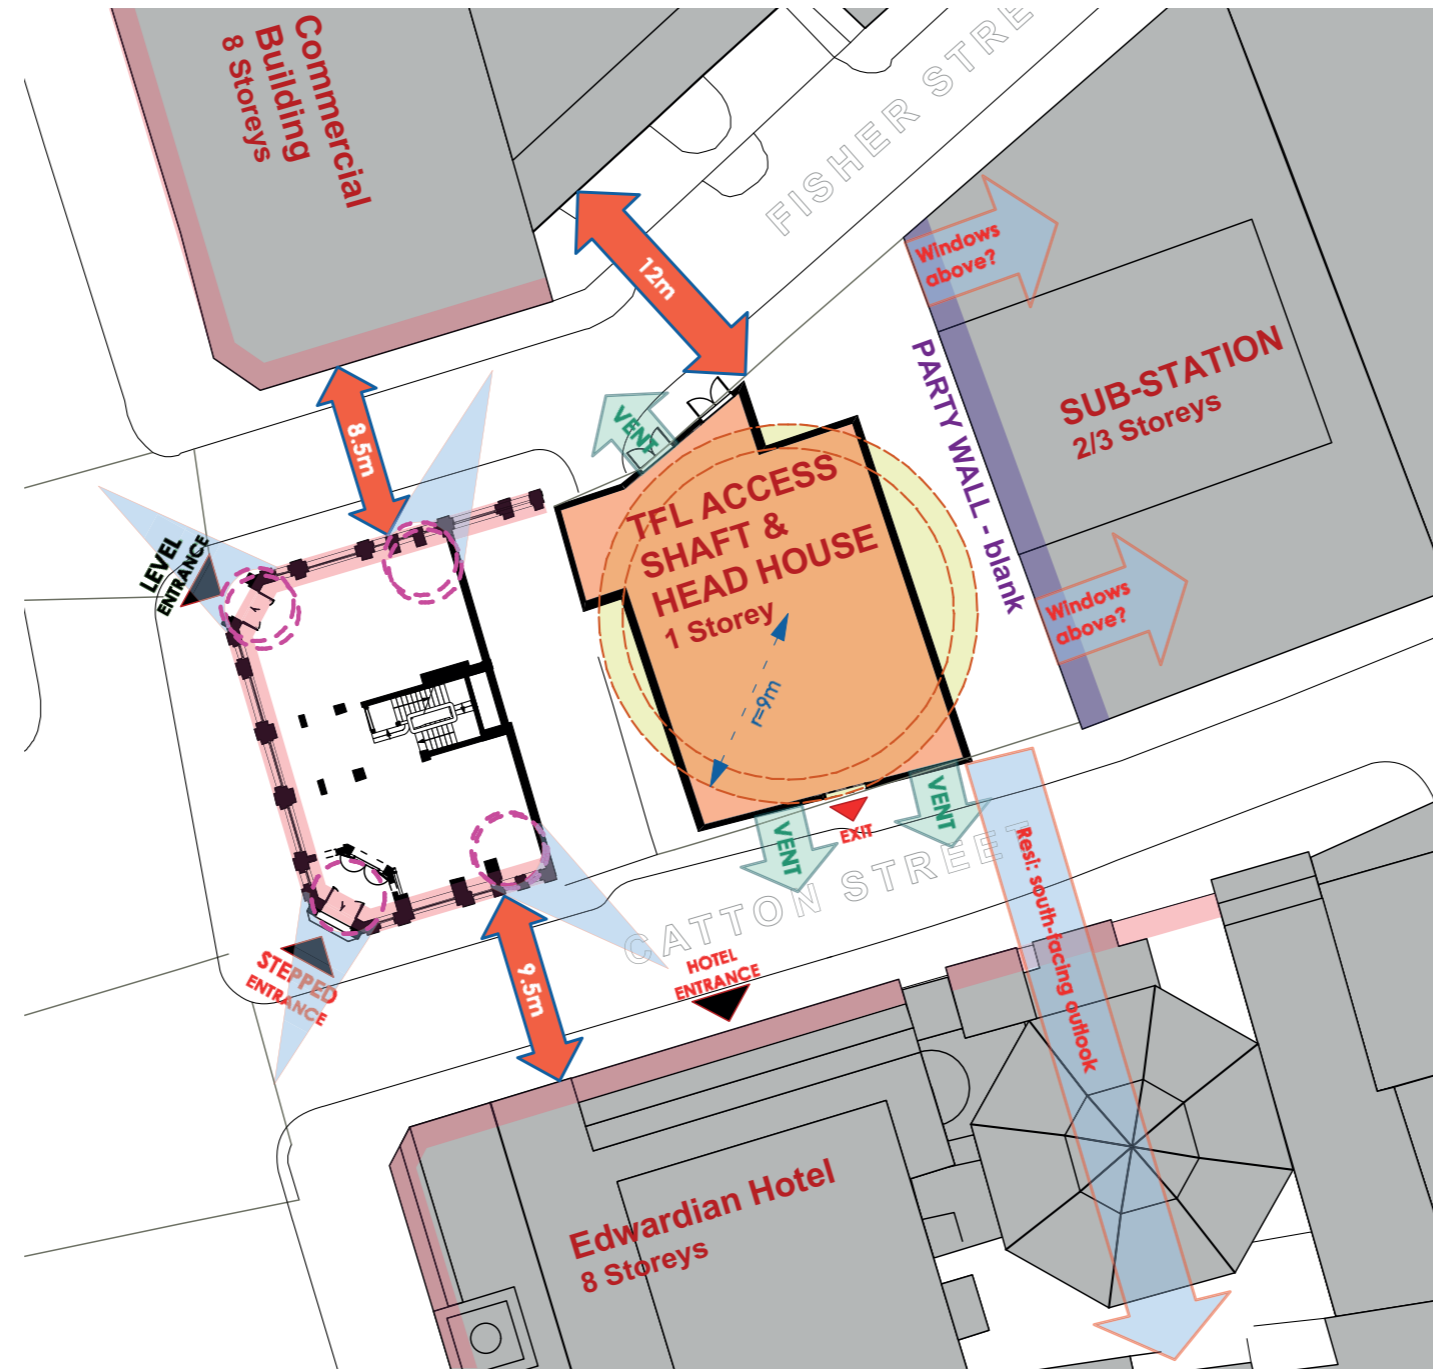
4.6 IMMEDIATE SITE CONSTRAINTS & OPPORTUNITIES

- Built Context
- Historic Frontage
- Party Wall
- TFL Access Shaft below ground
- TFL Headhouse
- Existing Turrets to be retained & expressed
- Separation distances
- Sun Path

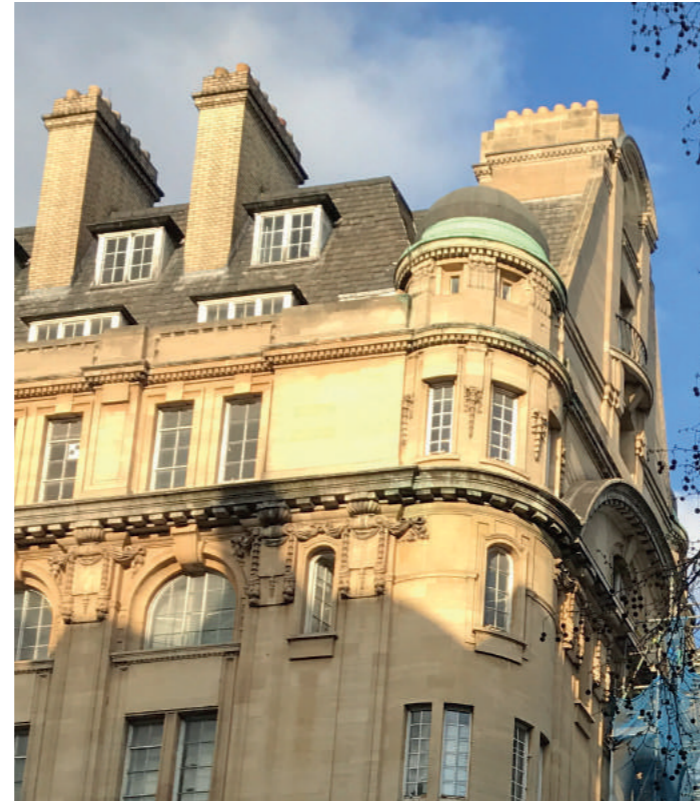
Carlisle House - turrets, chimneys & dormers

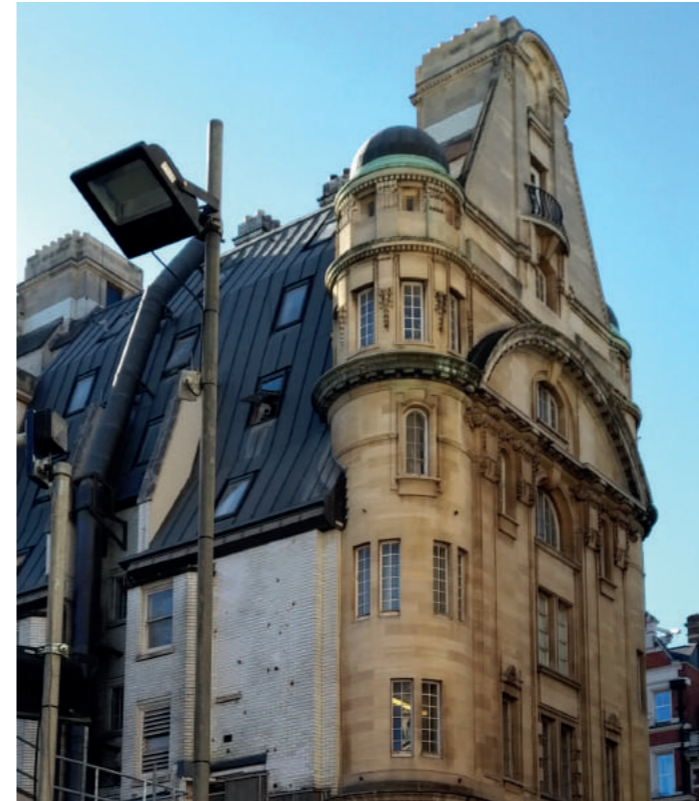
Carlisle House - 'catslide' roof and northern gable

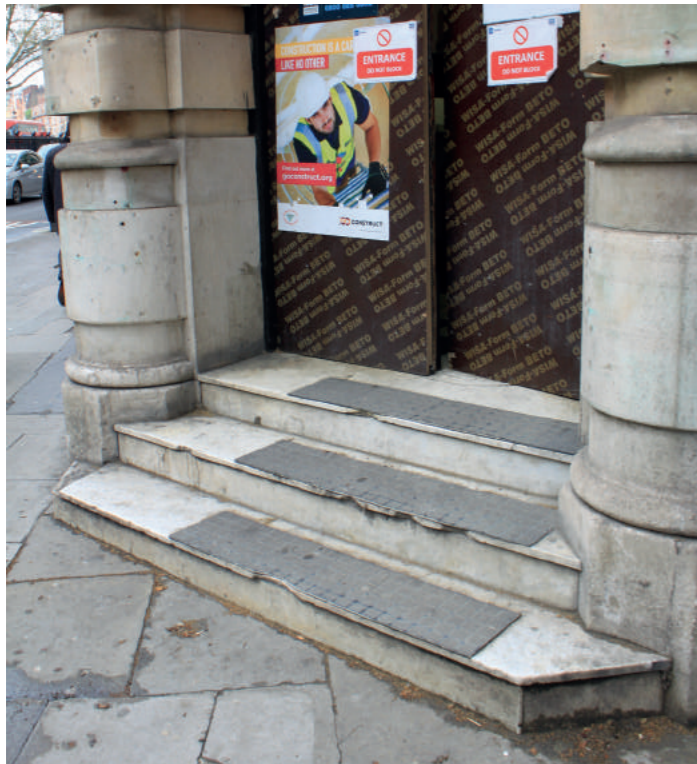
Carlisle House - stepped entrance at southwest corner

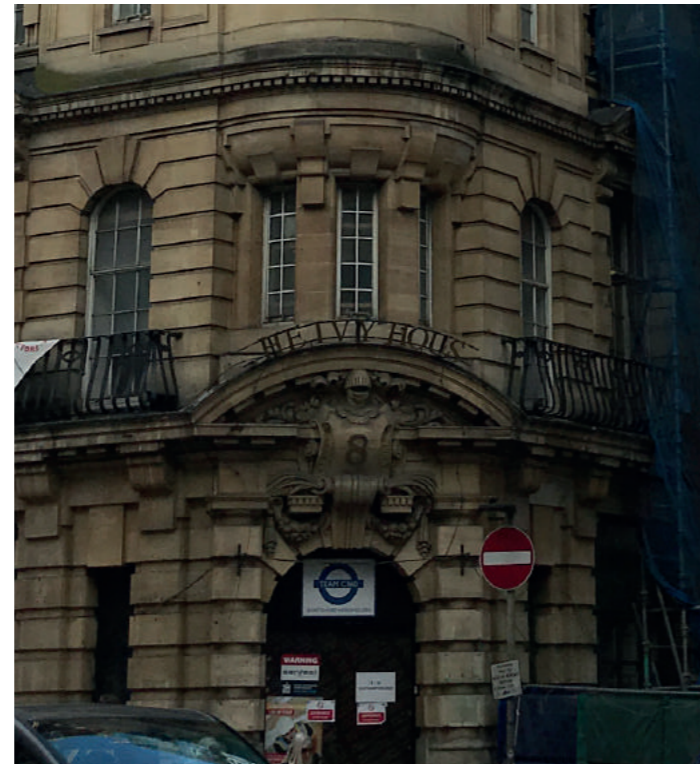
Carlisle House - decorative southwest entrance and first floor balustrades

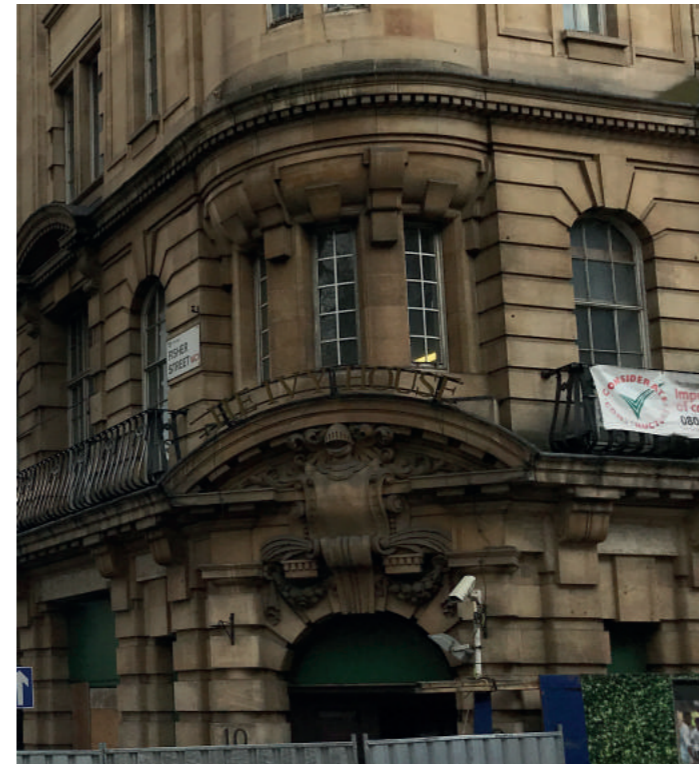
Carlisle House - decorative northwest entrance and first floor balustrades

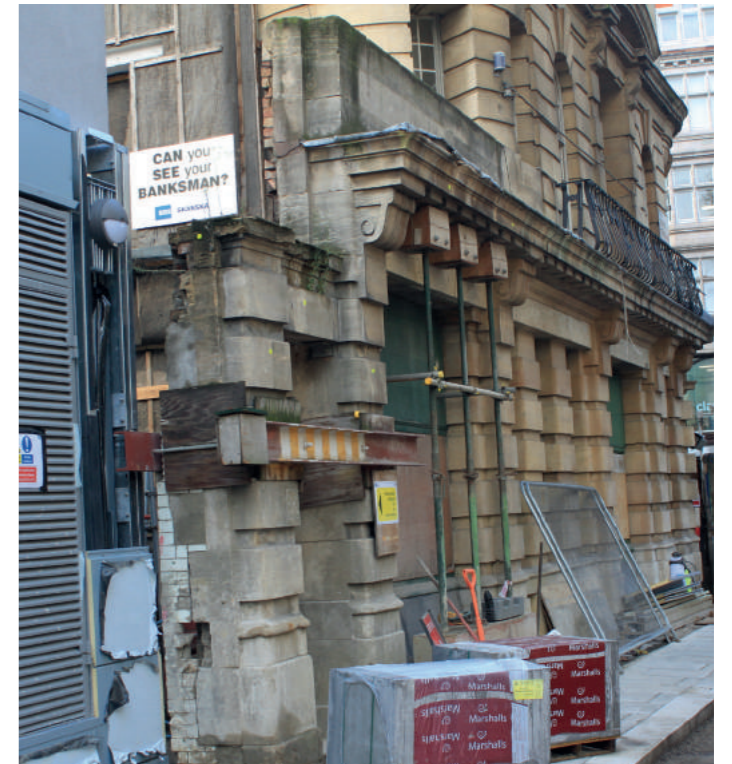
Remaining northern wall of demolished rear extension

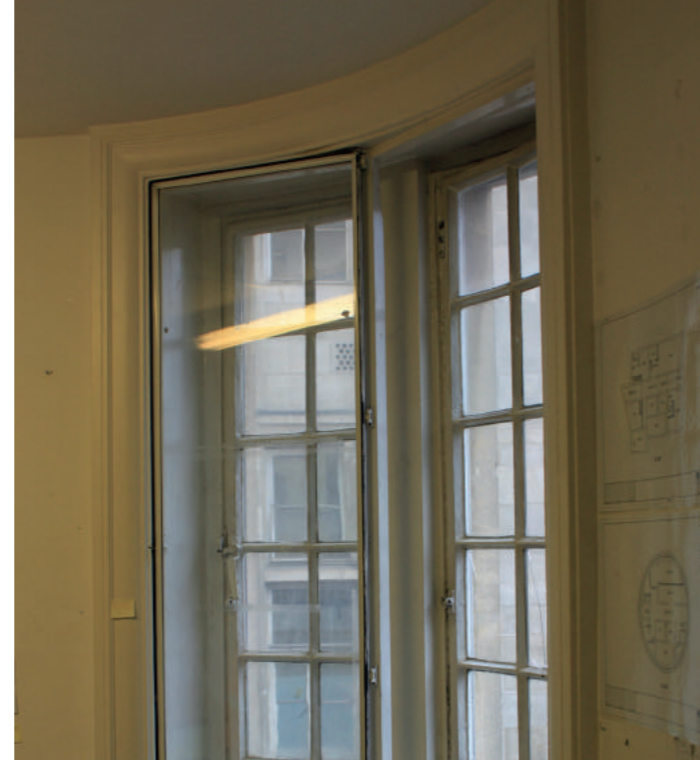
Corner windows and secondary glazing at 2nd floor

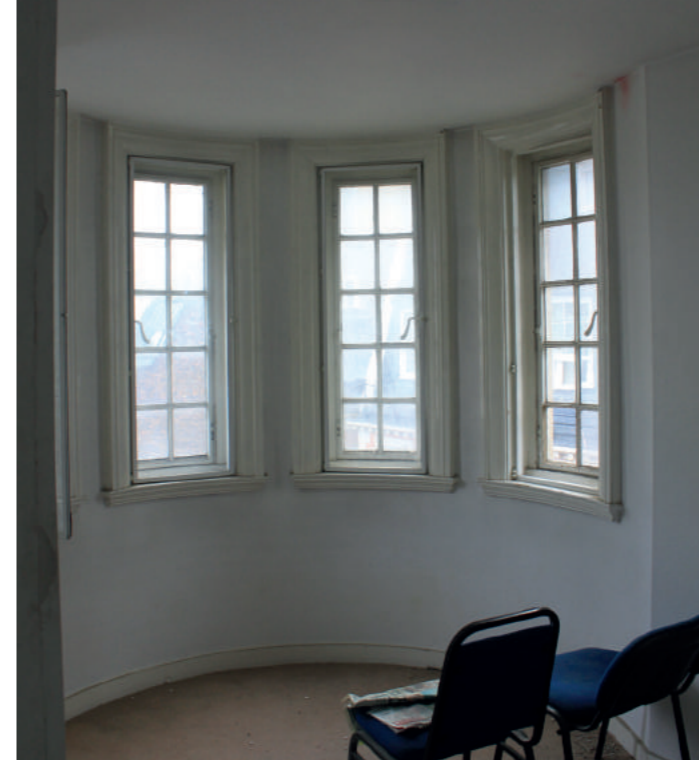
Corner windows and secondary glazing at 1st floor

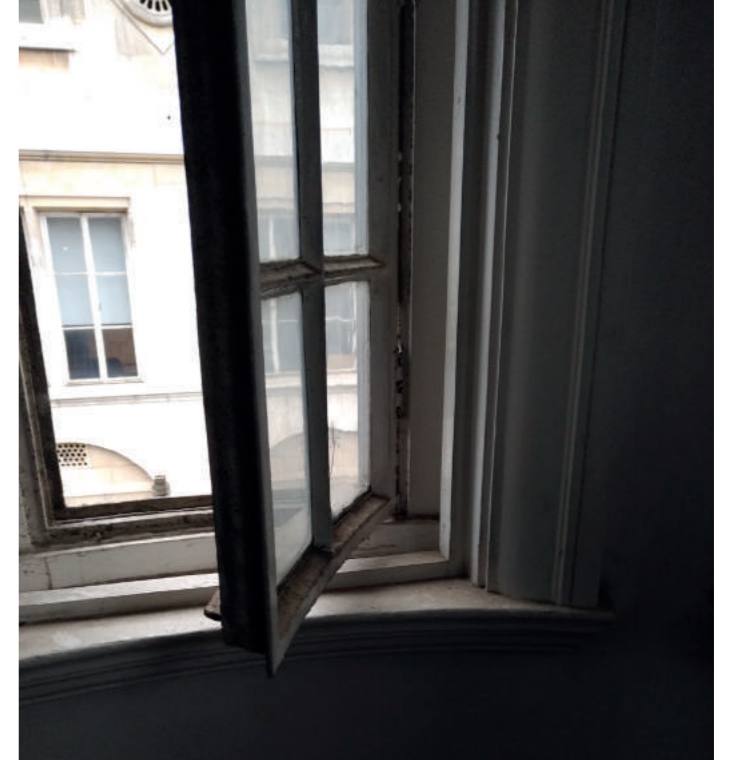
Curved window leaf

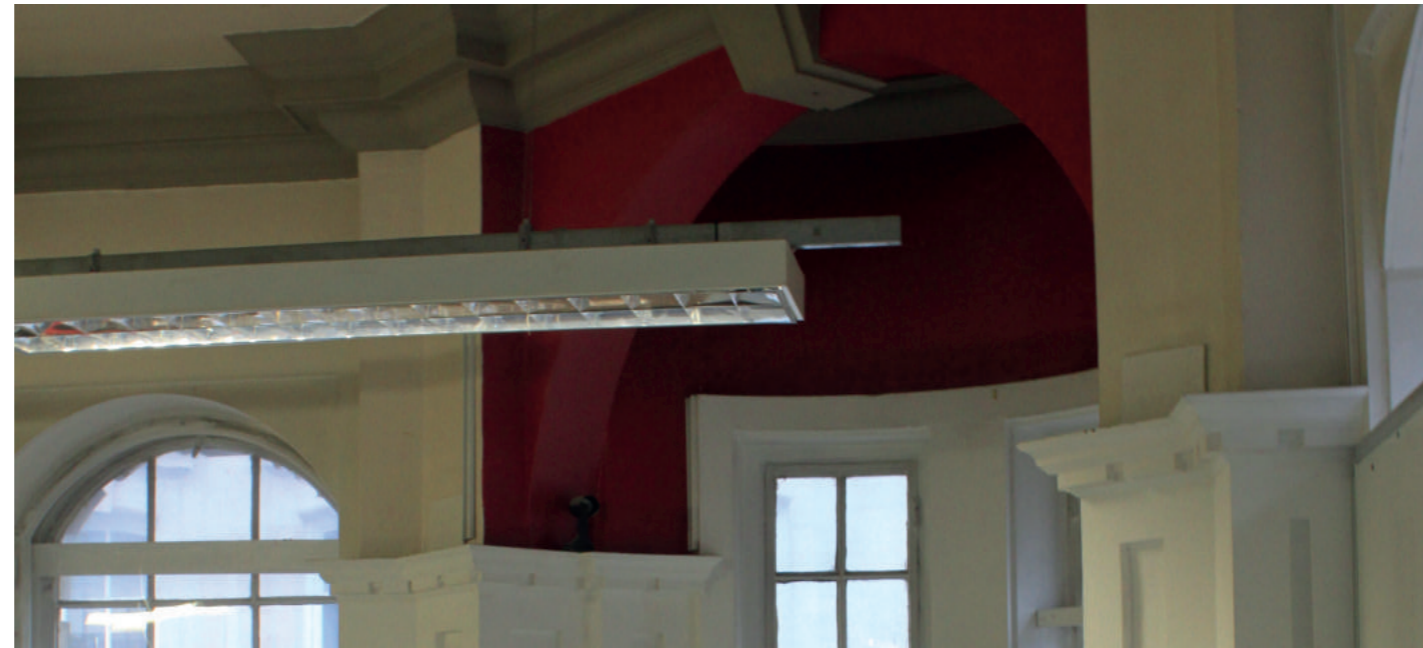
Decorative cornices & beams at 1st floor ceiling

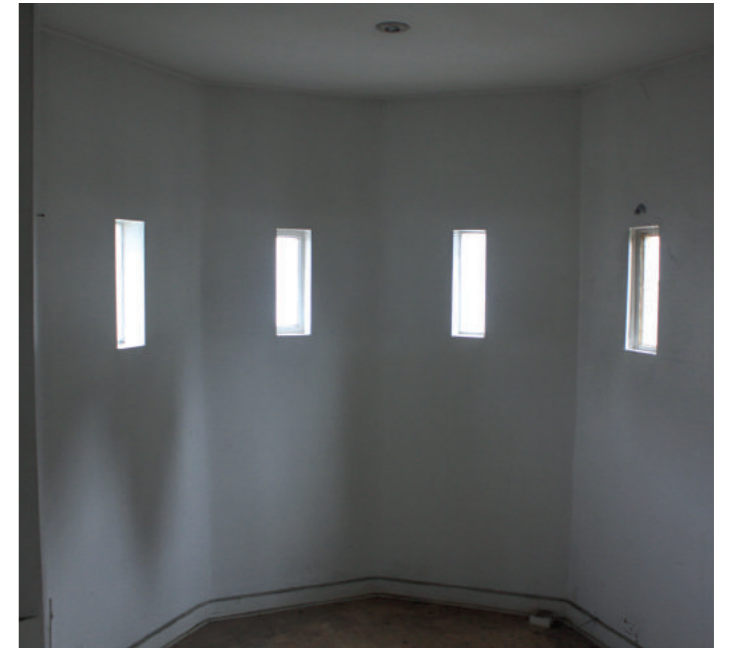
6th floor turret windows & plasterboard lined interior

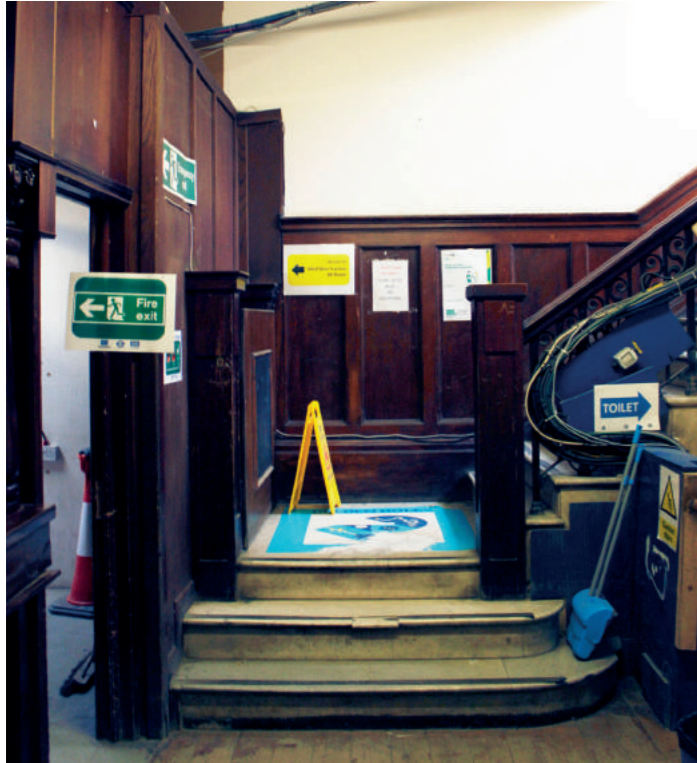
Ground floor stair & 1996 Edwardian style joinery to the left

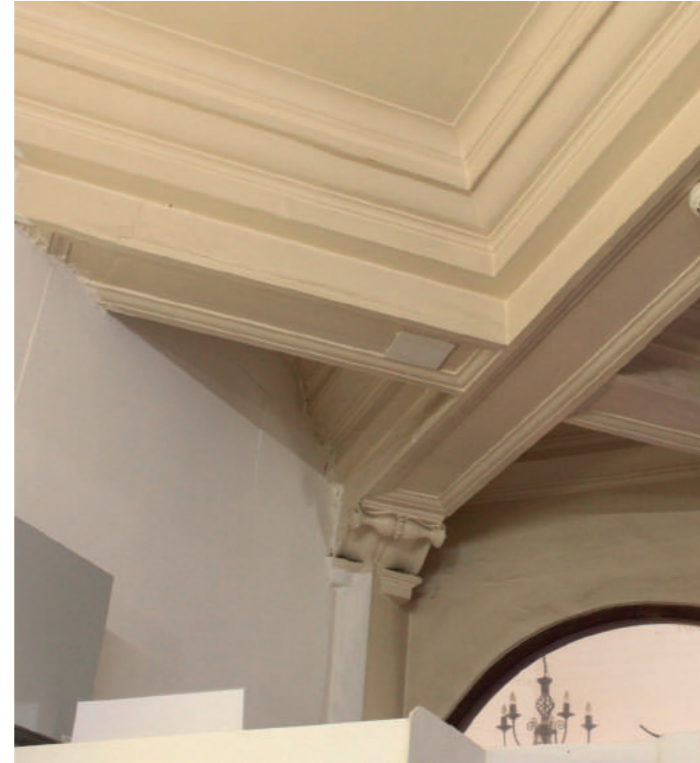
Non-original partition clashes with decorative ceiling

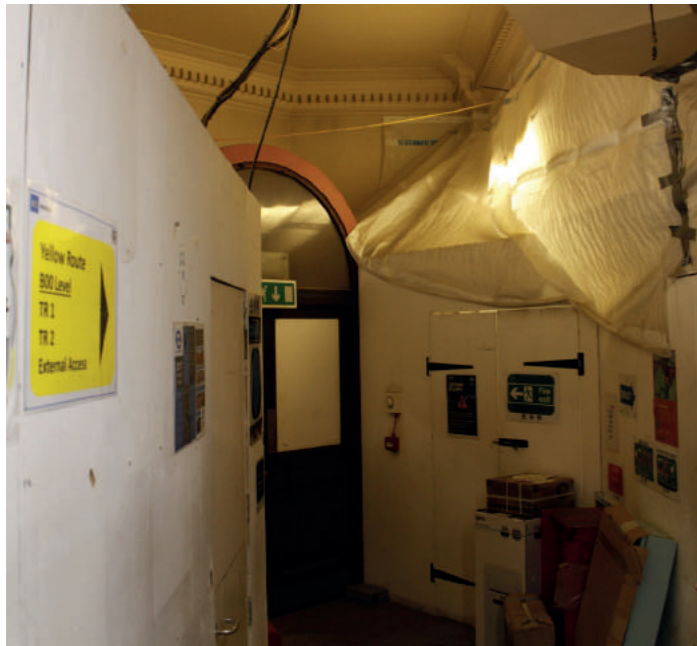
Southwest entrance with Crossrail partitions

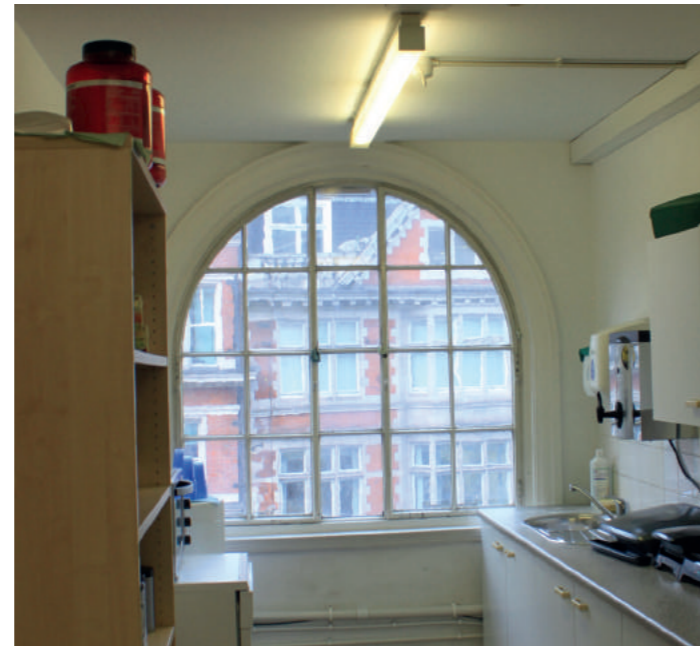
4th floor arched window

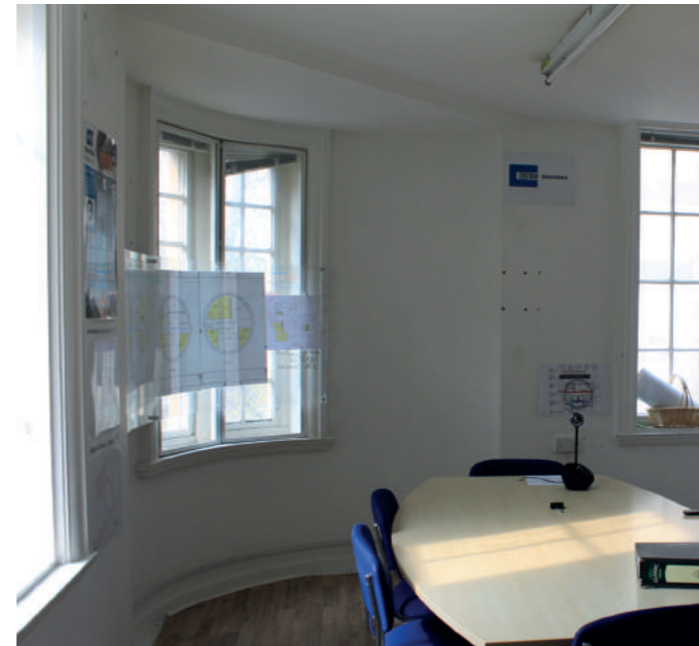
2nd floor corner windows, currently a meeting room
