FENTON HOUSE, HAMPSTEAD GROVE, HAMPSTEAD, LONDON, NW3 6SP

ALTERATIONS TO LEANING BOUNDARY WALL AND PIER

DESIGN AND ACCESS STATEMENT

MAY 2019

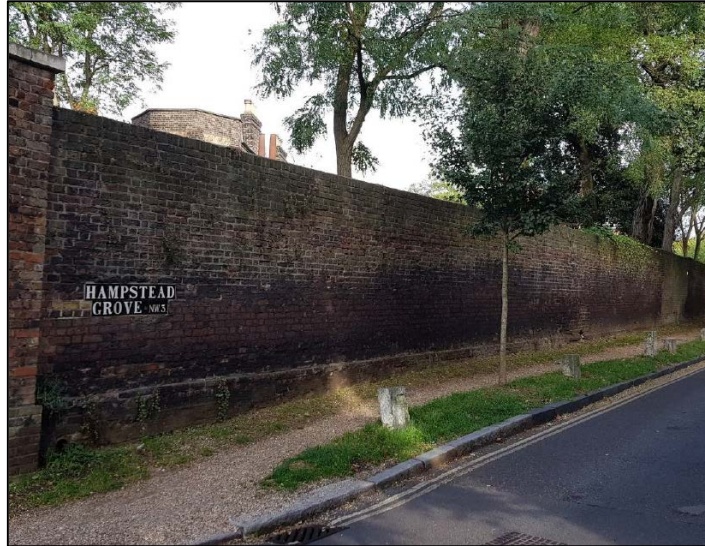
Leaning boundary wall

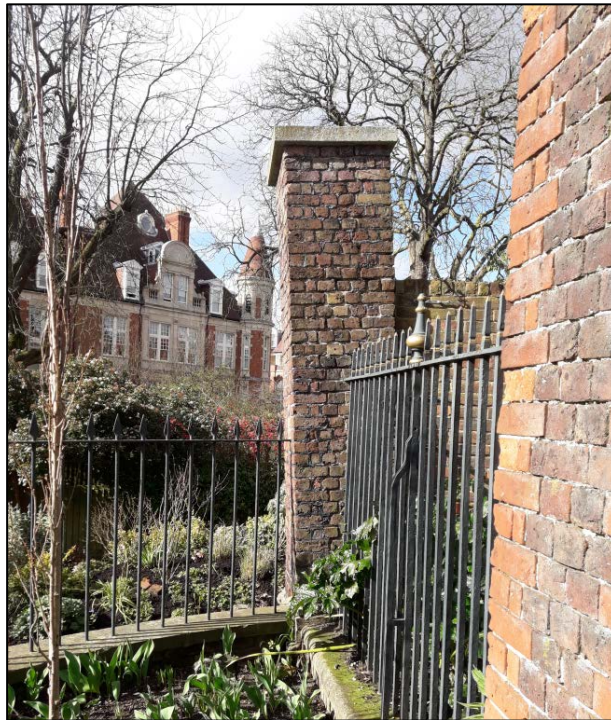
Leaning pier

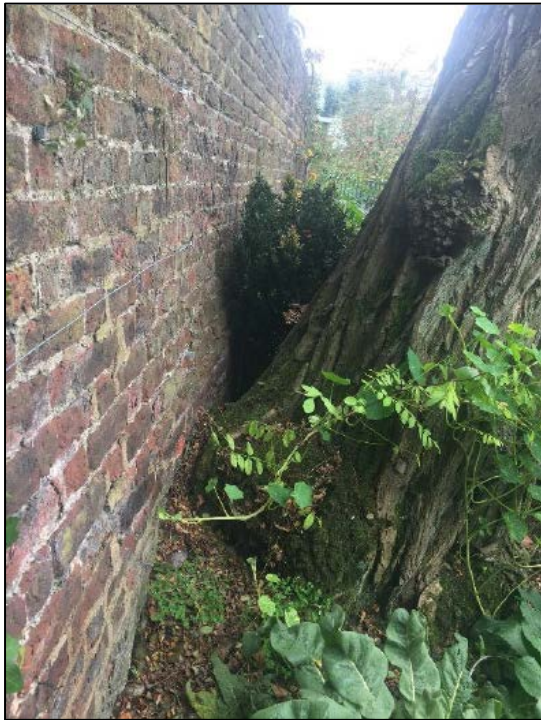
3.2 The report carried out by Civic Engineers (Civic Engineers, 2017, p8) indicates that the trunk of a large Robinia tree is growing against the inner face of the boundary wall, pushing out the bottom of the wall (Photo 1). There is evidence of sections along the base of the wall that have previously been reset and repointed, but continuous pressure has caused localised cracking and bricks to fall out onto the public footpath on Hampstead Grove (Photo 2).

Photo 1: Robinia tree growing against the wall

3.6 Part 1 involves removing some of the bricks around the base of the wall to provide space for the tree roots to grow. A brick arch will be created here with a bespoke metal grille installed to prevent unauthorised access. HeliBars will be installed in the section above the wall to prevent further cracking. See drawings below for further details.

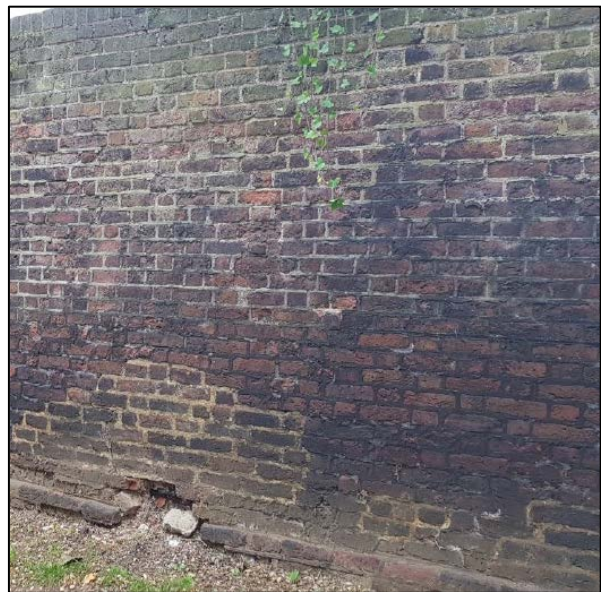
Photo 2: Loose bricks on Hampstead Grove

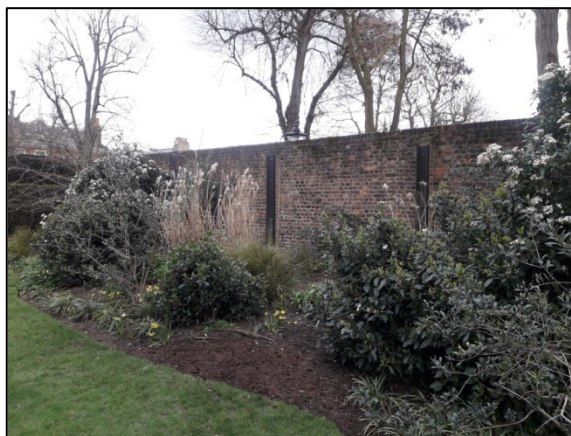
3.3 Further north along the same wall remedial work has previously taken place in the shape of steel 'L' supports on the internal face, secured below ground level to a concrete counterweight foundation (Photo 3). The work is assumed to have been carried out between 2002 and 2016.

Photo 3: Steel supports securing the boundary wall

3.4 This previous intervention has prevented the wall leaning any further and retains the wall in its position.

- a) The existing steels (see photo 3 above) are not surrounded in brick and aesthetically it would be better to have a matching intervention.
- b) Digging foundations for the brick encasement would involve removing more plants and would cause unnecessary damage and intervention to the garden.

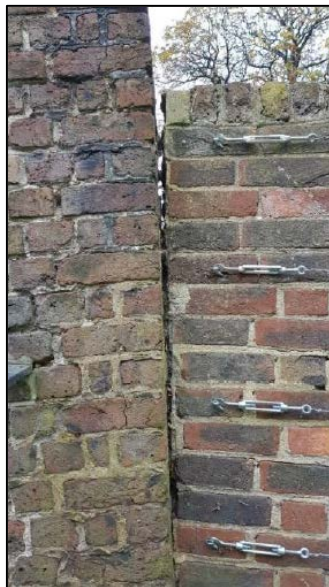
4.2 Civic Engineers Report (Civic Engineers, 2017, p12) indicates that the western party wall has been rebuilt and is leaning where it meets the pier. Since this reconstruction, the pier has displaced further, creating a larger joint between the wall and the pier as shown in photo 4. There is also mortar loss where the pier meets the single skin party wall.

Photo 4: Open joint between pier and wall

4.4 Rebuilding the pier will ensure the longevity of both the party wall and pier. Drawing “893-07-(AS)004 C01 - brick pier sequence of work” provides the full details but to summarise, the work involves:

1. Deconstructing the pier taking note of existing bricks and patterns
2. Stitching the cracks in the party wall using Helifix bars
3. Reconstructing the pier vertically and tying to the end of the party wall

4.5 As many of the existing bricks as possible will be reused. Where the bricks are beyond their useful life, they will be replaced to match the material and colour using handmade Mulberry Stock bricks manufactured by Bulmer Brick and Tile Company. The existing mortar has been sent for analysis and the same mix will be used for rebuilding.

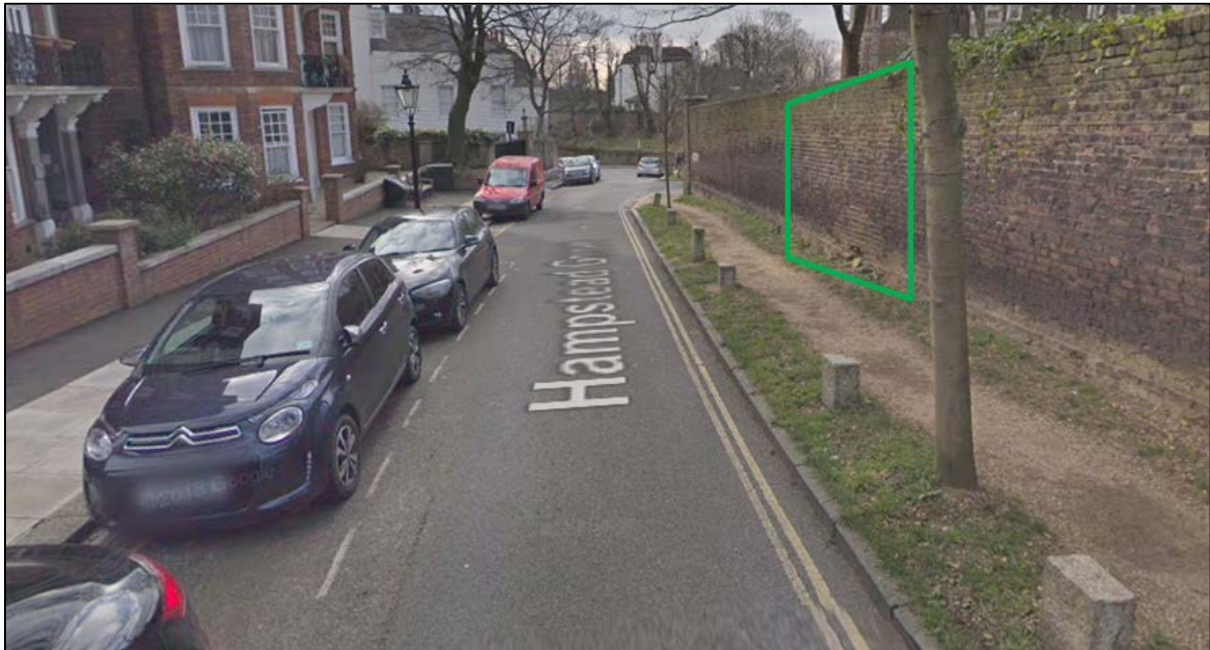
5.4 Whilst the arch is created in the base of the boundary wall, propping will be required along the footpath of Hampstead Grove. This side of the road has double yellow lines however there is a pavement on the other side so cars and pedestrians will still be able to use the road. Permission from the council will be sought prior to establishing the propping. Photo 5 shows the location of the props.

Photo 5: Approximate location of props whilst the arch is created at the base of the wall
