VERIFICATION REPORT
of a site at
1 Belmont Street, London NW1 8HJ
for
RISNER DESIGN

Project No 1557
Report ref: 1557-P4E-1
Issued: 17 May 2019
Revision: A

**1557-P4E-1-A: Belmont Street, Chalk Farm
Risner Design**

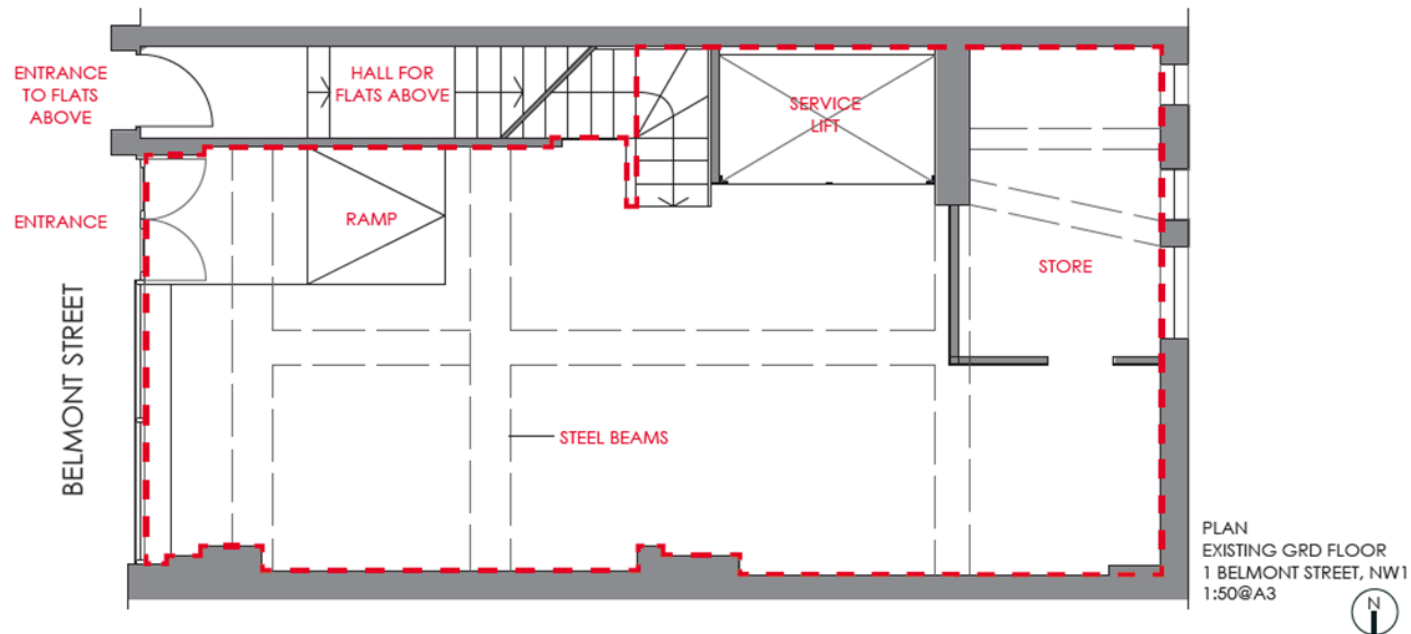
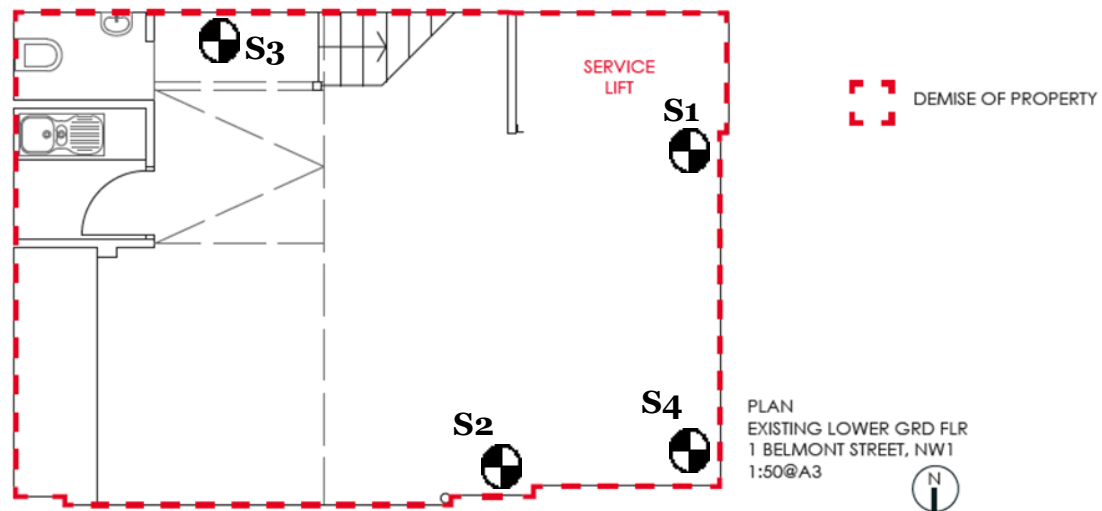
Appendix B – Sample Location Plan

A plan of the verification sample locations is contained in appendix B

| Location Reference | Rationale for Location | Depth (mbgl) | Sampling, Testing & Monitoring |
|---|--|---|---|
| S1-S4 | Samples were located where previously vapours or visual evidence of oil were identified. | 0.2-0.3 | Samples taken from old made ground, below geotextile membrane. Tested for vapours |

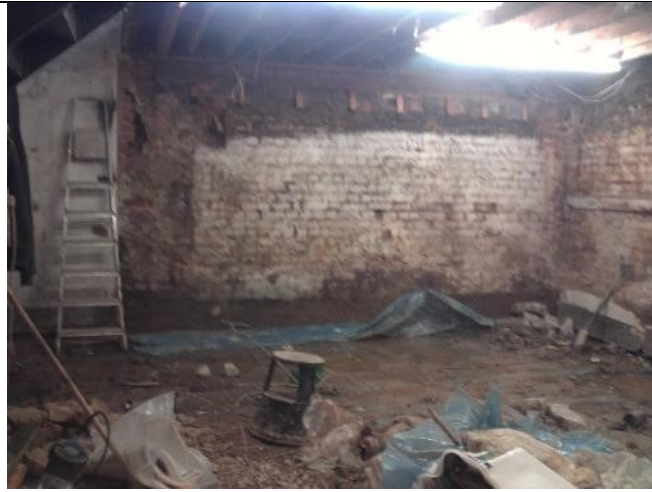
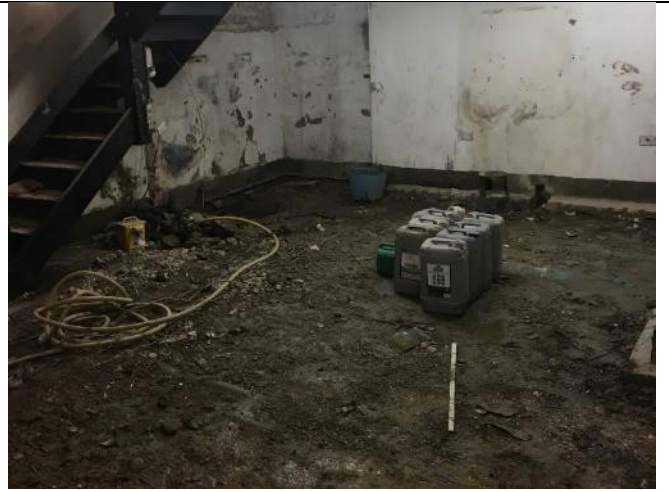
Area before excavation

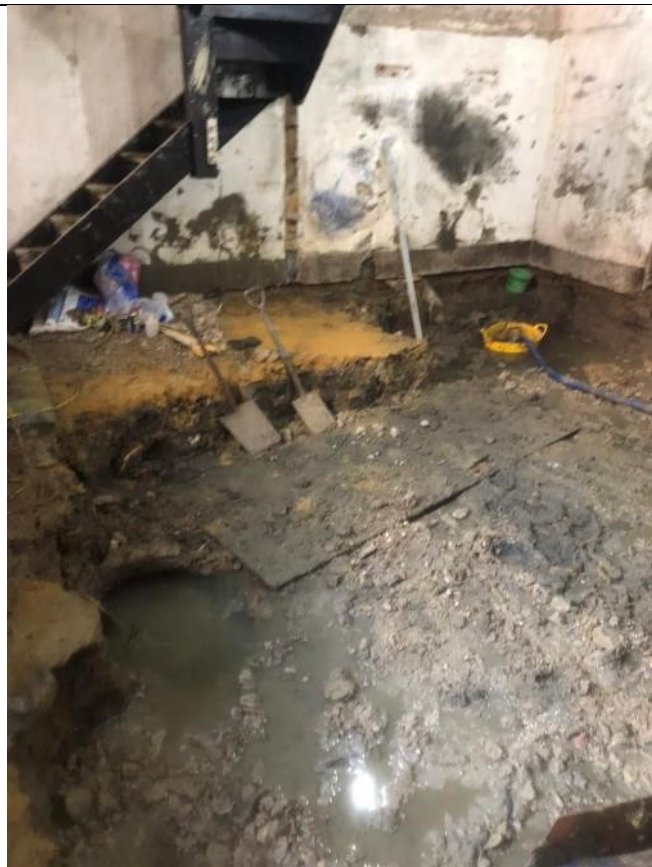
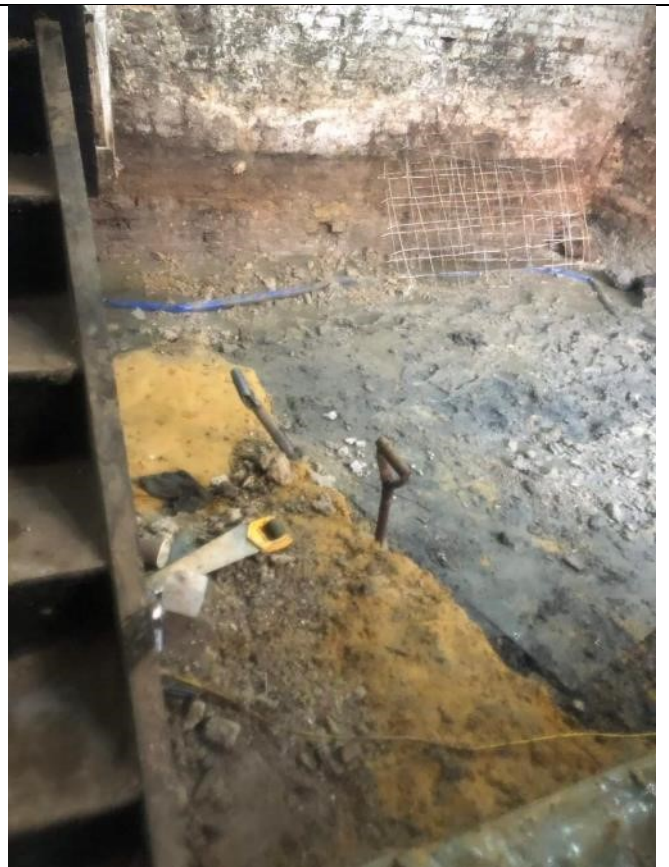
Area during excavation

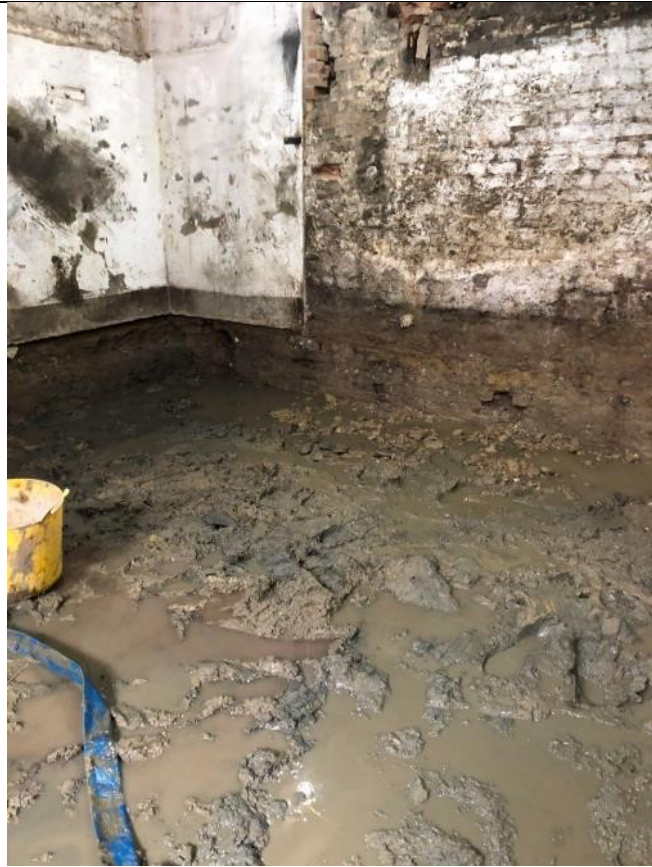
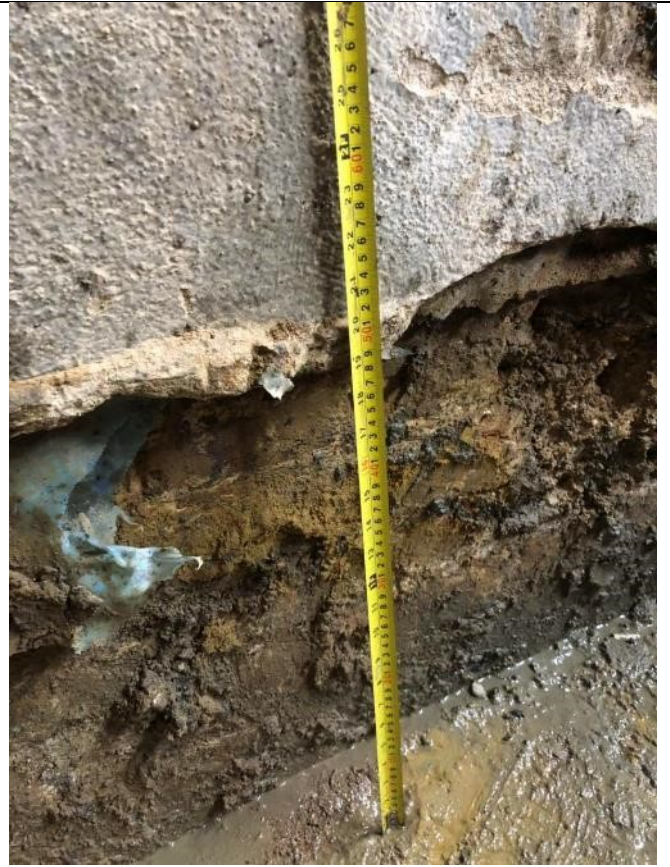
The area of the basement was excavated to a depth of 500mm below the existing level. At that depth there was no visual contamination present. Photographs are contained in appendix D.

The variation in colour, shown on the photographs, on the excavated surface, is considered to be a natural phenomenon, as it was also noted during the phase 2 and 3 site works. This can be confirmed from borehole logs obtained from the near vicinity as they describe the clay variously as black/grey, brown/blue and grey/brown clay. The borehole logs from the surrounding area can be found in appendix G.

left. The photos show clean clay and clean water sitting on top”.

Area after excavation

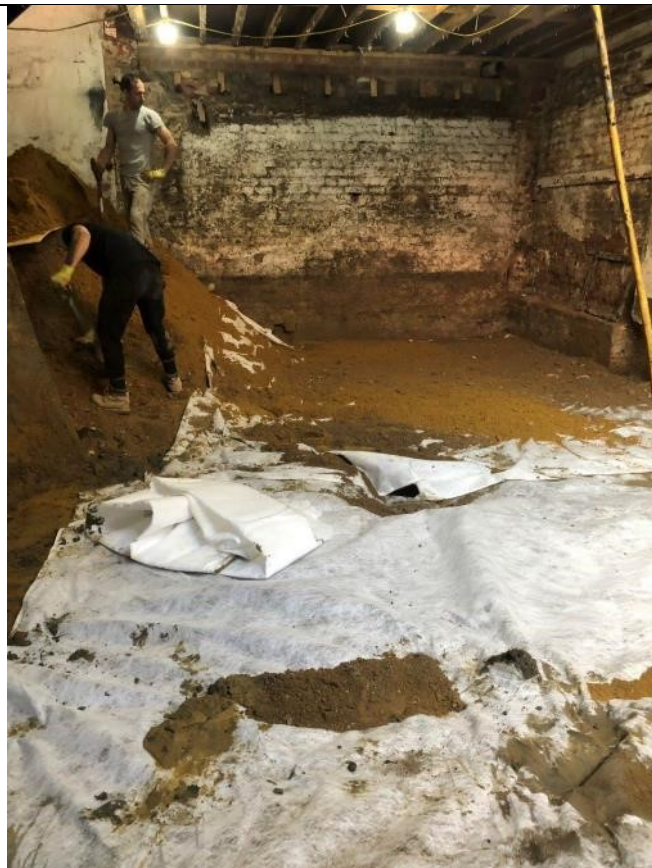
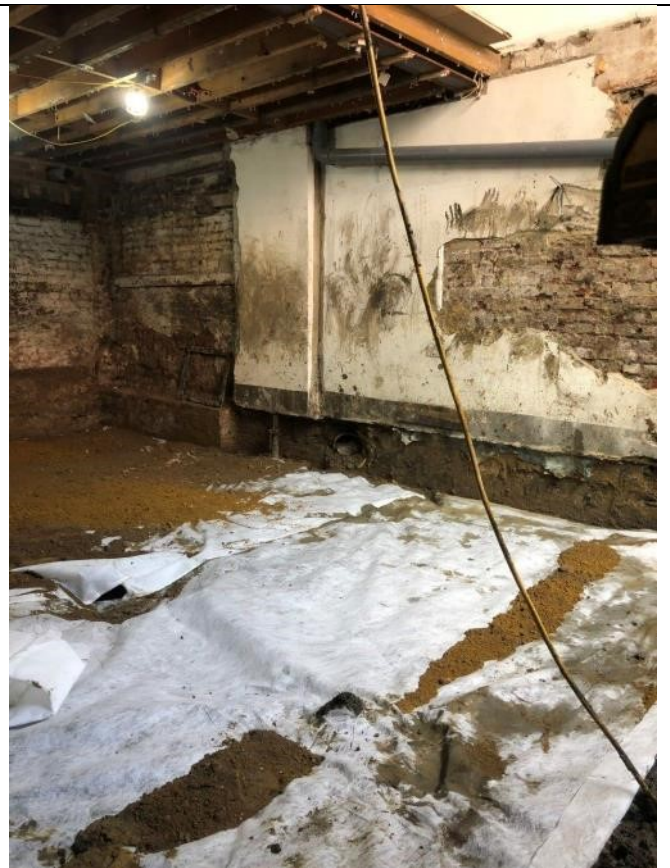
A geotextile membrane was laid down and a 150mm layer of hardcore was placed on top. Following the hardcore, a 50mm layer of concrete blinding was poured and on top of that, a Memtech Pro M1 membrane was placed. Then a 150mm reinforced concrete slab, insulation and screed.

Geotextile membrane and new hardcore
