Planning Application Grade II Listed Building

Existing Windows & Condition Report

Sash Windows: Planning Application - 16 New End Square

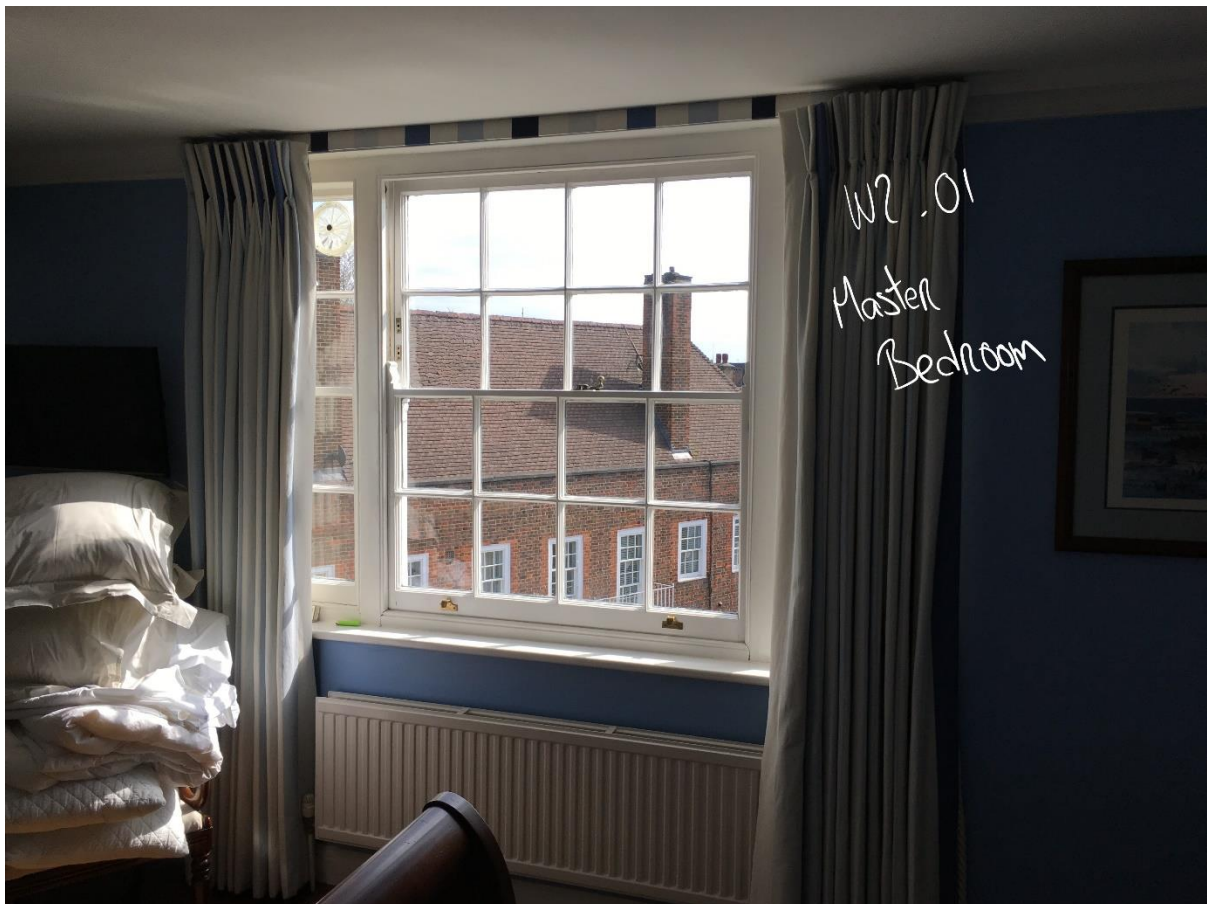
W2.01	Master Bedroom
Window Type	Venetian Sash Window
Timber -	Softwood The timber is of poor condition. The windows have been renovated and rotten areas filled with an inadequate decorators' filler a number of times.
Glass -	4mm Clear Poor condition scratched in numerous places. The glass does not show any signs of being either crown glass or historic rolled plate glass.
Paint -	White Gloss Paint Good condition – recently painted
Liners / Architrave	Internal liner and architrave Good condition (to be retained)
Ironmongery	Brass fastener and sash lifts Broken Fastener and sash lifts
Design	Venetian window Correct design
Issues:	Unsightly plastic air-vent

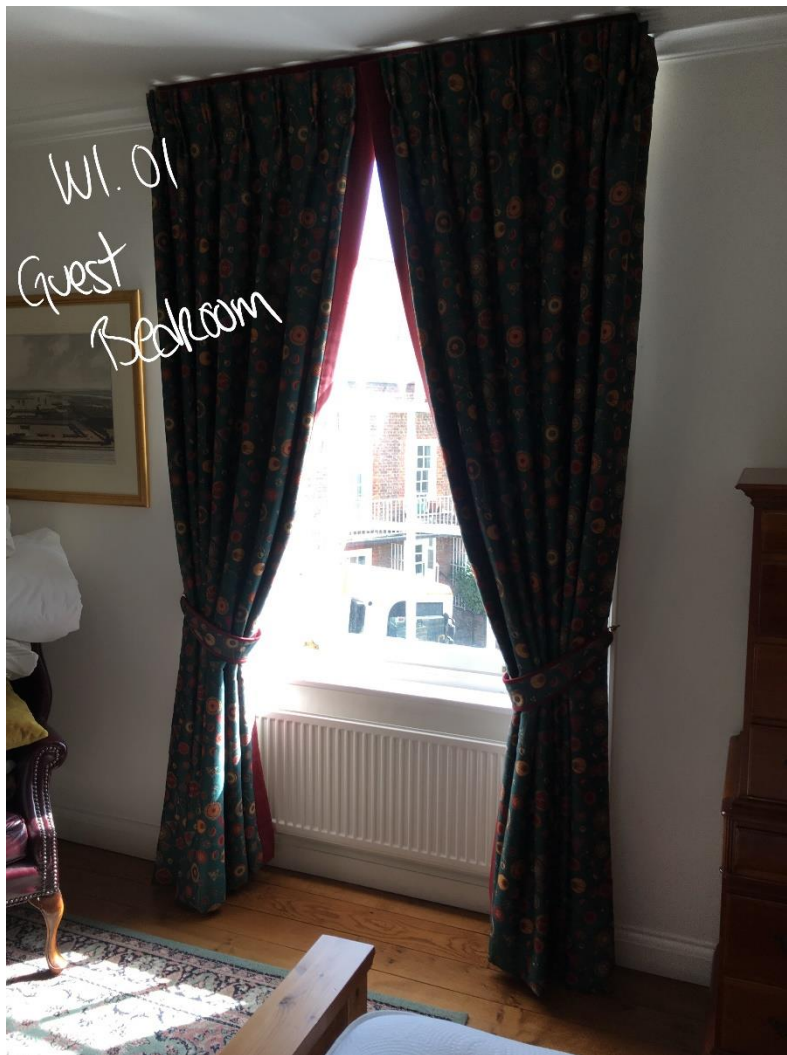
W1.01 Guest Bedroom
Window Type 8 panes over 8 panes Sash Window

Timber - Softwood
The timber is of poor condition. The windows have been renovated and rotten areas filled with an inadequate decorators' filler a number of times.

Glass - 4mm Clear
Poor condition scratched in numerous places. The glass does not show any signs of being either crown glass or historic rolled plate glass.

Paint - White Gloss Paint
Good condition – recently painted

Liners / Architrave Internal liner and architrave
Good condition (to be retained)

Ironmongery Brass fastener and sash lifts
Useable and signs of age

Design Correct design

Additional Unsightly plastic air-vent

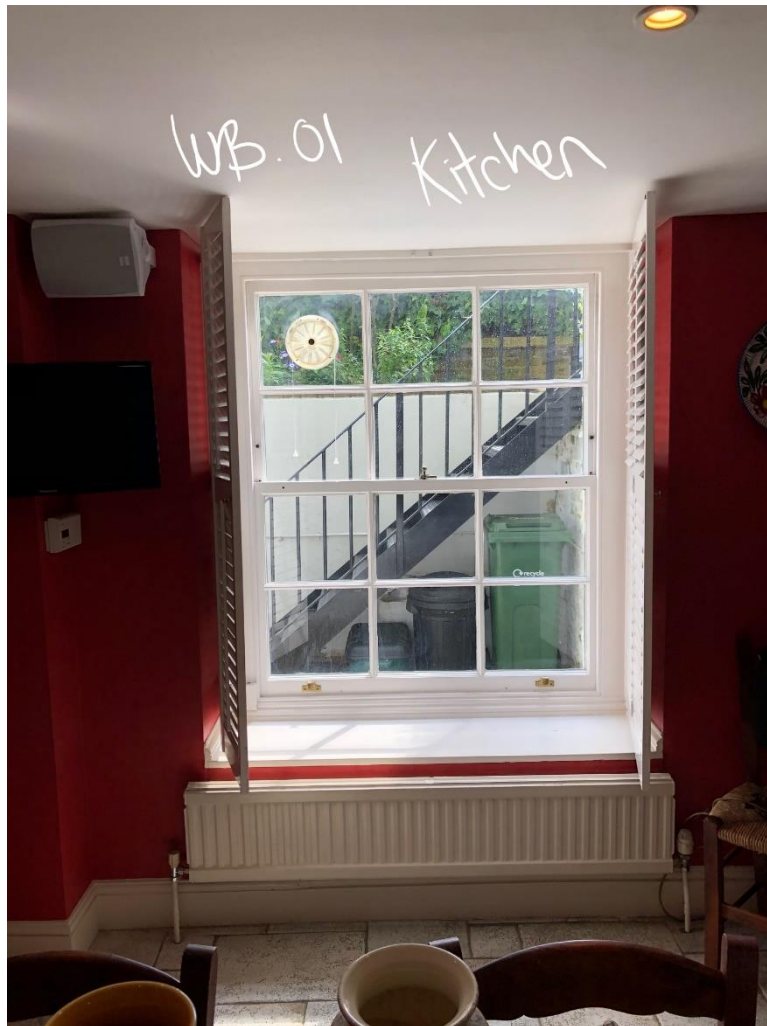
WB.01 Kitchen
Window Type 8 panes over 8 panes Sash Window

Timber - Softwood
The timber is of poor condition. The windows have been renovated and rotten areas filled with an inadequate decorators' filler a number of times.

Glass - 4mm Clear
Poor condition scratched in numerous places. The glass does not show any signs of being either crown glass or historic rolled plate glass.

Paint - White Gloss Paint
Good condition – recently painted

Liners / Architrave Internal liner and architrave
Good condition (to be retained)

Ironmongery Brass fastener and sash lifts
Useable and signs of age

Design Venetian window
Correct design

Additional: Unsightly plastic air-vent

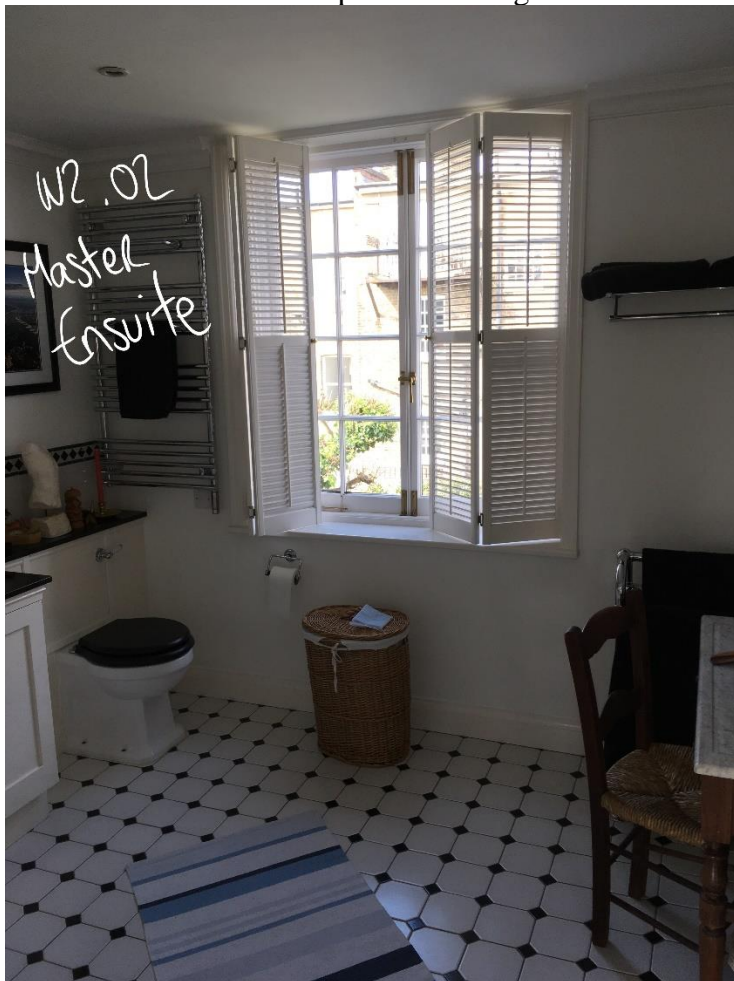
W2.02 Master Bedroom Bathroom (Ensuite)
Window Type Casement

- Timber - Softwood
The timber is of very poor condition. The windows have been renovated and rotten areas filled with an inadequate decorators' filler a number of times. Rot is evident in a number of places
- Glass - 4mm Clear
Poor condition scratched in numerous places. The glass does not show any signs of being either crown glass or historic rolled plate glass.
- Paint - White Gloss Paint
Good condition – recently painted
- Liners / Architrave Internal liner and architrave
Good condition (to be retained)
- Ironmongery Brass Casement Furniture
Useable and signs of age
- Design Casement Windows
The casement windows looks to be a later alteration from a sash window and does not match the rest of the sash windows in the house and the neighbours window.
- Additional Proposed to change to a sash window a

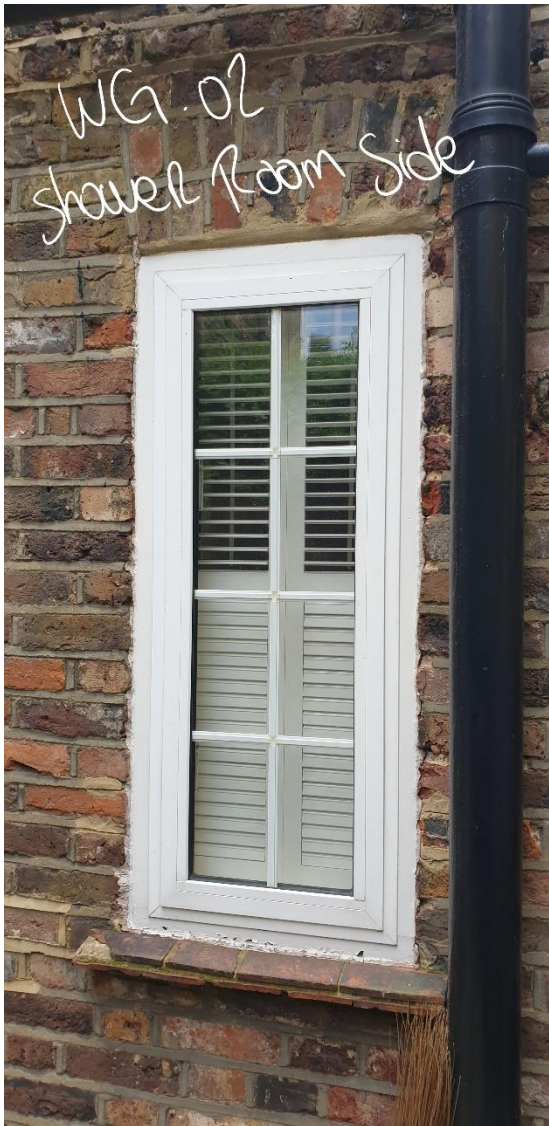
WG.02 Shower Room
Window Type Aluminium Casement Windows

Material - Aluminium
New fitted in good conditon
Glass - Double Glazed
Paint - White powder coated
Liners / Architrave No present – Tiled internal wall
Ironmongery White
Design The windows type is correct but the glazing bars are wrong and the material used is wrong.
Additional

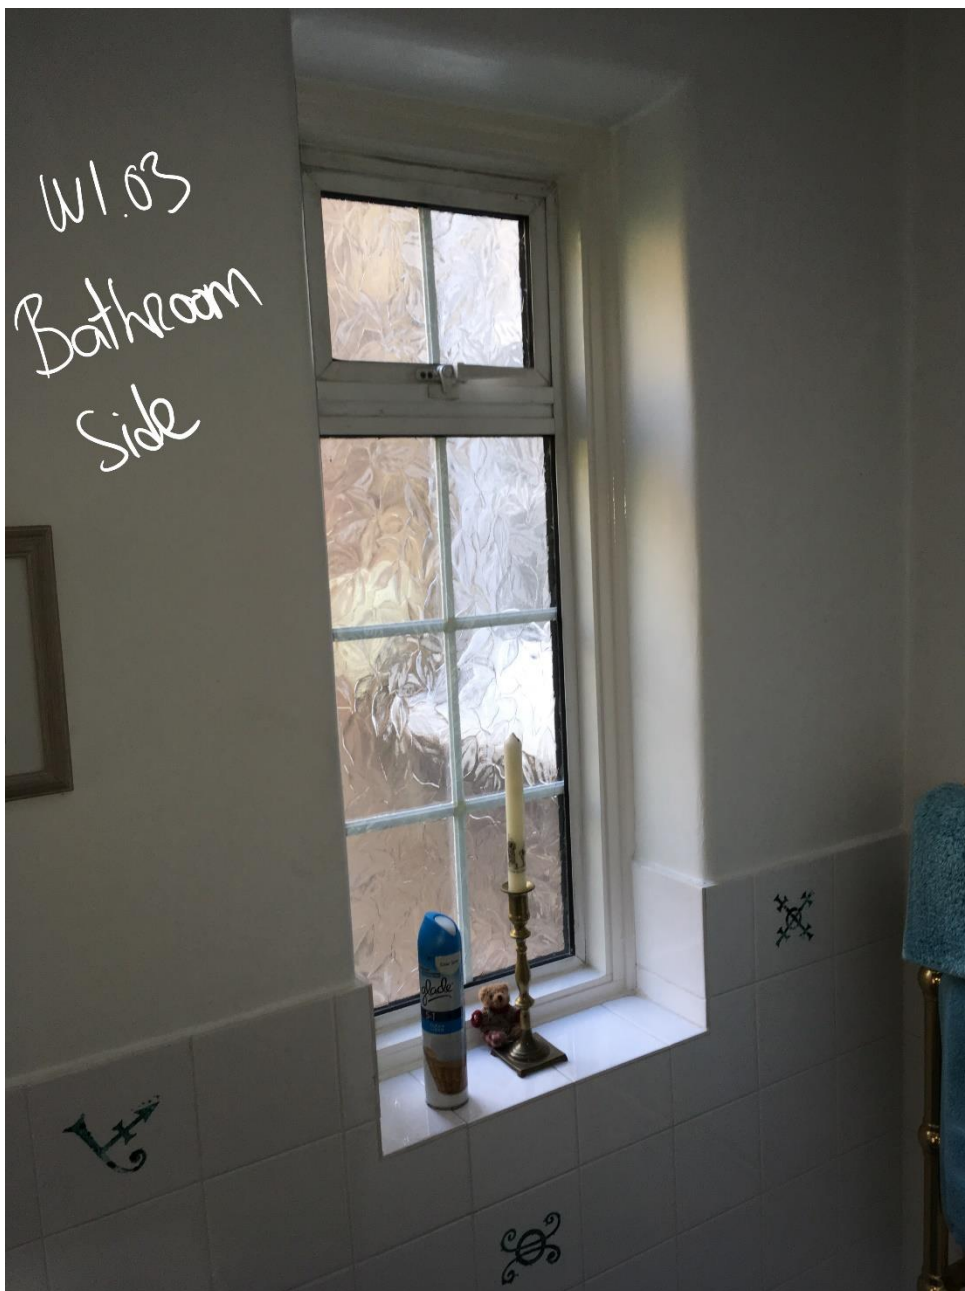
W1.03	Bathroom
Window Type	Aluminium Casement Windows
Material -	Aluminium
Glass -	New fitted in good conditon
Paint -	Double Glazed
Liners / Architrave	White powder coated
Ironmongery	No present – Tiled internal wall
Design	White
Additional	The windows type is correct but the glazing bars are wrong and the material used is wrong.
