Site Monitoring Report - Supporting the Addendum to: Tree Report & Arboricultural Impact Assessment Ref: SB/JS/616

Land at 6 Templewood Avenue, London NW3.

Reference: SB/JS/616/SM.

Site Monitoring Report Sheet 1

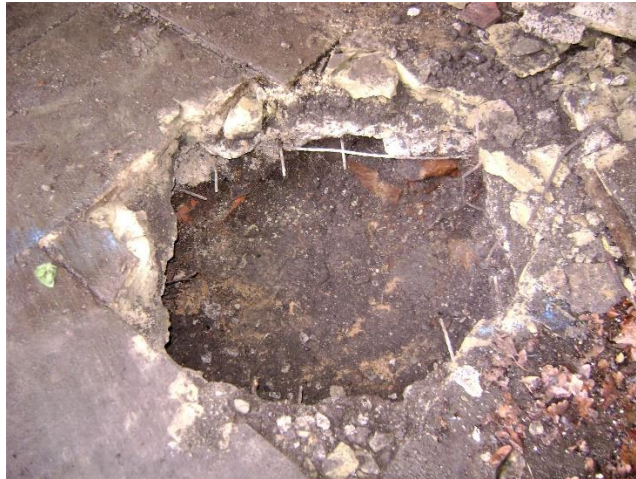
Test Pit 1.

Six pits were dug to a depth of 500mm in the locations shown on the attached Plan SB/JS/616/TPE. A few minor feeder roots were found in pits 1, 4, 5 & 6 in the topsoil layer to a depth of 250mm. The roots are very likely to be from nearby garden shrubs that include Hydrangea, Camelia, Skimmia and Box. There was no evidence of any substantial tree roots which suggests very strongly that the brick boundary wall has acted as a barrier to roots from the Oak tree T2 and Silver Birch tree T3 in the adjacent garden (see attached Tree Schedule). Pits 1, 2 and 3 had to be excavated through the concrete base of the former summer house / shed building. The concrete base was approximately 180mm deep and reinforced with steel bars. Below that was a deep fill of hardcore rubble. The concrete and rubble base has also inhibited the spread of roots from the Sycamore tree T4 on the northern boundary. Pits 4, 5 and 6 were dug into deeper garden soil. See photographs of the six pits below.

Conclusion: The tall brick boundary wall has acted as an effective root barrier and has prevented the spread / extension of roots from the Oak tree and Silver Birch tree into and below the site of the proposed Orangery building. From an arboricultural point of view the foundation for the Orangery as designed will cause no harm to the Oak tree and Silver Birch tree in the adjacent garden and the Sycamore tree on the northern boundary. As a precaution the heavy duty matting should be extended across the lawn to protect the roots of the large Cedar tree T1 adjacent to the house and the Sycamore tree T4 on the northern boundary (see attached Tree Survey and protection Plan SB/JS/616/TS).

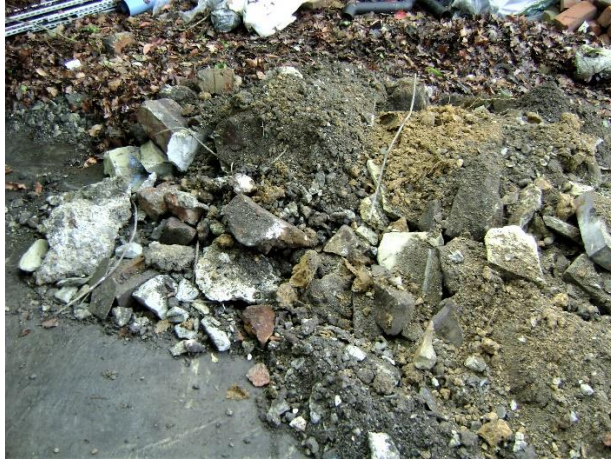
Concrete and rubble dug out of test pits 1, 2 and 3.

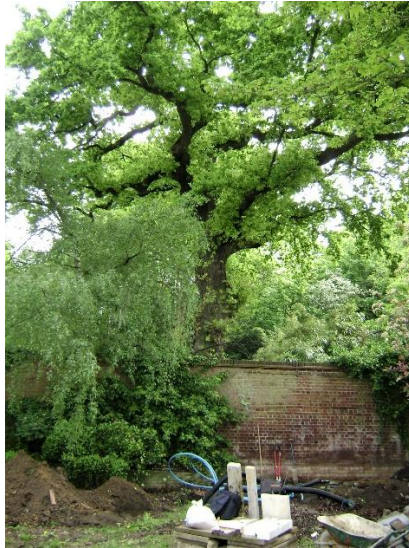
Oak tree T2 in centre photograph and Silver Birch tree T3 just to the left, in the adjacent garden on the far side of the brick boundary wall.

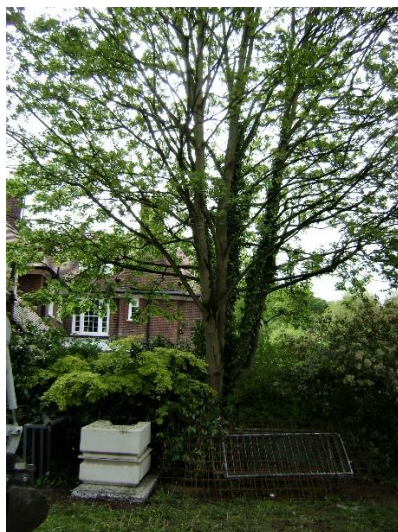
Sycamore /Maple tree T4 on the northern boundary.
