121 Canfield Gardens,  
London, NW6 3DY

Arboricultural Survey,  
Arboricultural Impact  
Assessment

Arboricultural Method  
Statement

Project No.: YMCQ101/001

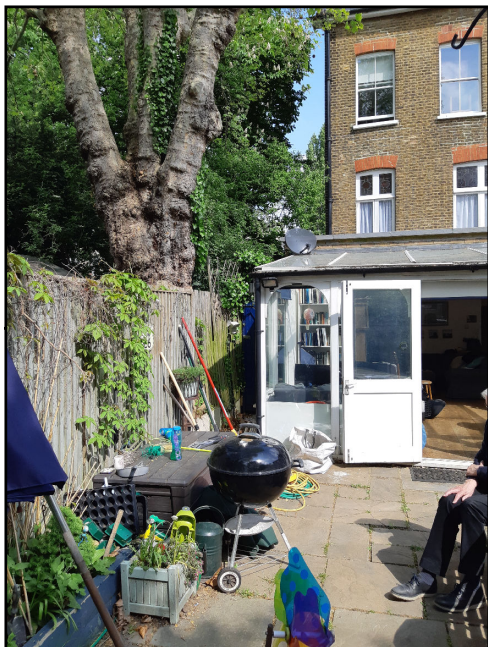
Photograph 1:  
Looking north along the line where the proposed extension is to be located adjacent to London plane tree T3.

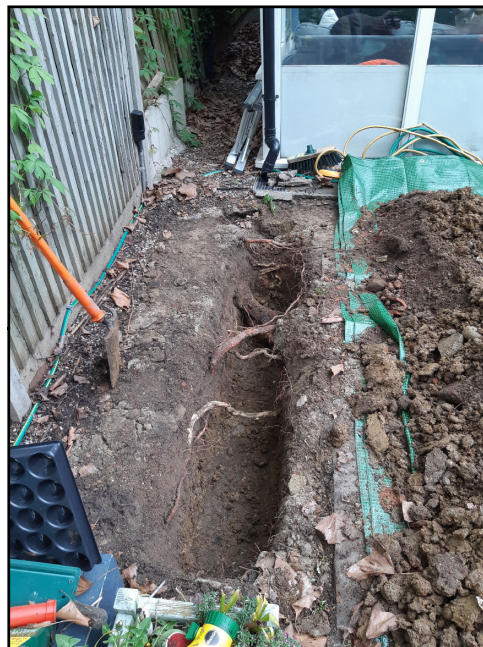
- 1.1.6 A trial pit was excavated within the Root Protection Areas (RPA) of trees T3 and T4. A number of small roots with a diameter less than 25mm were uncovered and one larger root with a diameter of approximately 100mm was uncovered in the top 300mm of the existing ground.

Photograph 2:  
Looking at 2m long trench (500mm deep) showing all roots uncovered during excavation.

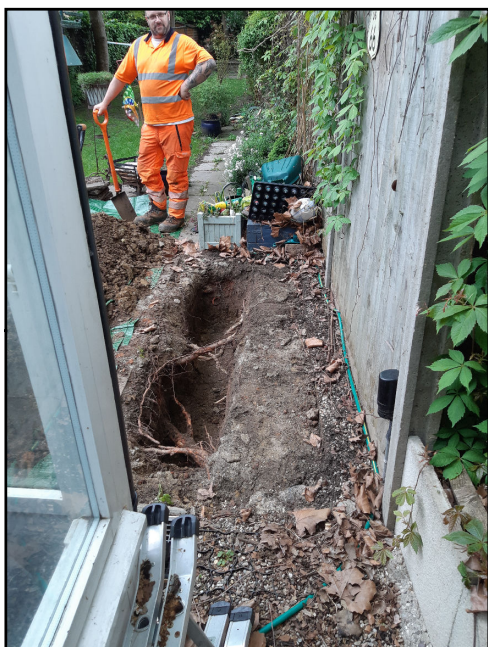
Photograph 3:  
Looking south along the excavated trench.

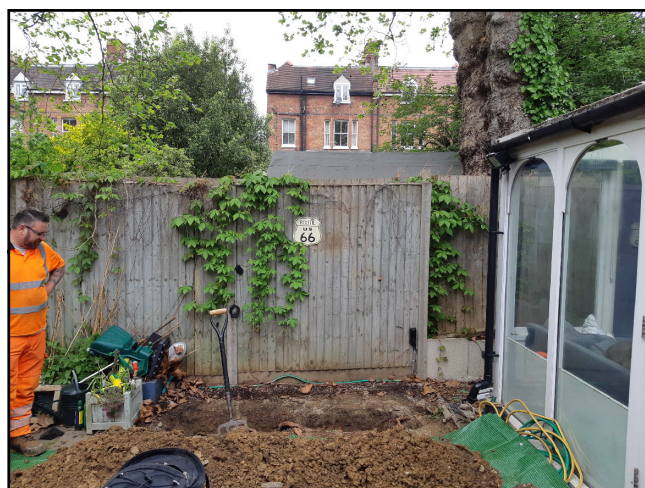
Photograph 4:  
Looking west at the location of the trench adjacent to T3.

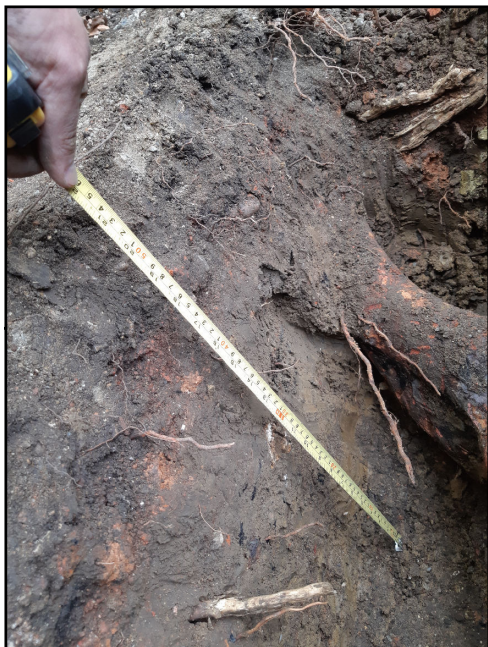
Photograph 5:  
Showing the depth of the trench, 500mm or greater than 500mm.

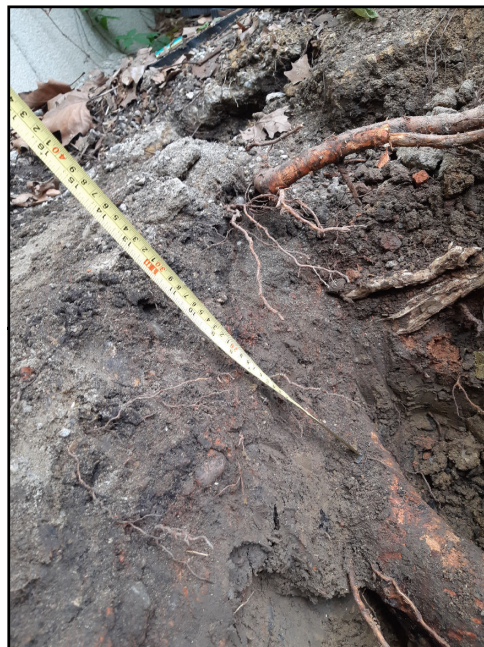
Photograph 6:  
Showing the depth of the largest root at 300mm below ground level.

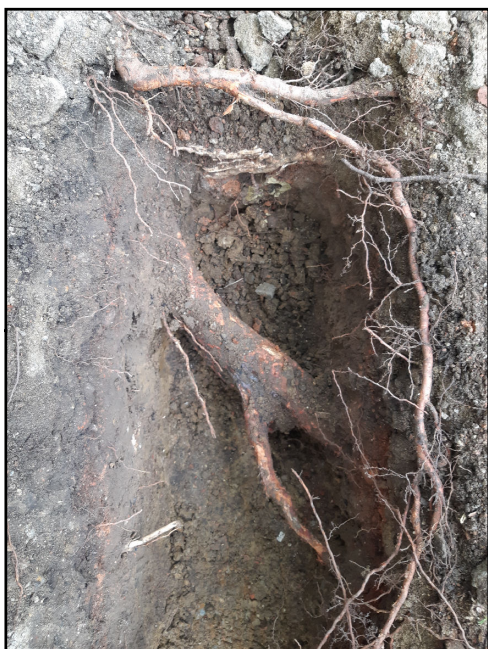
- 1.1.7 Severance of these roots will result in approximately 4% loss of the total RPA of tree T3 which is considered to be an acceptable level of loss. There should be no long term significant effect on this tree's health.

Photograph 7:  
Looking at largest root uncovered which grows from the direction of T3 in a south east direction.

- 6.10.1 Where the building footprint overlaps the RPAs of trees T3 and T4, mini-pile and raft foundations shall be used to prevent root damage. Approximately six mini-piles with anti-heave protection will be installed and a 300mm thick, reinforced concrete slab laid on top. A void will be left under the slab.

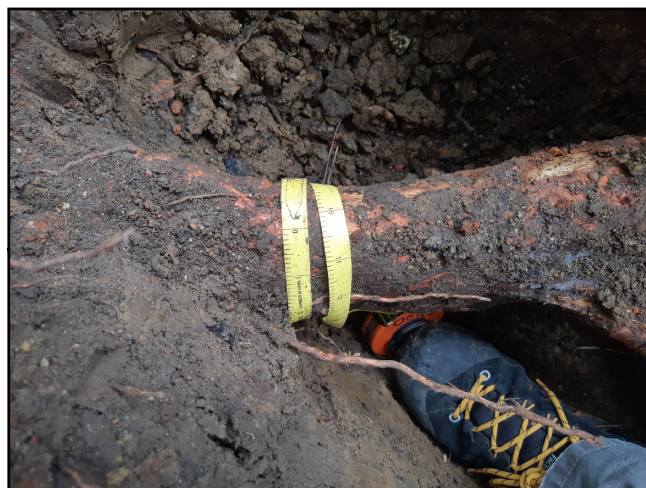
Photograph 8:  
Showing the largest root uncovered being 103mm in diameter.
