# 1EW02 Enabling Works – Area South

## Heritage Agreement Method Statement: Recording and Dismantling of Robert Stephenson Sculpture in Euston Station Forecourt

**Document number:** 1EW02-CSJ-HS-MST-S003\_000562

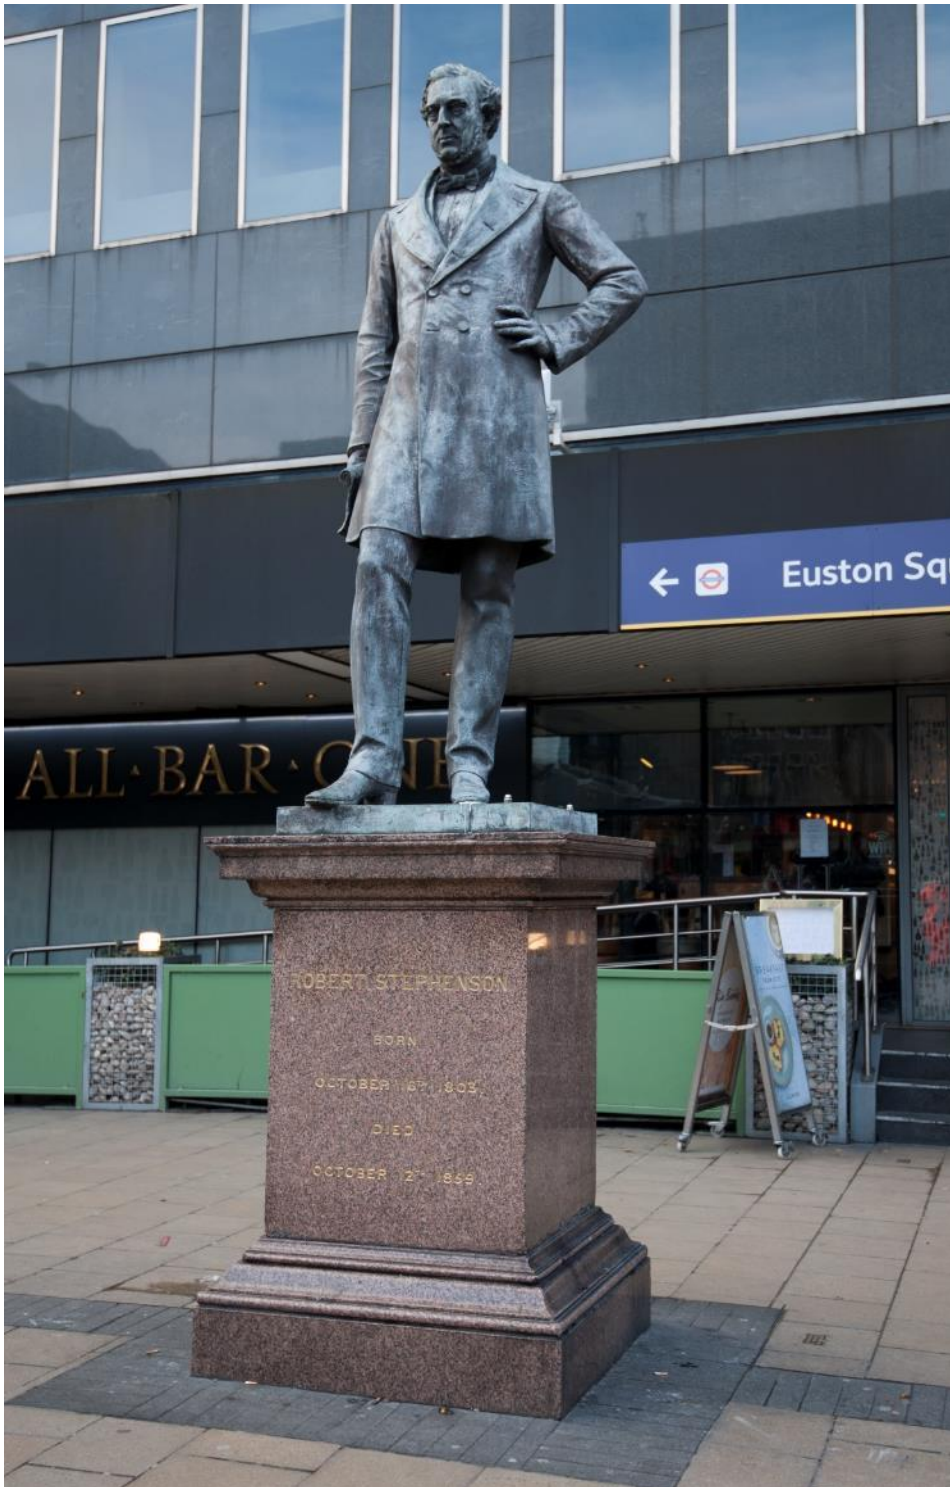
Figure 3 Robert Stephenson sculpture in its current location at west end of Euston Station forecourt, main elevation, from the northeast

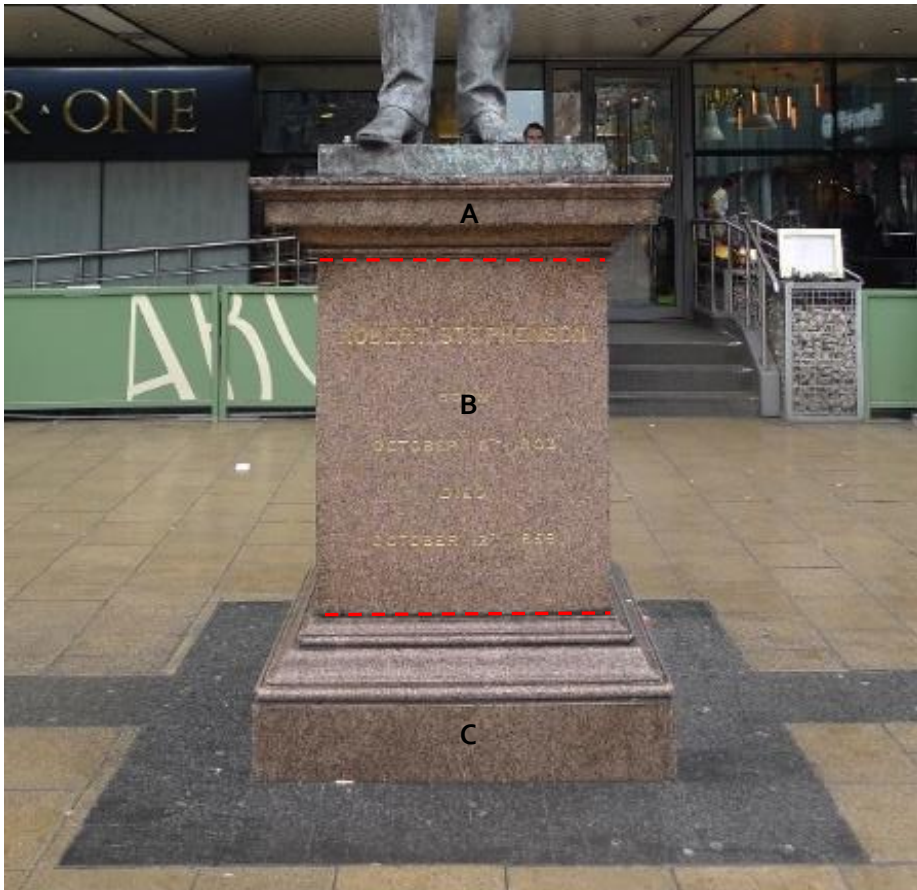
Figure 4 Robert Stephenson sculpture pedestal, facing east, with dashed red lines indicating the fine bed joints between the three pedestal blocks

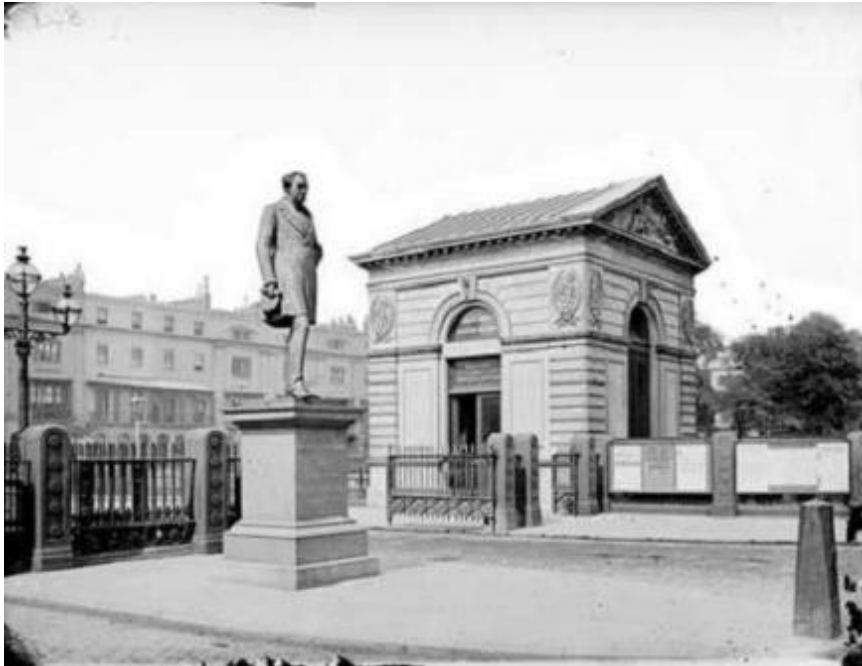
Figure 5 The statue photographed in its original position adjacent to Euston Road. (reproduced by permission of Historic England Archive, image no. CC97/00265, General View of the Robert Stephenson Statue in Euston Square London)

- 2.2.8 It has been suggested that initially the intention was to erect the statue on the Thames Embankment or in the garden of Great George Street, home of the Institution of Civil Engineers. The statue was reportedly stored at the Institution of Civil Engineers for a number of years before a suitable location was found. At the invitation of the LNWR, it was decided to erect it at Euston in c. 1870-1871. The statue was originally installed between the Portland limestone lodges at the southern end of Euston Grove, facing onto Euston Road, as shown in Figure 5 below.

- 2.5.1 The statue derives some significance from its current setting within the Euston Station forecourt. Robert Stephenson played an integral part in the construction of the London and Birmingham Railway, the first inter-city railway line into London and in the location of the L&BR terminus at Euston. However, the sculpture is much less prominent in its current location, relative to its original position on the station site, when it sat in front of the entrance gates facing onto Euston Road, flanked by the Portland stone lodges. The current orientation of the sculpture, with Stephenson facing past the station rather than to or from it, slightly detracts from its significance.
- 2.5.2 In its c.1870 location on Euston Road the figure sculpture stood slightly taller than at present. Comparison of archival black and white photographs (see figures 5 and 6 above) with current

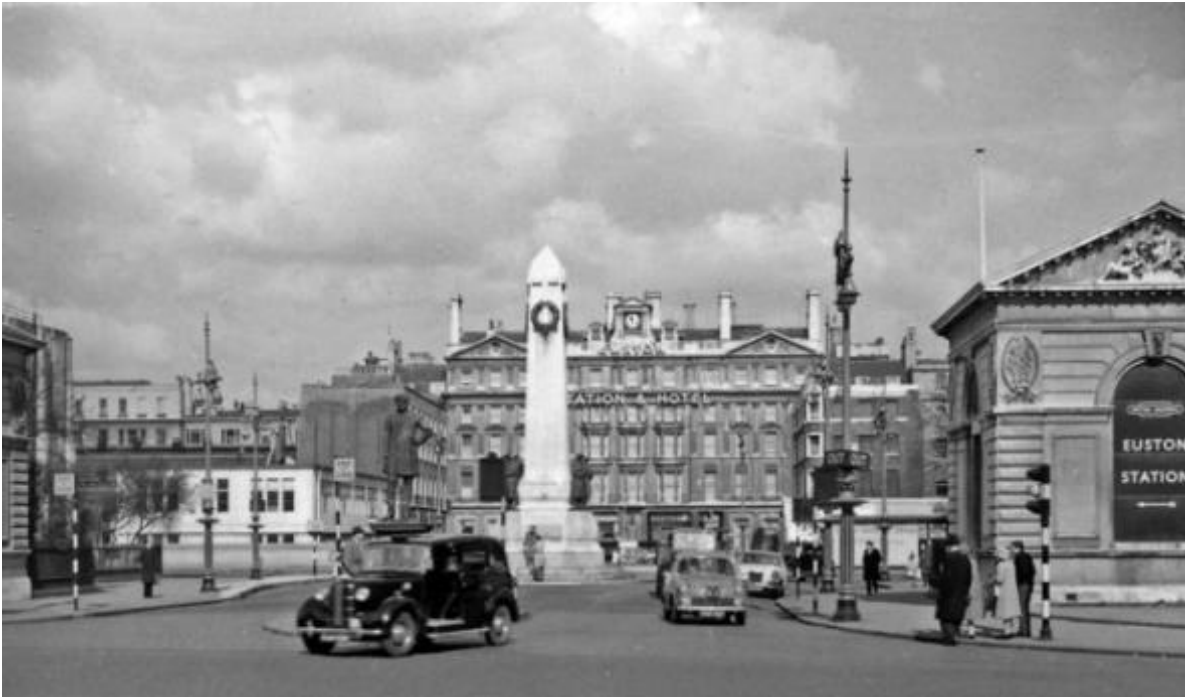
Figure 7 View of sculpture looking north up Euston Grove in 1962 just before demolition of station buildings, [https://commons.wikimedia.org/wiki/File:Euston\\_old\\_Station\\_entrance\\_no\\_arch\\_geograph-2991077-by-Ben-Brooksbank.jpg](https://commons.wikimedia.org/wiki/File:Euston_old_Station_entrance_no_arch_geograph-2991077-by-Ben-Brooksbank.jpg), copyright Ben Brooksbank

2.2.10 The sculpture was still in its original position on Euston Road when the photograph above was taken in 1962. This image illustrates changes to the site since the previous photograph of 1913 - removal of the gates and railings and installation of the war memorial. The statue was subsequently moved to at least two other locations, as illustrated in the images on the following pages. It was apparently relocated to Euston Station forecourt as part of the redevelopment which followed demolition of the Victorian station, and was placed at the eastern end of the piazza, next to an ornamental pool (see Figure 8 below). Demolition of the Victorian station and construction of the new one was not completed until the end of the 1960s; the station was formally opened in 1968.<sup>3</sup> The exact date of the first relocation of the Robert Stephenson sculpture is uncertain; it likely coincided with the construction of the new bus station and redevelopment of the forecourt area, in the 1970s.<sup>4</sup> It is uncertain if it formed a forecourt feature as part of the scheme for new office blocks designed by Richard Seifert & Partners and executed between 1974-78.

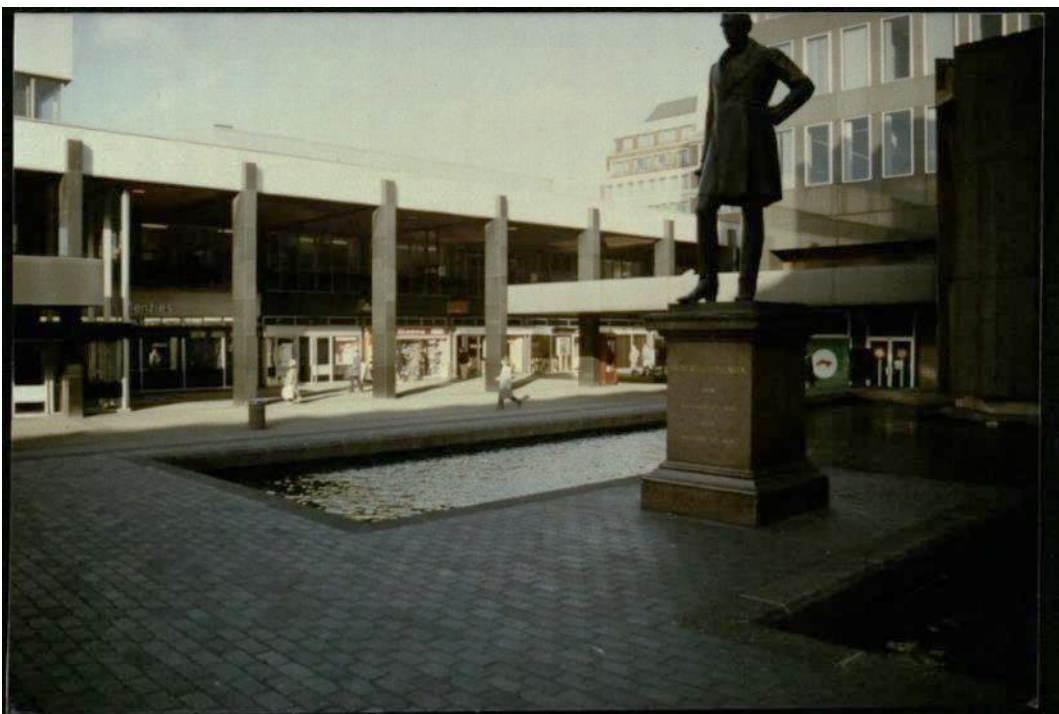
*Figure 8 Image of sculpture in previous location at east end of forecourt, surrounded on three sides by a pool*

- 2.2.11 The two images of the sculpture at this stage in figures 8 and 9 below appear to be of the same location, with different landscaping. In figure 9 grassed areas surround the sculpture in figure and in figure 8 a u-shaped pool surrounds the sculpture on three sides.

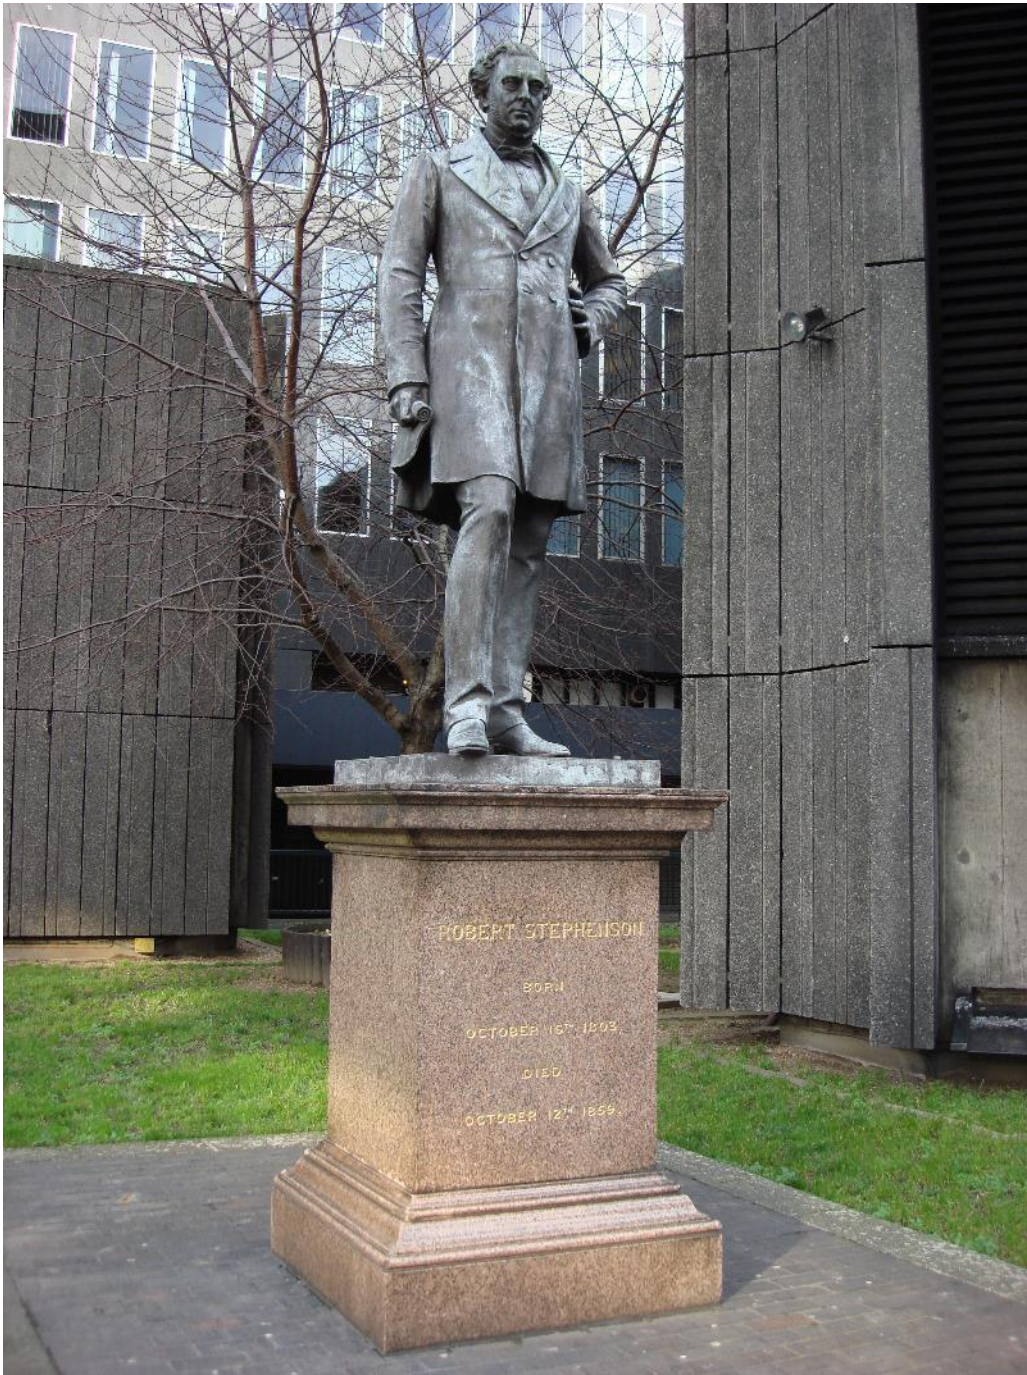
*Figure 9 image of sculpture taken in 2007, in public domain, available online at [https://upload.wikimedia.org/wikipedia/commons/e/e7/Robert\\_Stephenson\\_statue\\_Euston.jpg](https://upload.wikimedia.org/wikipedia/commons/e/e7/Robert_Stephenson_statue_Euston.jpg), taken 7 Dec 2007, copyright Oxyman (photographer), reproduced under license [GFDL (<http://www.gnu.org/copyleft/fdl.html>), CC-BY-SA-3.0 (<http://creativecommons.org/licenses/by-sa/3.0/>)]*

- 2.2.6 Four stainless steel bolts, one at each corner, secure the bronze figure to its pedestal. These bolts project above the bronze base, are clearly modern and were presumably inserted during the most recent move to its current location. Bolts are visible in similar positions in a photograph taken in 2007 (figure 9). It is likely that the sculpture was originally fixed to its stone pedestal with concealed fixings.

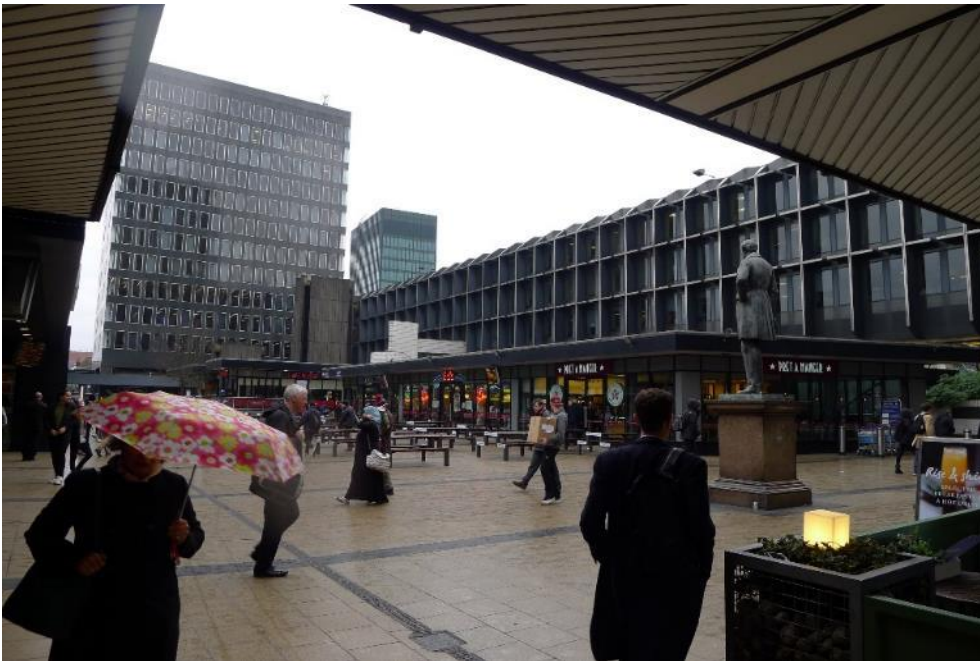
Figure 10 The current location of the statue, at the western end of Euston Plaza.

- 2.2.12 The Robert Stephenson sculpture was subsequently relocated again, to its present position at the west end of the forecourt. This is thought to have occurred c.2008 along with re-ordering of the forecourt.<sup>5</sup> The statue is currently orientated facing east overlooking Euston piazza, located close to the western pedestrian entrance to Euston Station concourse. In this location, the setting of the statue comprises the modern station forecourt which is a heavily trafficked paved space lined with restaurants and cafes. To the west and south are the modern glass and granite-faced office blocks designed by Seifert; these buildings enclose the space, severely limiting views to the wider area including Euston Square Gardens. To the north of the statue is the modern Euston Station concourse building.

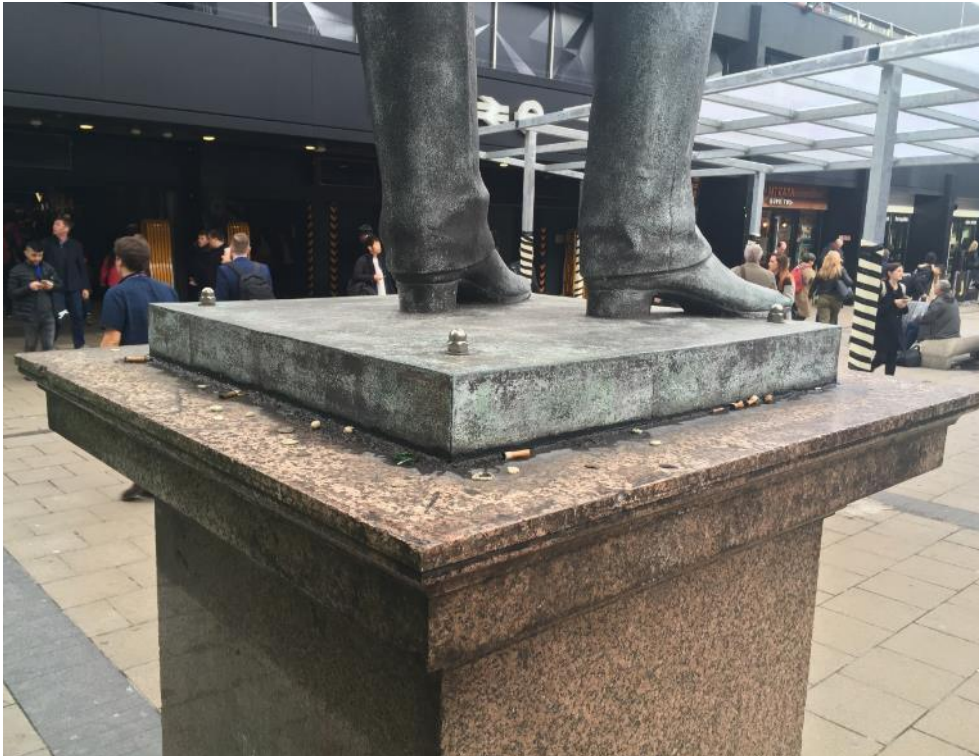
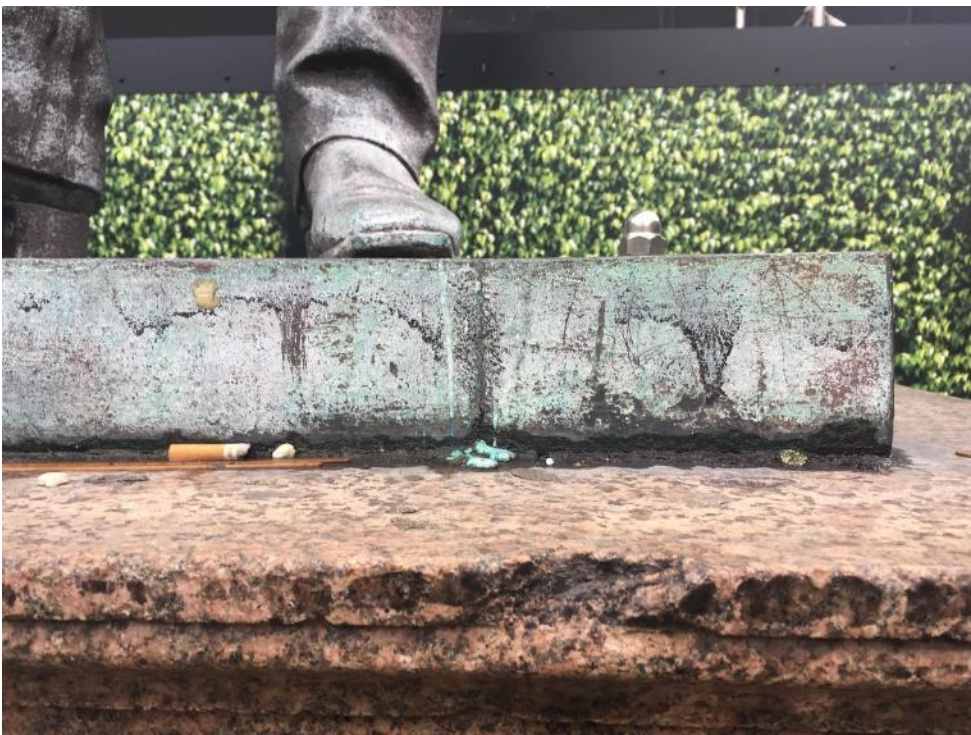
*Figure 12 Details of sculpture base illustrating condition and bolts inserted through bronze, with chewing gum on bronze and stone surfaces, and graffiti scratched on the bronze base in image at bottom*

- 2.4.8 The statue is fixed to the granite plinth by four stainless steel bolts, one at each corner of its square base. The acorn (cap) nuts used to secure the bolts protrude above the bronze surface. As noted above, it appears that these were inserted in the latest move when the sculpture was re-erected on its current site. Fortunately these appear to be corrosion resistant stainless steel.

acidic and also a source of potentially damaging salts and should be removed along with other soiling deposits, which include chewing gum, pushed into the surface of the base, and dark soiling derived from atmospheric pollution which have accumulated in areas not subject to thorough rainwater washing. Cleaning work will be done at the project’s long-term store by the specialist subcontractor for dismantling work, as set out in Section 4.2 below.

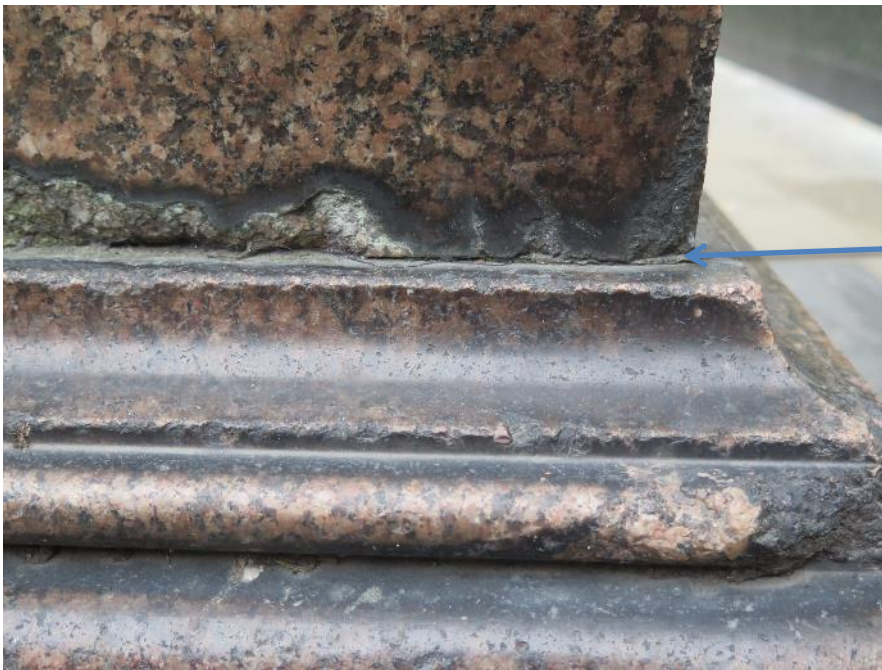
Appears to be fine lead sheet sandwiched within the fine bed joint

Spalls to stone above bed joint possibly caused by past attempts to move stones

- 2.4.9 The granite plinth exhibits damage to its sharp arrises at bed joints, where small chips and spalls are visible, and along the moulded cap stone. These are typical of impact damage or, at joints, of pressure from past attempts to lever and lift the stone and have probably occurred during re-location. Chips and spalls on the base of the inscribed central granite block, at the bed joint, as shown in figure 14, appear to be due to this kind of damage. These small spalls have been previously filled with a hard mortar. (Figures 12 to 14)

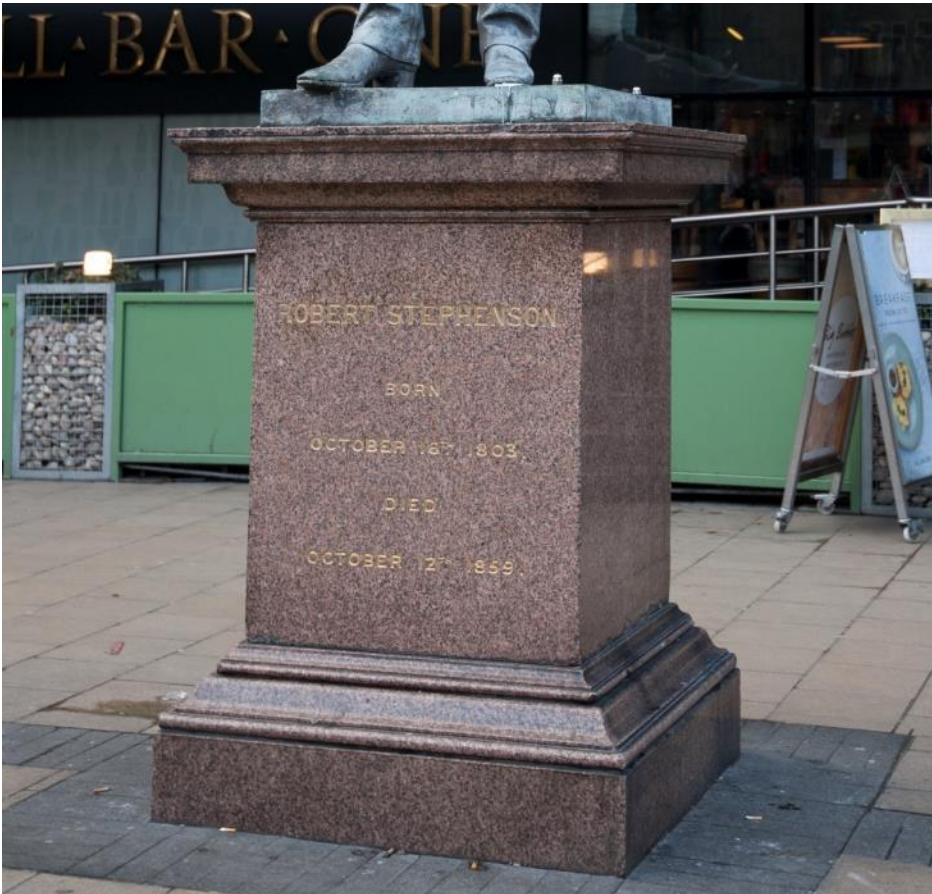
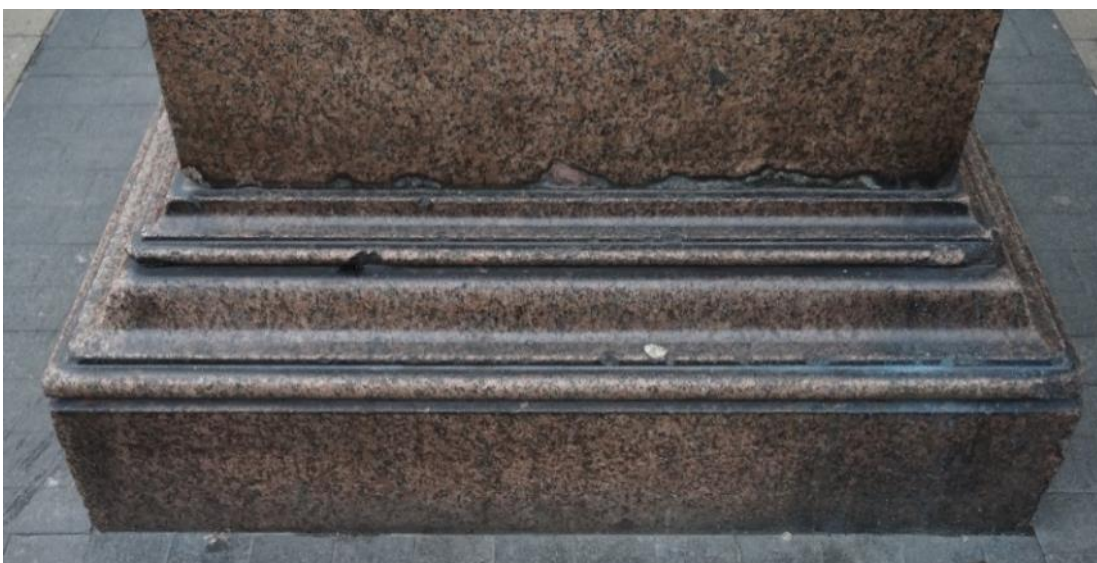
Figure 14 Pedestal from northeast, and below detail of north elevation with dark soiling on base (at lower right) and small spalls along the bed joint, which have been filled

- 4.2.3 Cleaning is to be carried out carefully, to remove surface soiling deposits without removing the natural green patina that has developed over time, is stable and poses no risk to the condition of the sculpture.<sup>7</sup> Care will also be taken in cleaning the granite pedestal. The face bearing the gilded inscription (east, principal, face of Block B) will not be cleaned; soiling is barely visible on this face – the gilding remains bright and legible and the granite face retains its polished finish. (Figures 14 and 15)

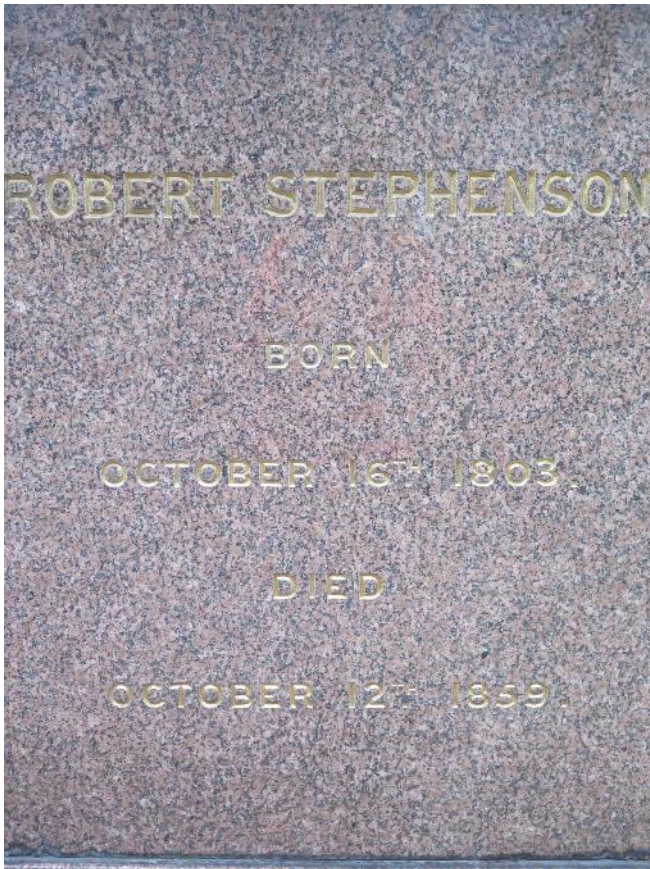
*Figure 15 Inscription with letters finished in oil gilding, and below a detail where some loss of gold leaf has occurred revealing traces of the underlying preparatory layers*

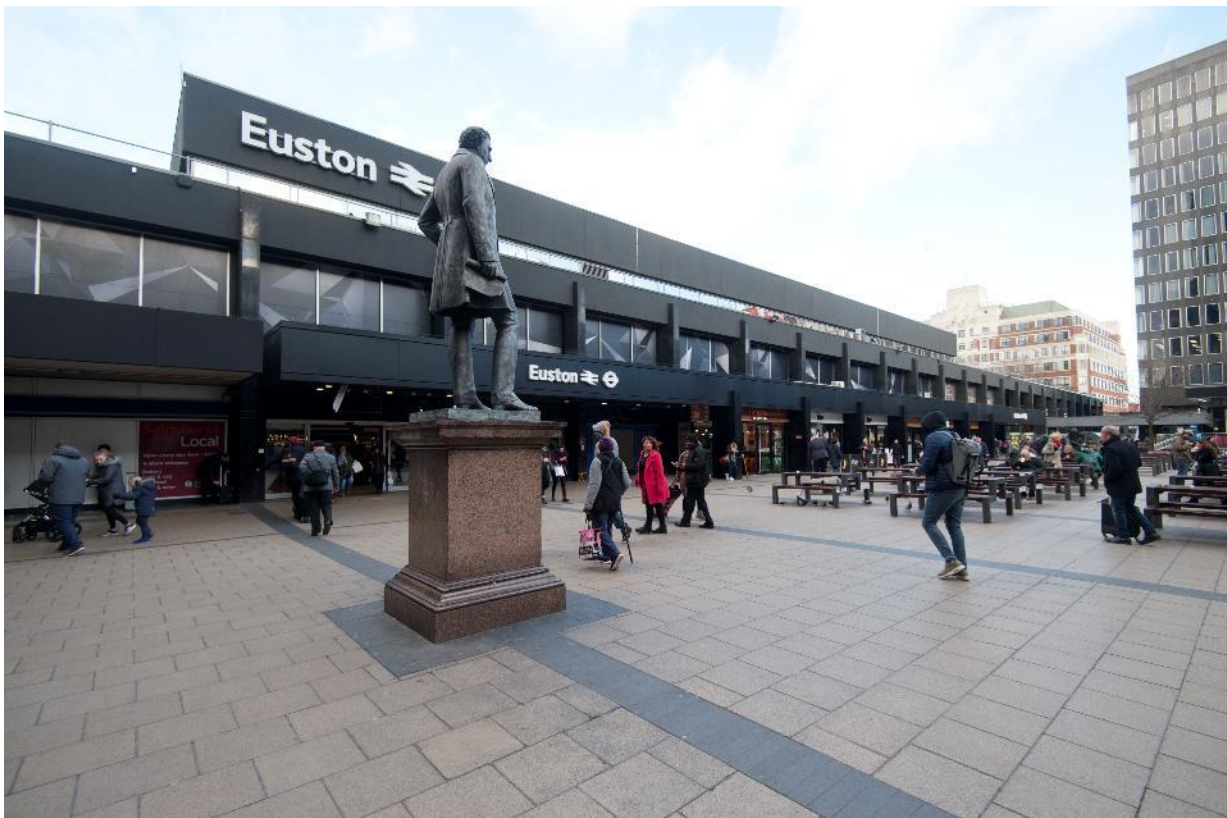
*Figure 16 View of site setting of Robert Stephenson Sculpture at west end of station forecourt*

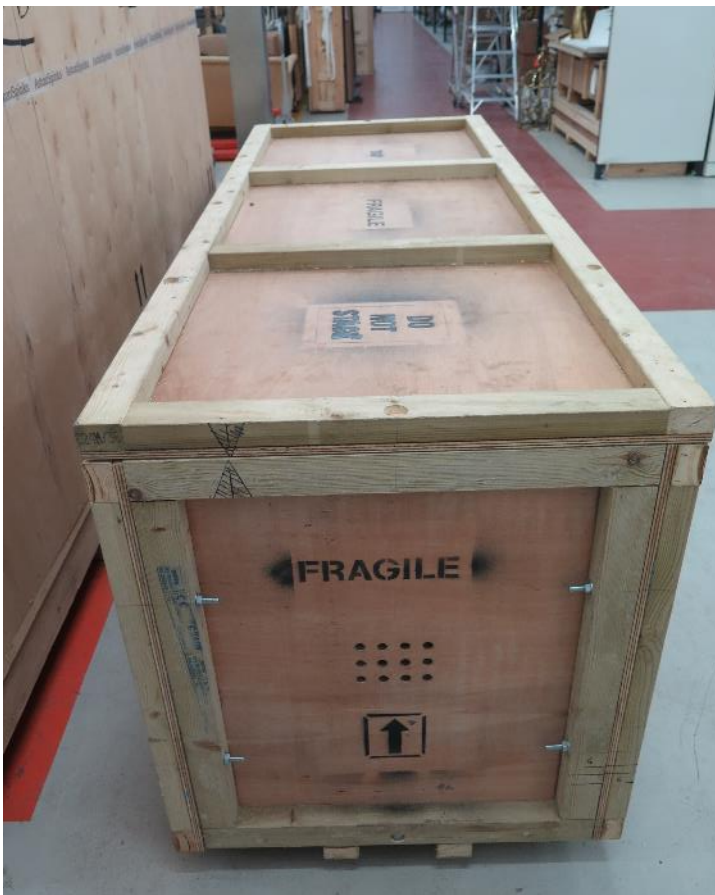
*Figure 17 Transport case illustrating construction and appropriate labelling*

- 4.5.1 The component parts of the sculpture – the bronze figure and the stone pedestal – will be packed separately in purpose-made cases to be produced in advance ready for immediate transport to storage. The bronze sculpture and its pedestal will then be removed from their crates inside the store and the bronze remounted and re-fixed in position on its pedestal, where it will remain for the duration of the storage period. Due to the vulnerability of the metal to corrosion, the sculpture will not be set on the concrete floor of the store.
