Landmark Trees

Re: Installation of two piles at 53 Fitzroy Park, London N6 6JA

Piling Insertion Letter: 53 Fitzroy Park, London N6 6JA
Instructing party: Michael Burroughs Associates, 93 Hampton Road, Hampton Hill, Middlesex, London TW12 1JQ
Prepared by: Adam Hollis of Landmark Trees, Holden House, 4th Floor, 57 Rathbone Place, London W1T 4JU

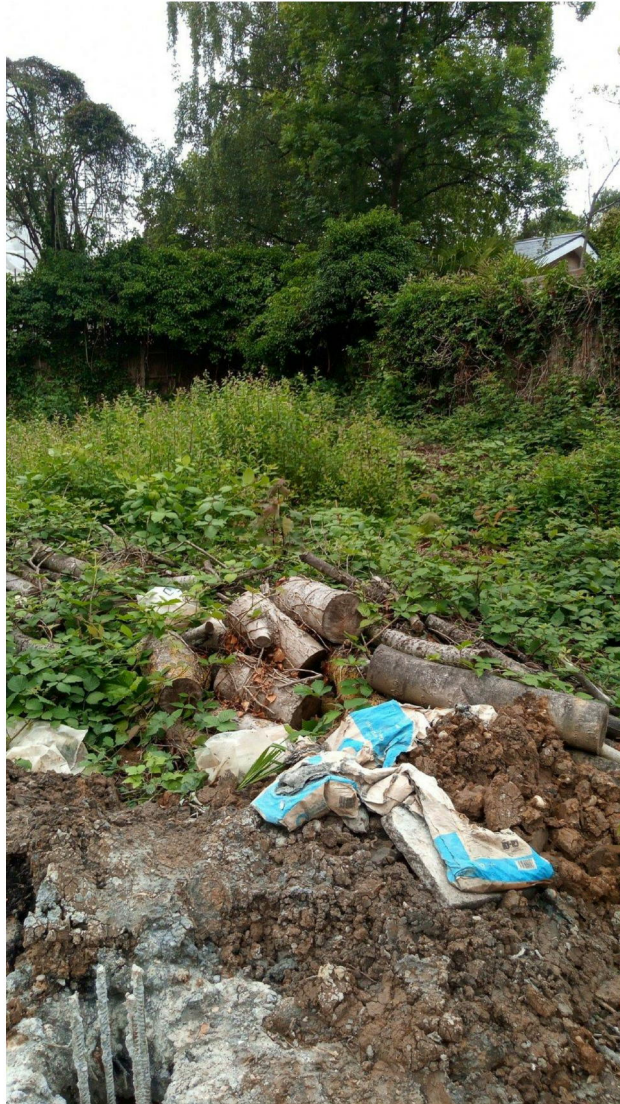
I can confirm that the location of the piles is as per drawing 322 - 100 - Piling Setting Out and as such is well outside the RPA of all retained trees and further to this, no evidence of soil compaction was observed during David's site visit.

Photograph 1: Distance from piles to nearest retained tree

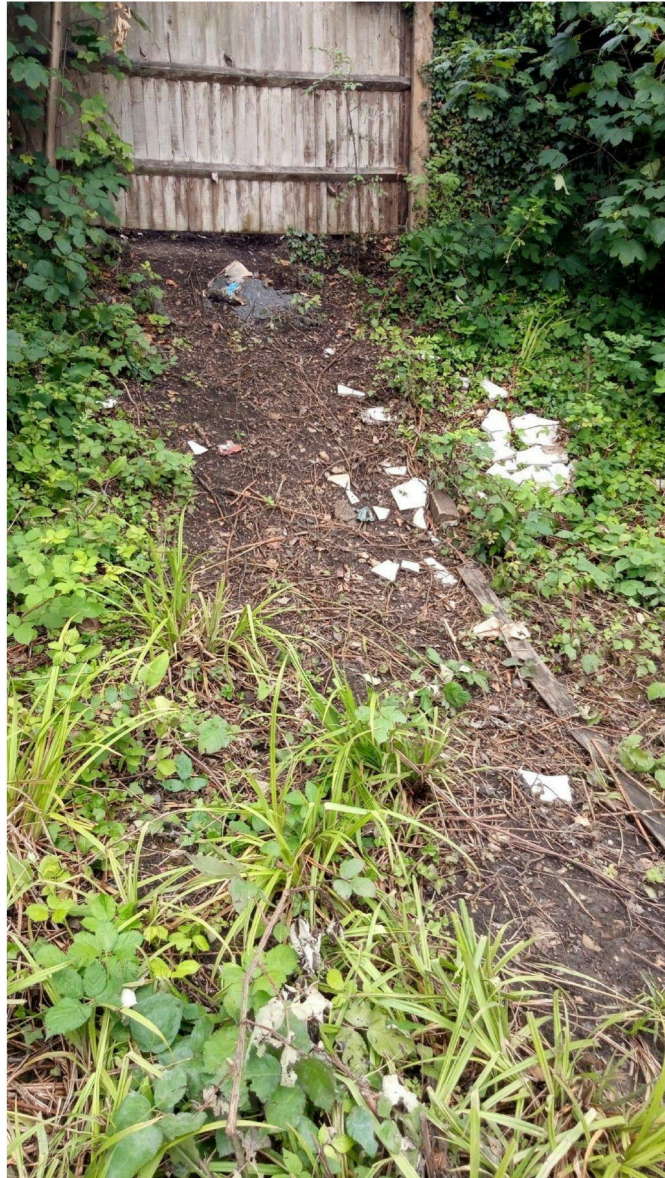
Given the steep nature of the access into the site from Fitzroy Park, soil compaction or disturbance would have been readily observable, that none is visible in Photograph 2 confirms our assessment that no harm was caused to any retained tree as a result of the installation of the piling.

Photograph 2: No evidence of soil disturbance / compaction at point of access into site

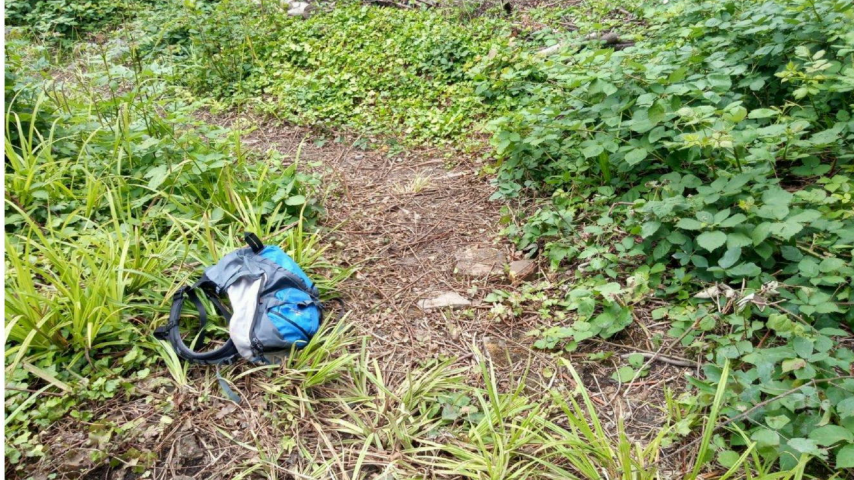
Photograph 3: No sign of vegetation / soil disturbance on route to piling location from access point
