3.0 Site Existing

3.07 Existing Property

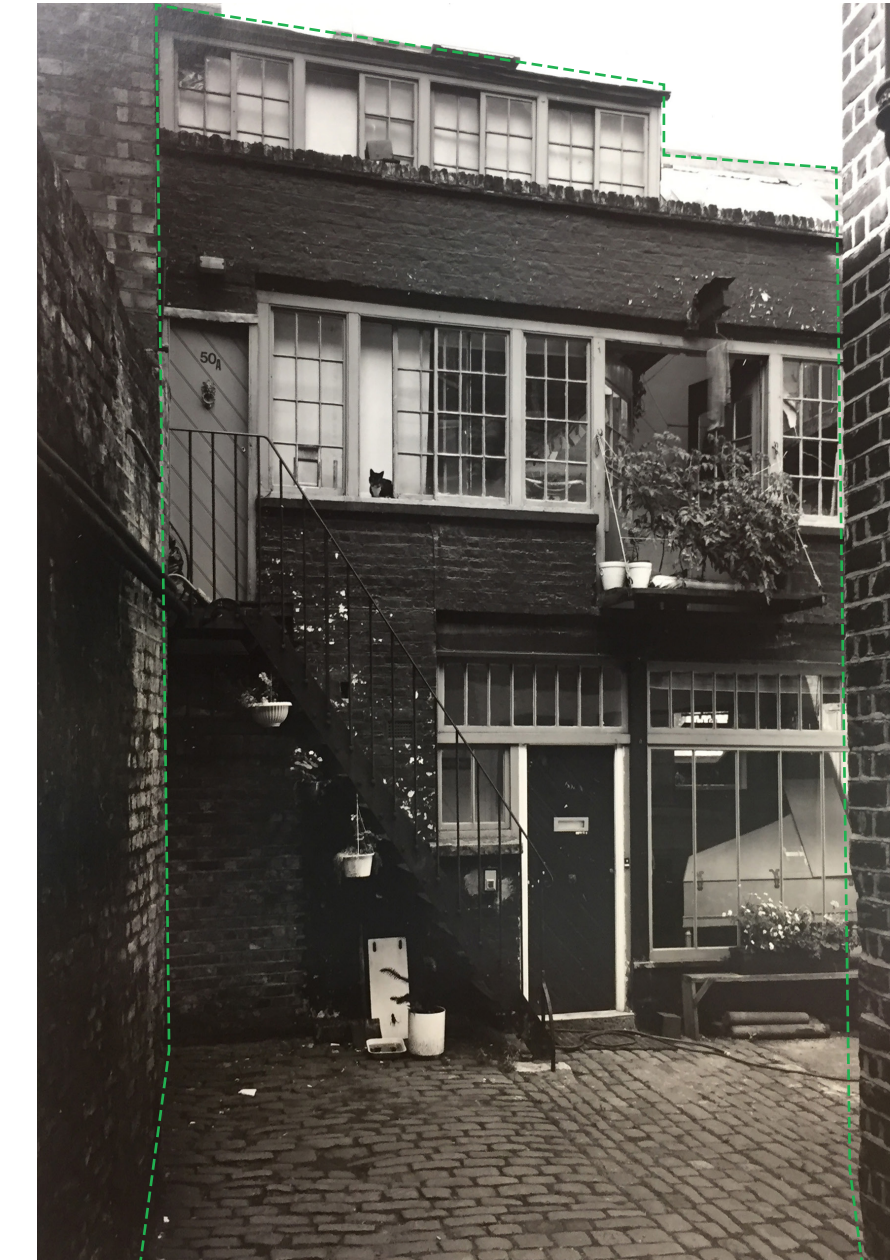
Wheatshaf Yard taken by P. Barkshire on the 8th August 1981, Camden Local Archives.

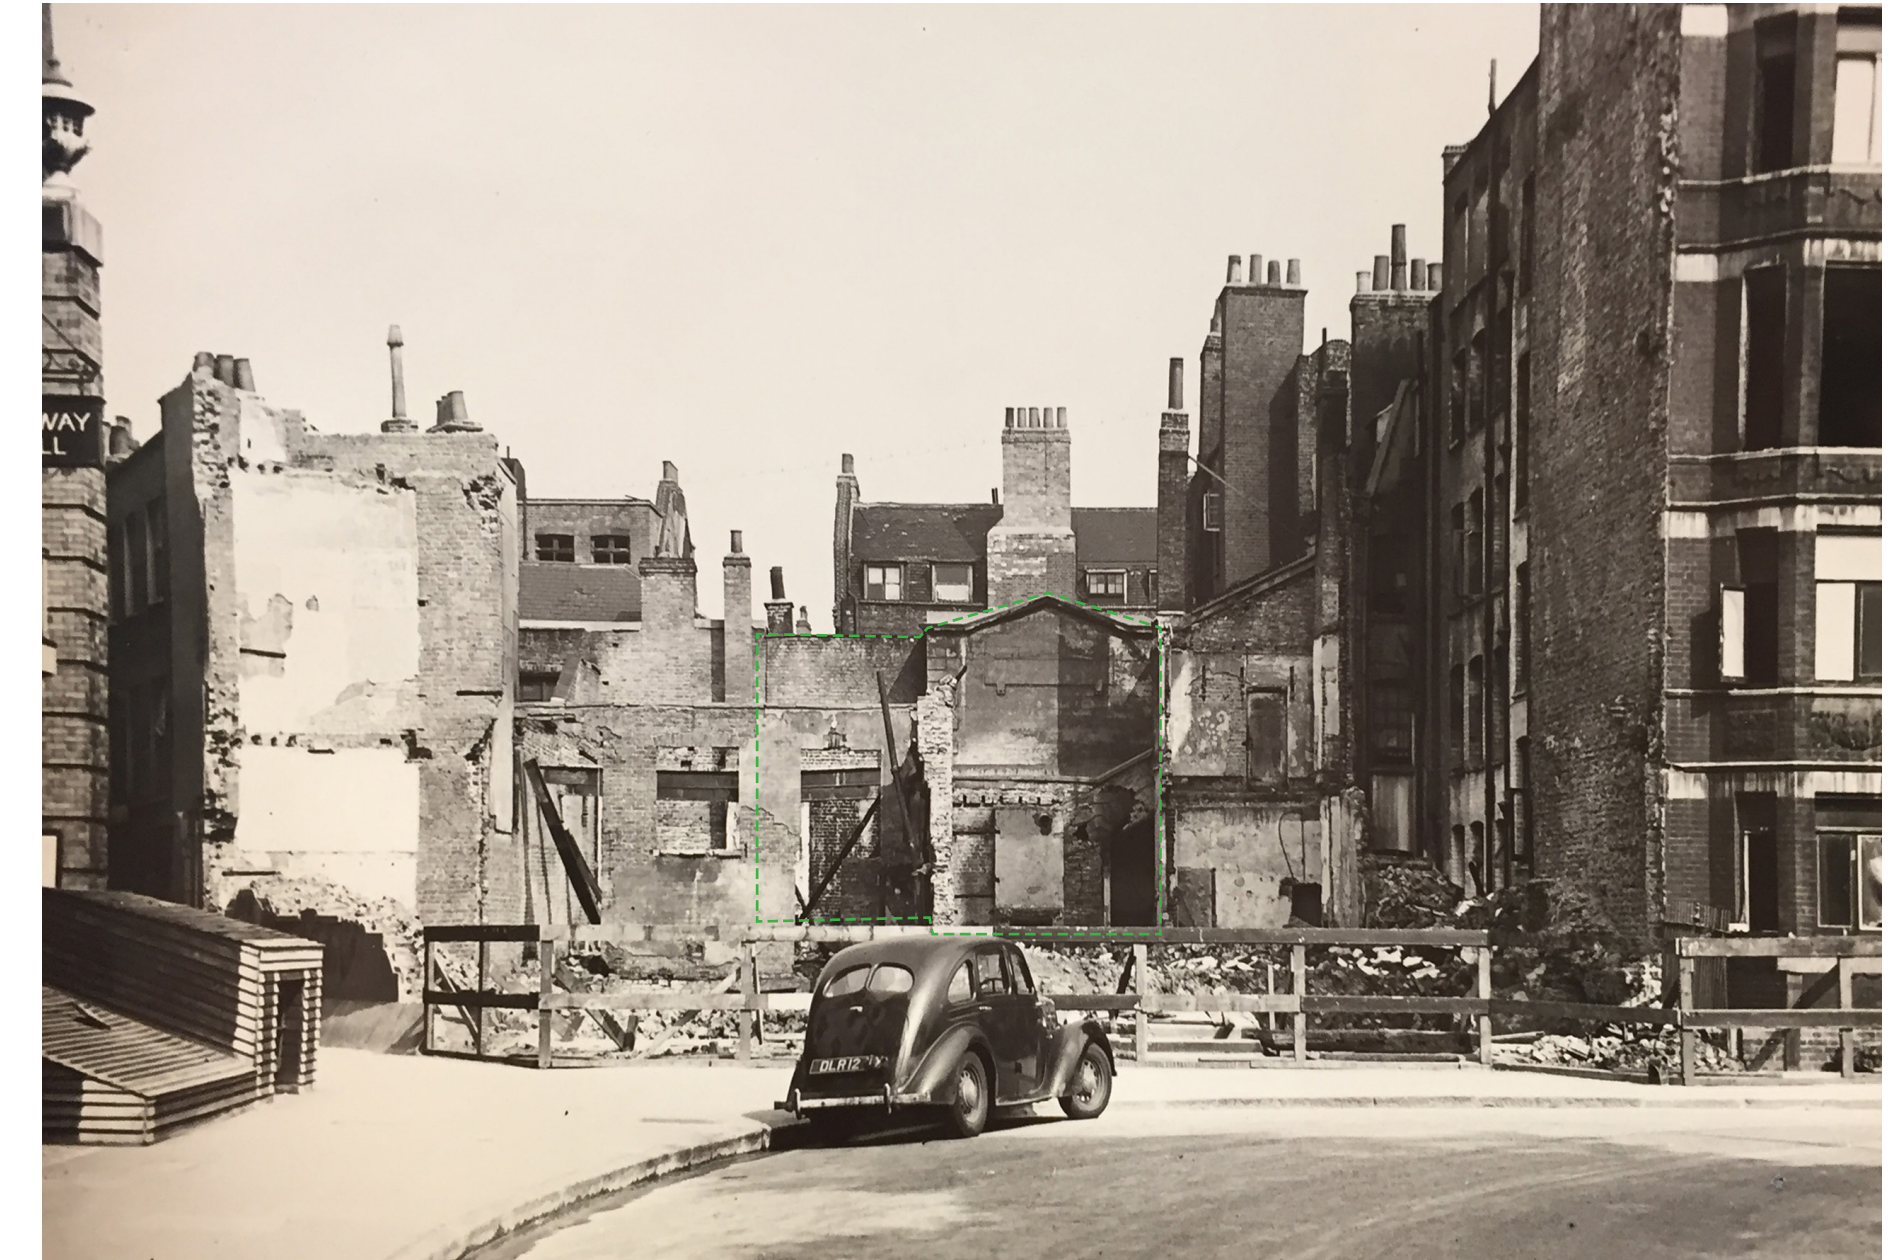
Photographs showing the ruins of 22-24 Red Lion Square in 1941 with the rear of Wheatshaf Yard now visible, Camden Local Archives.

Wheatshaf Yard was originally connected to 23 Red Lion Square (now demolished, following bomb damage during WWII) and served as a stable and coachhouse, with the upper floors used as workshop spaces. Since the early 20th century the property has been used as an artist studio-cum-residence.

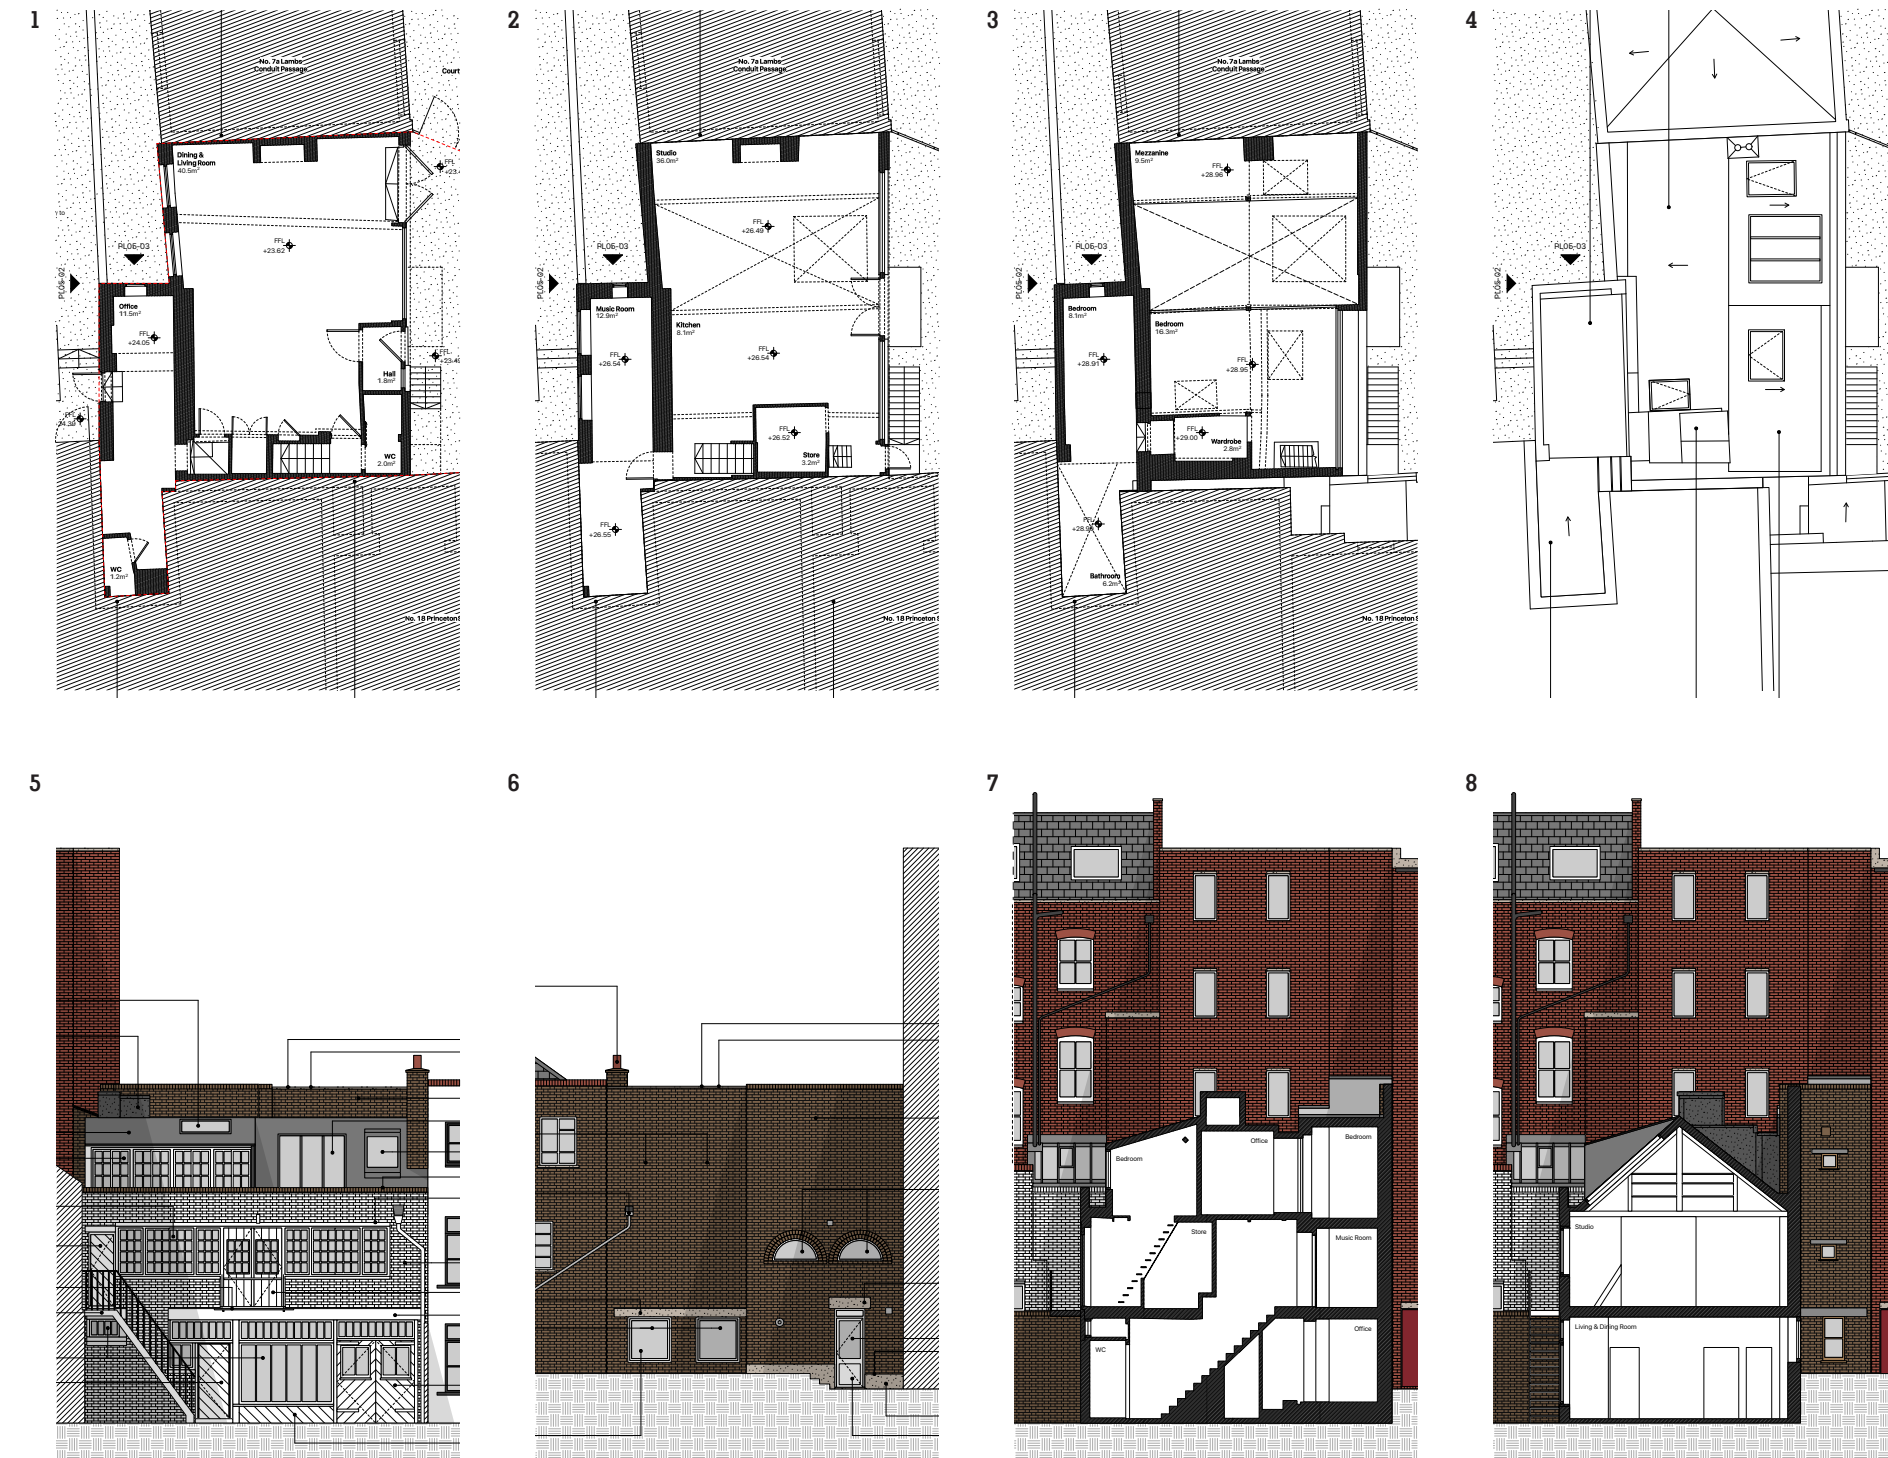
3.12 Existing Drawings
Existing drawings of the property, shown at 1:200:

- 1 Ground Floor Plan;
- 2 First Floor Plan;
- 3 Second Floor Plan;
- 4 Roof Plan;
- 5 Front Elevation;
- 6 Rear Elevation;
- 7 Section 2;
- 8 Section 3 / Side Elevation.

3.11 Measured Survey
Maltby Surveys undertook a measured survey of Wheatsheaf Yard recording in plan, section and elevation the existing property and site. This information has been used to generate the existing drawing set.

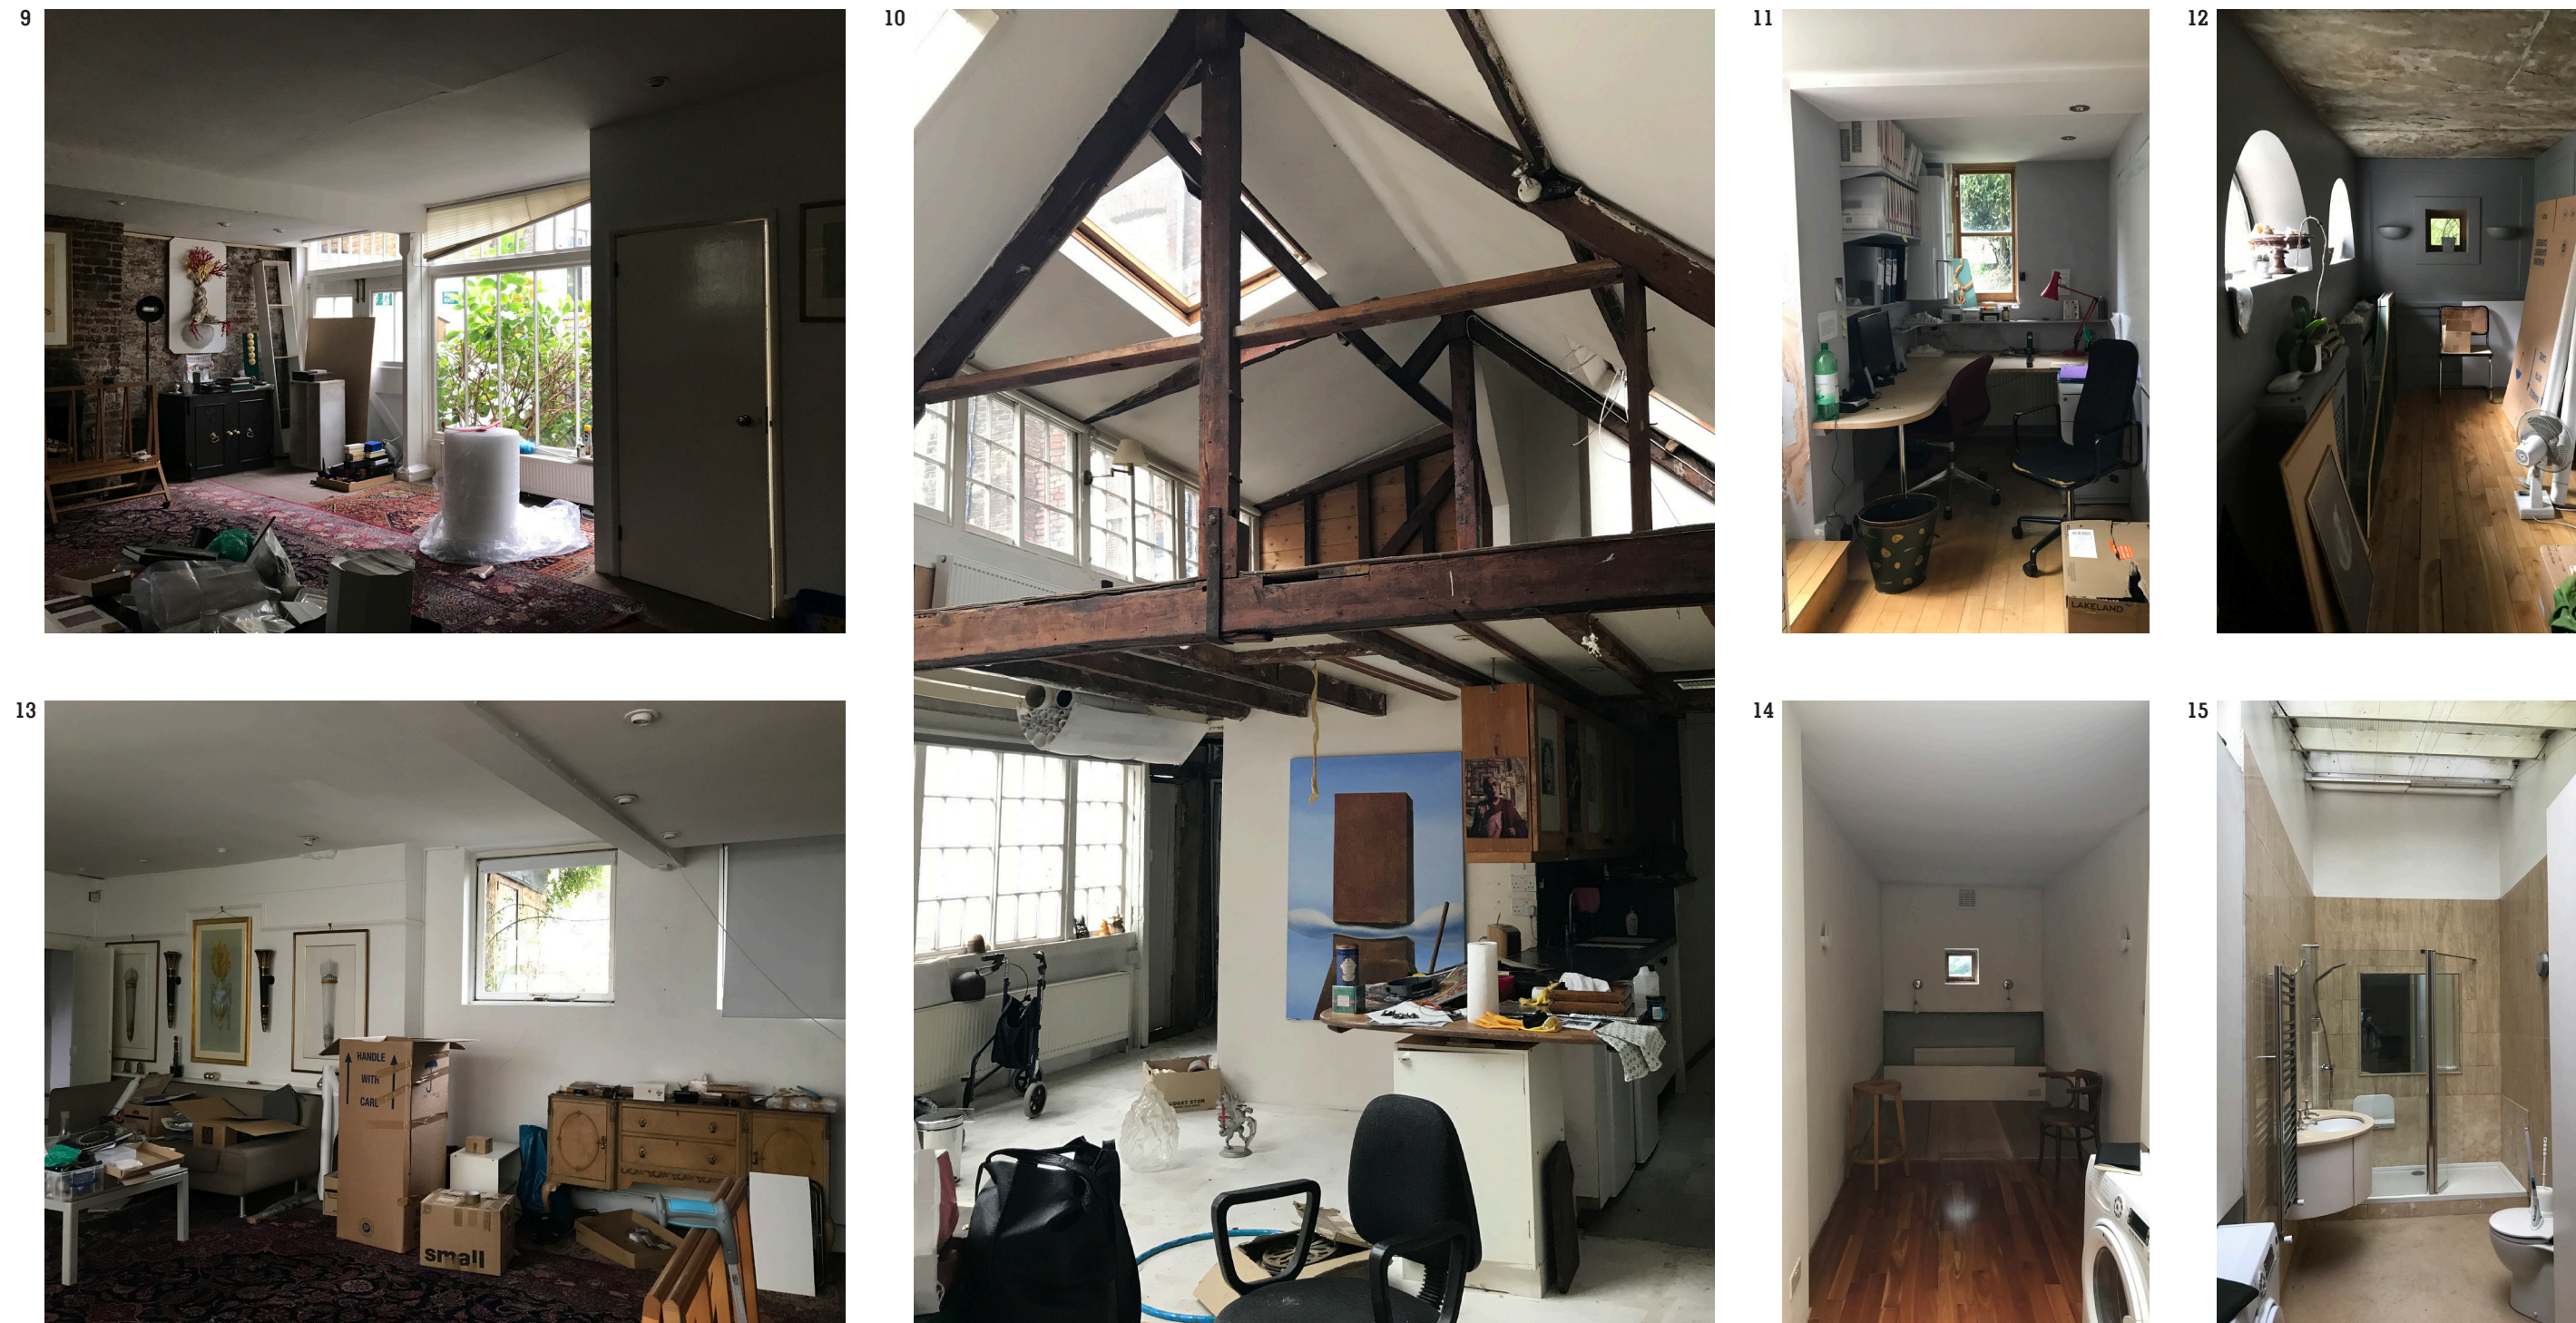
3.13 Internal Photographs
Photographs showing the interiors of the property:

- 9 Ground floor living room, looking towards the front windows;
- 10 First floor kitchen and studio space, looking up to the second floor mezzanine bedroom;
- 11 Ground floor office at the rear of the property with door to rear courtyard;
- 12 First floor music room with half-moon windows;
- 13 Ground floor living room, looking towards the rear windows;
- 14 Second floor bedroom at the rear of the property, which opens directly to the bathroom behind (see 15);
- 15 Second floor bathroom set within the 'nook' of Omnium Court with glazed roof.
