21 Harrington Square Camden London NW1 2JJ

Heritage Statement

Nicola de Quincey architecture and conservation

July 2019

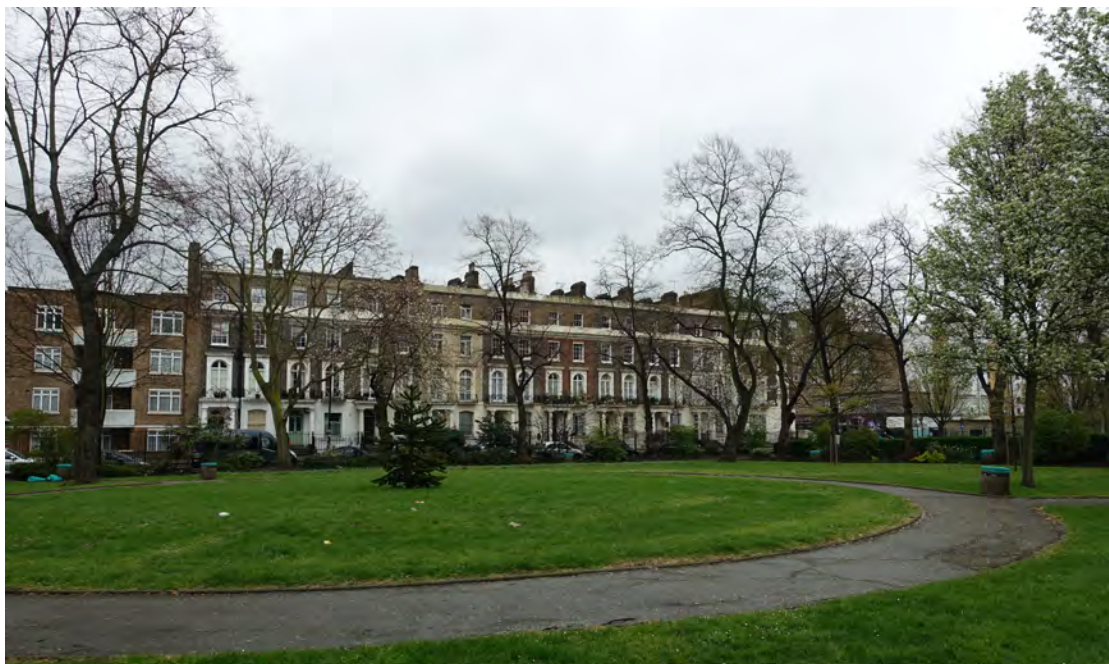
Figure 1 Harrington Square Gardens with the terrace in the background. Number 21 is the paler coloured house in the centre

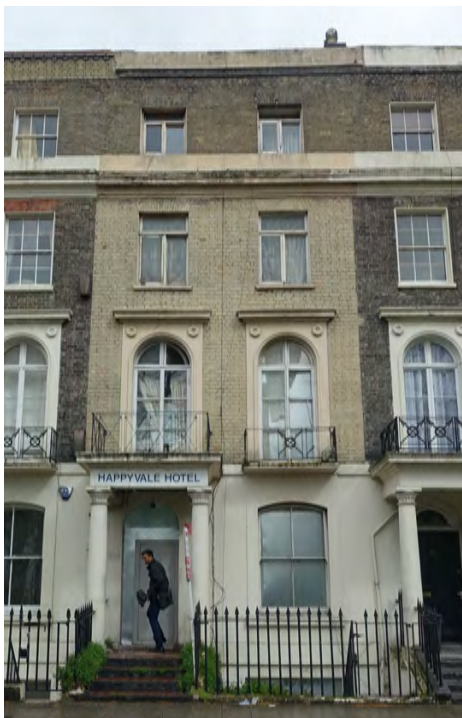
Figure 12 Front elevation

All upper floor windows had been replaced with modern casement windows; ground and basement were two-over-two sash pane sash windows at the front. The first floor windows were timber casement doors with fanlights. All the sash windows on the rear elevation had been replaced with poor quality casements, or one-pane over one-pane sash window replacements.

It was a priority to restore missing external features including metalwork and the window configuration, stucco and railings. This would have a major positive effect on the building and its appearance in the conservation area.

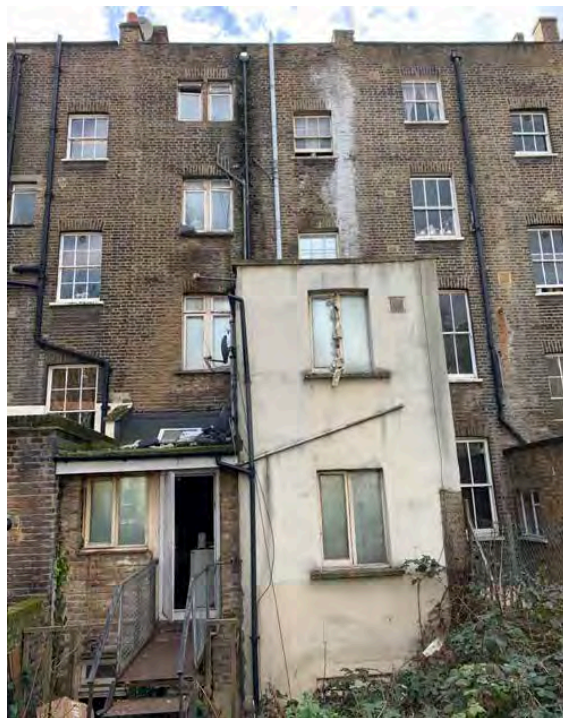
Figure 13 Rear elevation

The rear area was built over; the rear outrigger was extended up to the intermediate landing between ground and first floors.

The existing rear area is very narrow (see survey drawings) and this would result in the basement bedroom being dark. In order to increase daylight levels, the proposed retaining wall has been set back into the garden by three metres, new stairs taken from the basement to the garden level and a new bridge from ground floor to the garden.

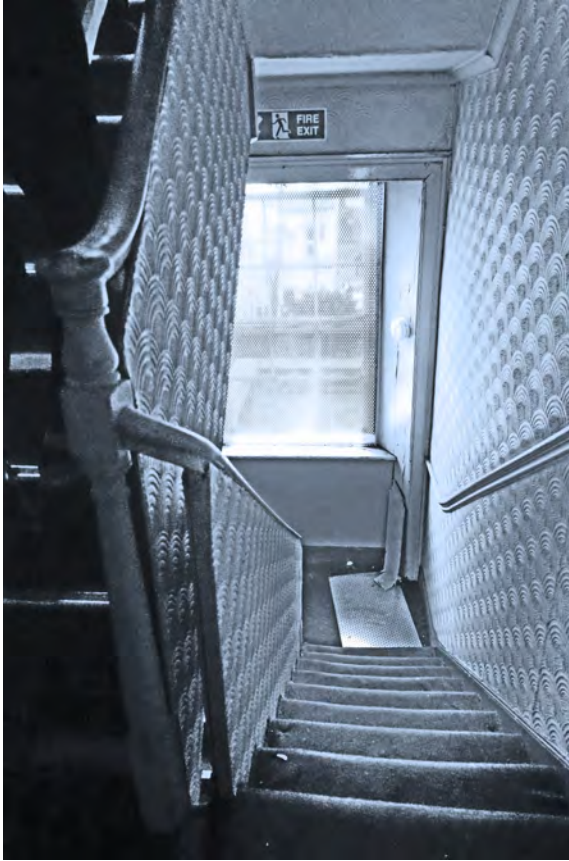
Figure 15 Upper floor subdivided rear room

Partition to be removed and window restored

These were the remains of a very poor quality HMO layouts and many of which are detrimental to the building, or mask original plan form and resulted in altered or removed internal features. It was a benefit to the historic building to remove them.

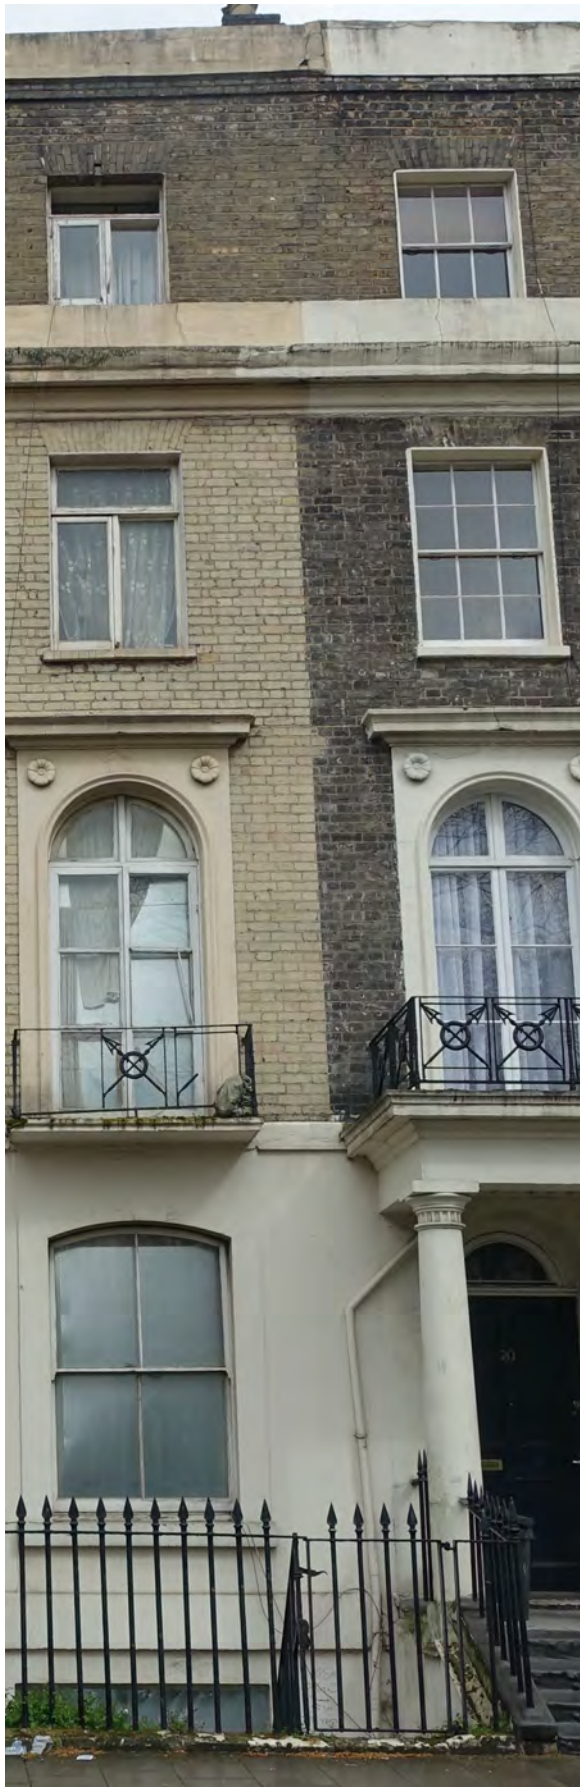
Figure 16

Detail of front elevation

21 to the left side and part of adjoining property (no.20) to the right

This shows the erosion of detail : casement windows that replaced sash windows, damaged cornice that has lost the front edge and weathering, incorrect recent crossed spear balcony railings and damaged front area railings

Taken as a group of terraced properties, there is a consistency in the front elevations that this scheme seeks to address. The first floor casement windows and the ground and basement windows may have been replaced as a group along the terrace at some uncertain date (possibly post war). For consistency, this proposal has taken the approach of matching with the neighbouring properties.
