128-130 GRAFTON ROAD, LONDON, NW5 4BABasement Impact Assessment: Land Stability Assessment Report July 2019

40213-3

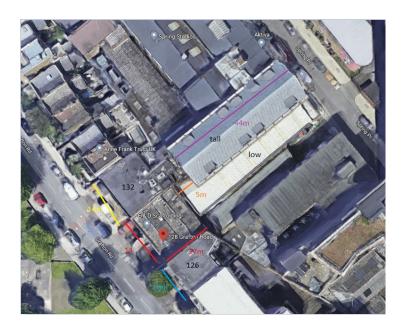
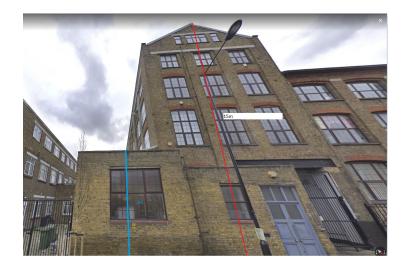
Spring Studios, 10 Spring Place (Tall), H=15m, L= 44m, offset from basement wall :5m

Spring Studios, 10 Spring Place (Low), H=3m, L= 49m, offset from basement wall :0m

### **Calculation Results Summary**

The calculations are presented on the attached spreadsheets and summarized in the table below.
