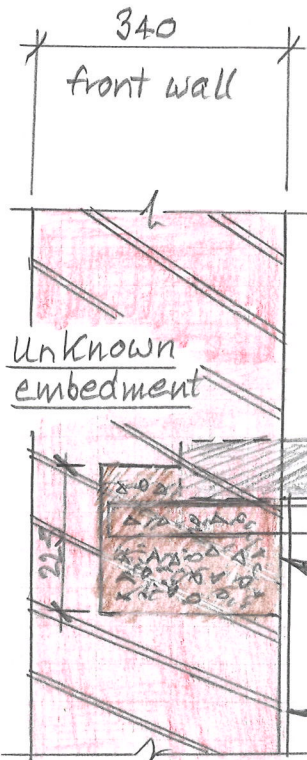
SECTION (1:10)

Angle support at joint of slabs. Typical. Two additional angles may be needed to support the rest of the balcony to 114.

50x50 Tee cast into 225x225x225 concrete

Stucco removed to expose Lintel/arch over window. Lintel repaired or replaced. Stucco redone and painted.

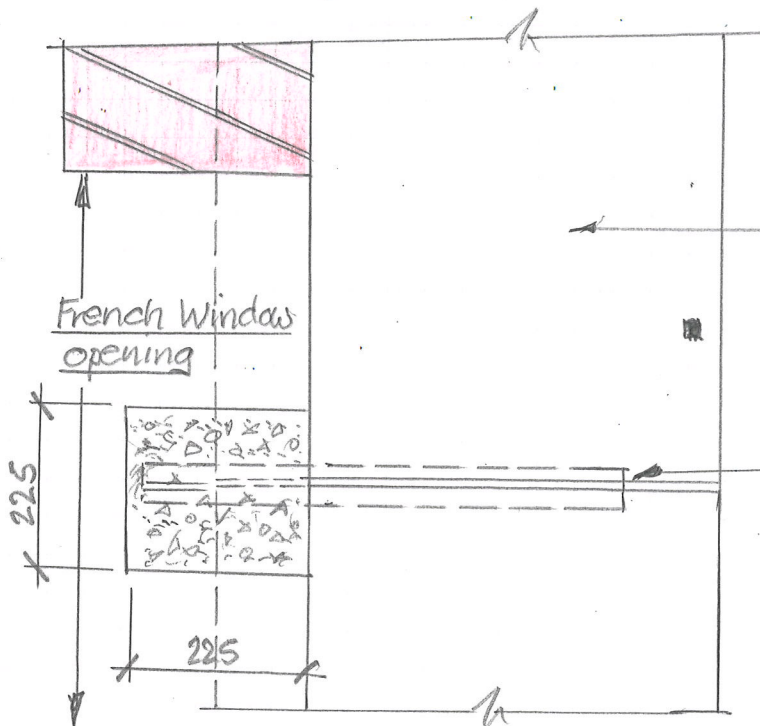
PLAN (1:10)

This slab has dropped, and is now temporarily supported.

Tee centred on joint between stone balcony slabs
