HERITAGE, DESIGN AND ACCESS STATEMENT

1 ST. MARK'S SQUARE, LONDON NW1 7TN

6.0 APPENDIX A:

Schedule of Proposed Rectification and Regularisation Works

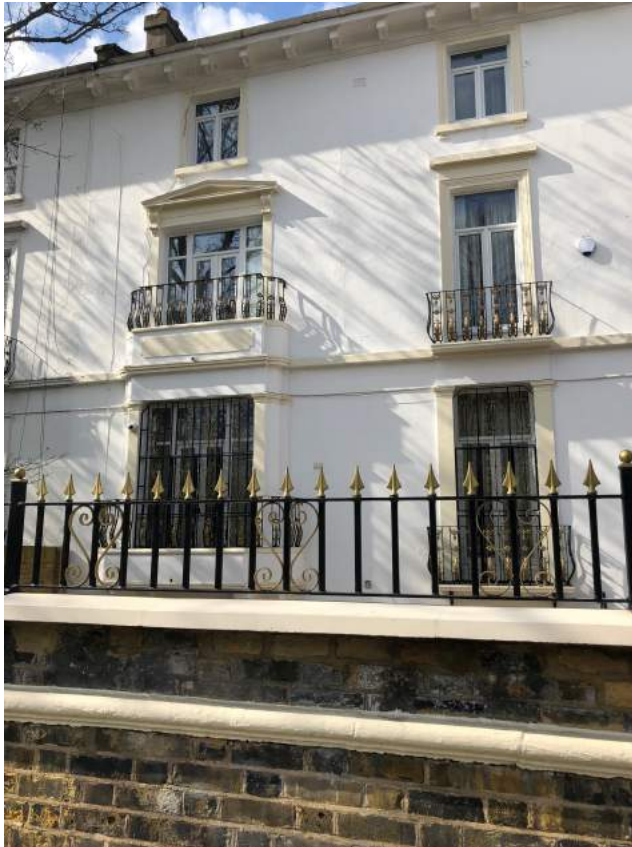
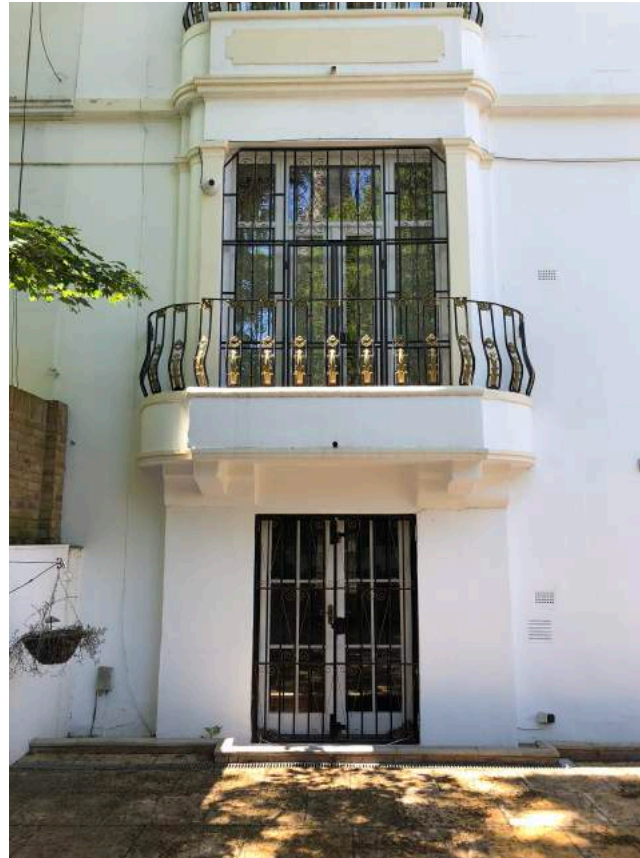
1. Windows

Front Elevation Windows, Balcony Metal Railings and Security Grilles

PREVIOUSLY EXISTING (Based on drawings from 2000 consents ref: PE9900835 / LE9900836 drawings and as indicated on the pre-existing plans)	AS BUILT (As surveyed in May 2019 and indicated on the 'as existing' plans and appended photographs)	PROPOSED (As indicated on 'as proposed' plans)
EXTERNAL ELEMENTS			
Windows	Painted timber sash and casement windows. Assumed to be single glazed.	White uPVC double glazed casement windows and French doors generally apart from window F-06 which remains as a painted timber casement window and French doors B-08 which remains as a painted timber French doorset.	Existing uPVC windows to be replaced with single glazed painted timber casement and sash windows and boxes to match previously existing. Painted hardwood timber sills. Overhaul and redecorate window F-06 and French doors B-08. See window schedule for details.
External security grilles	Black painted metal external security grilles to windows B-05, B-08, B-09, G-02, F-02.	Black and gold painted metal external security grilles to windows B-05, B-08, B-09, G-02, G-03, G-05, G-06, F-01, F-02, F-03.	Remove external security grilles to windows G-03, G-05, G-06, F-01, F-03 and make good.

External metal balcony railings	Black painted decorative metal railings to balconies/ windows G-06 and F-05.	Black and gold painted decorative metal railings to balconies/ windows G-05, G-06, F-04, F-05.	Retain all balcony metal railings. Precedent exists for similar decorative metal railings fixed to the top of balcony parapets at
