Tony's Pitta

KITCHEN EXTRACTION SYSTEM

PRE AND POST CLEAN PHOTO'S

Clean Completed 10th June 2019

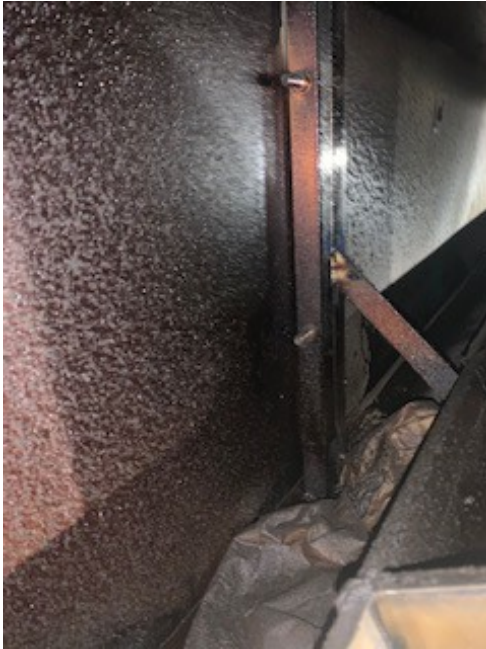
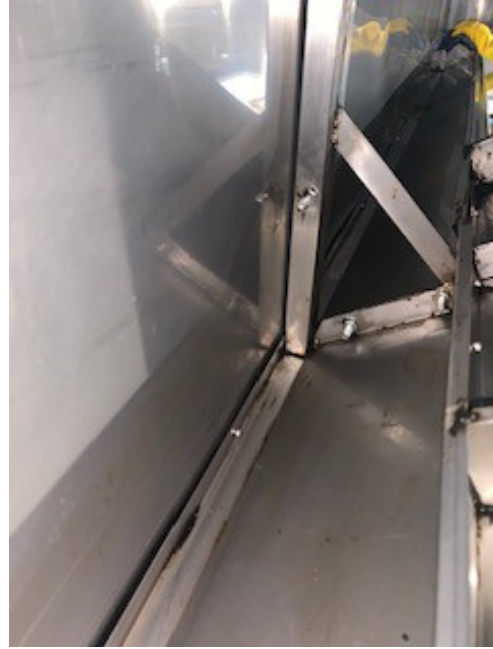
Pre and Post : Canopy:

Fabrication/Description	Stainless Steel Box Canopy. Stainless Steel baffle filters.
Access:	Via filter housing.
Pre Clean:	Heavy grease build-up.
Post Clean:	All areas cleaned.
Recommendations:	Scheduled maintenance clean.

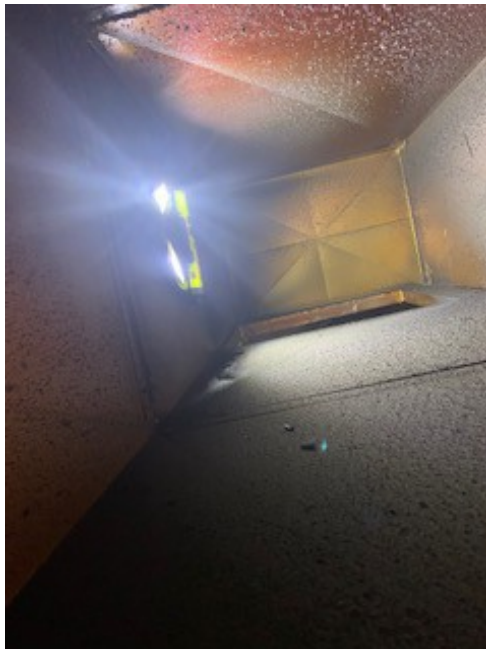
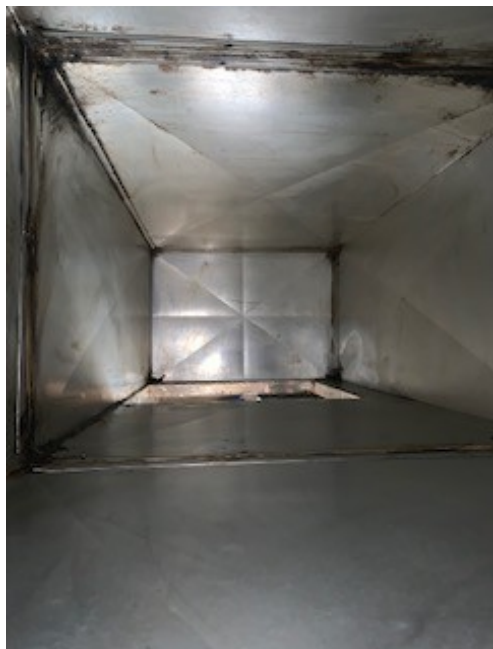
Pre and Post : Duct from canopy:

Fabrication/Description	Galvanised square duct.
Access:	Via canopy.
Pre Clean:	Heavy build-up.
Post Clean:	All areas cleaned.
Recommendations:	Scheduled maintenance clean.

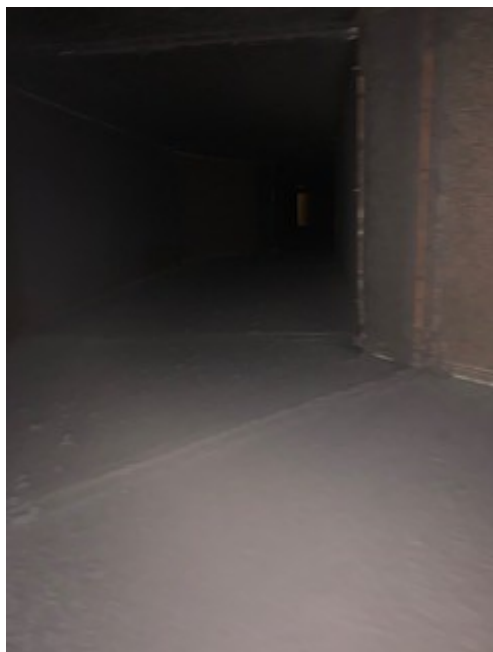
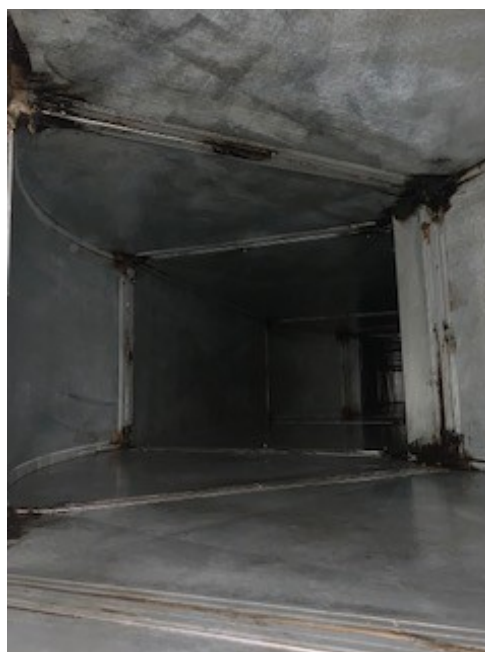
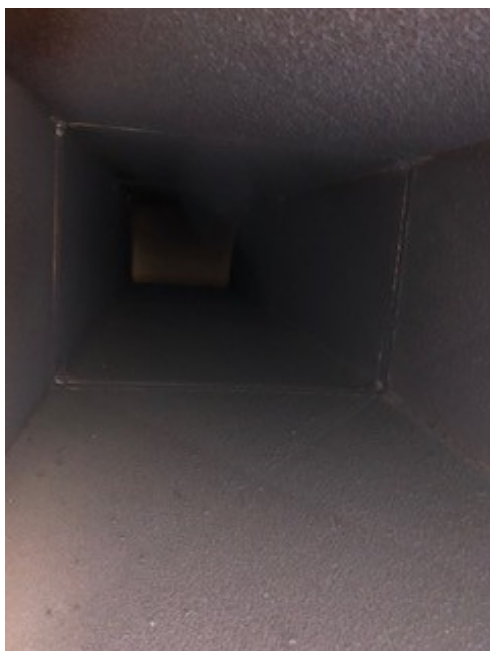
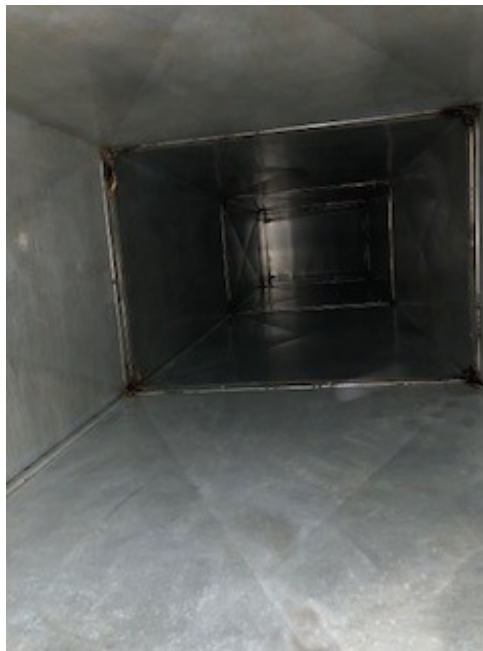
Pre and Post : Duct:

Fabrication/Description	Galvanised square duct.
Access:	Via access doors.
Pre Clean:	Heavy build-up.
Post Clean:	All accessible areas cleaned.
Recommendations:	Scheduled maintenance clean.

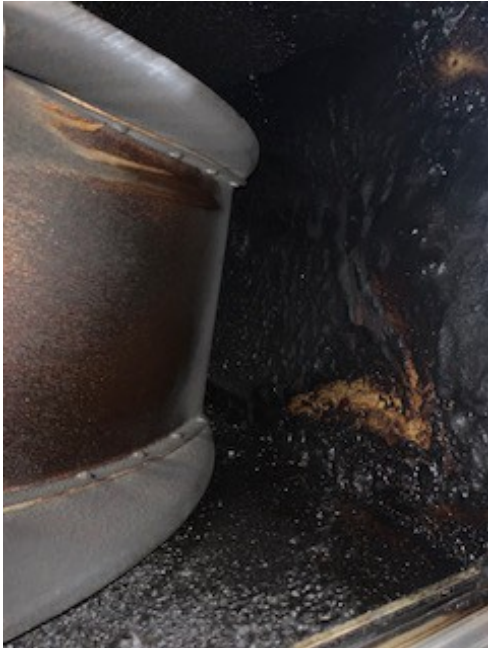
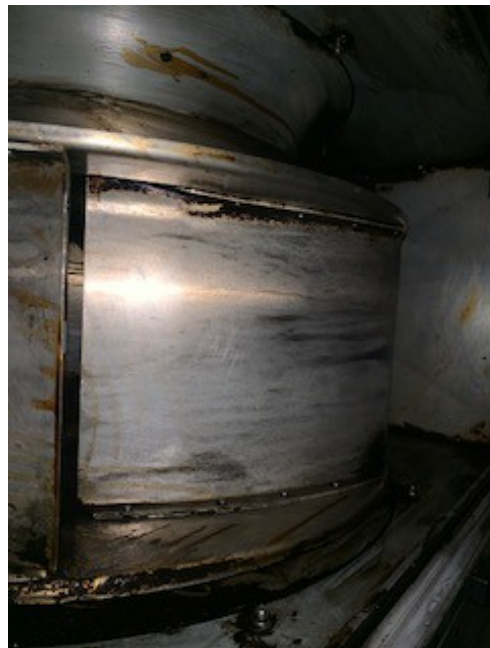
Pre and Post : Fan:

Fabrication/Description	Box fan.
Access:	Via side panel.
Pre Clean:	Heavy build-up.
Post Clean:	Cleaned.
Recommendations:	Scheduled maintenance clean.
