42 ELSWORTHY ROAD, LONDON

Introduction

Encl. Photograph Record Sheet (Drg. No. 193172/01)

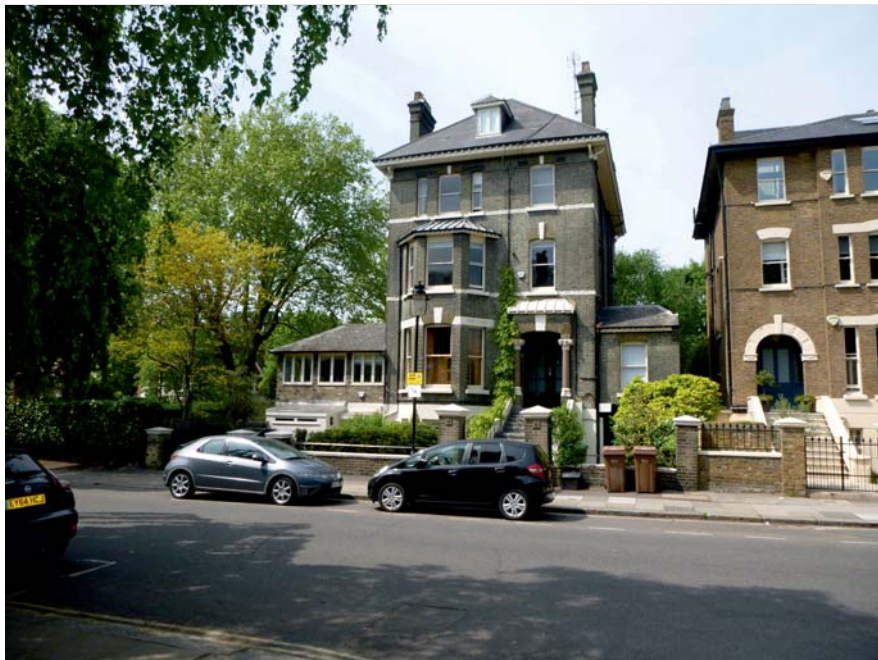
The property was of masonry construction, comprising four and a half storeys, with a pitched and slate tiled roof. The majority of the roof space had been converted into accommodation, with a restricted attic space used as a plant room. Several additions to the property included both single storey and two storey extensions to the south-west elevation and a two storey extension to the north-eastern elevation, all of which were of a similar construction type as the main property. A conservatory was also recorded at the south-western elevation. The attic was well-lit by a number of windows, including a single dormer window to the front of the property and several Velux windows to the rear and sides. Lead flashing was also recorded on the property, which appeared well-sealed and in good condition. The overhanging eaves were tightly sealed by timber soffits and fascias, which were well maintained and sealed. The main entrance to the property was an enclosed porch of masonry construction, with an ornamental, single pitched roof of stone construction and an ornamental stone pillar on either side.

Photograph 1: Showing the front of the property.

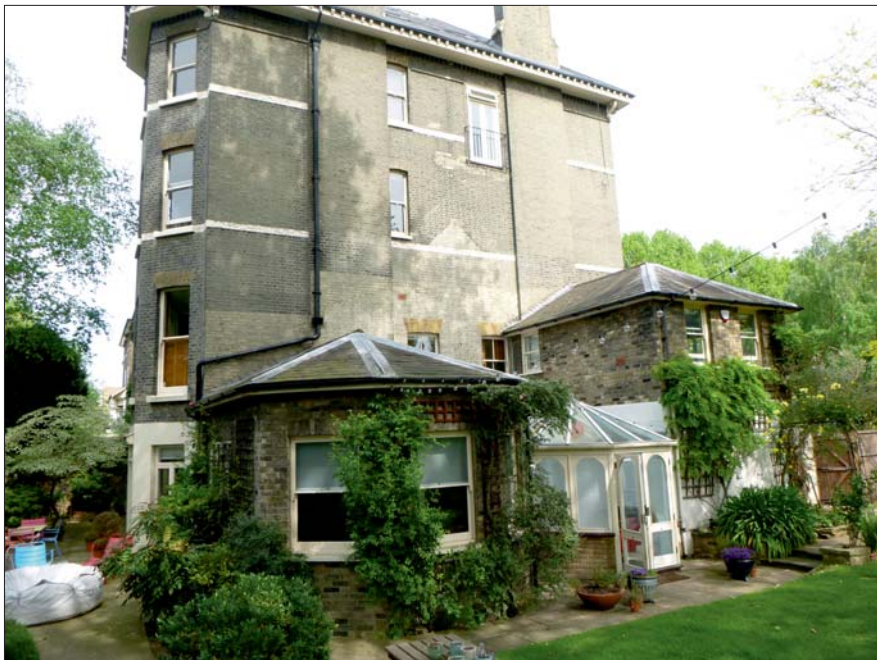
Photograph 2: Showing the single and two storey extensions and conservatory on the south-western elevation, scheduled to be demolished.

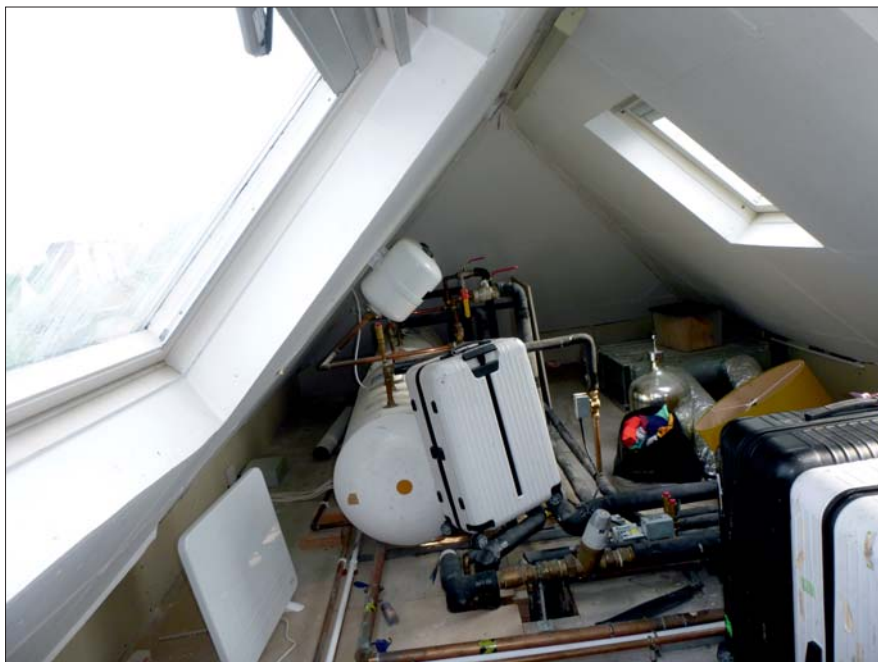
No evidence of bats was recorded during a careful internal and external inspection of the property. The restricted attic space was well lit with light cobwebbing throughout. Timber sarking was present but there was no roof membrane (the undersides of the tiles were visible) facilitating the visual inspection for any evidence of bats. The roofs of the main house and side extensions were well sealed and maintained in good condition, with the slate roof tiles tightly fitted as were the timber soffits/fascias and lead flashing. The property lacked any obvious access points for bats.

Photograph 3: Showing the well-lit, restricted attic space.

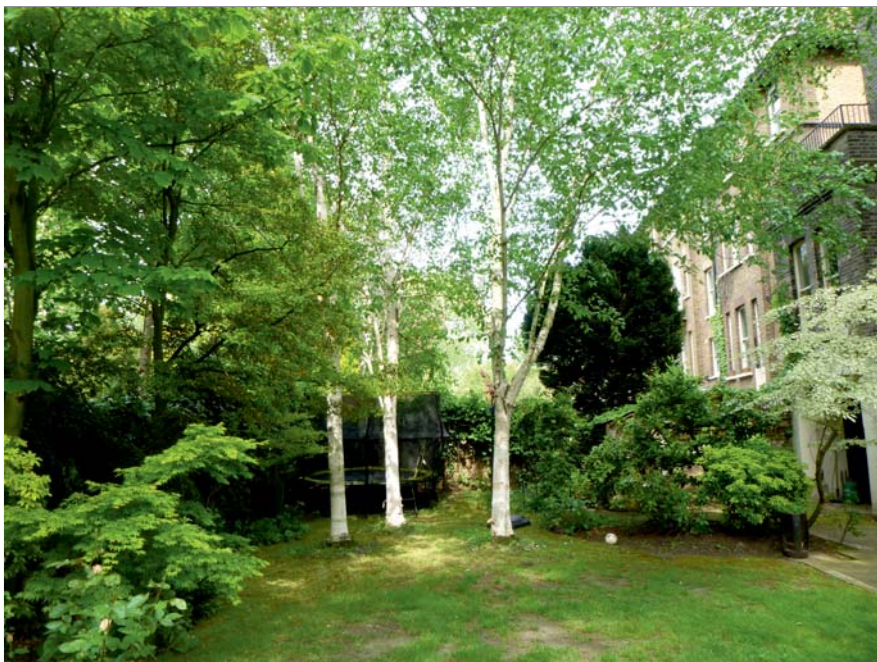
Lawns dominated the garden with some areas of ornamental planting and individual trees also present. Species recorded in the lawns were typical of amenity grassland and included perennial rye-grass (*Lolium perenne*), Yorkshire-fog (*Holcus lanatus*), yarrow (*Achillea millefolium*) and daisy (*Bellis perennis*). Ornamental species recorded included wisteria (*Wisteria sp.*), Aunt-Eliza (*Crocosmia paniculata*), cherry laurel (*Prunus laurocerasus*), forsythia (*Forsythia x intermedia*), camellia (*Camellia sp.*), holly (*Ilex aquifolium*), fatsia (*Fatsia japonica*), roses (*Rosa spp.*), box (*Buxus sempervirens*), bay (*Laurus nobilis*), hebe (*Veronica sp.*) and a yew (*Taxus baccata*) hedge. Tree species recorded on site included false-acacia (*Robinia pseudoacacia*), silver birch (*Betula pendula*), London plane (*Platanus x hispanica*) and yew.

The majority of the trees in the garden were considered to have **negligible** bat roosting potential due to their age, size and lack of any obvious PRFs. A single mature London plane and false acacia were considered to be of **low** potential due to their age and size, although no visible PRFs were recorded. The site being located in a residential area of London provides only limited foraging opportunities for common species of bats. It should be noted that the majority of the property and garden area will remain unaffected by the proposals. There are only a few trees scheduled to be felled all of which have been assessed to be of **negligible** potential for roosting bats.

Photograph 4: Showing the well-maintained garden.

In order to protect the established vegetation to be retained, suitable fencing may be required at certain locations to reduce the possibility of any damage that could be caused during the works. To minimise accidental damage, any overhanging branches should be pruned back to suitable live growth points. All works should be undertaken by a suitably qualified and experienced specialist contractor and should conform to current industry best practice, i.e. BS 3998: 2010 '*Tree Work - Recommendations*'.
