Arboricultural Impact Assessment

- Tree Survey
- Tree Protection Plan
- Arboricultural Method Statement

58a Reddington Road
London
NW3 7RS

Survey Date: 18th January 2019
Report Date: 3rd April 2019
Project no: 1263

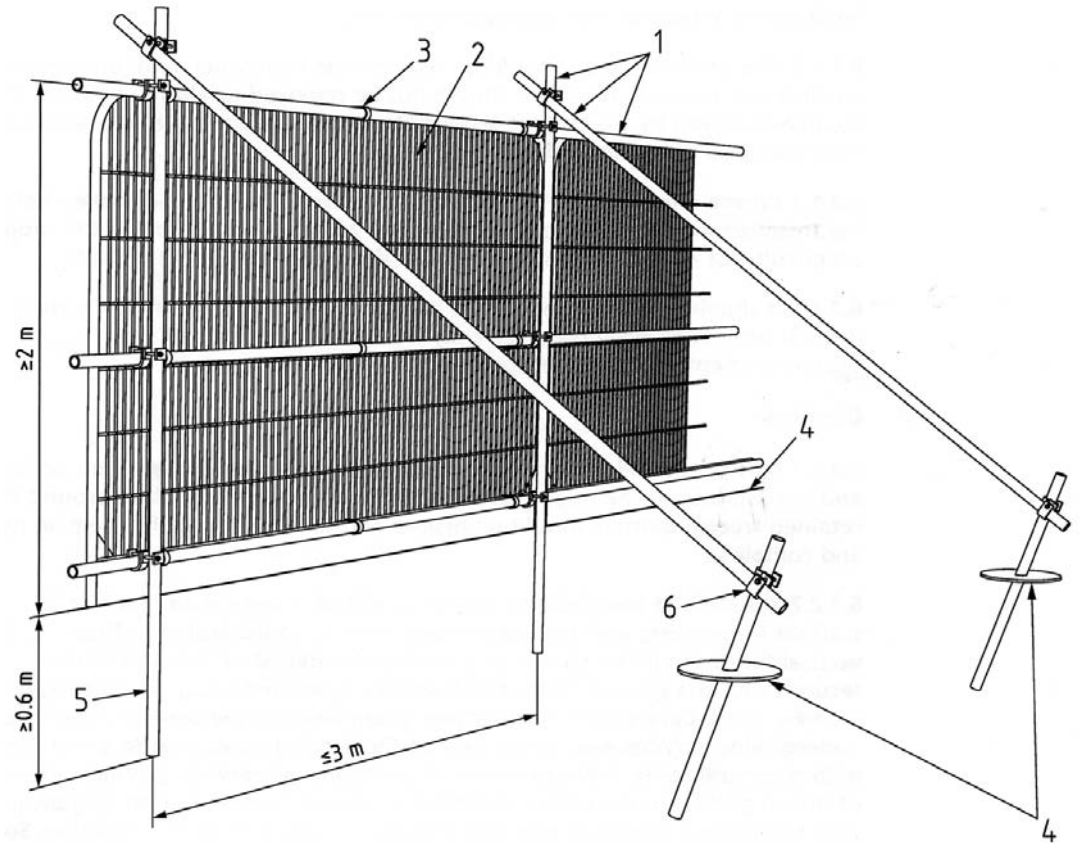
- 1 Standard scaffold poles
- 2 Heavy gauge 2 m galvanised tube and welded mesh infill panels
- 3 Panels secured to uprights and cross-members with wire ties
- 4 Ground level
- 5 Uprights driven into the ground until secure (minimum depth 0.6 m)
- 6 Standard scaffold clamps

- 5.4.2 Tree Protection Fencing must be from weldmesh panels, at least 2m high, securely fixed, with wire or scaffold clamps, to a rigid framework. This framework must be constructed from scaffold tubes with vertical tubes, at a maximum interval of 3m and driven into the ground at least 0.6m. The structure must be well braced to resist impacts, constructed as per Figure 2 of BS5837:2012, which is reproduced in Appendix D.

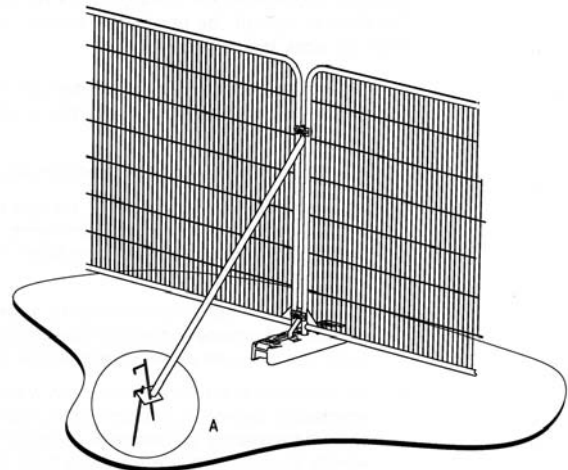
Figure 3a

Stabiliser strut with base plate secured with ground pins

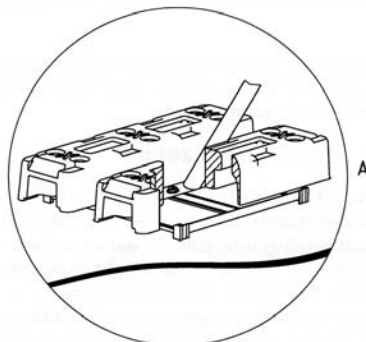
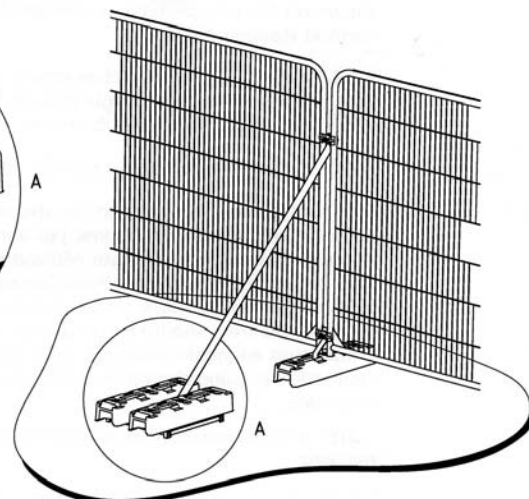
Figure 3b

Stabiliser strut mounted on block tray

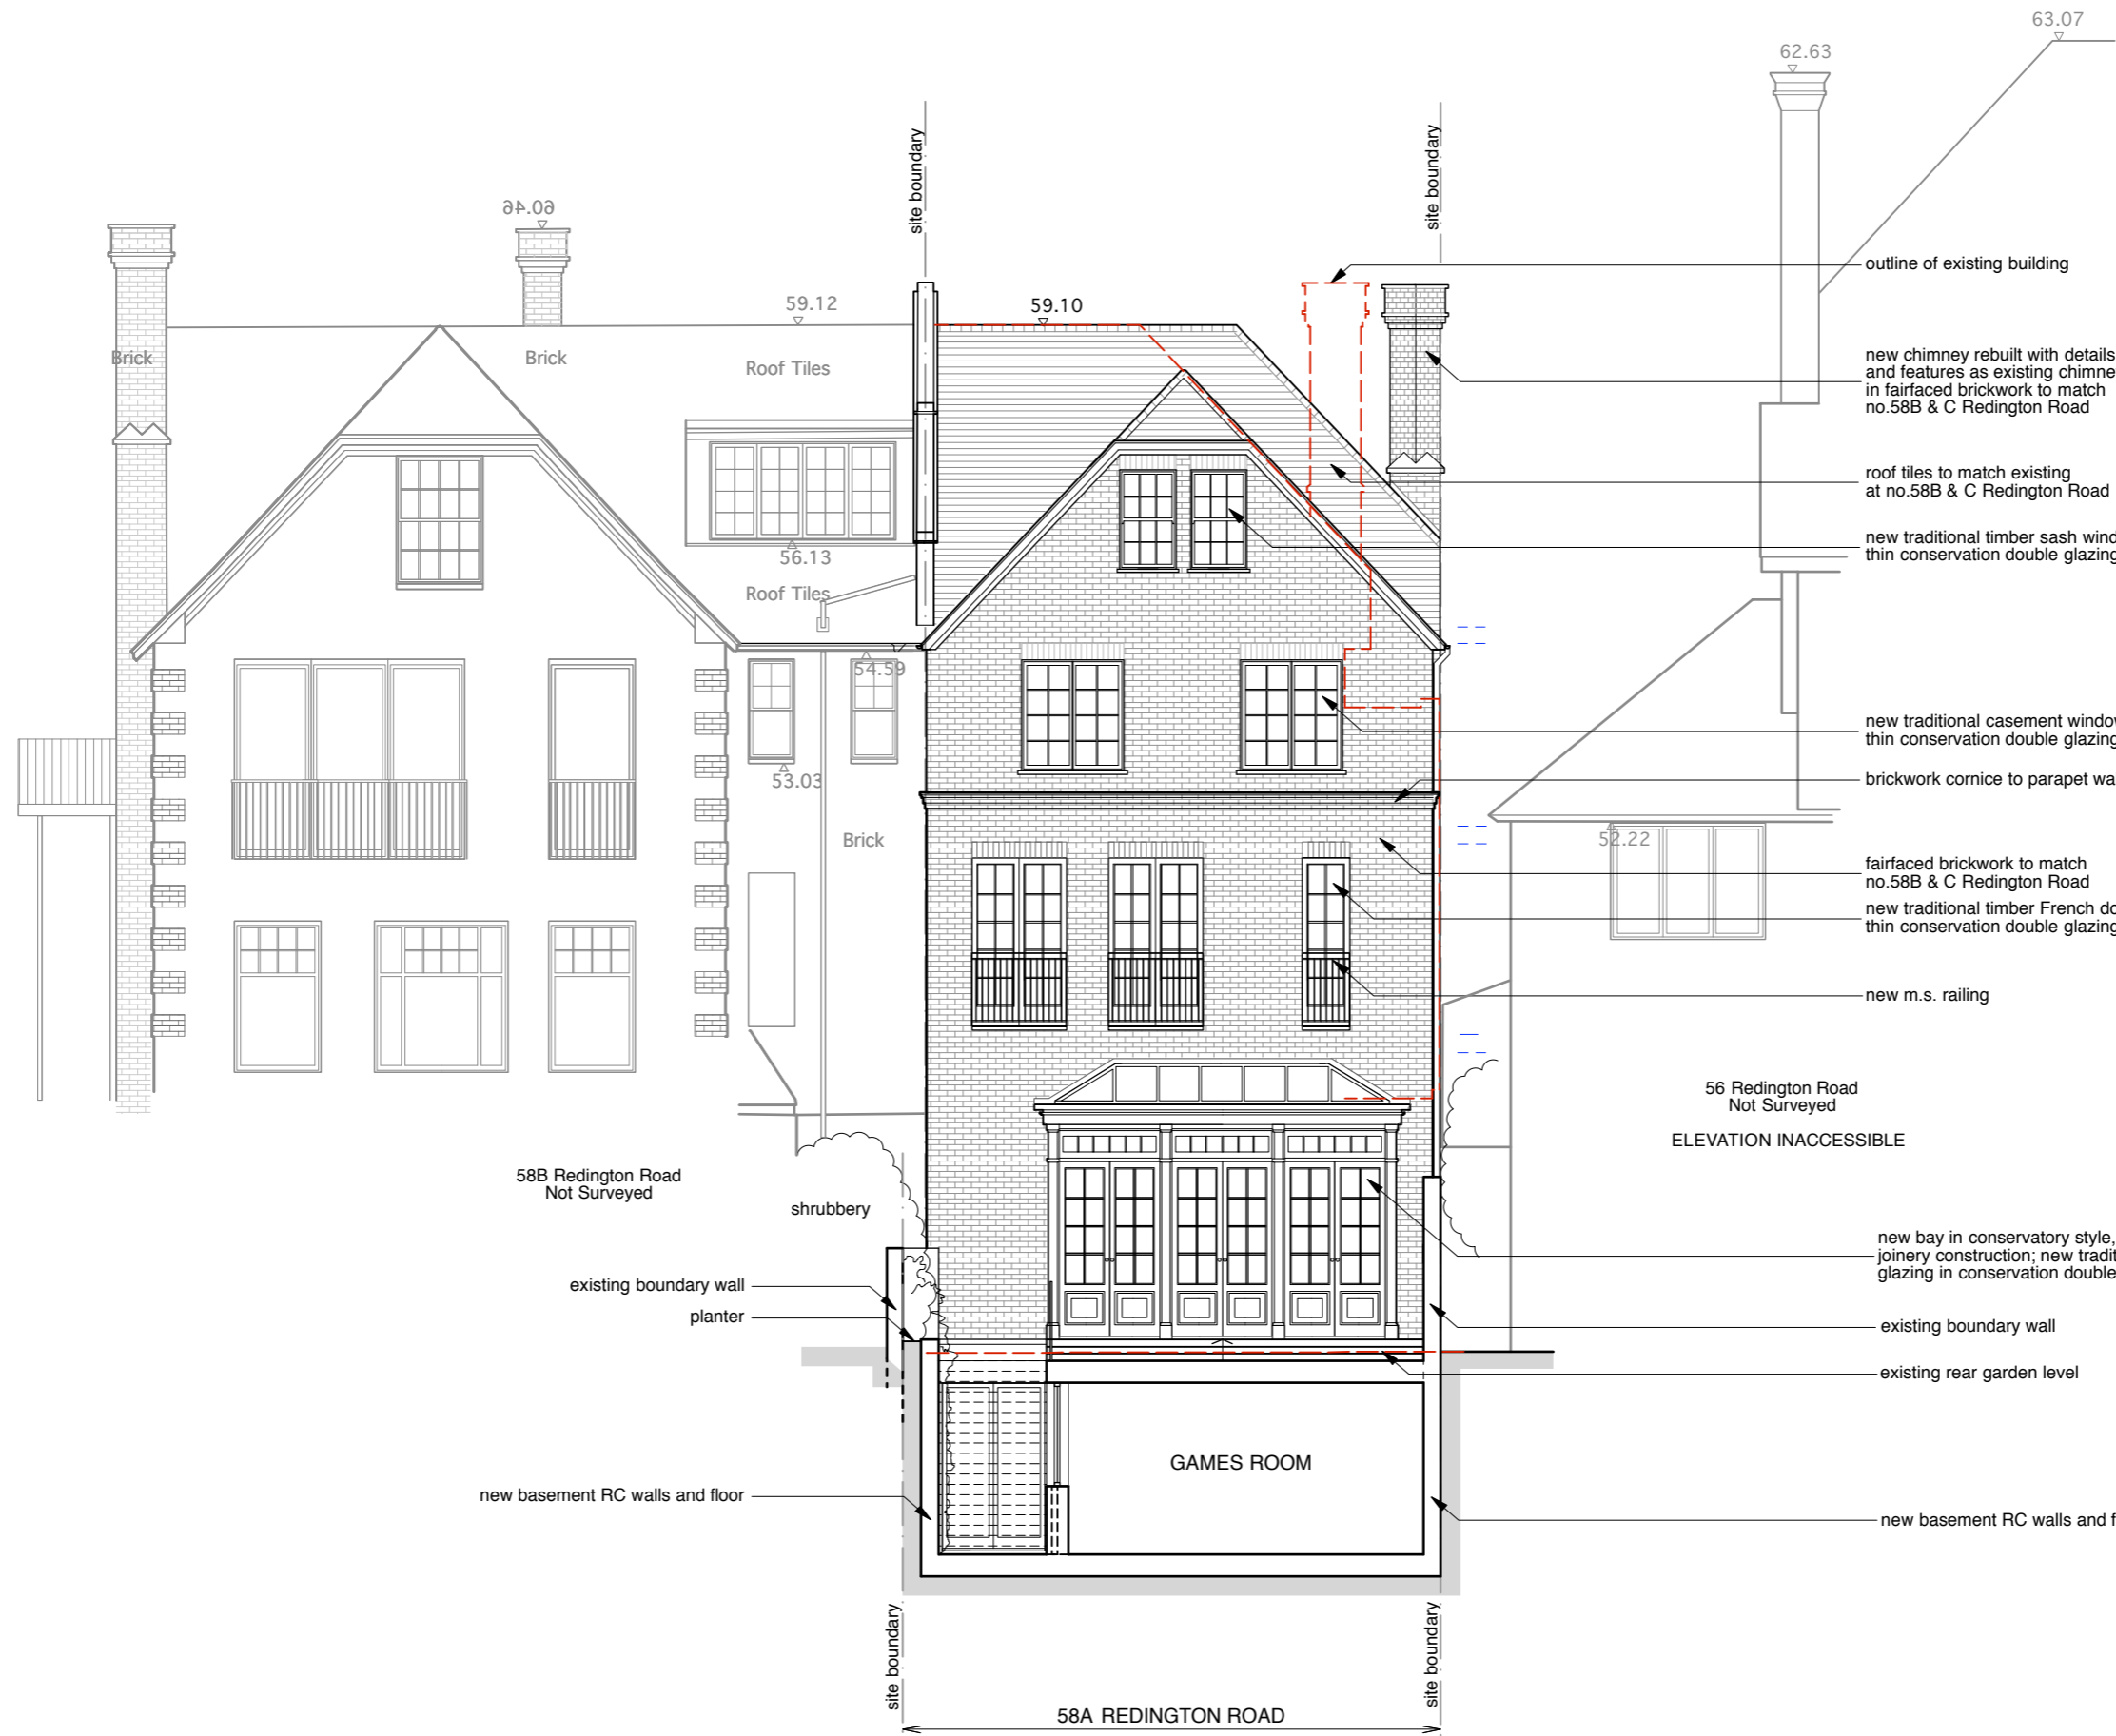
DRAWING: REAR ELEVATION - PROPOSED

- outline of existing building
- new chimney rebuilt with details and features as existing chimney in fairfaced brickwork to match no.58B & C Redington Road
- roof tiles to match existing at no.58B & C Redington Road
- new traditional timber sash windows with thin conservation double glazing
- new traditional casement windows with thin conservation double glazing
- brickwork cornice to parapet wall
- fairfaced brickwork to match no.58B & C Redington Road
- new traditional timber French doors with thin conservation double glazing
- new m.s. railing
- new bay in conservatory style, traditional timber joinery construction; new traditional French doors, all glazing in conservation double glazing
- existing boundary wall
- existing rear garden level
- new basement RC walls and floor
