Project Summary

Investigation to determine existing foundations and ground conditions. The investigation included a hand excavated trial pit, laboratory testing and a drainage survey.

Date	5 th April 2019
Client	Sedgwick
Policy Holder & Address	Ruth Tamir Flat 6, Fitzjohns Mansions, 10 Netherhall Gardens, London, NW3 5RS
Reference number	[REDACTED]
Shire Reference	[REDACTED]
Report prepared by	Rob Ray BSc(Hons) Env Eng

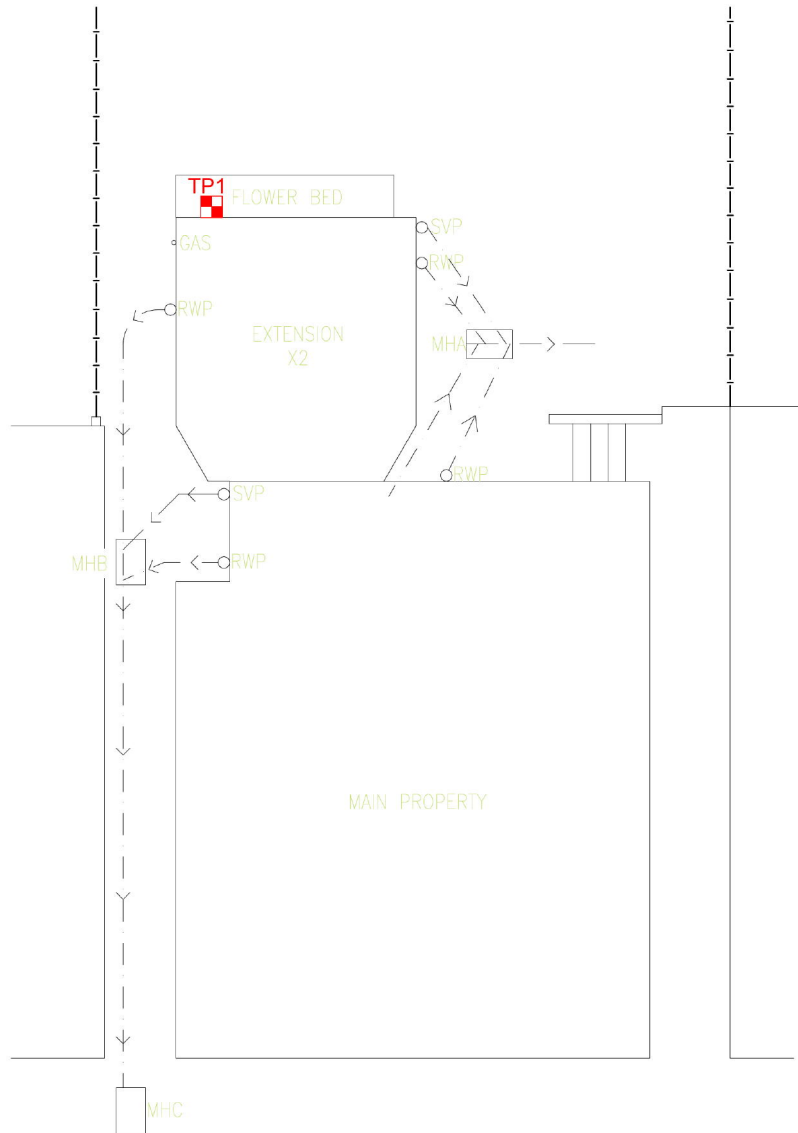
<p>Customer Name SEDGWICK-CET</p>		<p>Address FLAT 6 FITZJOHNS MANSIONS 10 NETHERHALL GARDENS LONDON NW3 5RS</p>		 
<p>Date 05/04/19</p>	<p>Scale AS SHOWN</p>	<p>Job No [REDACTED]</p>	<p>Drawing Title LOCATION PLAN No. 1</p>	
<p>Drawn BB</p>	<p>Checked RR</p>	<p>Drawing No LP1</p>	<p>Issue A</p>

TP1 was located on the rear of the two-storey extension and revealed a concrete foundation. The foundation was formed at a depth of 0.95m with a projection of 0.36m. The ground below the foundation was made ground to 1.1m over firm becoming stiff silty clay.

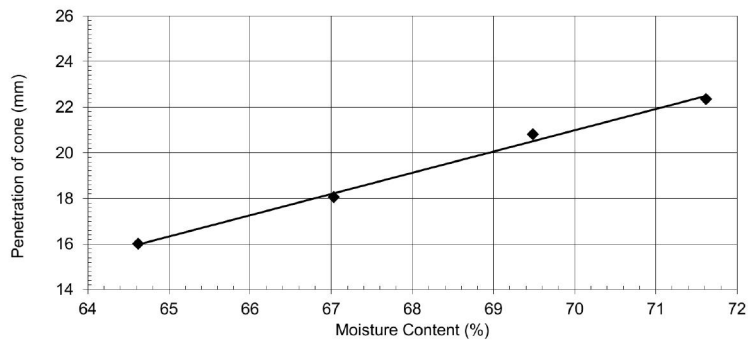
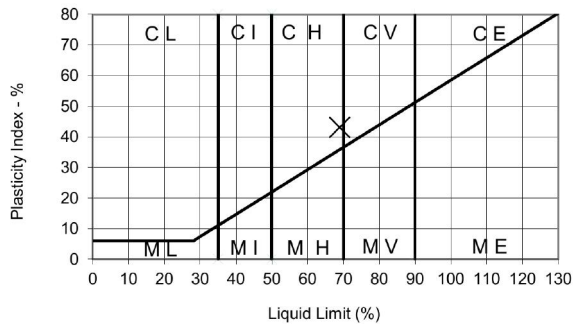
BS1377 : Part 2 : 1990 Clauses 4.3 & 5
LIQUID AND PLASTIC LIMITS

BH / TP Depth (m) Sample Type	TP1 1.00 D	Description: Brown CLAY with rare fine to meidum gravel.
-------------------------------------	------------------	---

Water Content : (BS EN ISO 17892-1:2014) 31.1 %
 Percentage passing 425µm sieve : 97 %
 Liquid Limit : 69 %
 Plastic Limit : 26 %
 Plasticity Index : 43 %

Equivalent Water Content of material passing 425µm sieve : 31.9 %
 Liquidity Index : 0.14

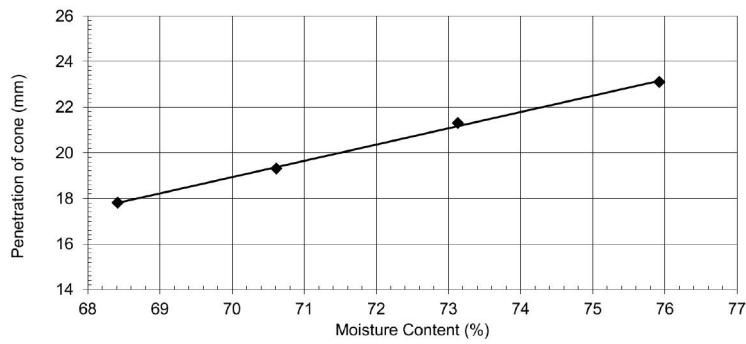
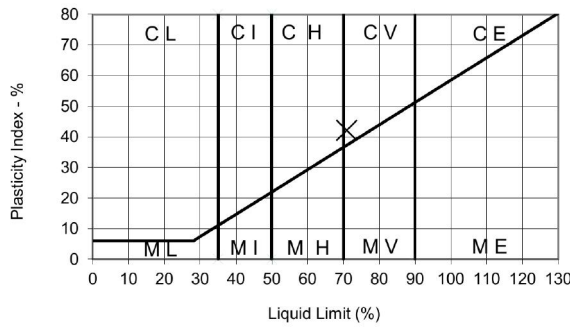
BS1377 : Part 2 : 1990 Clauses 4.3 & 5
LIQUID AND PLASTIC LIMITS

BH / TP Depth (m) Sample Type	TP1 2.00 D	Description: Brown CLAY with rare fine gravel.
-------------------------------------	------------------	---

Water Content : (BS EN ISO 17892-1:2014)	30.8 %
Percentage passing 425µm sieve :	99 %
Liquid Limit :	71 %
Plastic Limit :	29 %
Plasticity Index :	42 %
Equivalent Water Content of material passing 425µm sieve :	31.2 %
Liquidity Index :	0.05
