**1 HAMPSHIRE ST, KENTISH TOWN,
GREATER LONDON**

BAT SURVEYS

A Report to: SADA Architecture

Report No: RT-MME-150631

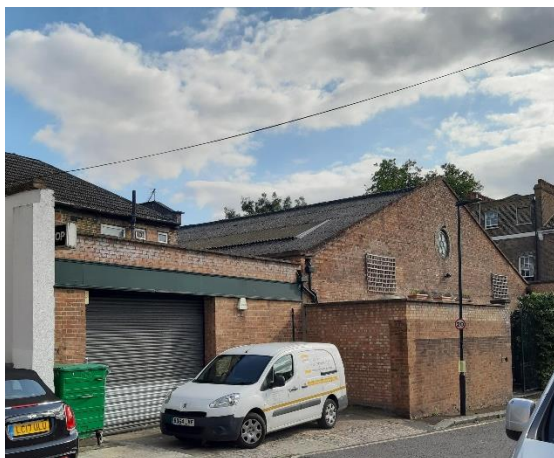
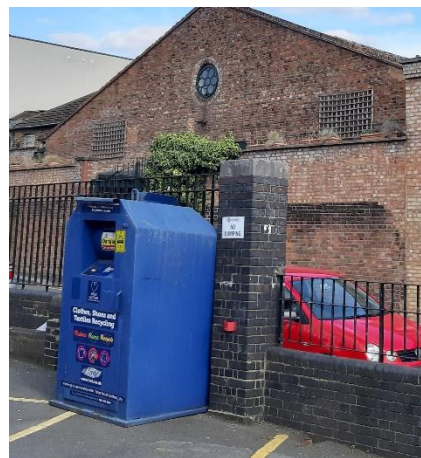
The building complex (Plates 3.1 and 3.2) was comprised of a large double height brick-built building with a pitched roof, connected to a smaller two-storey block with a hipped pitched roof on the north east side, with an additional three single-storey blocks with flat roofs along the front façade.

Plate 3.1 Building Complex Overview

Plate 3.2 Building Complex Overview

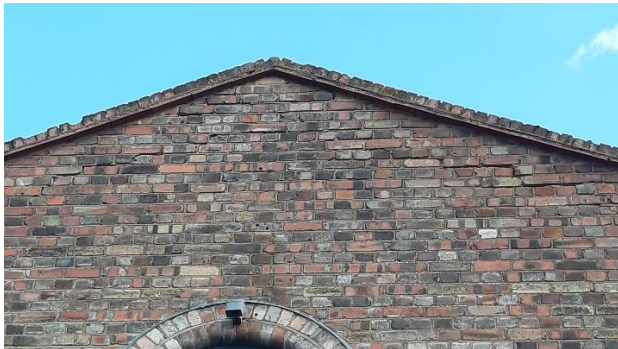
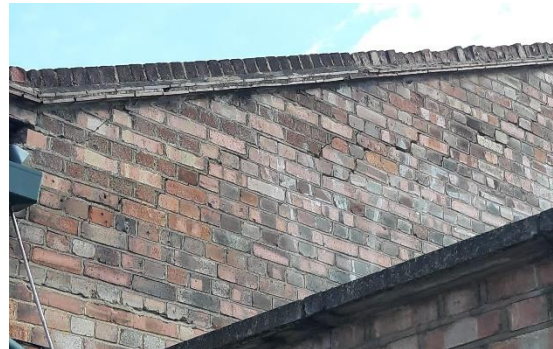
The brickwork was observed to be in generally good condition, however small cracks (Plates 3.3 and 3.4), holes (Plates 3.5 and 3.6) and a gap in the brickwork for piping (Plate 3.6) were identified which could allow

Plate 3.3 Cracks in Brickwork Near Roof

Plate 3.4 Cracks in Brickwork Near Roof

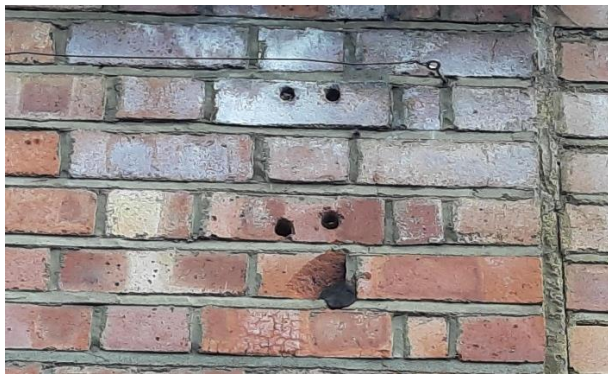
Plate 3.5 Holes in Brickwork

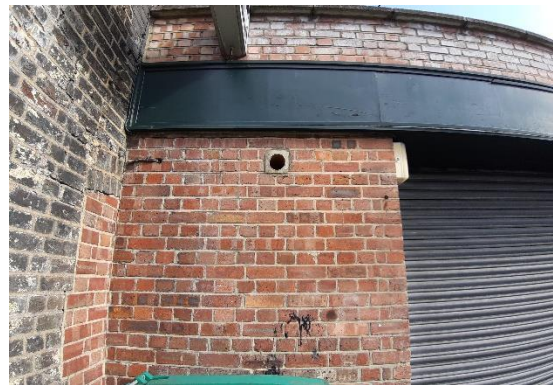
Plate 3.6 Gap in Brickwork for Pipe

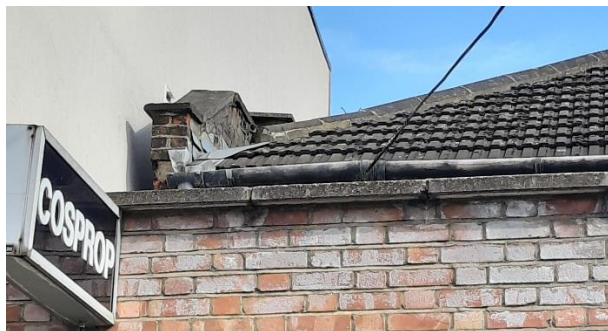
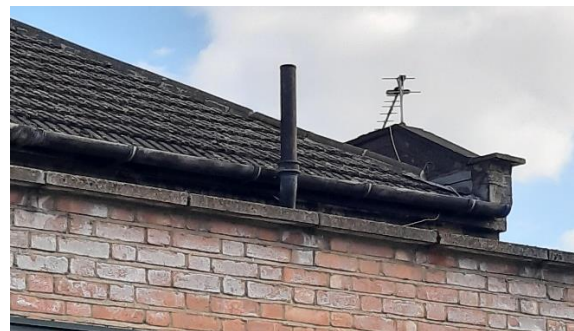
for potential bat ingress into the structure. Additionally, lifted lead flashing was identified on the corners of the pitched roofs (Plates 3.7 and 3.8) which could be utilised opportunistically as a roost for individual bats. Finally, a small area of dense ivy growth was present on the westernmost single-storey building (Plate 3.9) which could potentially obscure ingress points into the structure.

Plate 3.7 Lifted Lead Flashing

Plate 3.8 Lifted Lead Flashing

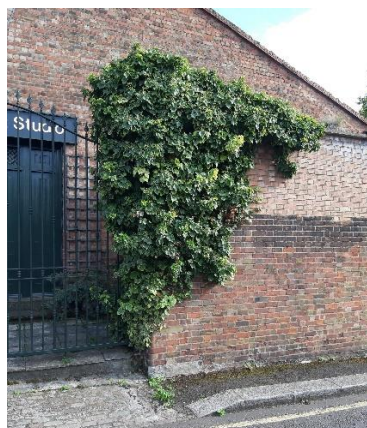
Plate 3.9 Dense Ivy Growth

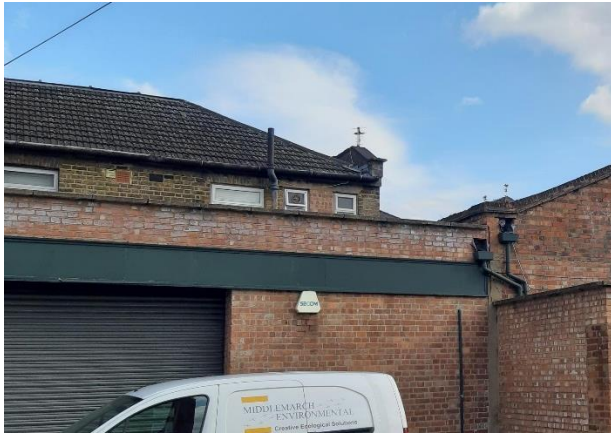
A close inspection of the entirety of the roofs was not feasible due to the height and position on the building. Ridge tiles visible along the top of the roof of the two-storey building were recorded as intact (Plate 3.10). From a ground level review, roof tiles appeared to be tightly fitted and flush to the building and no evidence of bats was recorded. The asbestos sheeting, where visible, was in moderately good condition with some slight lifting observed (Plate 3.11). A full inspection of the roofs was not possible, however, due to their height and location on the building.

Plate 3.10 Tiled Roof

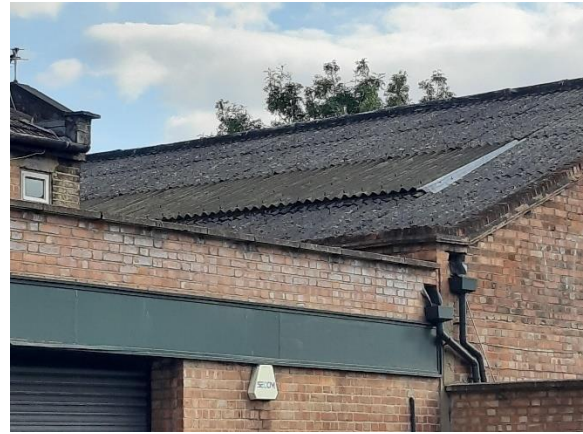
Plate 3.11 Asbestos Roof

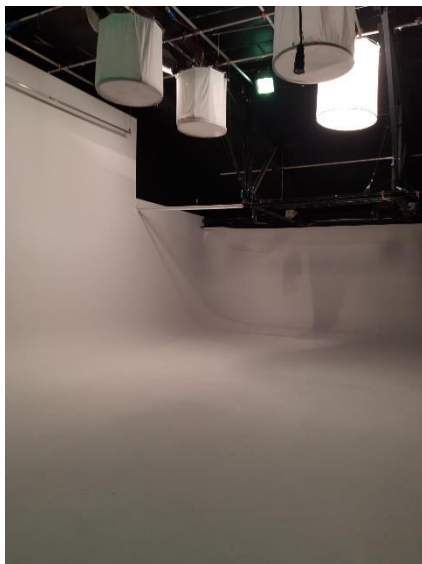
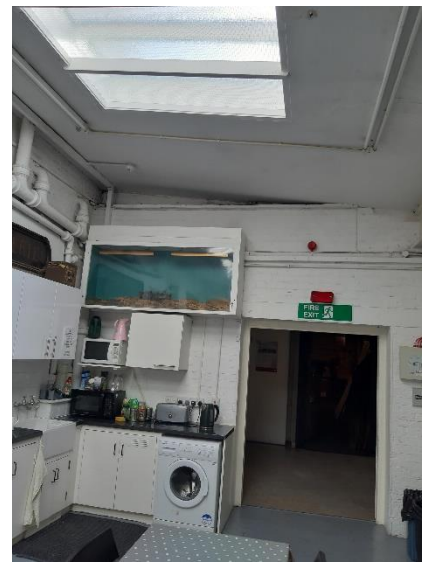
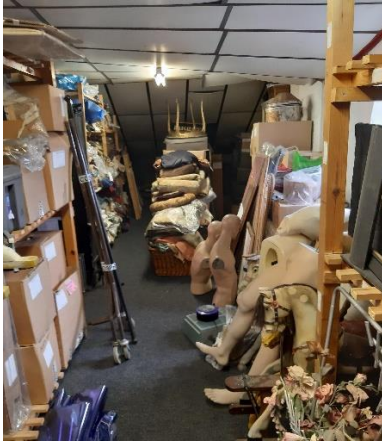
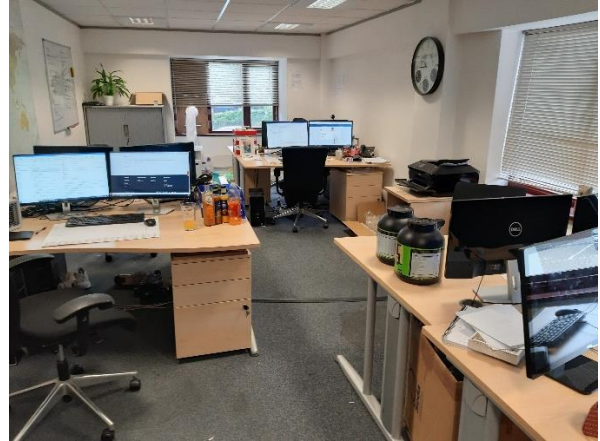
The internal area (Plates 3.12-3.15) consisted of a large open working photography/film studio, with two loft style rooms and smaller rooms utilised for storage and support facilities located in the adjoining structures. The internal space had mostly intact floors, walls and ceilings with the exception of lifted and damaged roof panels in one of the loft rooms (Plates 3.16 and 3.17).

Plate 3.12 Internal Overview

Plate 3.13 Internal Overview

Plate 3.14 Internal Overview

Plate 3.15 Internal Overview

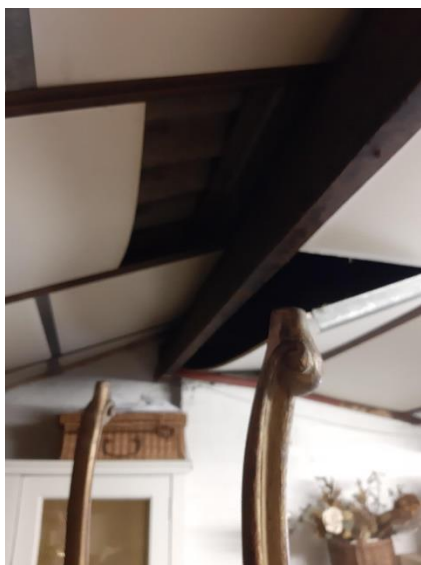
Plate 3.16 Lifted Roof Panels

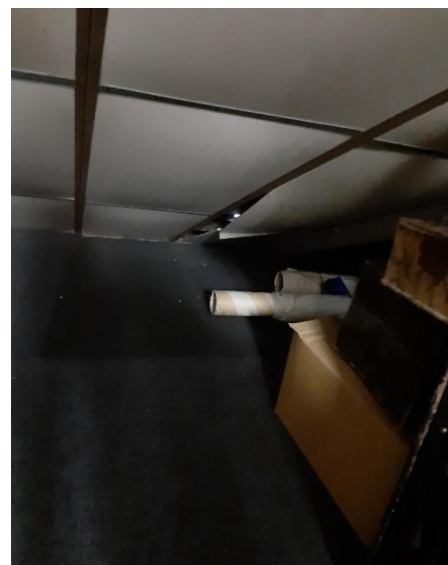
Plate 3.17 Damaged Roof Panels

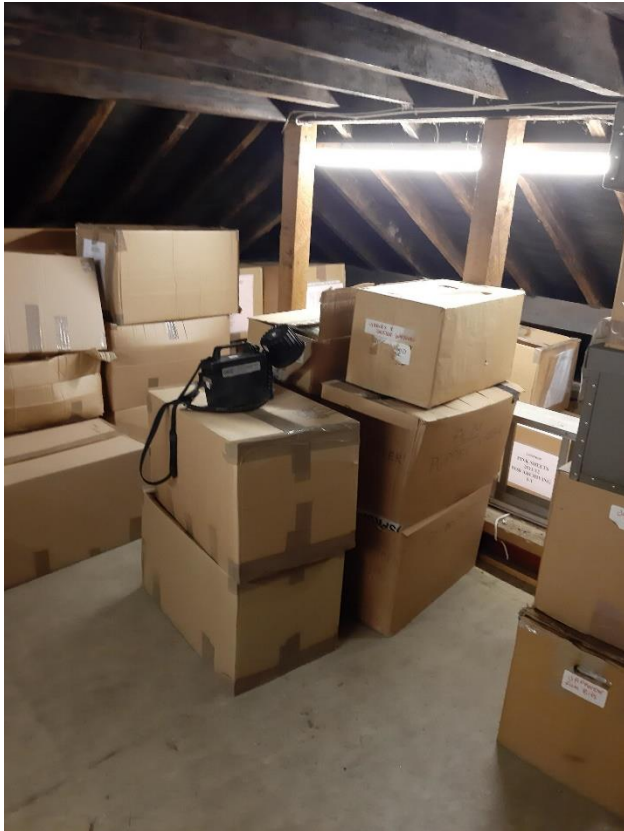
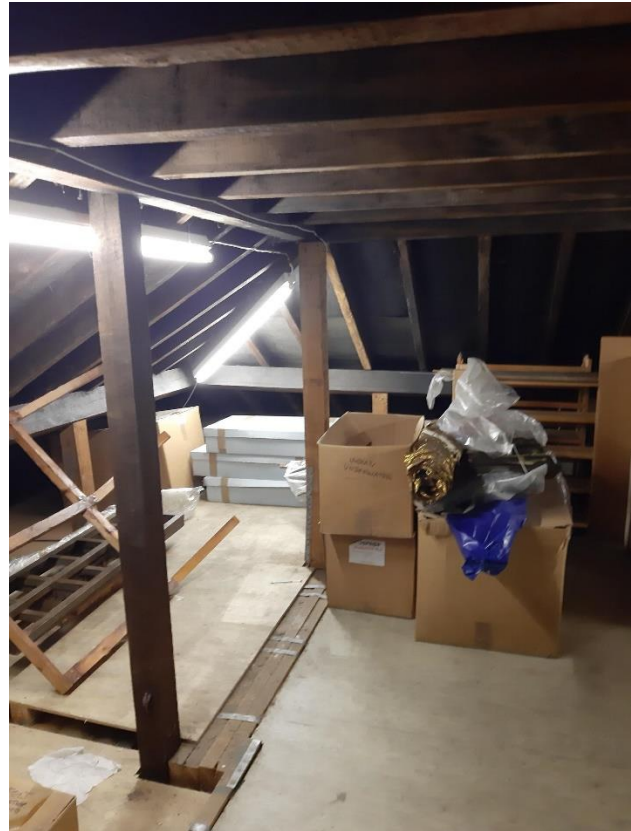
A loft space with a timber framework and felt sarking was present as depicted in Plates 3.18 and 3.19. This space was timber framed, approximately 2 m high, and cluttered with storage. The felt sarking was intact and there was no visible entry points for bats.

Plate 3.18 Loft Overview

Plate 3.19 Loft Overview
