**1- EXISTING ROOF PLAN**  
 SCALE 1.100 @ A1

Client Sign Off	North	Architect / Originator: <b>Tate Harmer</b>	Unit G182, Stamford Works, 3 Gilbert Street, London N16 8JH Tel: +44 (0)207 241 7481 Email: studio@tateharmer.com	Do not scale. All dimensions to be checked on site. This drawing is copyright.
		Client: <b>Platinum Land</b>	8 Overgate House, 1 Duke of York Square, Kings Road, London, SW3 4LY	
		Project: <b>Belsize Park Firestation</b>	Date of Origin: <b>28.11.17</b>	Drawn By: <b>ABF</b>
		Drawing Title: <b>Existing Roof - Conservation Rooflight</b>	Scale: <b>1:100</b>	Drawing Status: <b>Planning</b>
	Drawing Number: <b>BFS THA PR AL 524 P1</b>

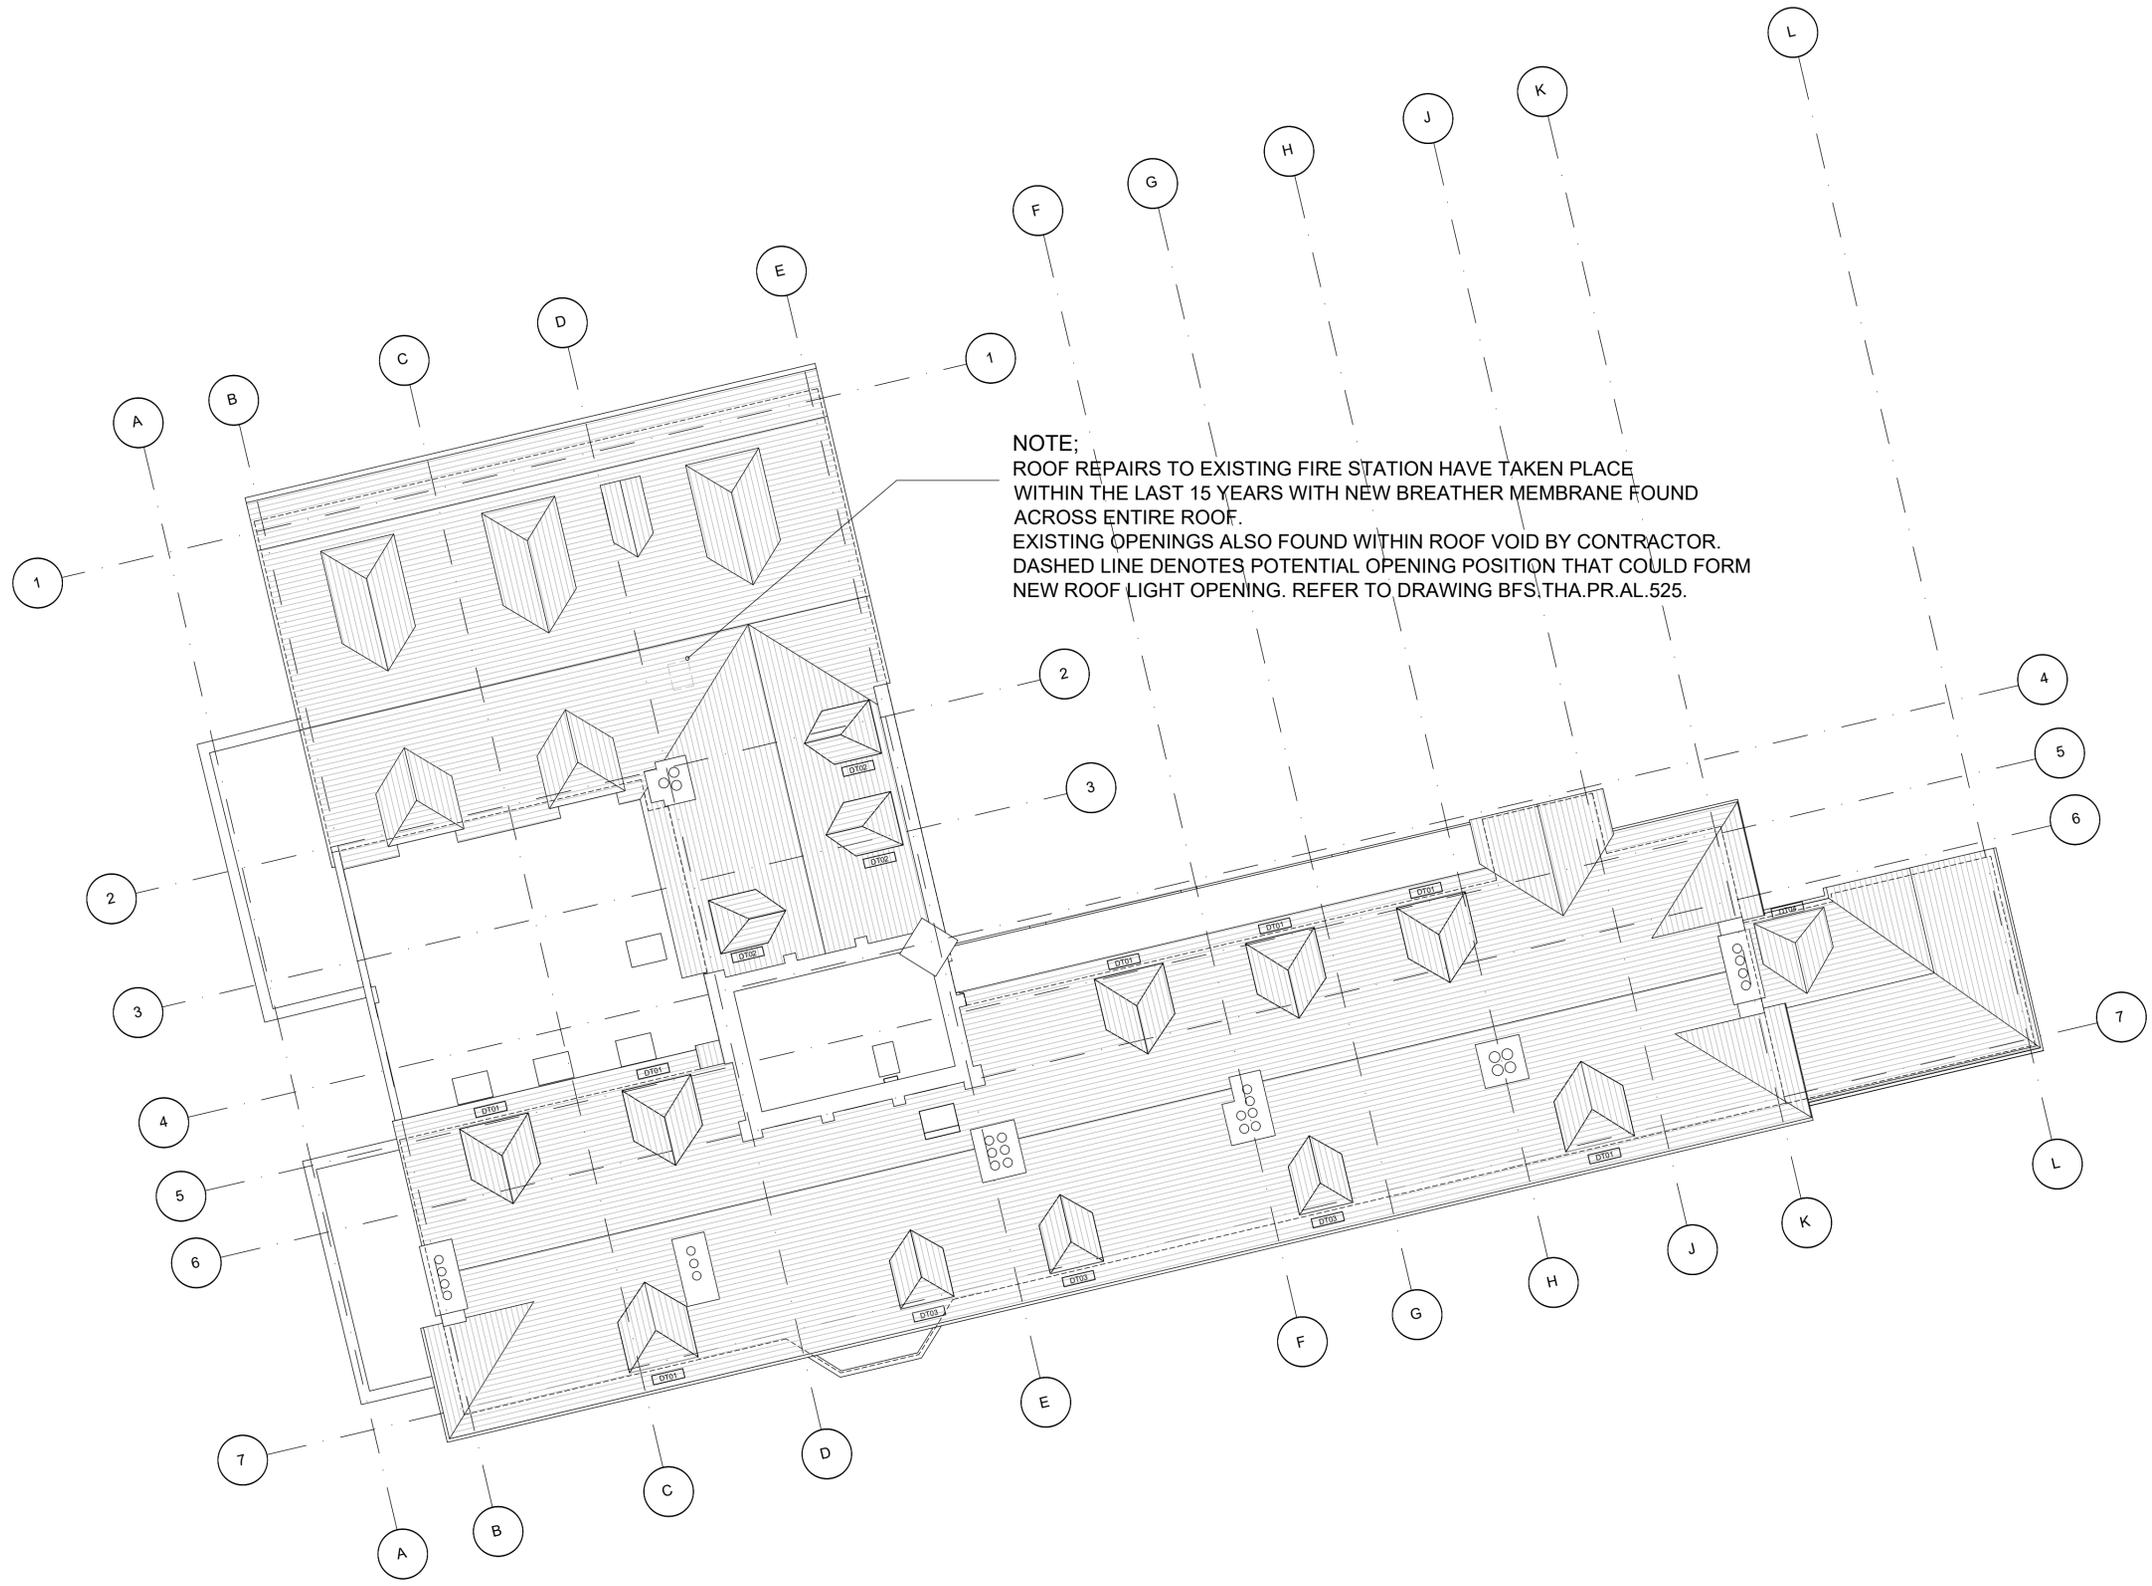
**NOTE:**  
 ROOF REPAIRS TO EXISTING FIRE STATION HAVE TAKEN PLACE WITHIN THE LAST 15 YEARS WITH NEW BREATHER MEMBRANE FOUND ACROSS ENTIRE ROOF.  
 EXISTING OPENINGS ALSO FOUND WITHIN ROOF VOID BY CONTRACTOR.  
 DASHED LINE DENOTES POTENTIAL OPENING POSITION THAT COULD FORM NEW ROOF LIGHT OPENING. REFER TO DRAWING BFS.THA.PR.AL.525.
