22 FROGNAL WAY **DESIGN & ACCESS** STATEMENT

This Design and Access Statement is submitted in support of the planning application and associated conservation area consent for the proposed works to the existing eastern boundary wall to No. 22 Frognal Way, London NW3 6XE.

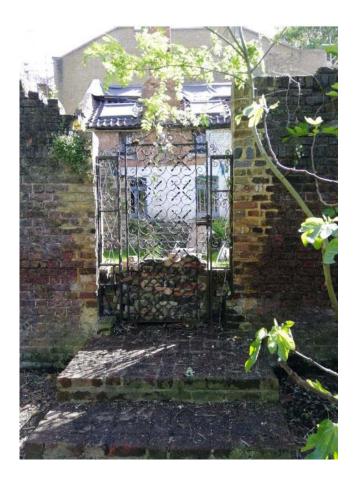
Photo 1: Metal gate - front view as viewed from No.22 Frognal Way

There are two existing openings to this boundary wall that contribute to the lack of privacy between the two properties. The gates do not match in its aesthetics – metal gate (Photo 1) and the weathered timber board gate (Photo 2) – and have missing brick courses at high level.

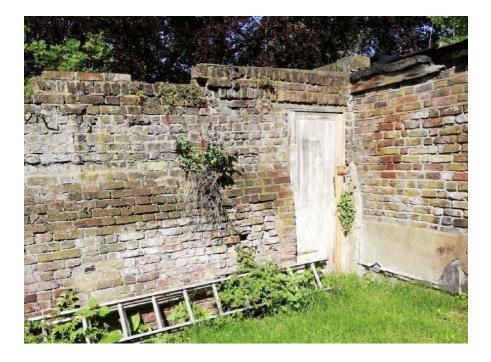
Photo 2: Timber gate as viewed from No. 20 Perrin's Walk

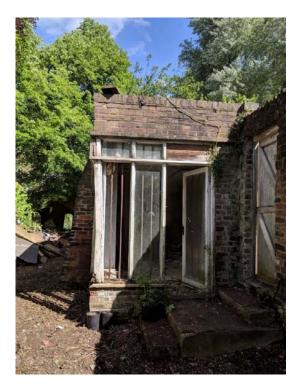
Photo 3: Outbuilding as viewed from No.22 Frognal Way

The boundary wall subject of this application is located in Conservation area and forms part of the eastern boundary with No. 20 Perrin's Walk. Attached to the boundary wall is an unused single storey brick structure outbuilding (Photo 3).

The structure and boundary wall are raised in yellow stock bricks of some age, laid in lime mortar, although the upper part of the outbuilding is raised in mass-produced machine-made bricks, laid in cement mortar.

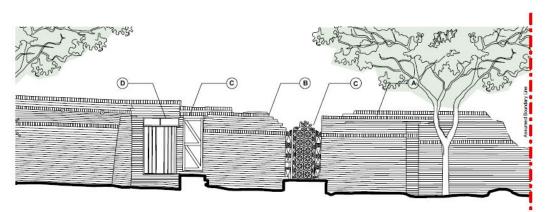
Image 1: Existing front elevation as viewed from No. 22 Frognal Way

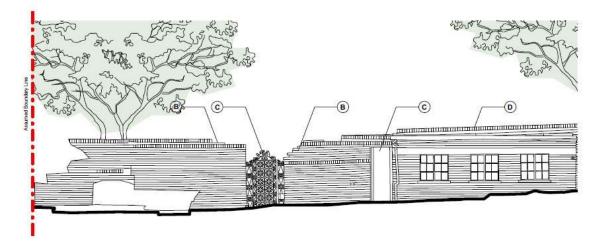
Image 2: Existing rear elevation as viewed from No.20 Perrin's Walk

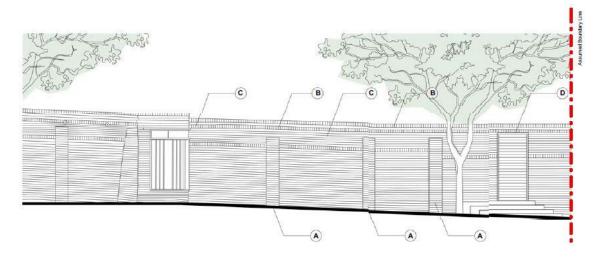
Image 3: Proposed front elevation as viewed from No. 22 Frognal Way

As part of the repair works, it is also proposed to infill the existing gate openings between the two properties with the matching brickwork to improve the privacy and security between the two properties. A new timber gate is proposed to the south most end of the wall in line with the owner's 'Right of Access' rights that will improve the existing condition.

The gate design will be of a panelled timber construction and in keeping with the overall landscape scheme and aesthetics of the site (Ref.2018/4405/P).

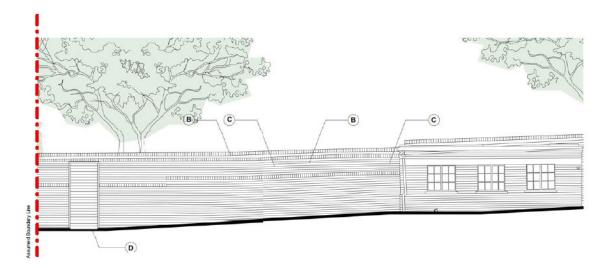
Image 4: Proposed rear elevation as viewed from No. 20 Perrin's Walk

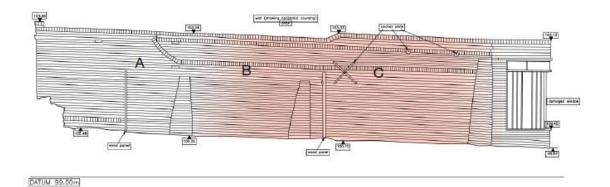
Image 5: North end of the boundary wall as viewed from No. 22 Frognal Way. (Structurally unstable sections of the wall highlighted in red)

The structural stability of the boundary wall will be achieved by carefully rebuilding the existing piers to Structural Engineer's requirements, new brick piers will be introduced to provide the required support to currently bowing unstable sections of the brickwork wall.

The report has identified key areas of the wall that are structurally unstable and require strengthening by either full rebuilding of the wall or by constructing new brick piers.

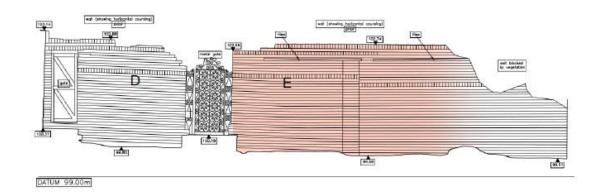
Image 6: South end of the boundary wall as viewed from No. 22 Frognal Way. (Structurally unstable sections of the wall highlighted in red)

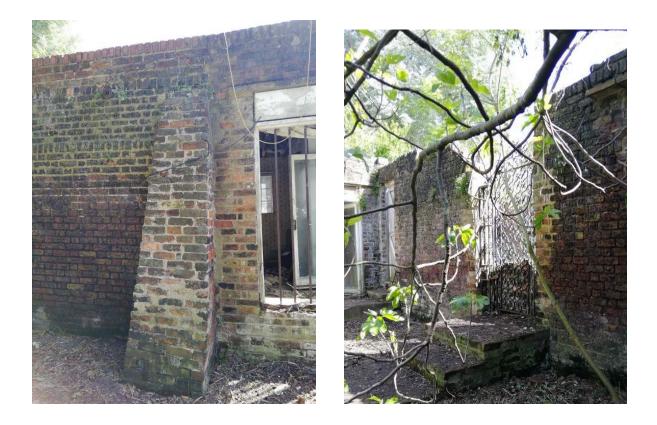
Photo 4 & 5: Outbuilding and existing boundary wall with unused gate openings as viewed from No. 22 Frognal Way

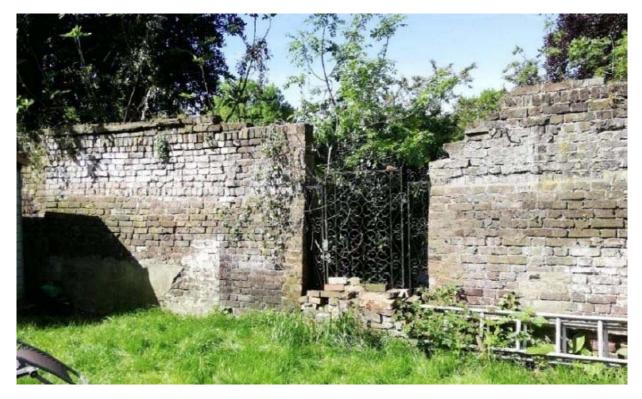
Photo 6: Boundary wall as viewed from No. 20 Perrin's Walk
