Arboricultural Impact Appraisal and Method Statement

27 John Street, London

Ref: 13355-A-1-NW

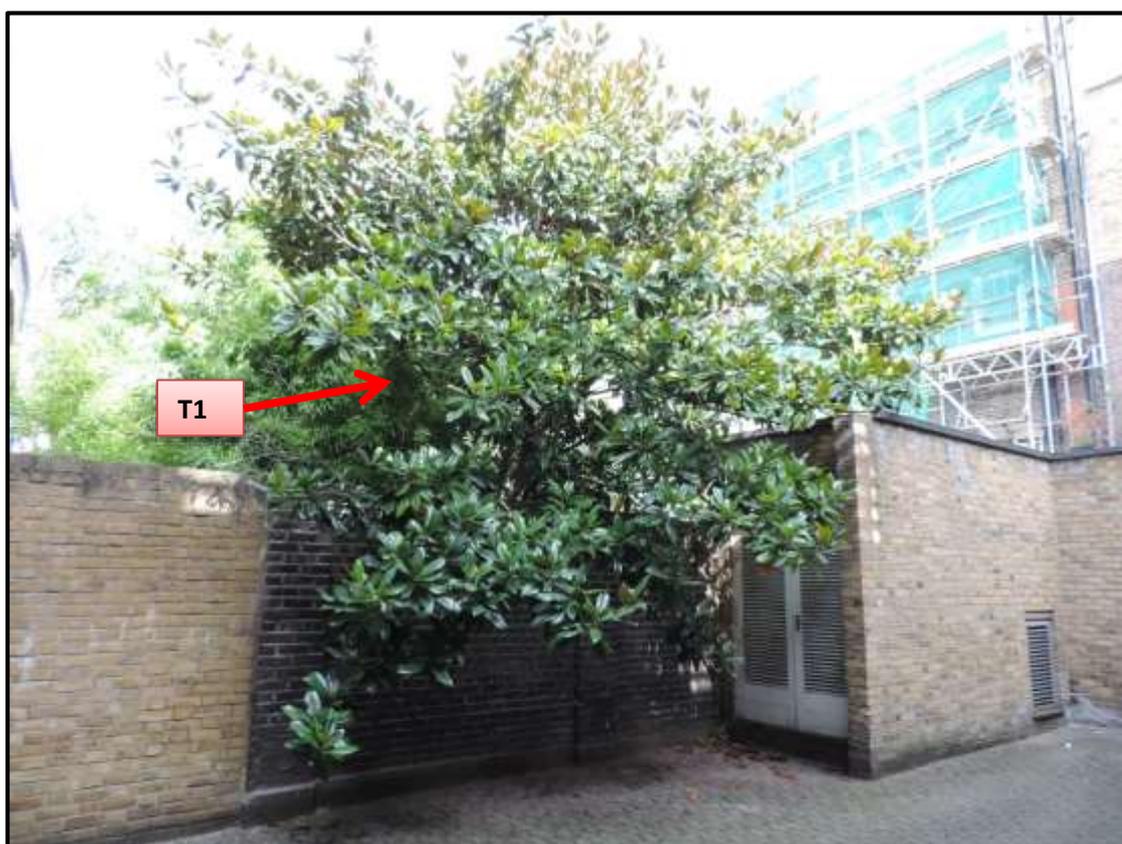
Image 1: The foundations of the boundary wall are likely to be providing a significant root barrier on the side of 27 John Street.

Tree 1: From the provided layout, only one tree (T1) growing in the adjacent property is close enough to be affected by the proposed basement works. Based on its estimated stem diameter it requires a RPA radius of 3.6m or an area of soil 41m². However, the tree grows about 0.5m from the boundary wall where the foundations are likely to have restricted root growth on this side (Image 1). From my observations, I believe it is unlikely that roots from this tree have found their way beneath the wall foundations and are probably growing in the adjacent garden. If this is the case, the tree is unlikely to be affected by the works. However, if some roots have managed to find their way beneath the wall foundations, special precautions will be required to investigate whether any roots are present using hand digging techniques. If roots are encountered, then it may be possible for careful root pruning to be done but this will need specialist advice and should only be done under a supervision agreement to minimise any adverse effects on the tree's health or amenity value. There are some small low branches that are likely to be restricting access for construction works but any necessary remedial pruning can be done without adversely affecting the health or visual amenity value of the tree.

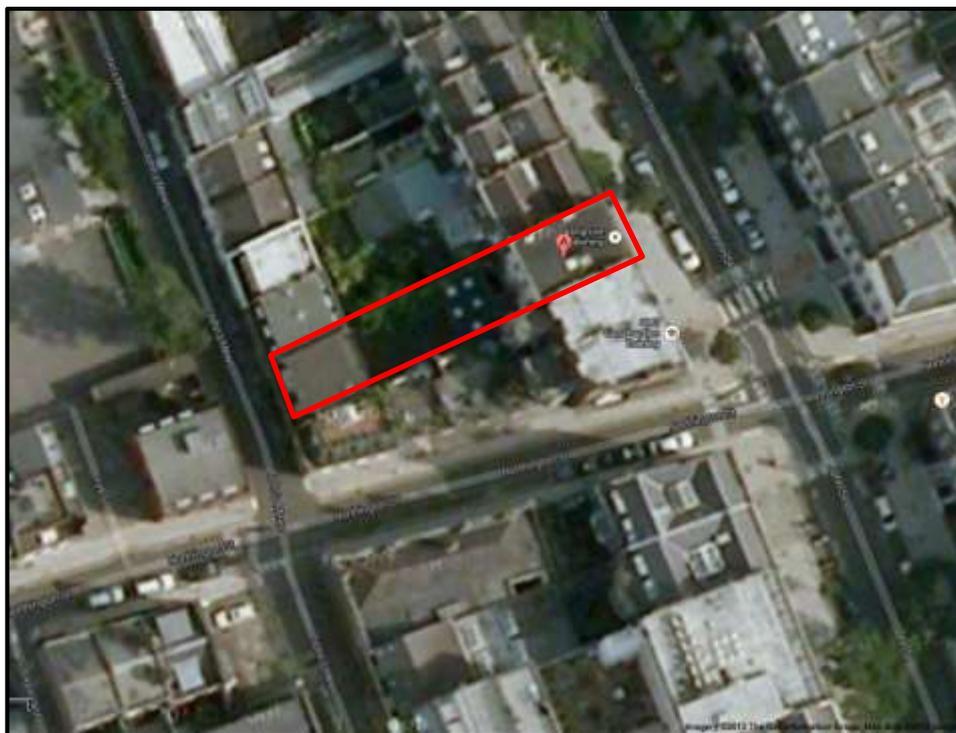
Image 2: The site boundaries are approximately indicated by the red outline

John Street is located in the residential suburbs of London. Number 27 is on the western side of the road and surrounded by similar residential development. The property consists of a terraced house with mews that are enclosed by high boundary walls. There are no trees within the property but there is a medium sized magnolia in the rear garden of the adjacent property close to the north boundary wall, but it is not visible from any public viewpoints.

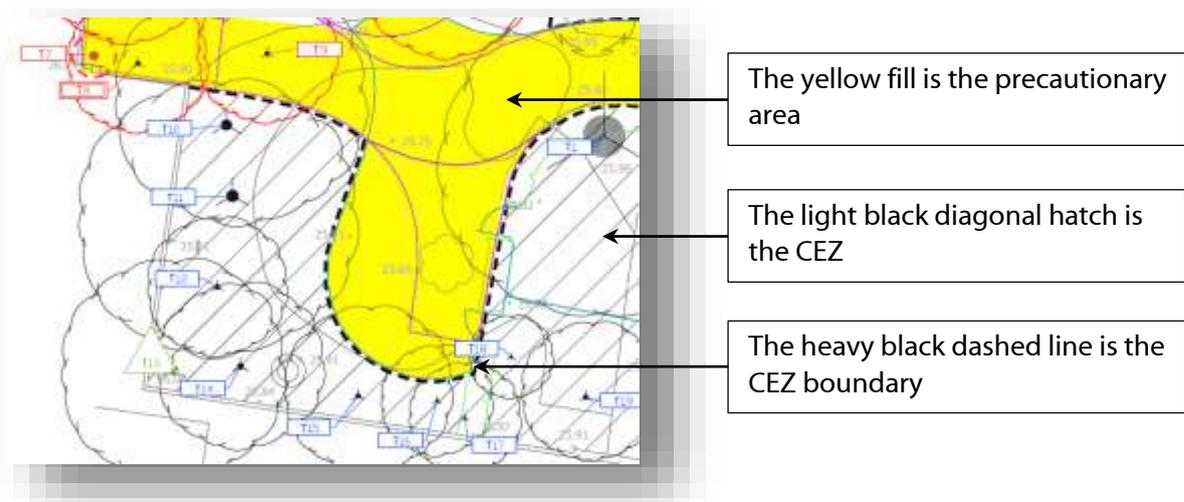
These areas are illustrated on our plans and annotated as follows:

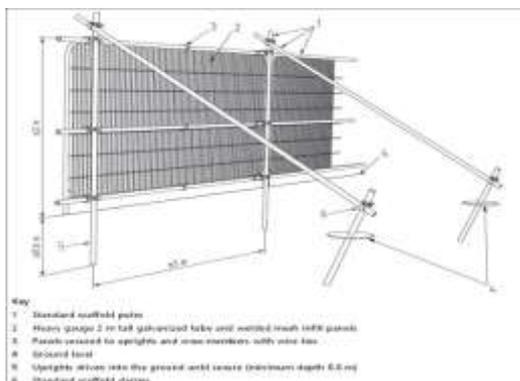
Figure 1: Recommendations taken from figure 2 of BS 5837.

Various fencing options are illustrated in figure 1 and photos 2–4 below. The minimum specification for the fencing must be as described in figure 2 of BS 5837 (figure 1 below) or an equivalent design that effectively restricts access to the RPA protects.

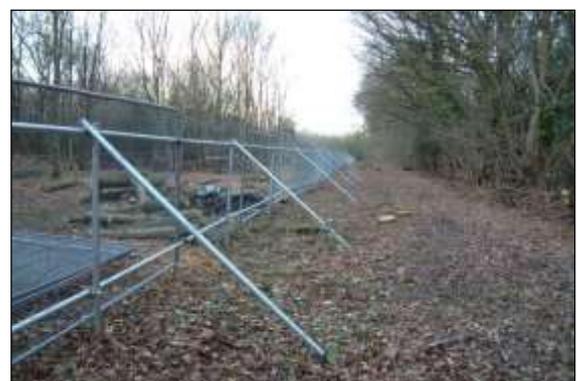
Photo 2: Heras fencing wired to scaffold braced posts is a robust and effective interpretation of the BS specification.

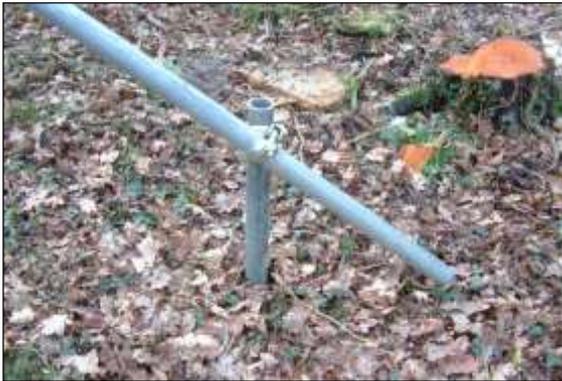
Photo 3: Close up of bracing detail, essential for increasing the stability of the vertical framework.

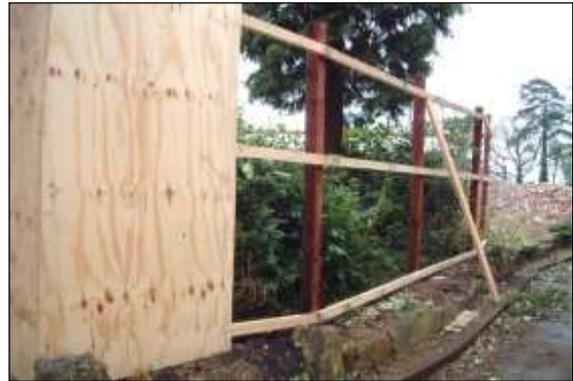
Photo 4: Board specification on secure wooden posts is a suitable alternative to the standard braced scaffold design.

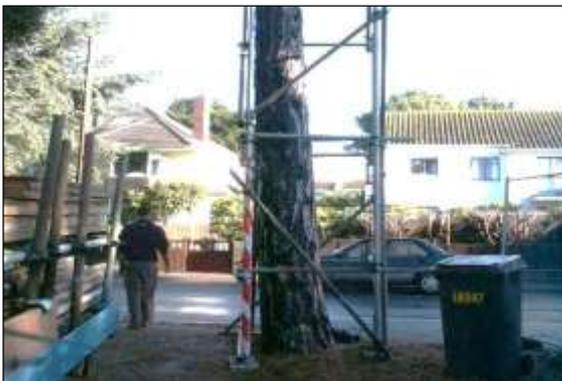
Photo 5: A scaffold braced framework surrounding the trunk reduces the risk of accidental impact.

Where individual trunks or branches are vulnerable to impact damage, a framework of scaffold or wood can be constructed to provide protection (photos 5 and 6).

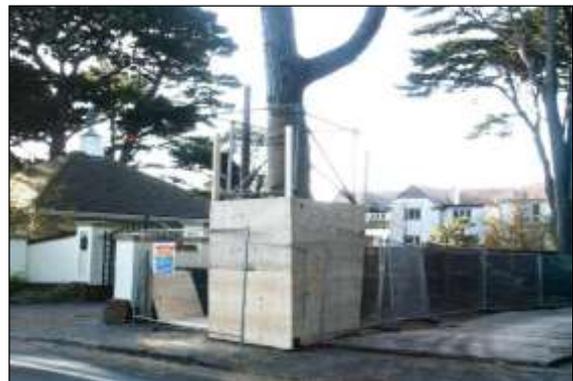
Photo 6: Board secured to scaffold framework adds another layer of protection for vulnerable trunks and branches.

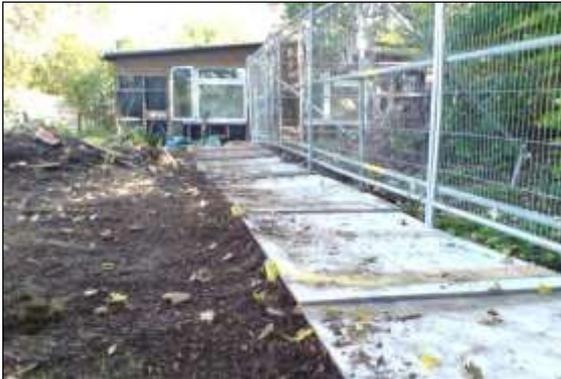
Photo 7: Heavy-duty plywood set onto a compressible woodchip layer and pinned into position is suitable to spread the loading from pedestrian access.

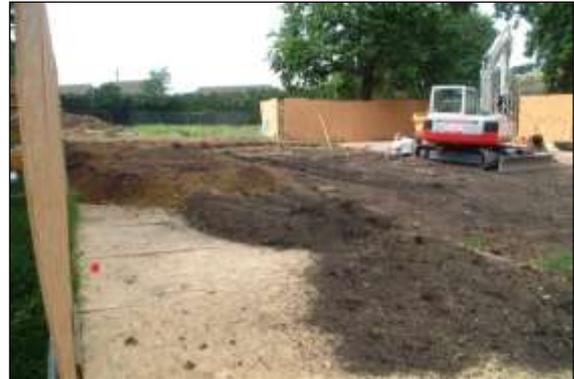
Photo 8: Spreading soil excavated from footings is an effective way of buffering the plywood surface from the wear of light vehicles.

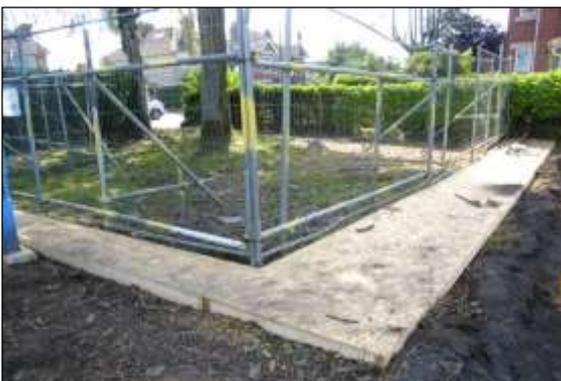
Photo 9: Plywood fixed to a wood frame is another effective method of protecting soil from pedestrian compaction.

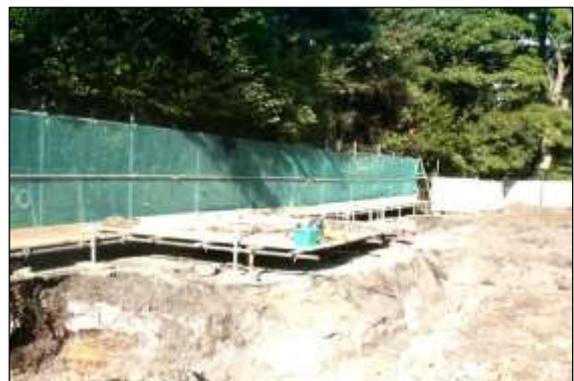
Photo 10: A scaffold framework attached to the main scaffold fencing can be used to support either scaffold planks or plywood to create an elevated platform with a gap beneath.

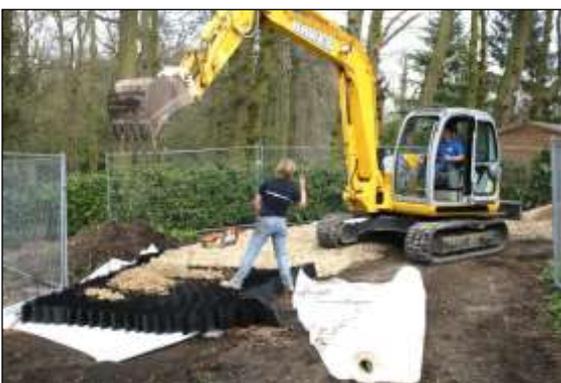
Photo 11: Cellular products are a very effective means of providing ground protection where heavy vehicle use is expected. Here, it is being used to temporarily widen an existing road, to be removed once the construction is finished.

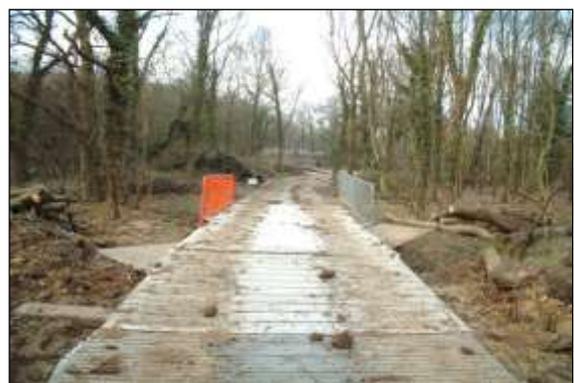
Photo 12: Custom designed sectional tracks can be joined to support very heavy traffic use through sensitive areas.

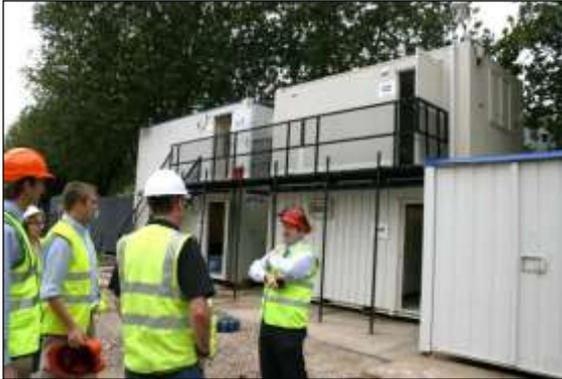
Photo 13: A combination of retaining existing surfacing and using temporary construction cabin accommodation can be a very effective means of preventing damage to sensitive areas.

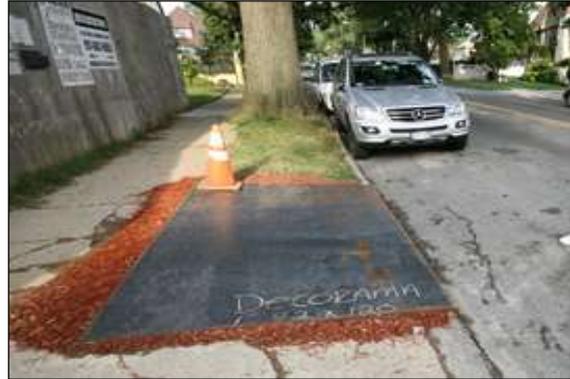
Photo 14: Steel plates can be an effective way of temporarily reinforcing weak surfacing over a construction access during the development activity.

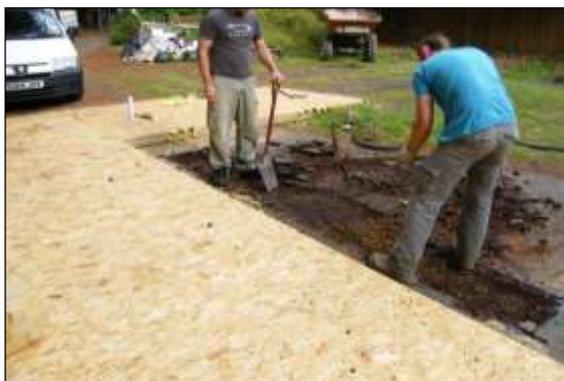
Photo 15: Careful hand-digging using conventional tools is acceptable for exposing roots in RPAs.

Precautionary areas are RPAs outside the CEZ, i.e. they are areas where construction activity can take place, but it must be carried out with care to avoid damaging the sensitive rooting environment. BS 5837 (7.2) makes provision for excavating in RPAs, explaining that all excavation must be carried out carefully using hand-held tools and preferably by compressed air soil displacement, taking care not to damage the bark and wood of any roots (photo 15, 16 and 17).

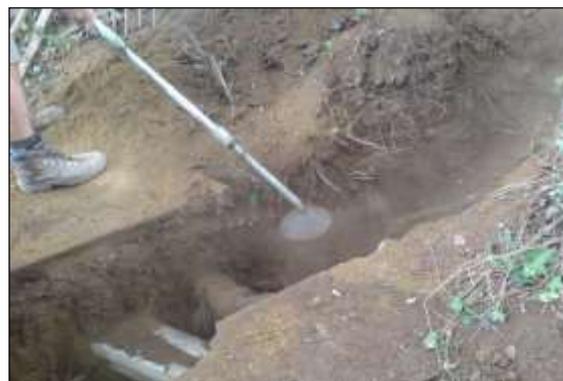
Photo 16: Air spades are very effective at exposing roots and services with minimal damage.

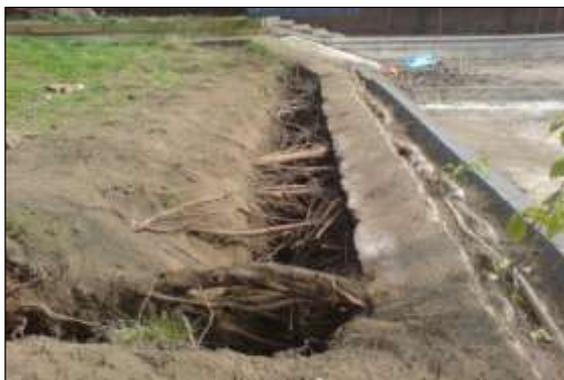
Photo 17: Air spades are particularly useful where roots are very dense.

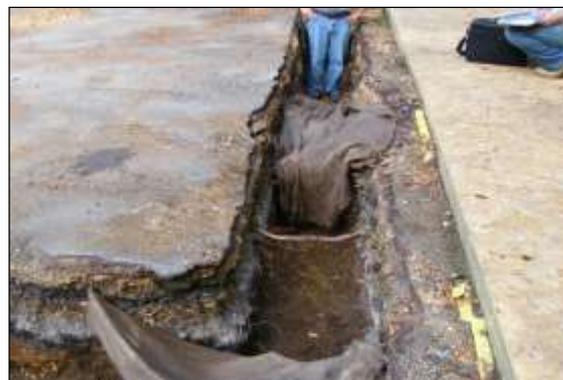
Photo 18: Exposed roots must be protected from light, drying out and extremes of temperature by covering with hessian sacking and boards until they can be covered back with soil.

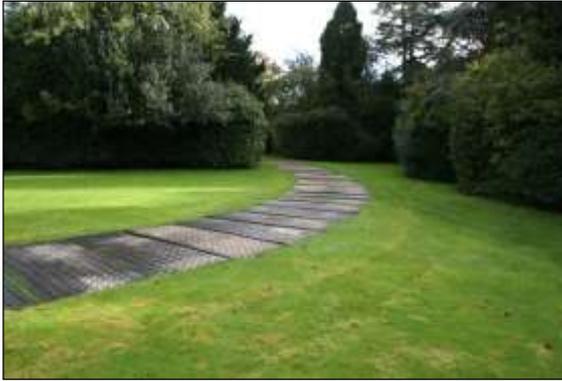
Photo 19: Ground protection must be used where repeated foot or vehicle traffic could cause compaction in sensitive RPAs. It can be as simple as plywood for pedestrians, but must be more robust for vehicles.

In summary, there should be no vehicular or repeated pedestrian access unless existing ground protection is retained or new protective measures are installed (photo 19). All exposed RPAs must be protected until there is no risk of damage from the development activity.

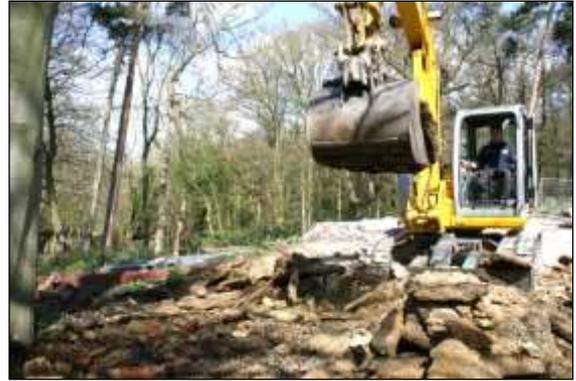
Photo 20: Machines with a long reach can be used to lift out heavy surfacing and structures as long as the machine sits outside the RPA and the exposed surface is protected before there is any further access.

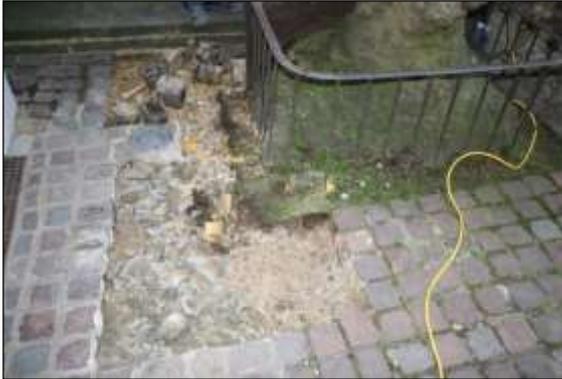
Photo 21: Careful lifting of cemented-in sets round this tree allowed them to be re-laid on a permeable sand base, improving the water input into the soil around the trunk.

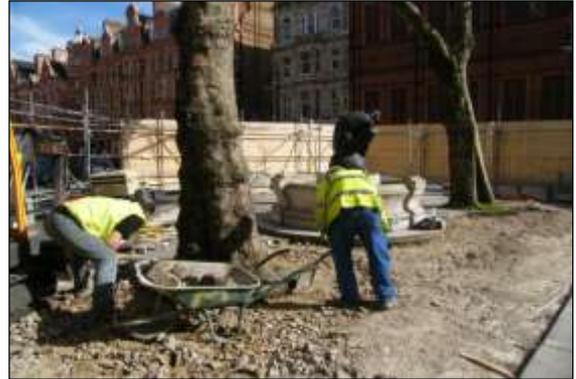
Photo 22: These trees had impermeable surfacing right up to their trunks, which had to be removed by hand before installing new structures.
