PHASE I AND II GEO-ENVIRONMENTAL ASSESSMENT

PREMIER INN EXTENSION, 1 DUKES ROAD, EUSTON

REC REFERENCE: 1CO104376/P2/R1

PREPARED FOR: WHITBREAD GROUP PLC

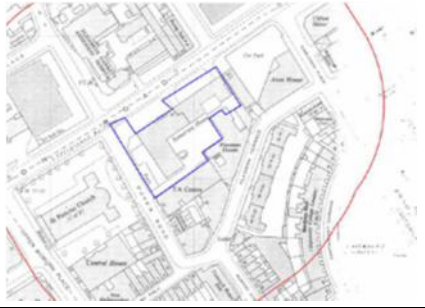
Map Edition	Historical Land Use	Map Excerpt
1965 – 2002 (1:1,250, 1:2,500 & 1:10,000)	By 1965, the site has been redeveloped into a large structure labelled 'Somerton House'. In the surrounding area the majority of small residential buildings have been converted into large residential buildings. A electricity substation is located 50m north west of site. The surrounding area has continued its industrial expansion

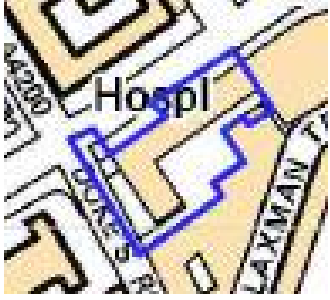
2002 - 2014 (1:10,000)	The site is in its current configuration.

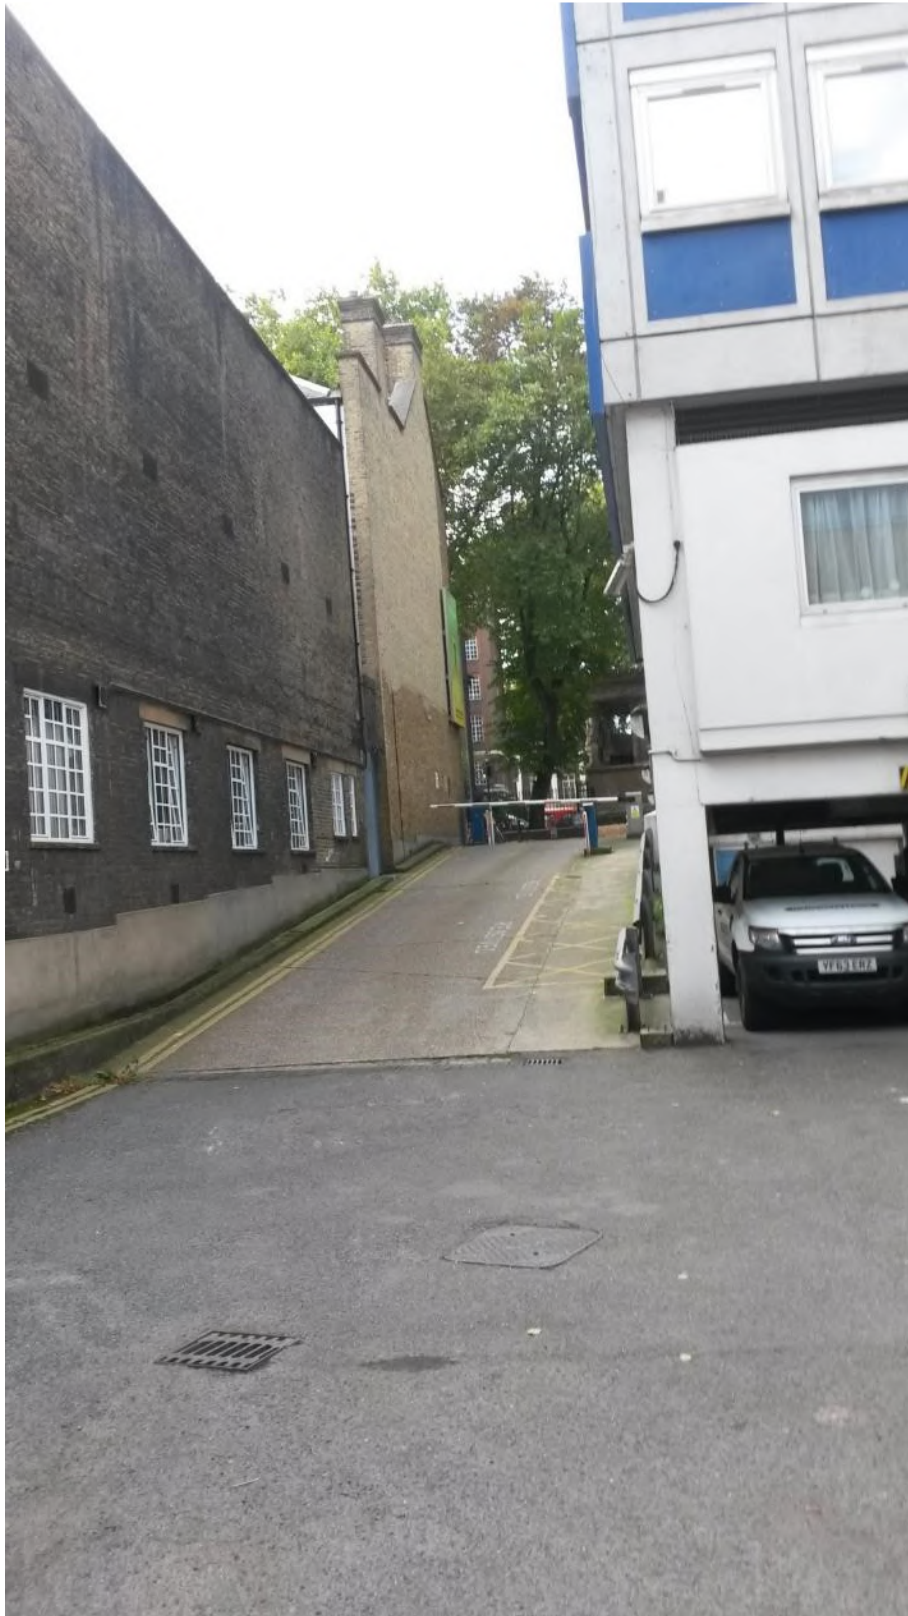
Plate 1 - Entrance to site from Dukes Road

Access into the site was off Dukes Road via an asphalt driveway with entry controlled by a ticketed barrier. Both the driveway and the car park surface are laid in asphalt and appeared to be in good condition.
