## Express Preliminary UXO Risk Assessment

<b>Client</b>	GEA Ltd
<b>Project</b>	12 Keats Grove, London
<b>Site Address</b>	12 Keats Grove, London, NW3 2RN
<b>Report Reference</b>	EP9454-00
<b>Date</b>	23/08/19
<b>Originator</b>	HAS

### **Ground Movement Assessment**

12 Keats Grove, London, NW3 2RN  
Installation Effects  
Underpin Installation

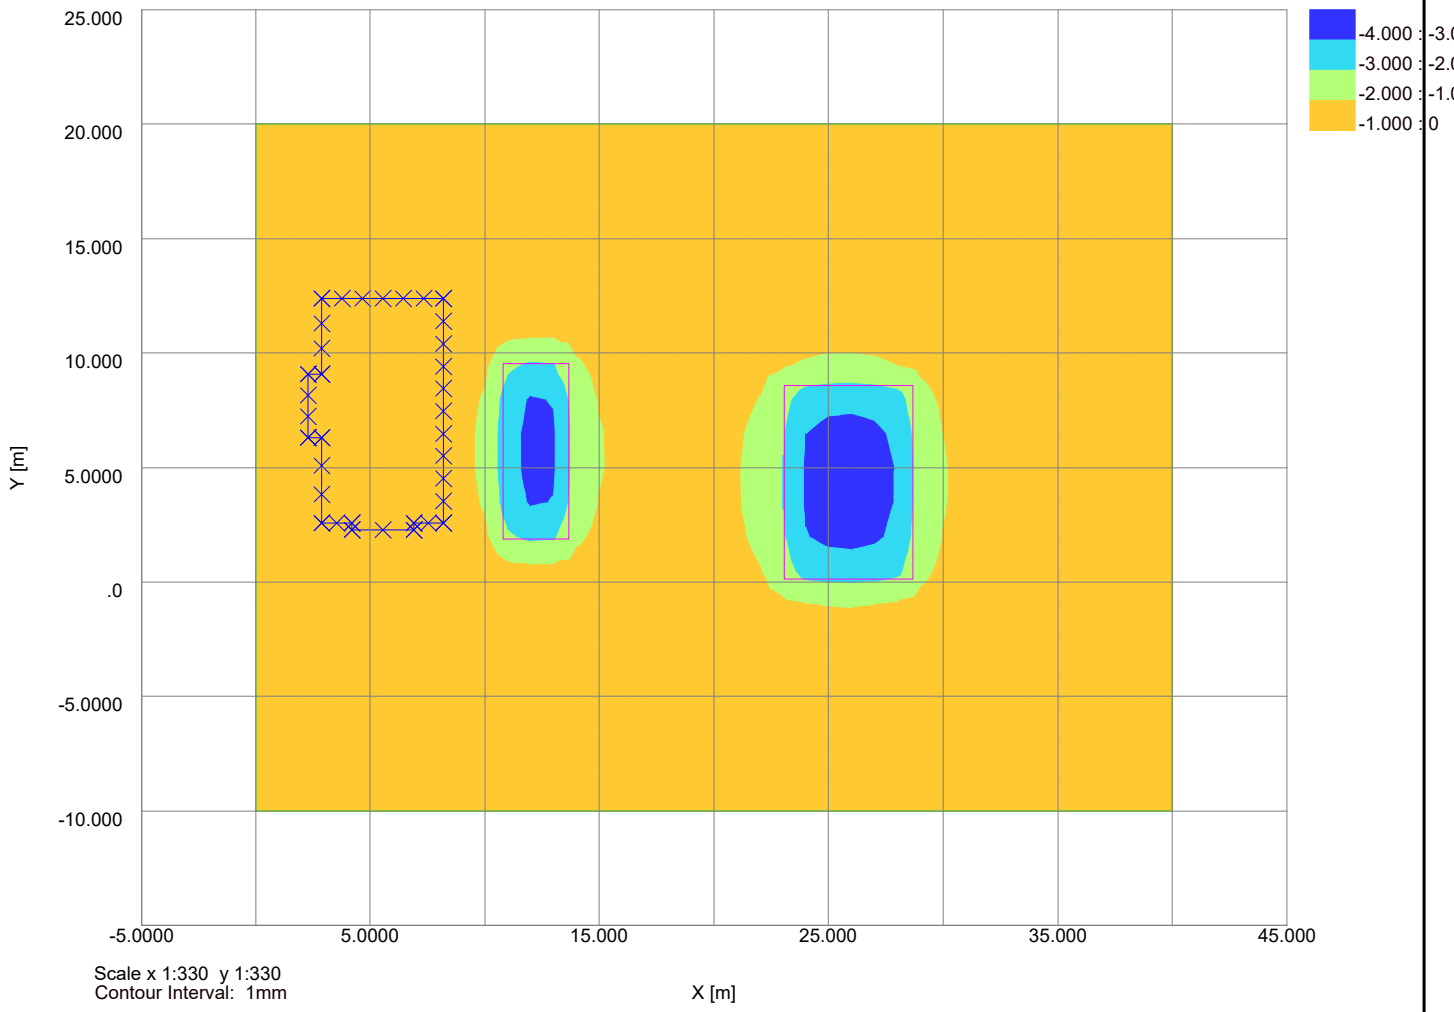
Settlement Contours : Grid 1 at -1.5000m

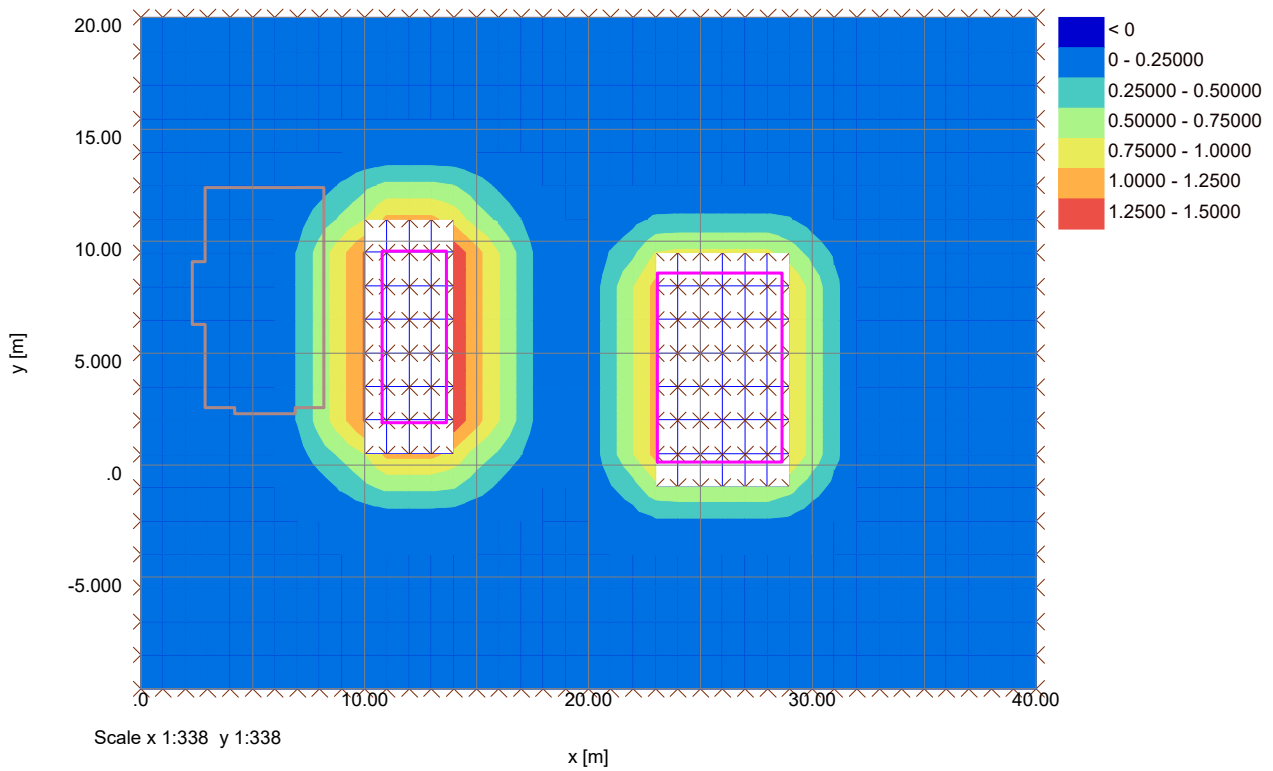
Horizontal Displacement Contours: Grid 1 (level -1.500m) Interval 0.25mm

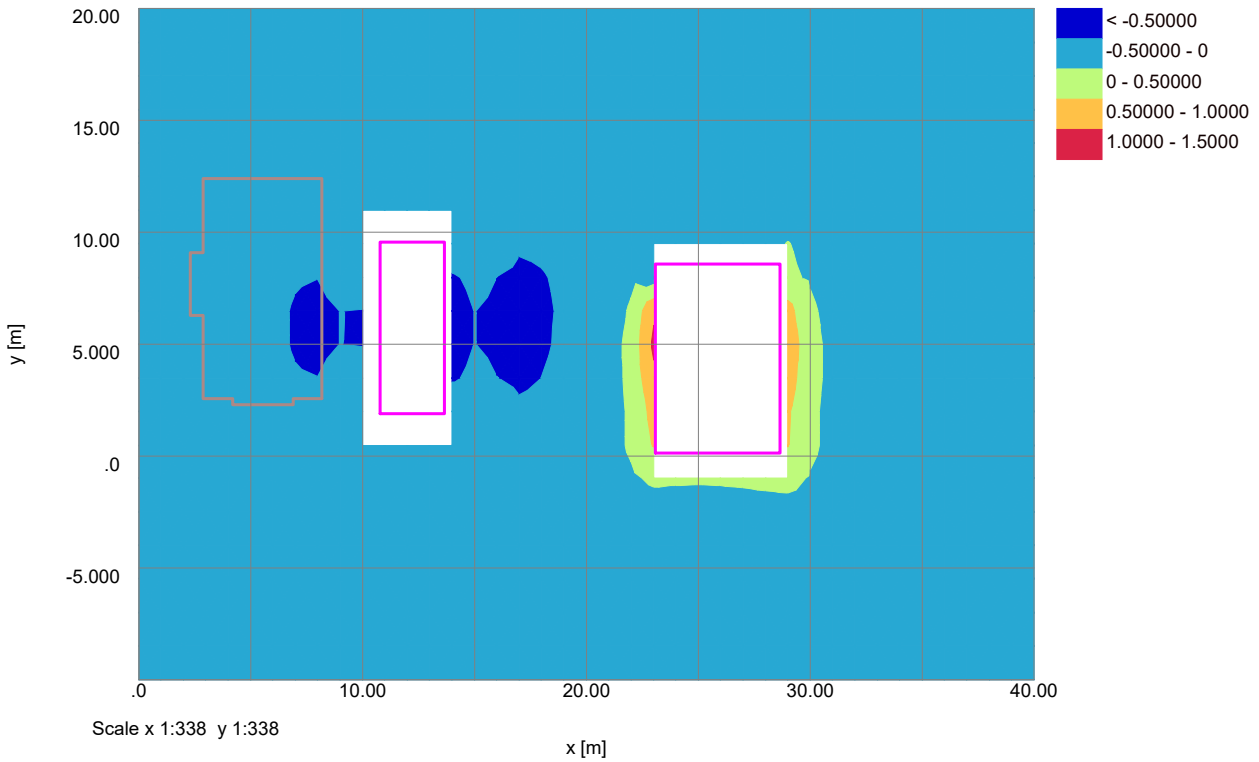
Vertical Settlement Contours: Grid 1 (level -1.500m) (Interval 0.5mm)
