**80 Highgate West Hill
Highgate
London (ex-Middlesex)
NGR: TQ 2818 8716**

**A
Heritage Impact Assessment**

March 2019
Mercian Heritage Series 1356

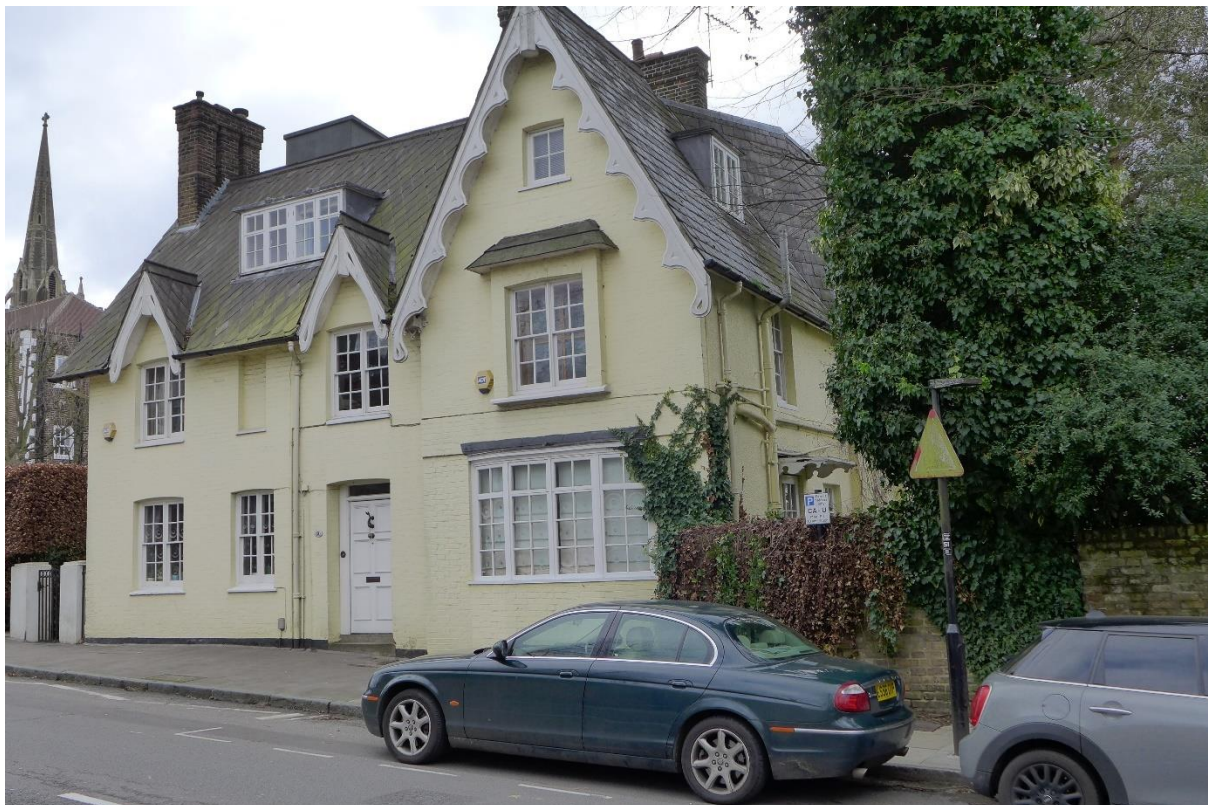
Pl.1: The house from the north-west, with the spire of St. Michael’s church to the left.

On the north side, the ‘hall’ section is still of three bays but the fenestration has been altered. There was originally a central doorway beneath a projecting canopy; these have been removed and there is now a window in the upper blocking of the original doorway. Above, the blind window on the first floor always seems to have been blind.

The main distinction now between the window in the former central doorway and those to either side is in the fact that it is narrower, though the two-light balanced multi-paned sash echoes that of the other windows. All of the openings in this section, except the blind central first-floor window, have plain brick flat arched heads, and the windows have projecting sills.

At ground-floor level, the present entrance doorway is to the right of centre; this has been inserted into the position of one of the original windows and the relatively modern door is actually too narrow for the openings – and so has rather wide jambs. The two upper sashes are set within raised brick dormers protected by boldly moulded timber bargeboards. Between these, in the roof slope, is a slightly utilitarian and obviously inserted flat-roofed boxed dormer lighting the attic.

To the right, or west, the north gable end of the ‘cross-wing’ has a shallowly canted almost full-width bay window on the ground-floor level; this has been remodelled and the window itself is relatively modern – but it retains some of the spirit of that shown on the late-19th century engraving.

Above, the first-floor window is set in a slightly projection beneath a shallow hipped lean-to canopy. It has the same double sash as the windows in the main section, though this would presumably have replaced an original taking-in door to the stores. Above is a small window lighting the top of the attic. This cross-wing gable is enriched with ornately cusped timber barge-boards and a finial.

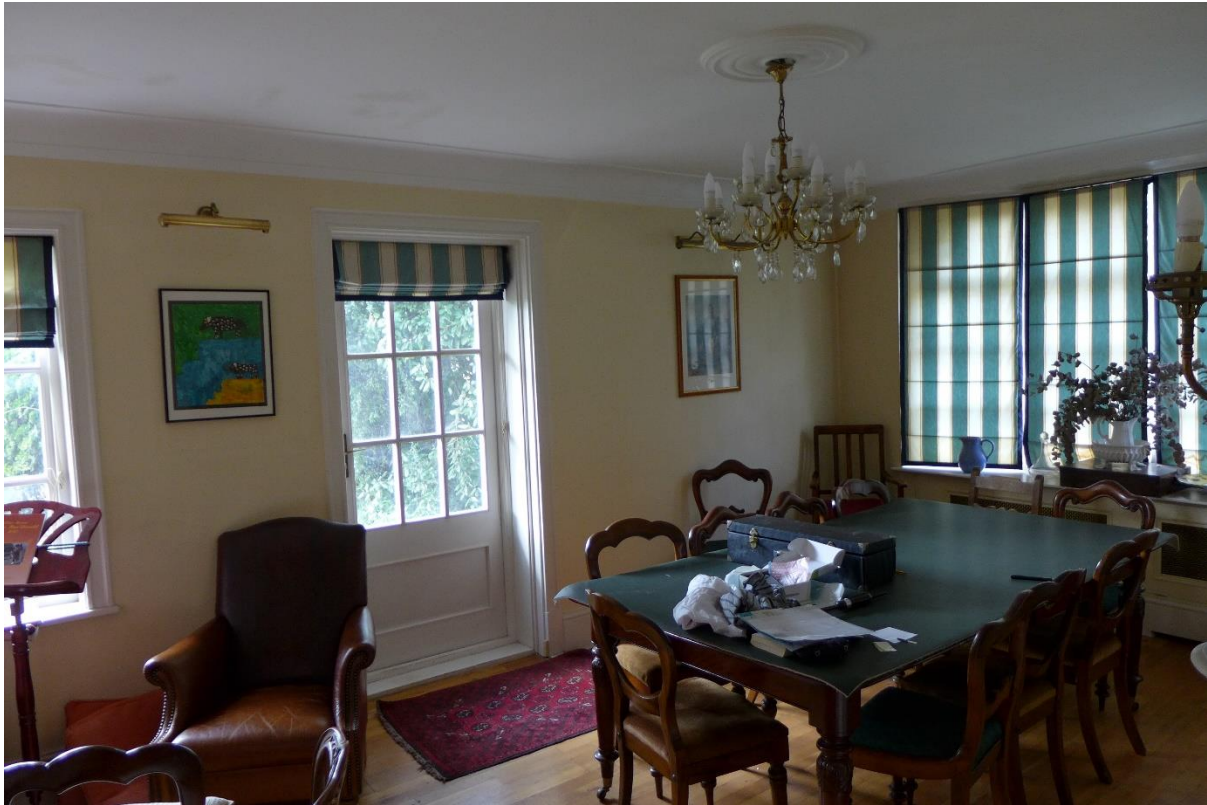
Pl.6: The former office and showroom, converted to domestic use in the 20th century.

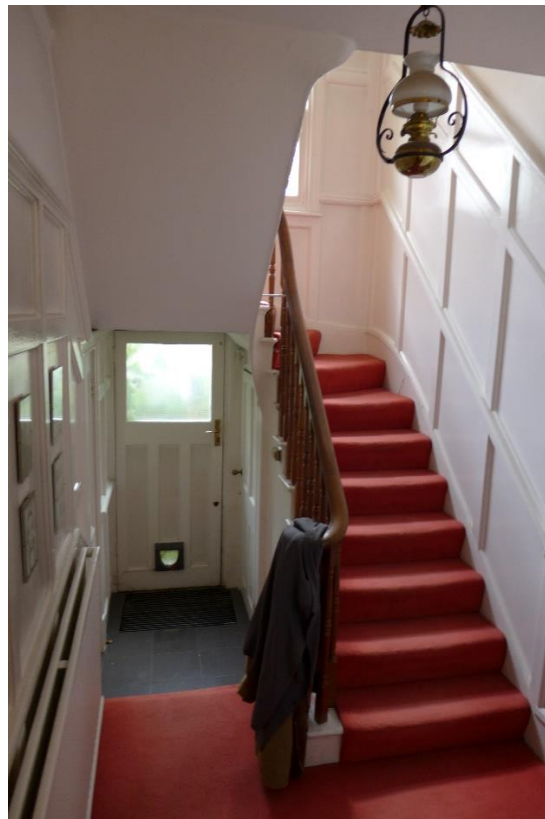
Pl.9: The stairs in the Rear Extension.
