HERITAGE STATEMENT FOR

17 WELL ROAD HAMPSTEAD

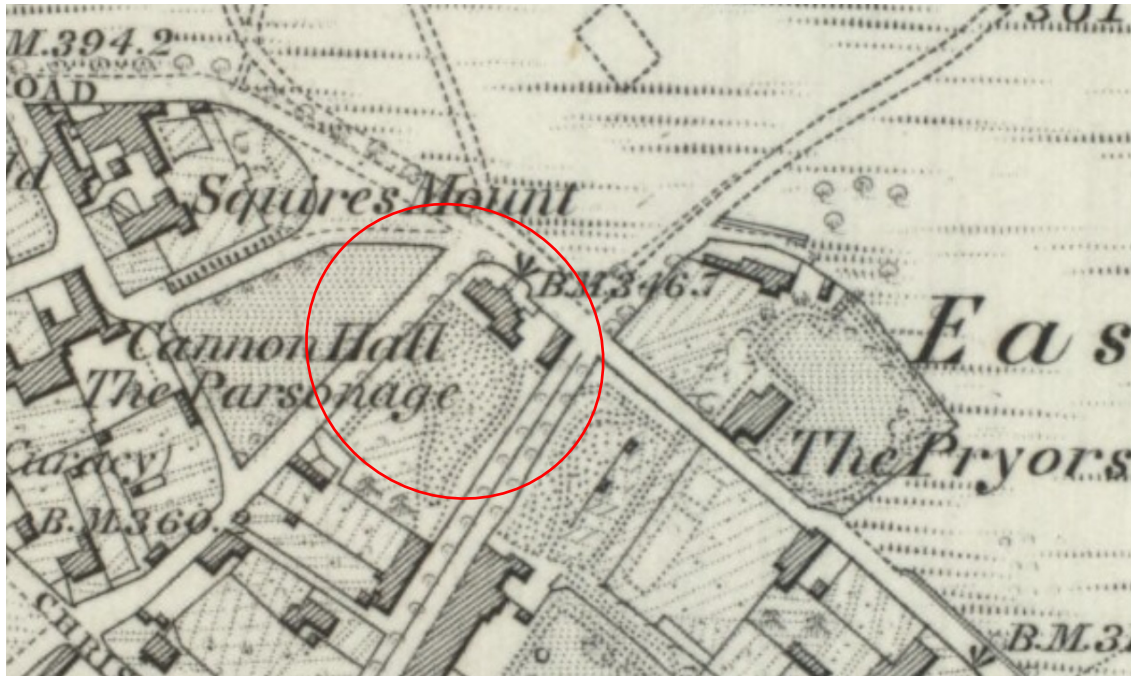
Figure 1 - 1873 OS First Edition Map (surveyed 1864-1865).

Historic maps show that the house was one of the last of a group of substantial houses to be built and it encroached upon a former Green.

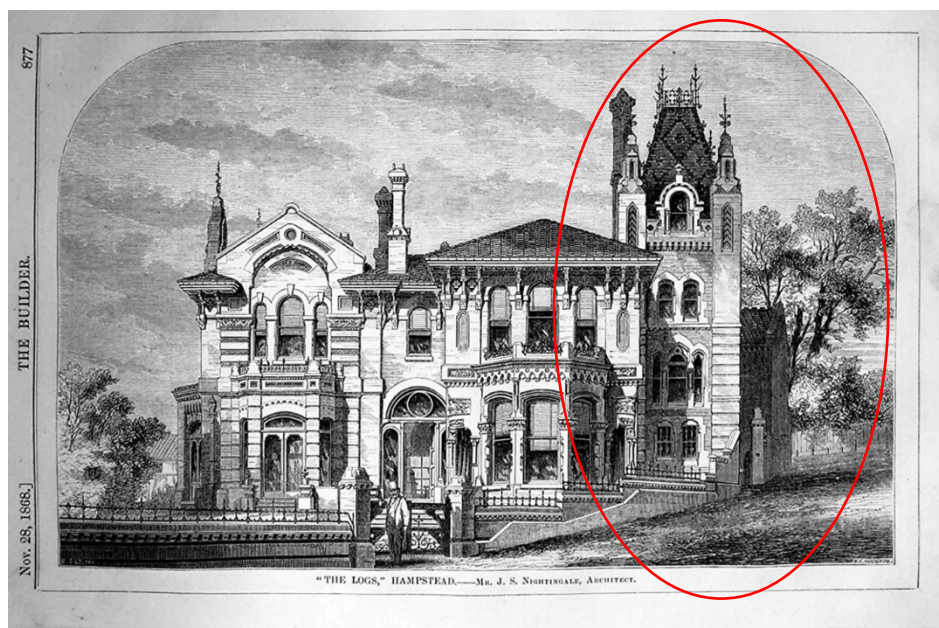
Figure 2 - 1868 Original Entrance Elevation. Number 17 comprises the tower element of the original house.

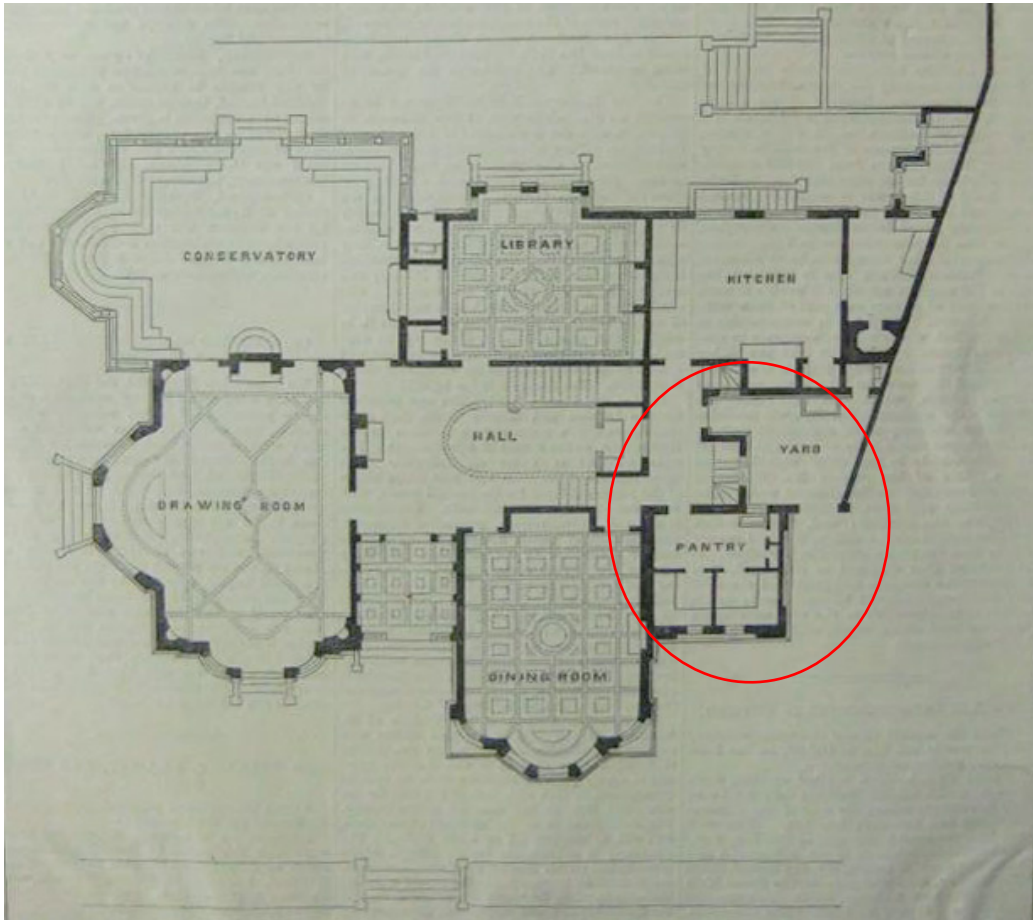
Figure 3 - . 1868 Original Ground Floor Plan and raised Garden platform.

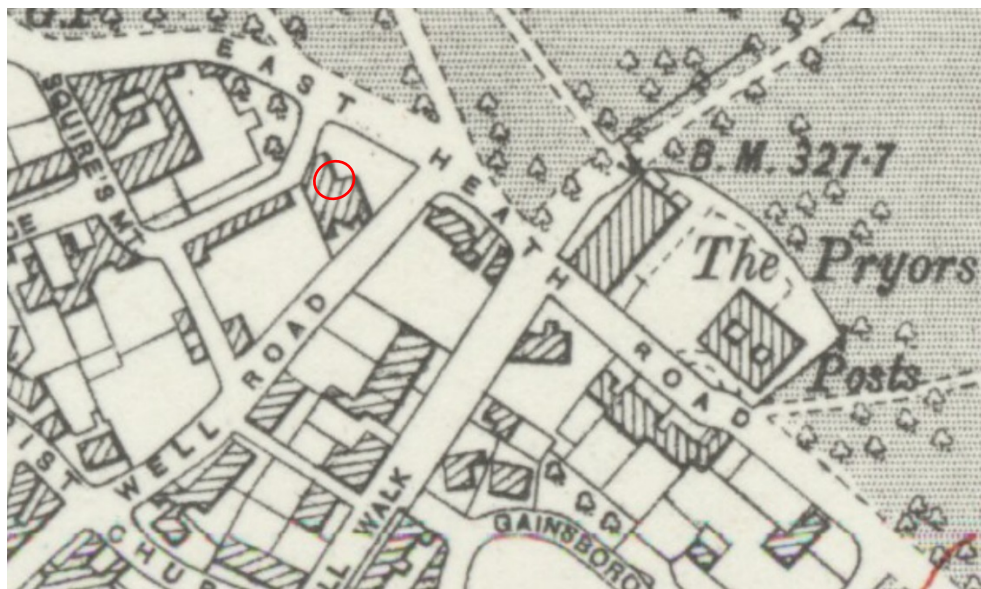
Figure 6 - 1920 Third Edition Ordnance Survey Map, surveyed 1912

Although the outline is simplified, it indicates that Frederic Pusinelli made no changes to the extent of the building.

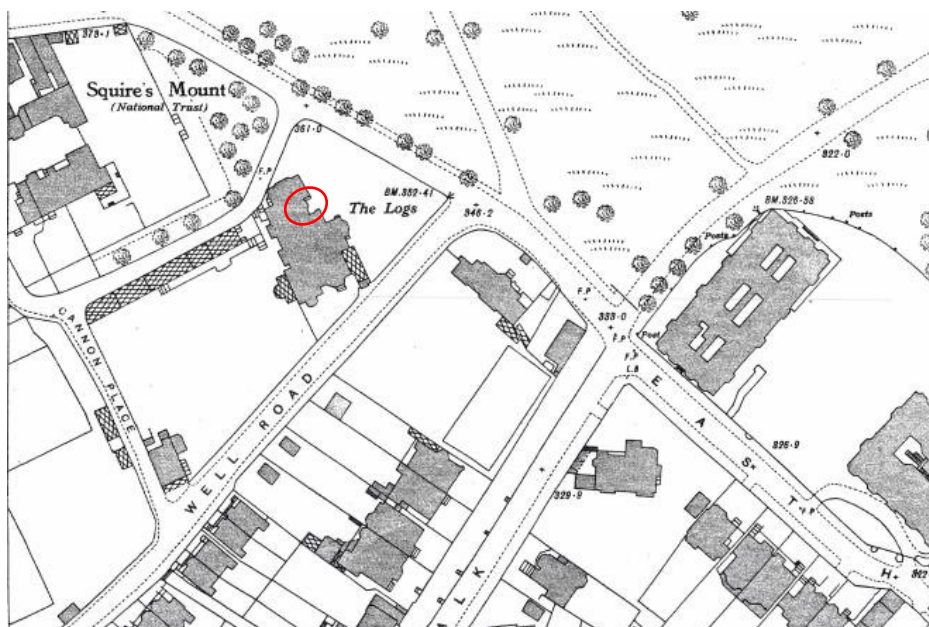
Figure 7 - 1935 Fourth Edition Ordnance Survey Map.

A further Conservatory had been added to the rear of the original Conservatory. The original Conservatory is shown solid rather than with the crosshatching denoting a glazed building. This is

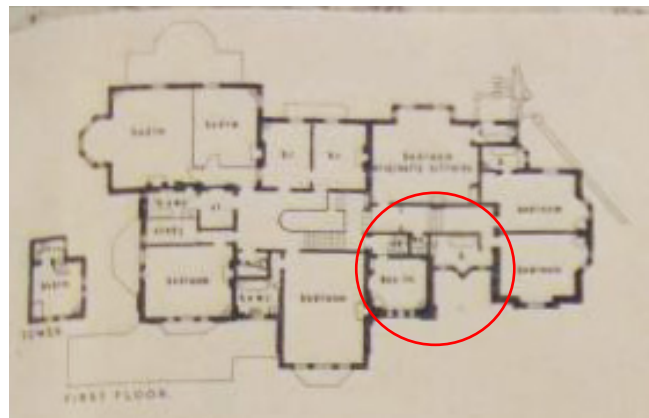
Figure 8 - Circa 1935 First Floor Plan

Figures 8 and 9 are reproduced from an undated article in the RIBA collection, which incorrectly attributes this floor layout to the original design.

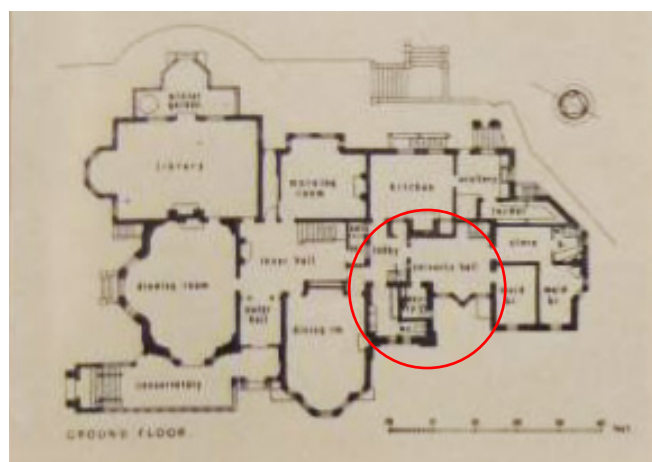
Figure 9 - Circa 1935 Ground Floor Plan.

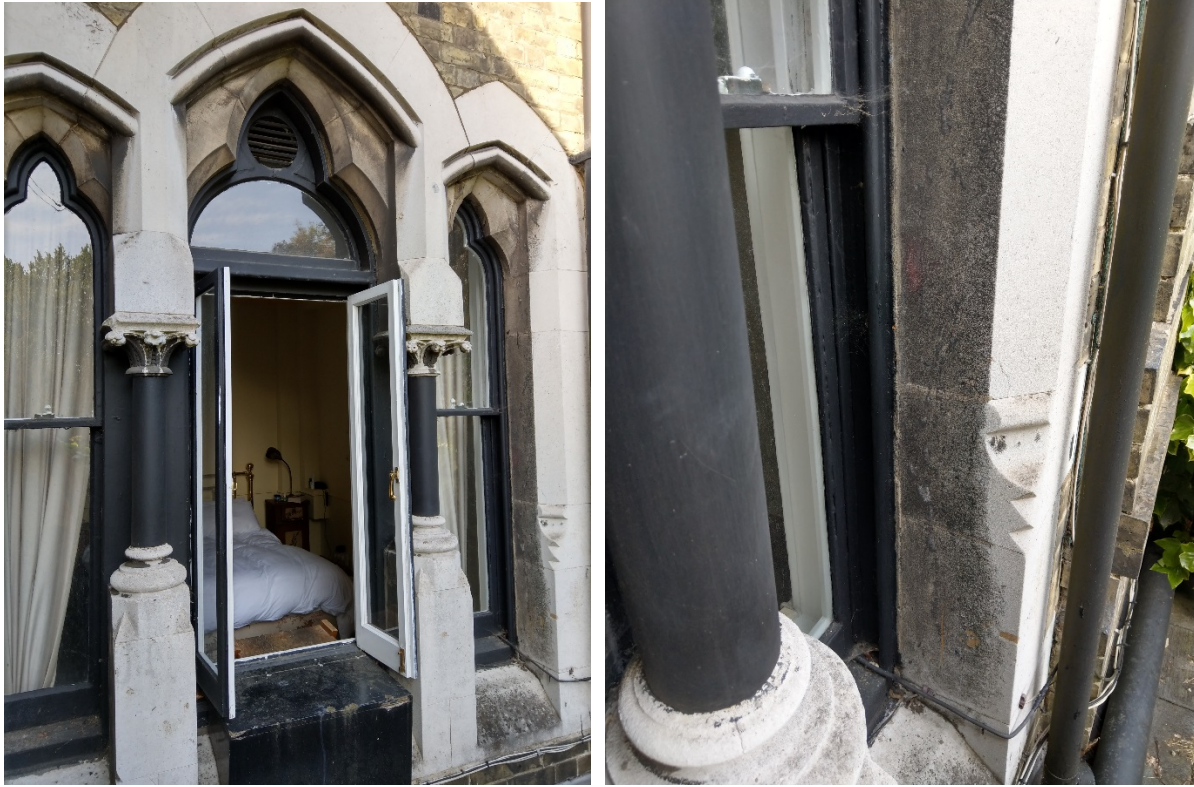
Figure 18 - Proposal - to remove unsympathetic black paint to stone and windows. Stone elements to be restored to original finish below and timber elements to be redecorated in an off-white to match immediately adjacent No.18 Well Road- providing a consistent and coherent front elevation.

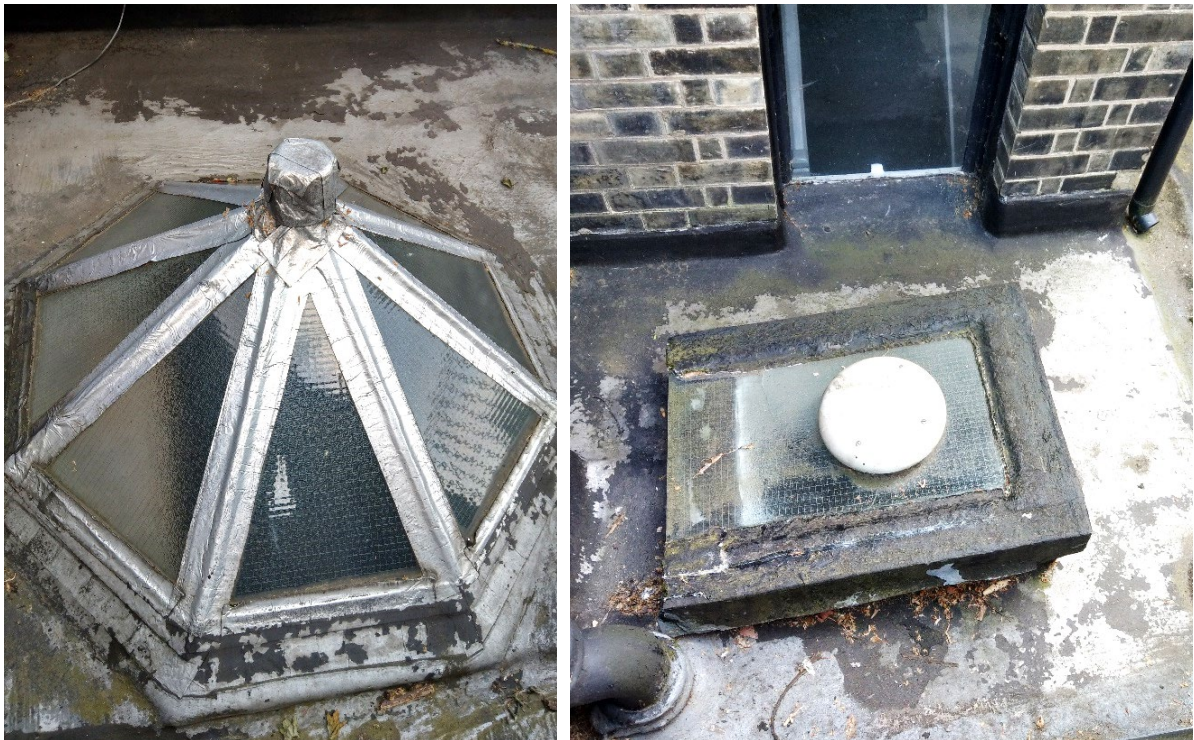
Figure 19 - Modern glazing and flashing to rooflights. LHS image - Proposals - remove modern glazing and Flashband and replace with clear, toughened glass to meet Part K requirements for protection from fall. RHS image - Proposals – rooflight to be removed and roof to be repaired accordingly.

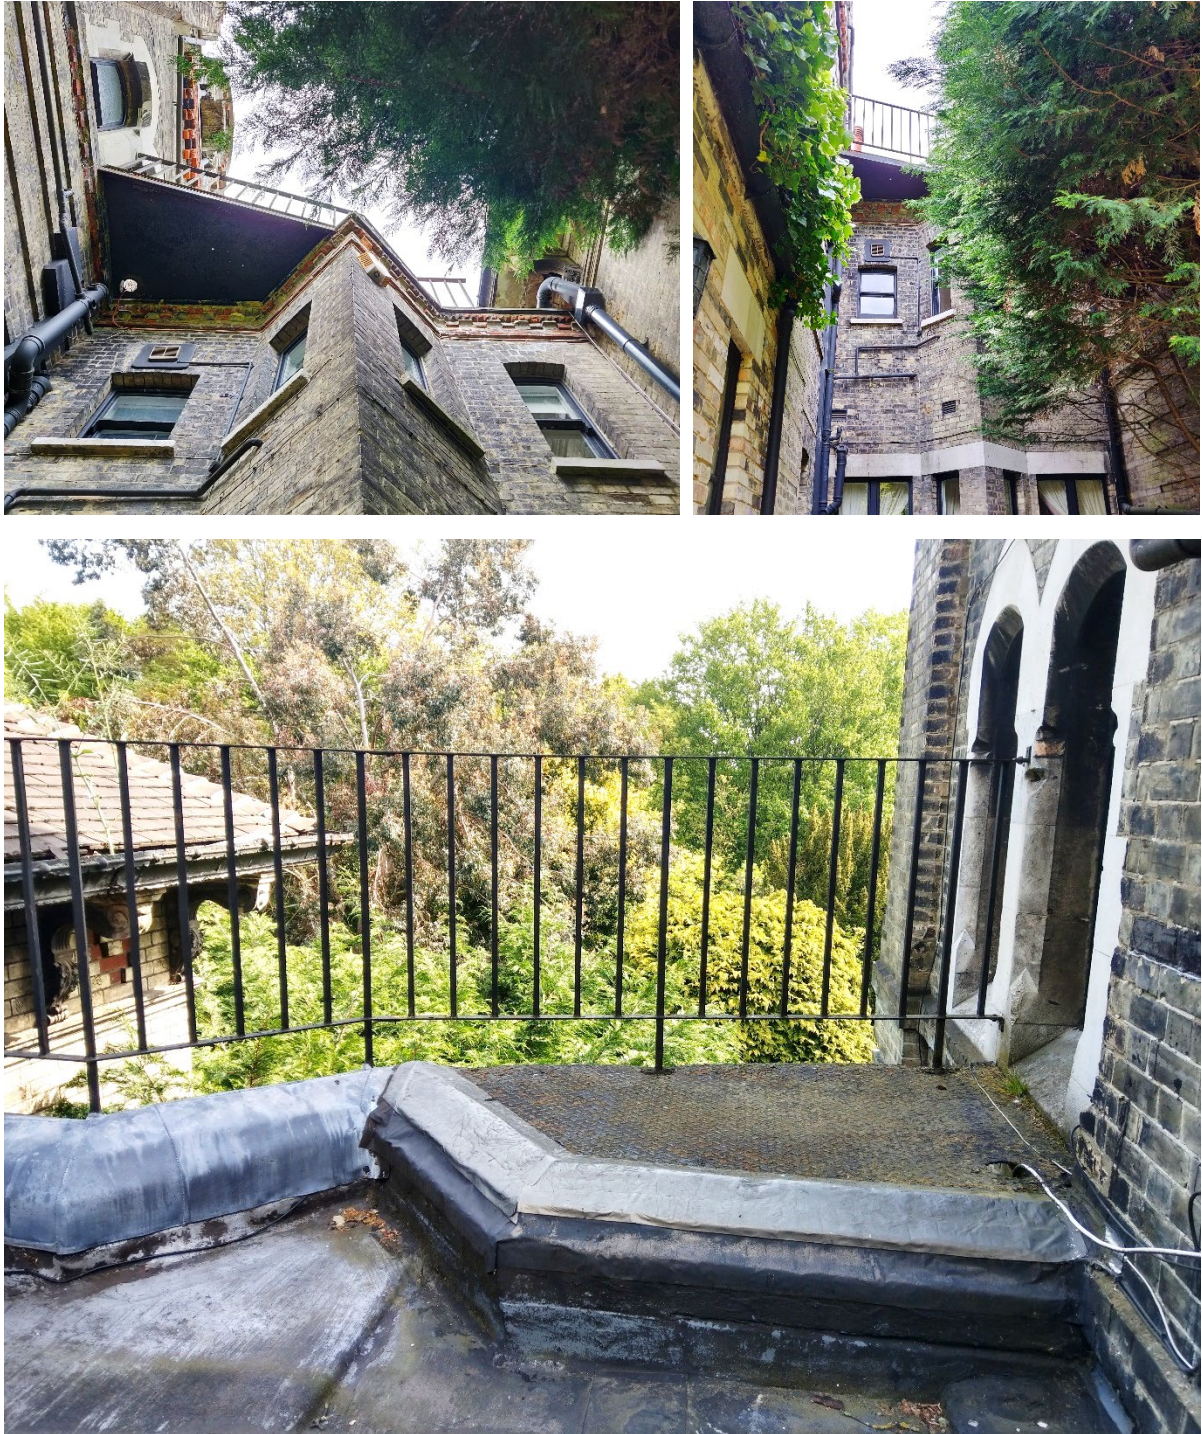
Figure 20 - View of existing roof terrace access - a metal landing bridges across from a tower window onto the roof terrace, with railings fixed into the top of the parapet. Proposal – remove unsympathetic bridge and metal balustrading. Provide alternative roof and maintenance access from the rear of the tower, where it will be concealed from view. Replace balustrading with a more sympathetic design that will not detract from the front elevation, set at the lower level of the roof terrace.

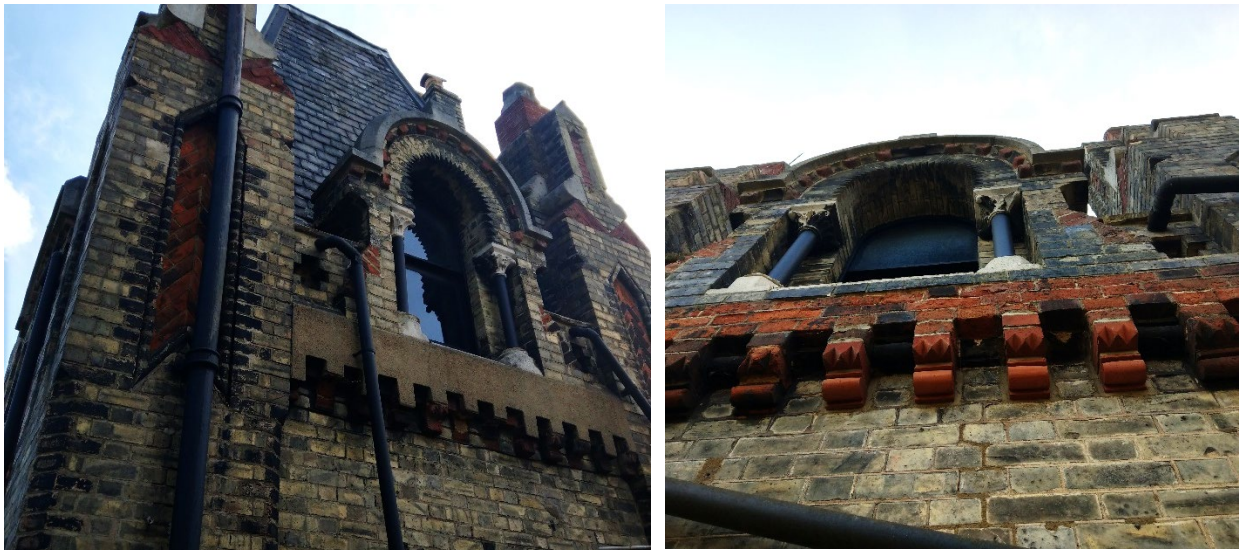
Figure 21 – LHS image shows unsympathetic cementitious render to rear elevation tower detailing. RHS shows original detailing to side elevation. Proposals – Brickwork to be repaired by specialist masonry conservator to match original detailing like for like.

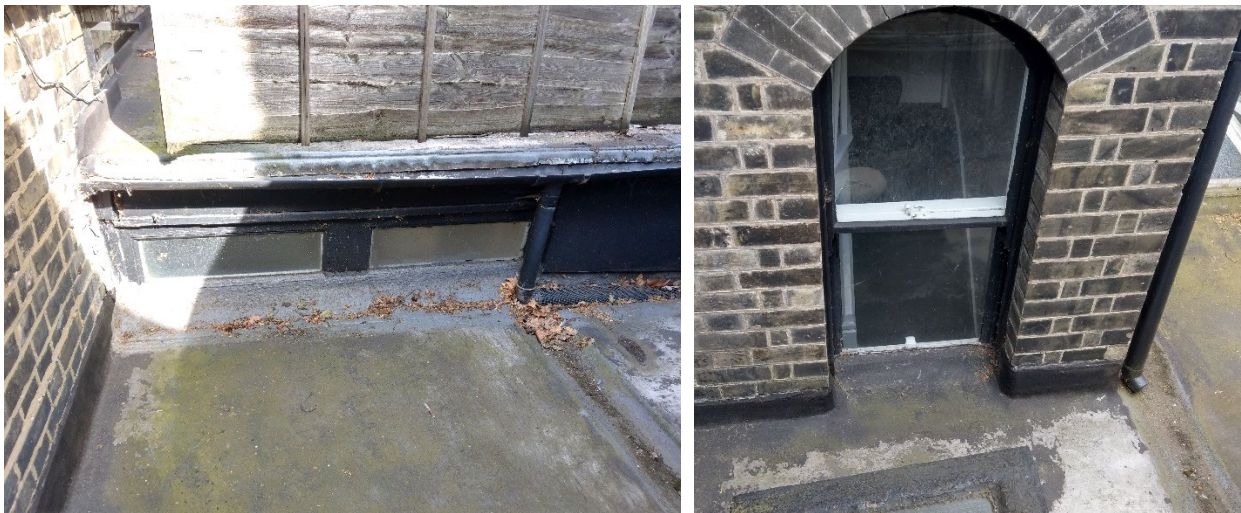
Figure 22 - Poor roof to glass detailing. Proposals - review roof waterproofing upstands and replace modern glazing with clear Part K compliant glazing to protect against fall. Window in RHS image – Proposals to raise opening to provide new access to roof and improve waterproofing junction.

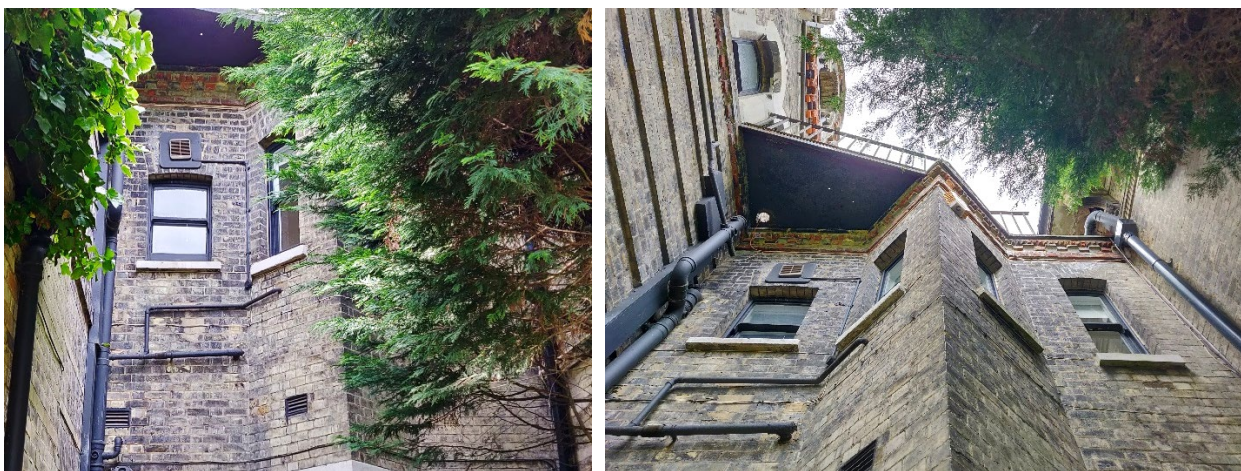
Figure 23 - First floor LHS window was reduced in size in 1950s for bathroom, to install vent above and bath at cill height. Proposal - remove vent and reinstate original window size to match other windows in the window group.

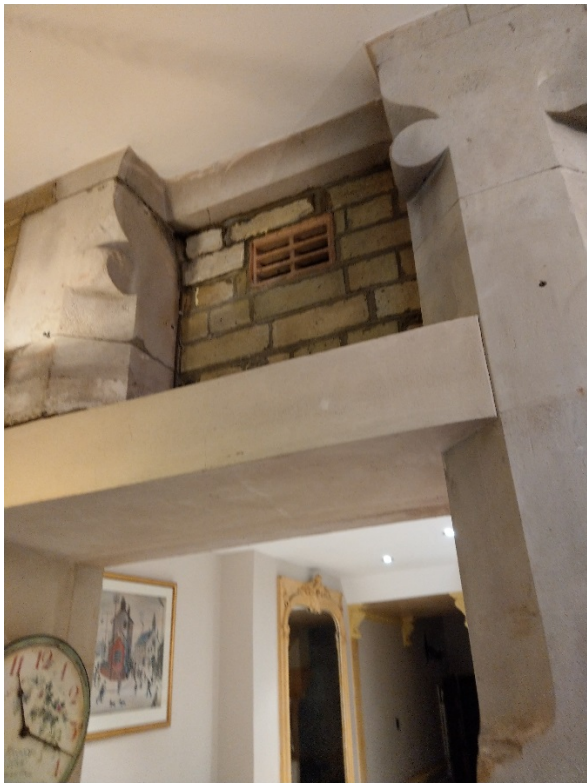
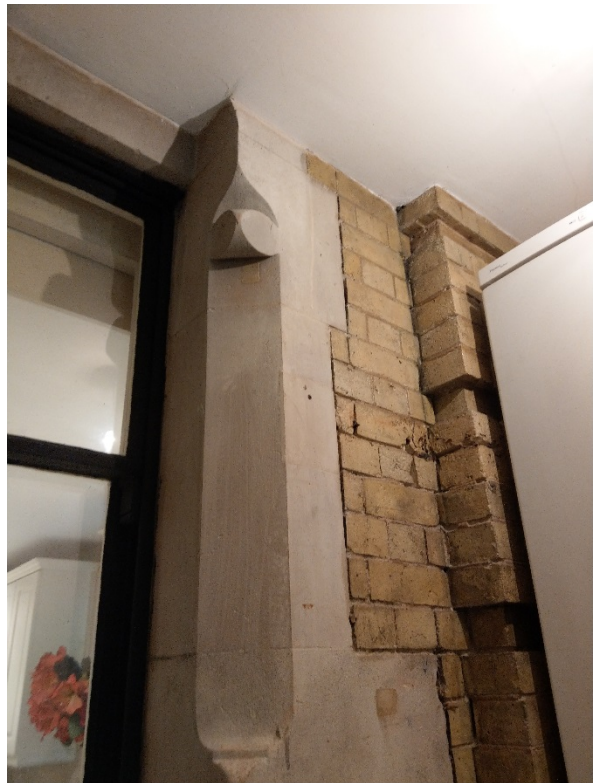
Figure 24 - Ground Floor - original window openings and external brickwork wall remain visible within 1980s porch extension, albeit modified to create a new front door during 1950s subdivision. Note the ceiling down-stand against the window in the RHS image.

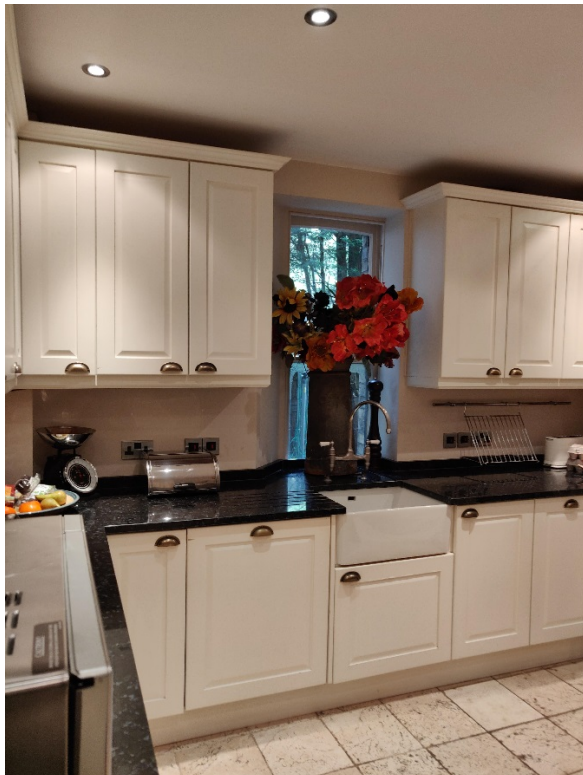
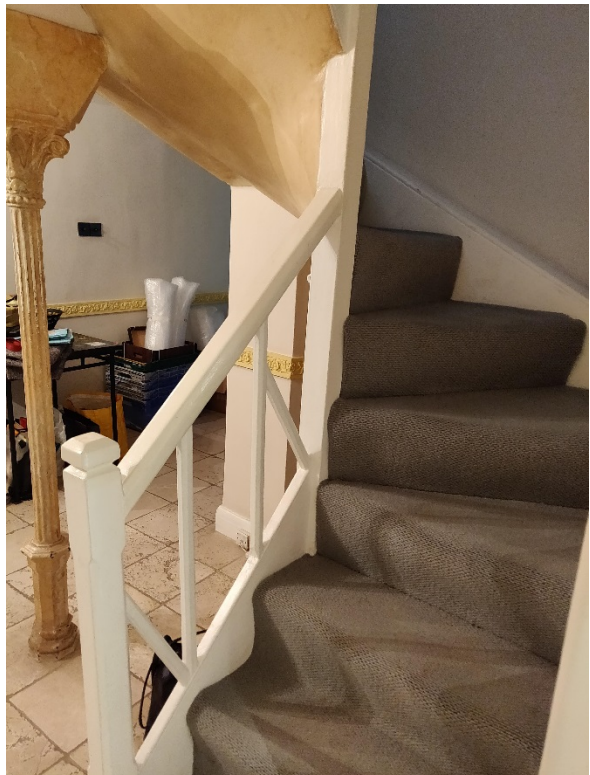
Figure 25 - Modern finishes throughout ground floor. 1876 Staircase and handrail retained.

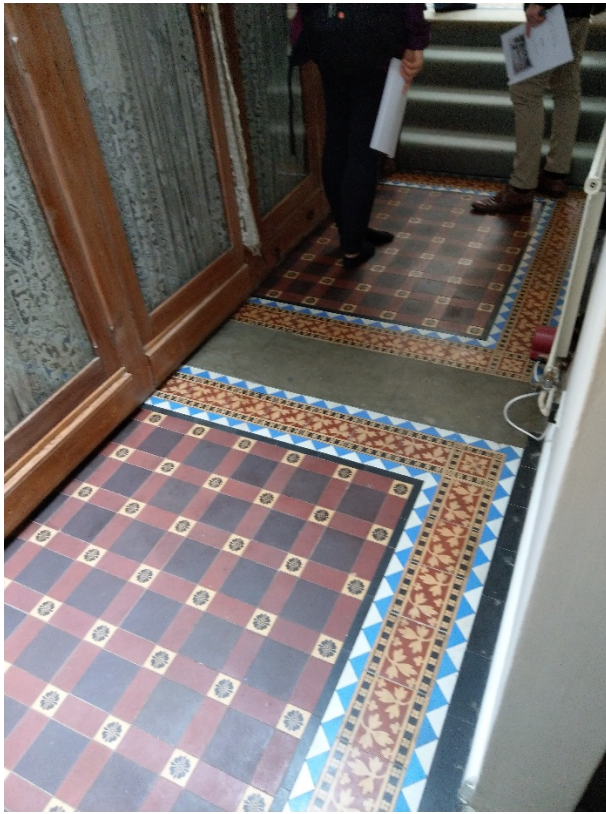
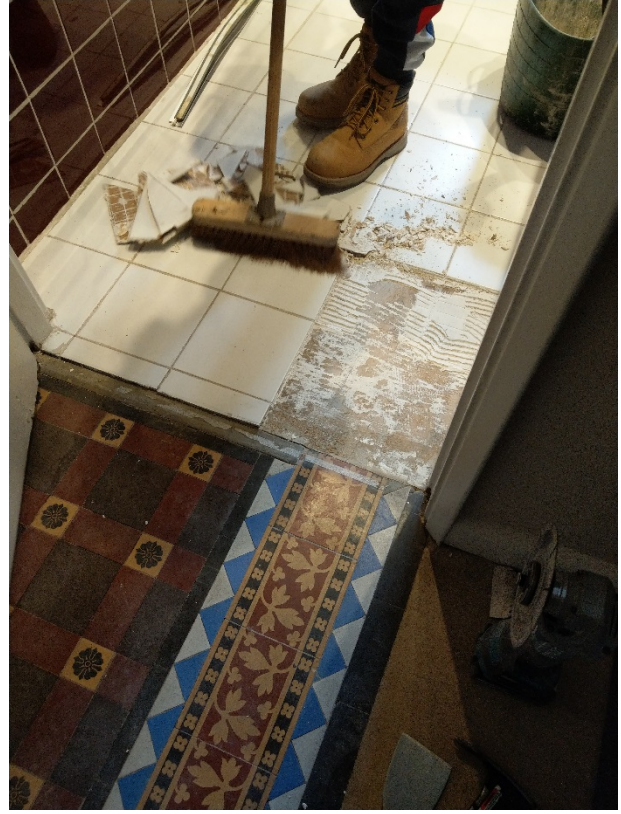
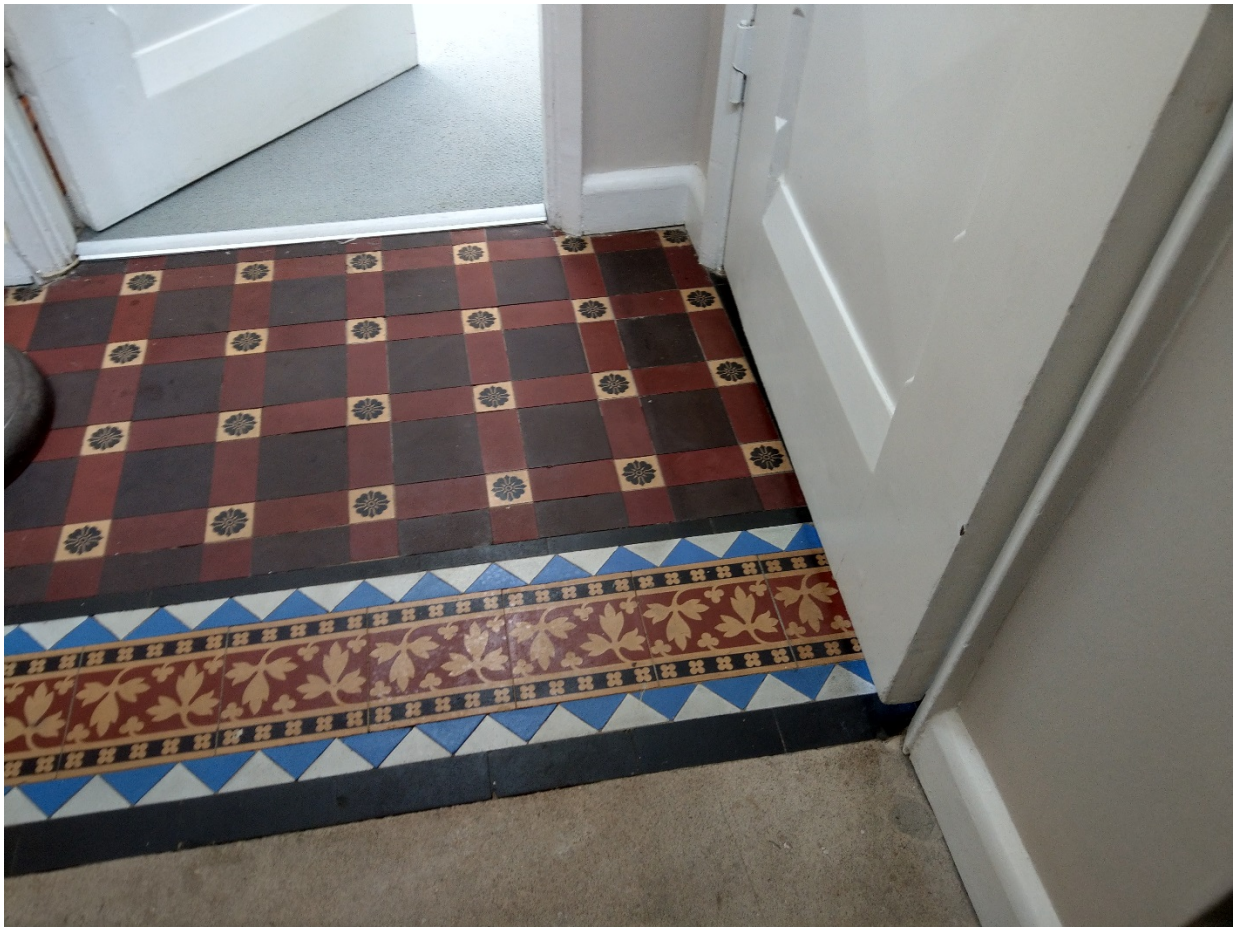
Figure 26 – Mezzanine landing - original Minton tiles retained, albeit opening up works show that these were unfortunately cut at the line of the bathroom and bedroom partitions, when they were created in the 1950s.

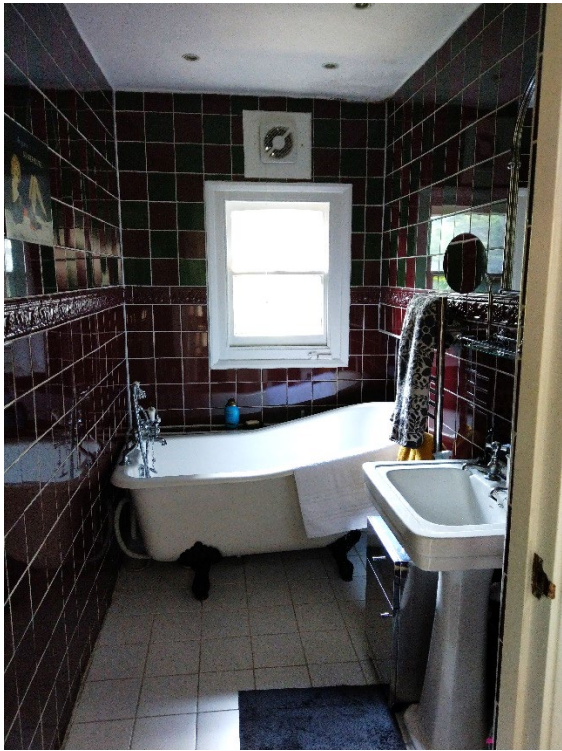
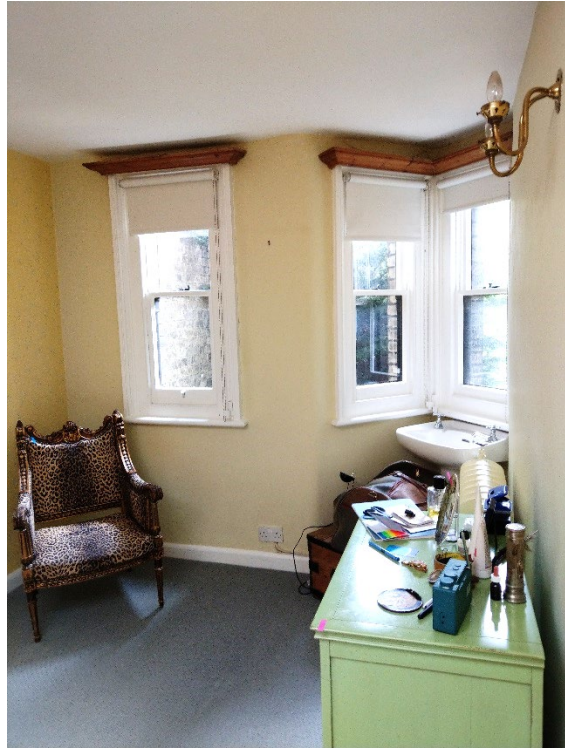
Figure 27 - Bathroom and Bedroom 2. Originally these would have been one room off the circulation corridor between the main staircase and the North Wing, these rooms were formed in the 1950 subdivision and the Minton tiles have been removed within these spaces. Original doors have been reused in modern frames, but no other internal finishes have been retained. The window was modified in the bathroom to create a smaller unit with space for an extract above. Proposals are for this to be reinstated, to match the other windows in the group.

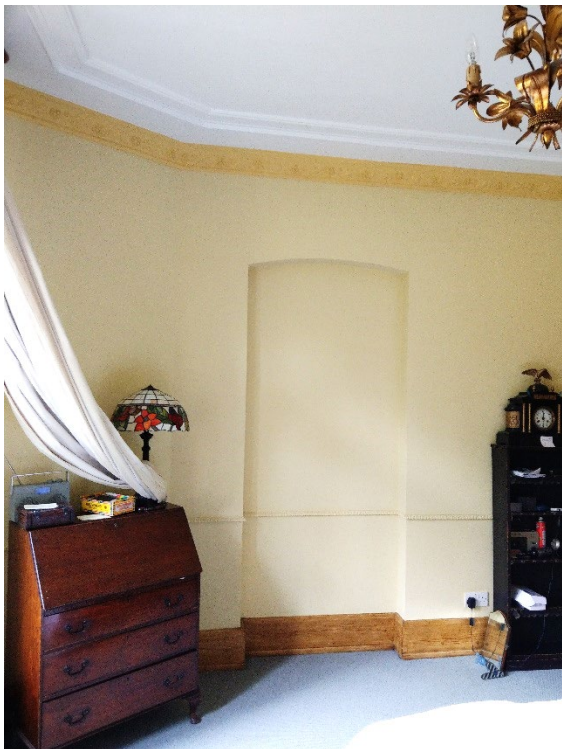
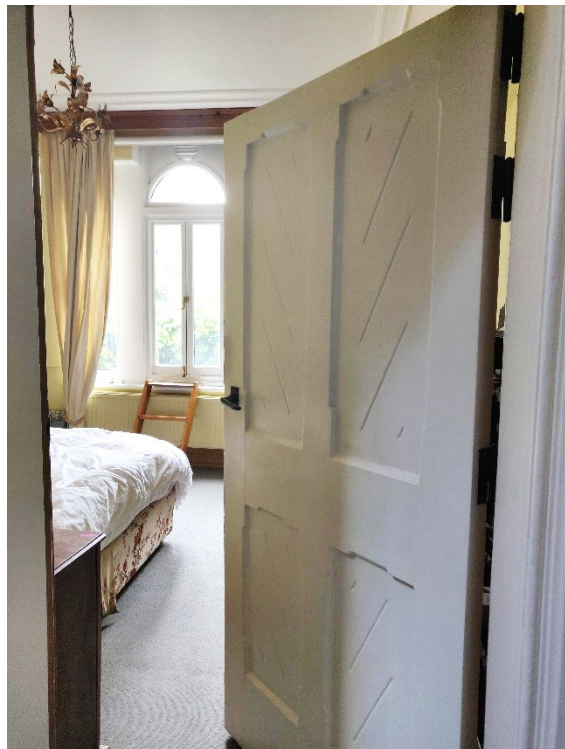
Figure 28 - Bedroom 1 - Original door, skirting and ceiling profile. Modern grape cornice.

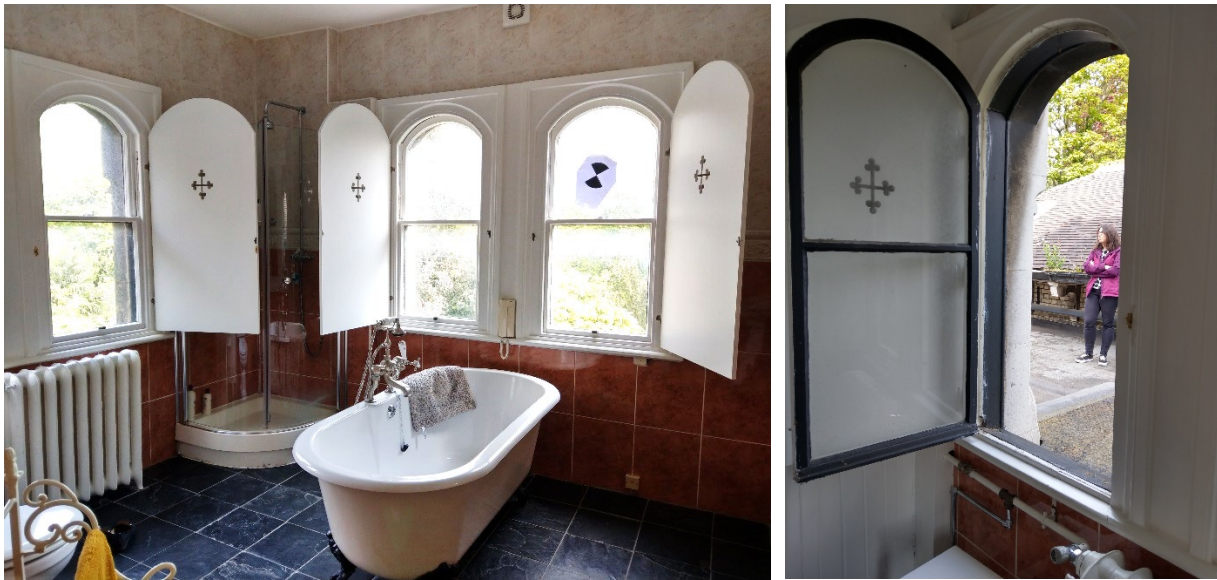
Figure 29 - Bathroom, with access to roof terrace via a window and metal bridge. Modern window shutters, finishes and ply flooring below tiles.

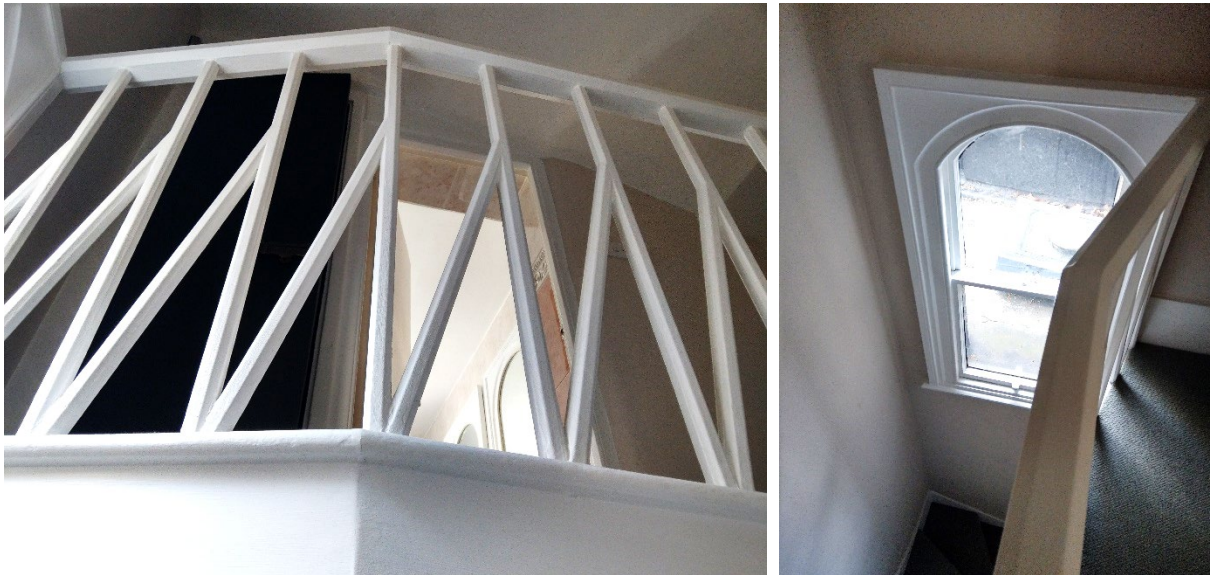
Figure 30 - Landing - 1876 Balustrade. Awkward junction between landing window (original) and 1876 extension roof. Poor waterproofing detail, with roof line hitting the glass above the window frame and cill. Window is concealed from all view except the roof terrace. This is the proposed location for the new roof maintenance access. Proposals – raise window opening and modify landing to provide door. Raising the opening will also improve the waterproofing detail on the roof side, with sufficient upstand to protect the brickwork and window from moisture damage.

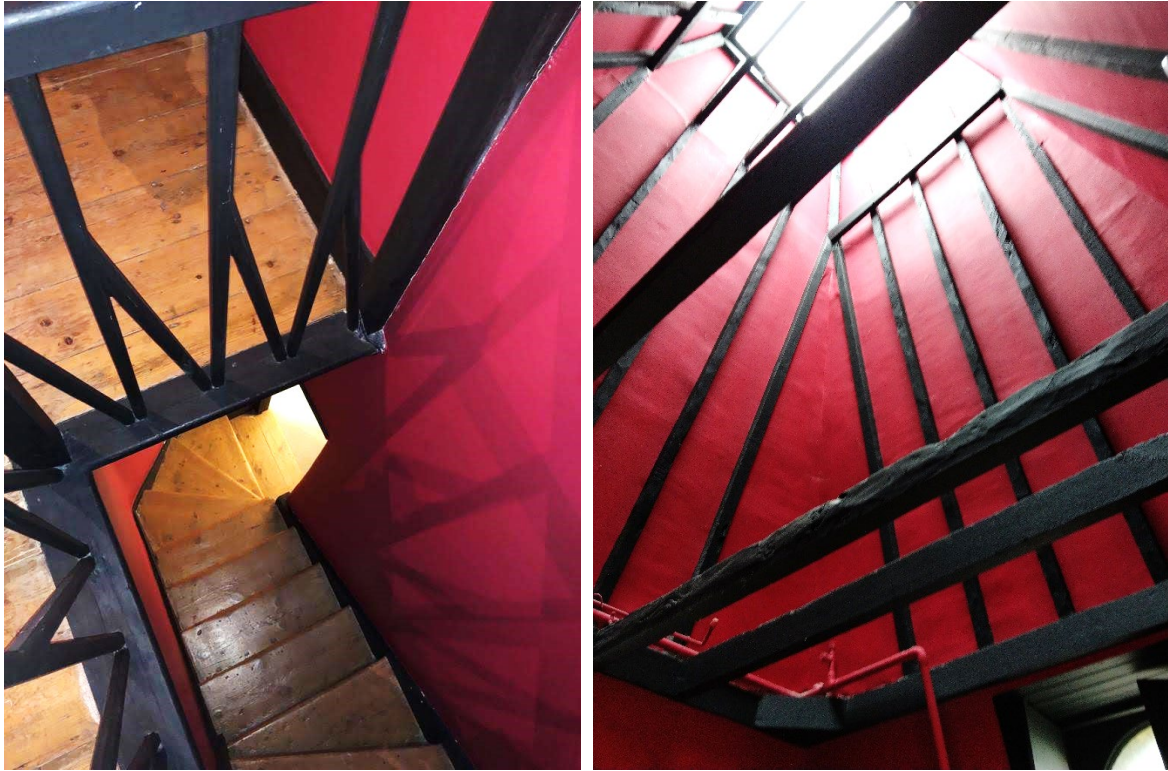
Figure 31 - Attic room and stair - Original staircase and timbers. Evidence of a previous mezzanine within the space (and ladder access notches). Modern rooflight at top of tower.
