Project: 10 Glenmore Road, London, NW3 4DB

Title: Basement Impact Assessment

Rep no: 19029.R01.P2

STRUCTURE WORKSHOP

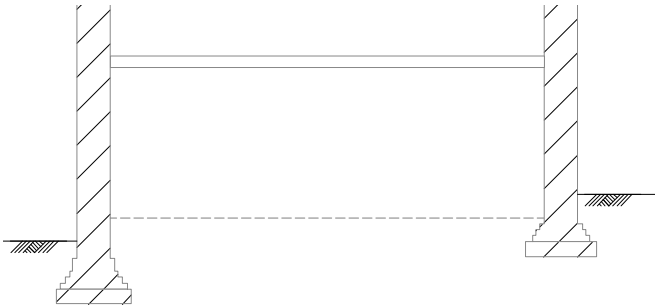
1. Existing arrangement

project	10 Glenmore Road	scale	NTS
drawn	WW	appr.	SR
title	Construction Sequence Plans	dep. no.	19029.601
rev.	P2

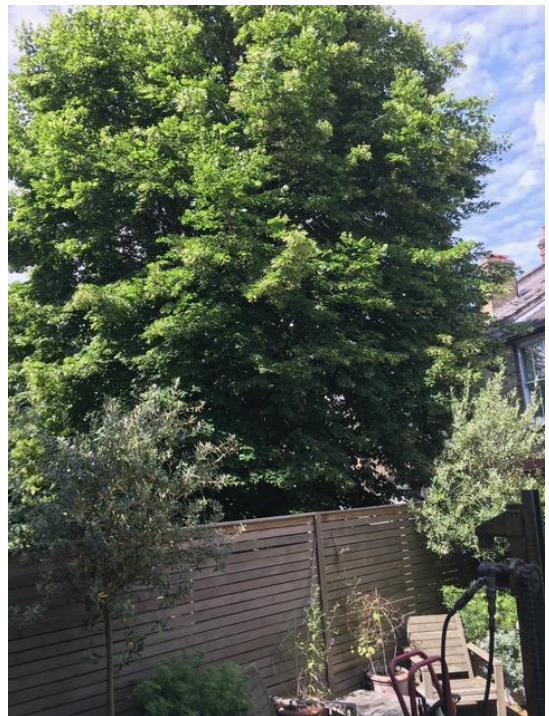
In addition to this, a single window sample borehole was drilled to the rear of the building using a light weight, restricted access, Competitor Window Sampling drilling rig with the borehole drilled within the rear garden. The borehole was progressed by the hammer drilling of 1m long steels cutting tubes within which are held a 1m long clear plastic liner which collects undisturbed samples. The diameter of the cutting tube is reduced regularly to allow for drilling to depths. This borehole was drilled to a depth of 5.00m where an impenetrable claystone layer prevented any further progress. Within the deep borehole a water monitoring standpipe was installed within the borehole at a depth of 5.00m.

Insitu strength testing was conducted within the borehole using the dynamic probe test which was set up to use the same drop weight and height as the Standard Penetration Testing (SPT). This test comprises the recording of the number of blows taken to drive a steel cone into the soil from the drop of a 63.5kg hammer of a distance of 760mm. For the dynamic probe test blow counts are taken at 100mm intervals throughout. To determine the SPT N Value, three of these increments are added together. To convert into an estimated shear strength a factor of 6.5 is used. The findings of the borehole drilling is discussed within Chapter 6.0 and held as a borehole log within Appendix 3. The location of the borehole is marked on the site plan within Appendix 1.

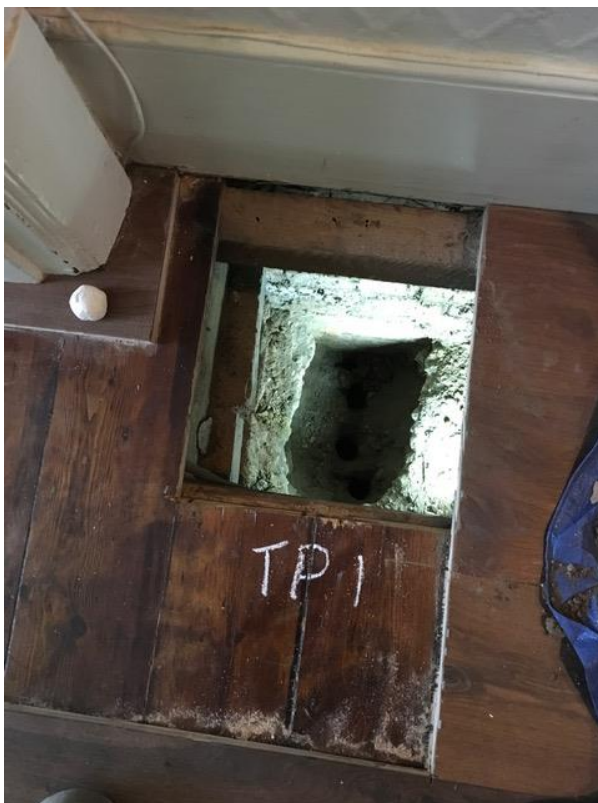
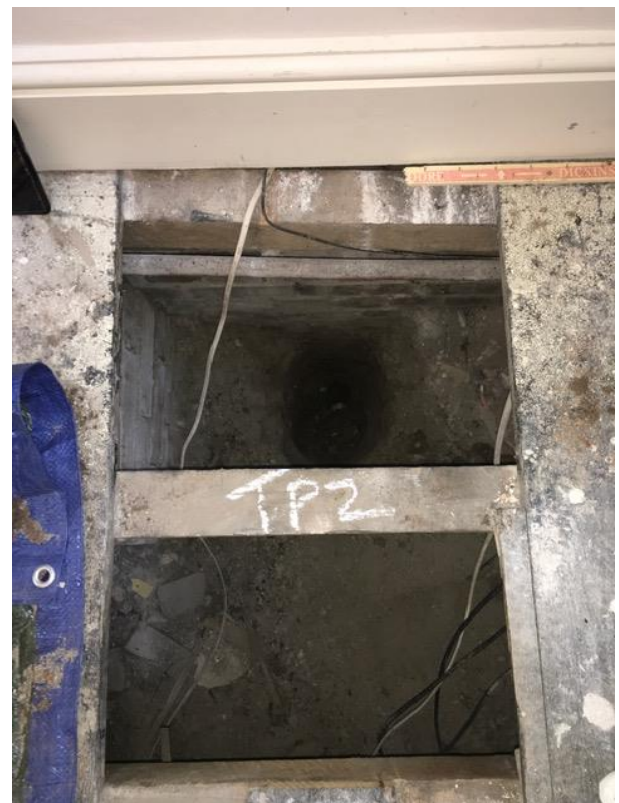
Trial pit 2 was excavated internally on the left hand party wall and exposed the party wall foundation (A-A) and the small internal return wall (B-B). The party wall foundation (A-A) comprised brickwork which extended to 1.50m (proved by full excavation) and then continued to a depth in excess of 2.00m (proved by probing). Unfortunately, due to the depth of the foundation and the collapse of trial pit sides, it was not possible to expose or locate by probing the extent of the projection or the base of the foundation.

The internal return wall foundation comprised brickwork which appeared to follow the party wall foundation with the brickwork continuing below 1.85m where a possible step out of the brickwork was present, although this was difficult to determine accurately due to the depths involved and collapse of the excavations.

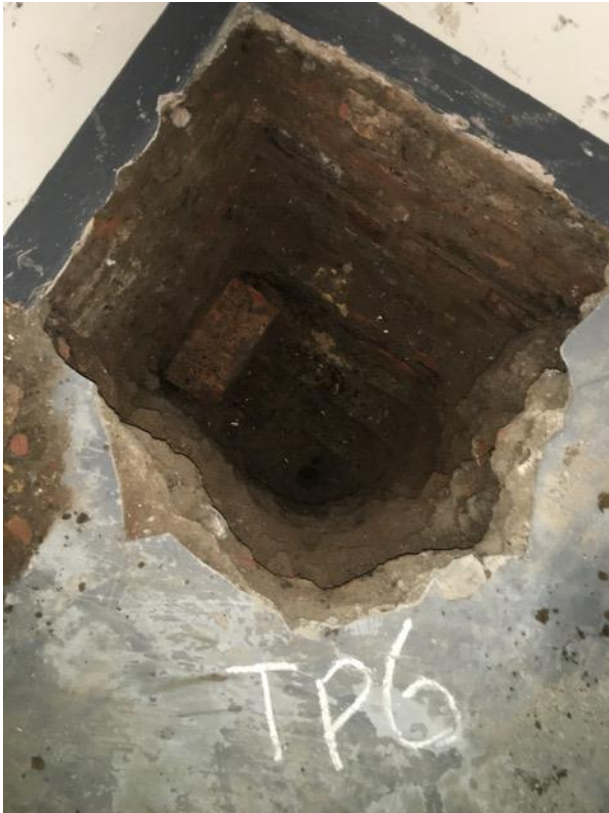
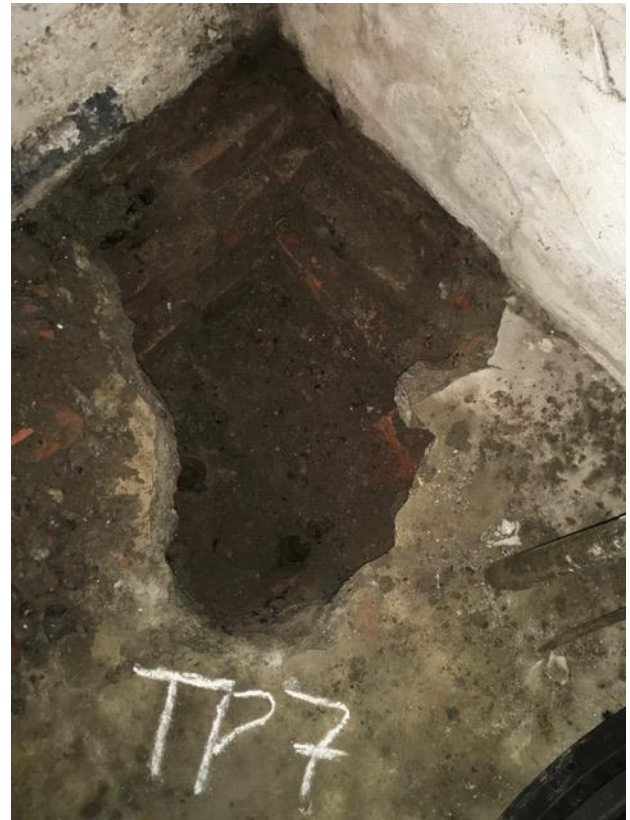
Trial pit 7 was excavated in the front right hand corner of the basement to the property and exposed the foundations to the front wall (A-A) and the right hand flank wall (B-B). The front wall foundation (A-A) comprised brickwork with two step outs onto a concrete strip. The total projection of this foundation was 380mm with the concrete 270mm thick and the foundation seated at a depth of 0.565m below the basement level. The foundation was seated onto soft, low strength (V: 34-38kPa), orange brown, silty CLAY.

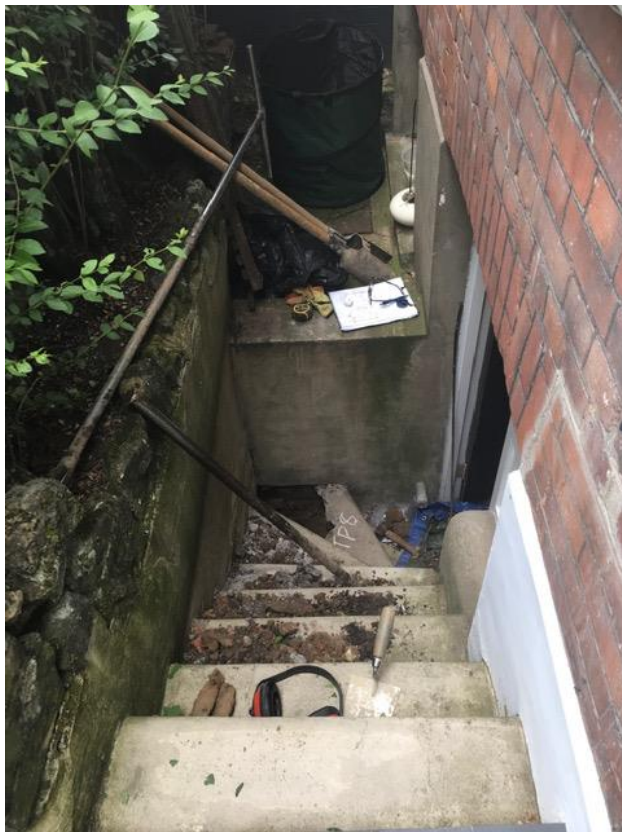
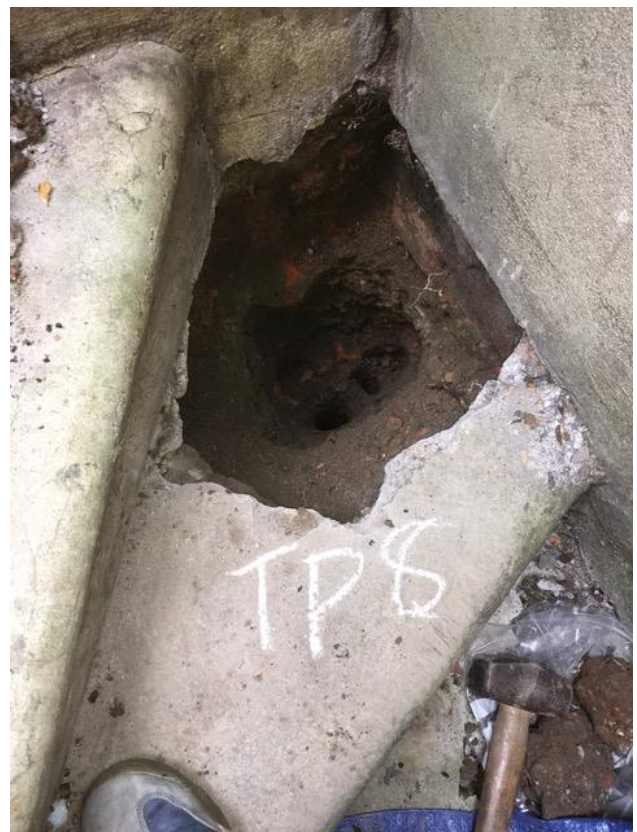
Trial pit 8 was excavated in the front lightwell and exposed the foundations to the rear wall to the lightwell structure (A-A) and a return wall at the bottom of the lightwell (B-B). The rear wall to the lightwell comprised brickwork with a single step out (projection 60mm) onto a weak concrete and brick footing which was 350mm thick and seated at a depth of 0.88m onto a soft, low strength (V: 28-32kPa), orange brown, silty CLAY. The side wall to the lightwell (B-B) foundation comprised brickwork onto weak brick concrete which was 800mm thick and appeared to be seated onto dense clinker / concrete which may be drain benching associated with the drainage running across the front of the house in this location.

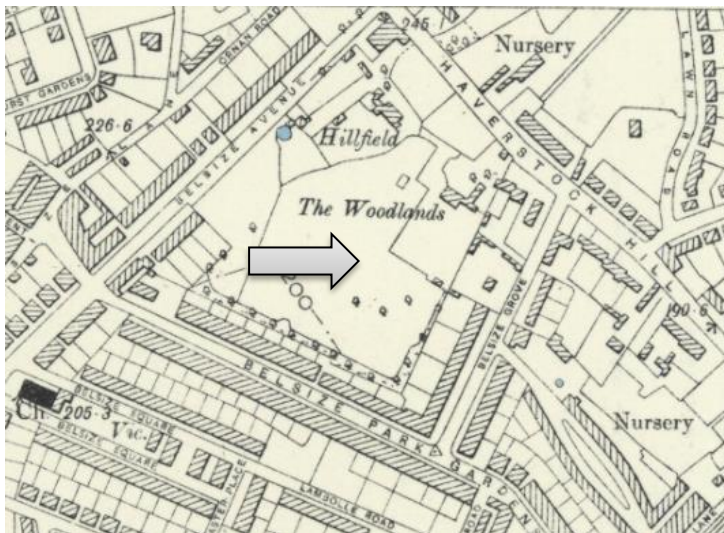
Figure 2: OS map from 1896 indicating absence of the terrace

- 3.2.1. The property is assumed to have been constructed between 1896 and 1914, from historical Ordinance Survey maps presented in Figures 2 & 3. The site is assumed to have been solely in residential use since the terrace was initially constructed. There is no recorded unexploded ordinance in the surrounding area. There is no evidence that the ground beneath the property has ever been reworked. There is no evidence that the existing basement has ever been altered structurally or extended since it was first constructed.

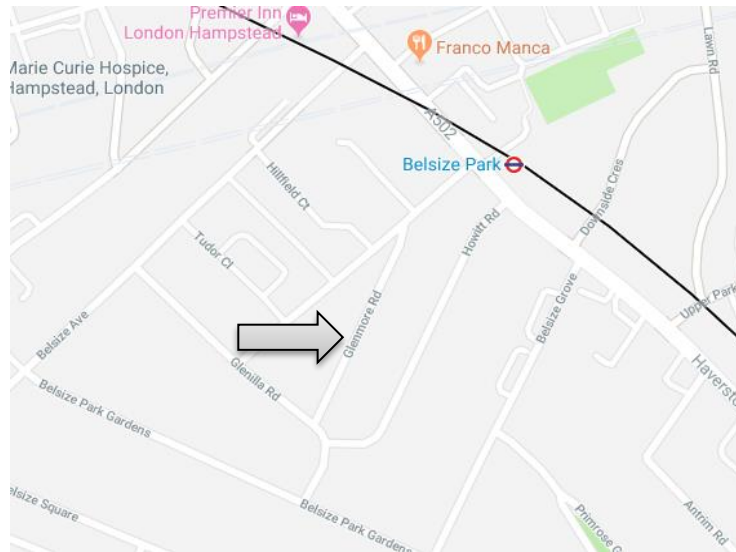
Figure 8: DEFRA map showing bedrock aquifers, superficial drift aquifers, and groundwater vulnerability zones

Question	Response	Details
1a. Is the site located directly above an aquifer?	No	DEFRA map showing bedrock aquifers, superficial drift aquifers, and ground water vulnerability zones (Figure:8, Appendix D)
1b. Will the proposed basement extend beneath the water table surface?	No	Site Investigation Report 0762 by Connaught Site Investigation Ltd. (7 th August 2019). See appendix B.

10. Is the site within an aquifer. If so, will the proposed basement extend beneath the water table such that dewatering may be required during construction?	No	DEFRA map showing bedrock aquifers, superficial drift aquifers, and ground water vulnerability zones (Figure:8, Appendix D)
