**CAMDEN GOODS YARD, CAMDEN,
GREATER LONDON**

**PRELIMINARY BAT ROOST
ASSESSMENT**

A Report to: St George PLC

Report No: RT-MME-151076-02 Rev A

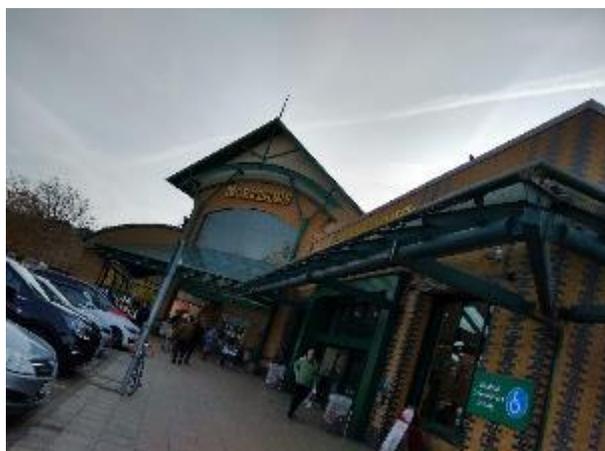
The Morrison’s supermarket building was a single storey, flat roofed building. At the entrance to the structure, on the northern aspect a pitched roof was present. It was constructed from brick and cement with a corrugated material and metal structure overhanging the walkway surrounding the north-east aspect of the brick structure. There were large glass windows located on the northern aspect of the building. The building was in use at the time of the survey as a supermarket. The exterior of the building was well maintained and in good condition as shown in Plate 4.1 and 4.2. There was no observed notable vegetation growth on the building.

Plate 4.1 Exterior of Morrison’s Supermarket (Pitched Roof)

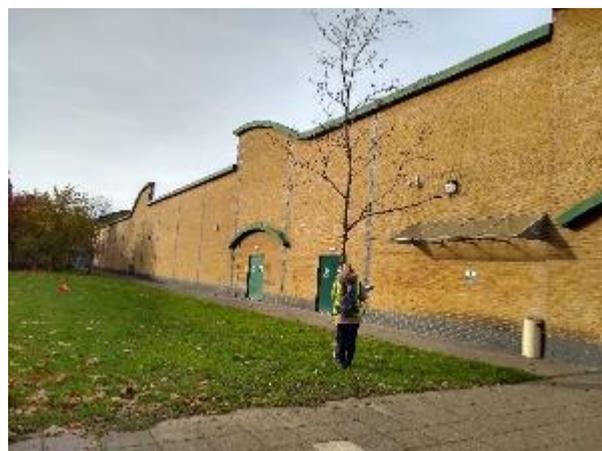
Plate 4.2 Exterior of Morrison’s Supermarket (Eastern Aspect)

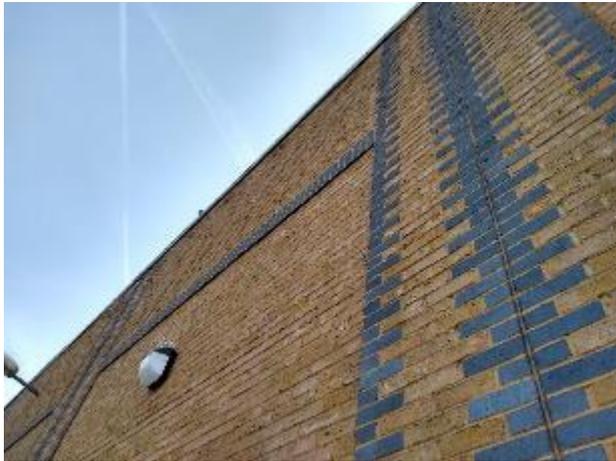
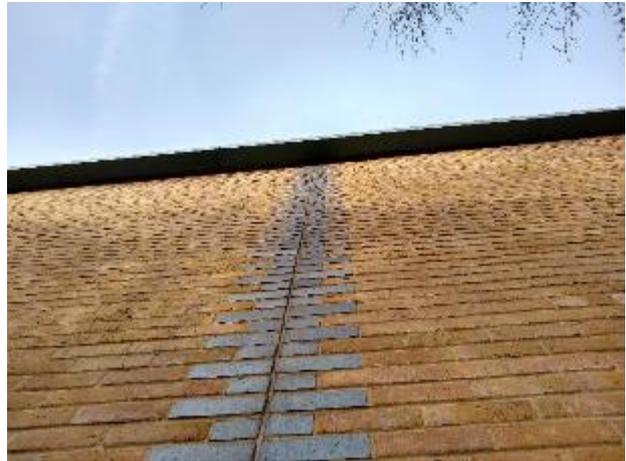
The majority of the roof of the supermarket building was flat. No suitable features for roosting bats were identified along the flat or pitched roof areas. The join between the brick wall and the roof was inspected on the eastern and western aspects of the building. This was observed to be tightly fitted around the building with no gaps or potential access points for bats, as depicted in Plates 4.3 and 4.4.

**Plate 4.3 Tightly Fitted Roof
(western elevation)**

**Plate 4.4 Tightly Fitted Roof
(eastern elevation)**

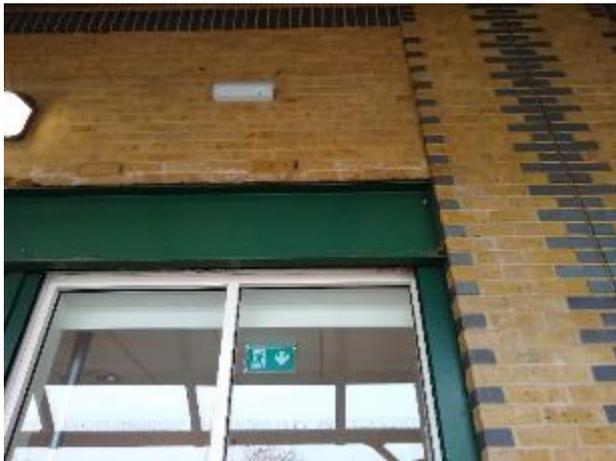
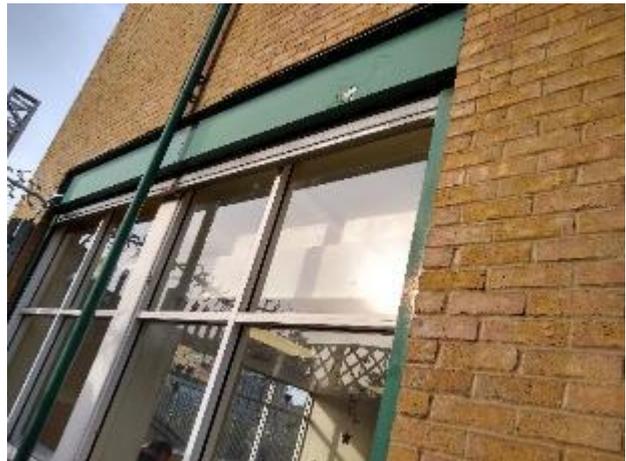
Elsewhere, the windows, door and shutters were all in good condition as depicted in Plates 4.5 and 4.6. There were no gaps or access points located during the assessment in these areas.

**Plate 4.5 Tightly Fitted Doors
(northern elevation)**

**Plate 4.6 Tightly Fitted Windows
(eastern elevation)**

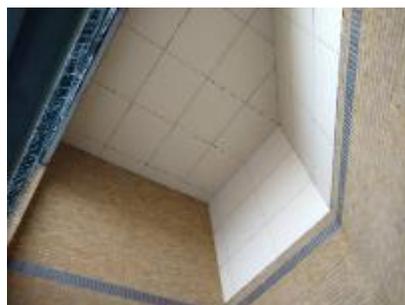
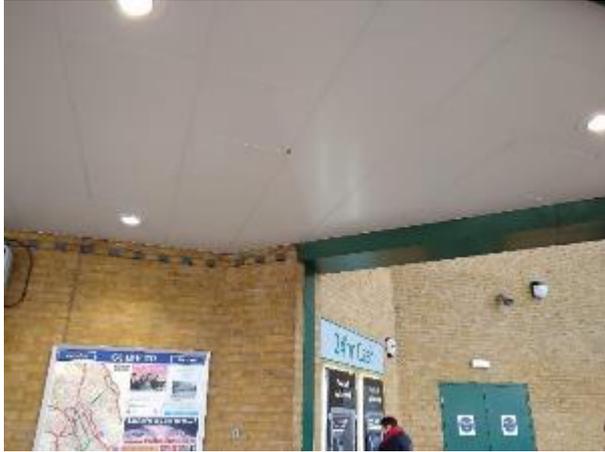
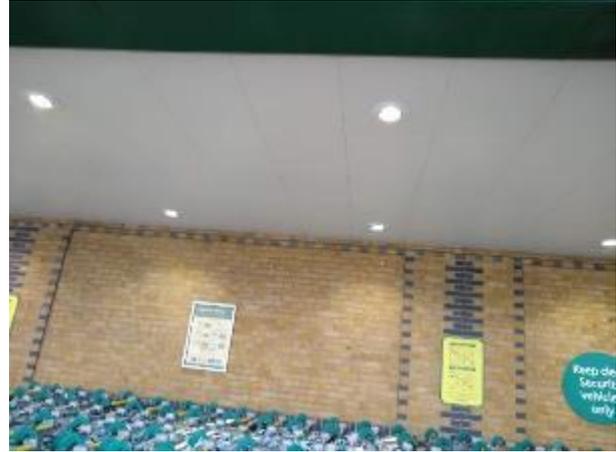
On the northern aspect of the building, ceiling tiles were present underneath a sheltered outdoor walkway. All ceiling tiles were observed to be tightly fitted (Plates 4.7-4.9). Light cobwebbing was recorded along many of the tiles and no evidence of bats was observed.

**Plate 4.7 Tightly Fitted Ceiling Tiles
(northern elevation)**

**Plate 4.8 Tightly Fitted Ceiling Tiles
(northern elevation)**

**Plate 4.9 Tightly Fitted Ceiling Tiles
(northern elevation)**

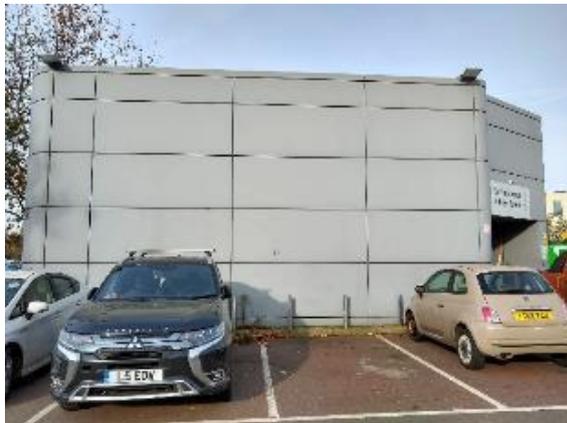
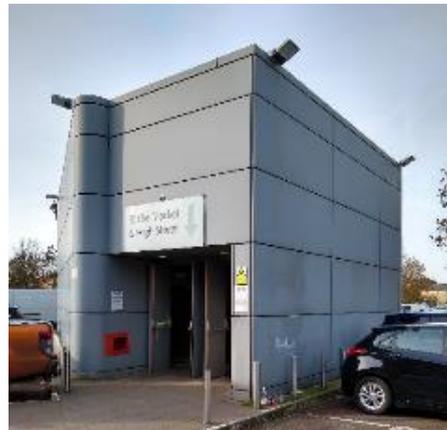
Within the car park to the Morrison's supermarket there was a second building which provides an access route to the market and high street. This building was single storey and had a flat roof, as depicted in Plates 4.10 and 4.11. There were no windows on the building and there was a single entrance and exit point on the north-east aspect of the structure. The building was in a good state of repair and tightly fitted with no gaps providing access for bats. There were no features identified on the building which could be utilised by bats to gain entry into the building and potential roost locations. In addition, no evidence of roosting bats, e.g. droppings, urine staining, feeding remains or scratch marks was recorded.

**Plate 4.10 Building Exterior
(eastern elevation)**

**Plate 4.11 Building Exterior
(north-eastern elevation)**

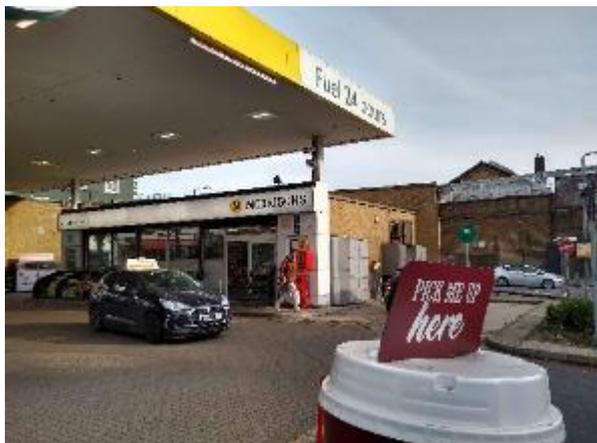
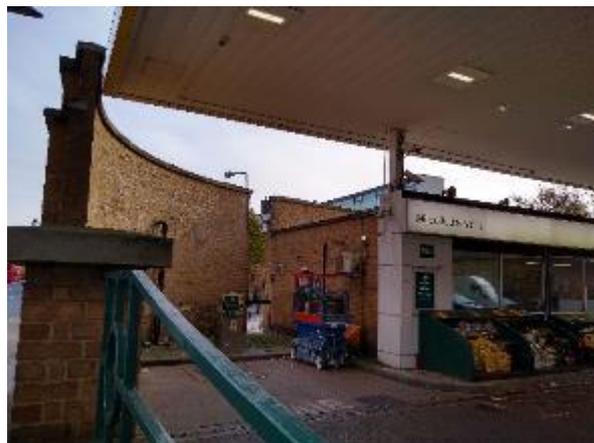
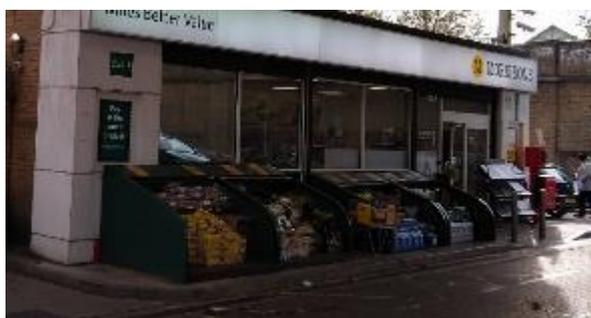
To the north of the Morrison's Supermarket there was a single storey brick-built building with a flat roof and a brick barrier wall which is the Morrison's Petrol Station as depicted in Plates 4.12 and 4.13. There were large glass windows located on the western aspect of the building, as shown in Plate 4.14. The building was in a

good state of repair with no gaps in the brickwork nor around the windows which could allow for bat ingress. There was no notable vegetation growth on the building recorded.

Plate 4.12 Building Exterior
(south-western elevation)

Plate 4.13 Building Exterior and Barrier Wall
(eastern elevation)

Plate 4.14 Glass Windows

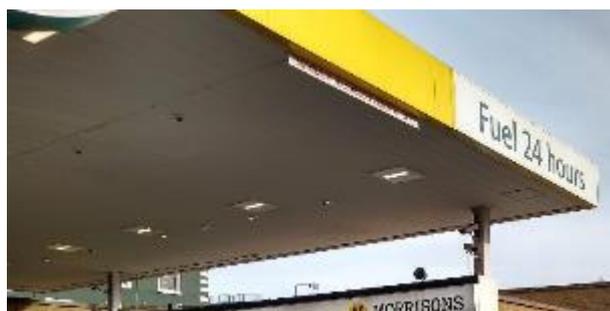
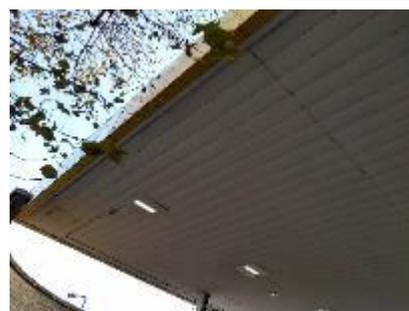
There was a metal sheltering roof over the petrol re-fuelling area as shown in Plates 4.15 and 4.16. However, this structure had no features identified which could be utilised by bats to gain entry into the roof and potential roost locations.

Plate 4.15 Metal sheltering roof

Plate 4.16 Metal sheltering roof

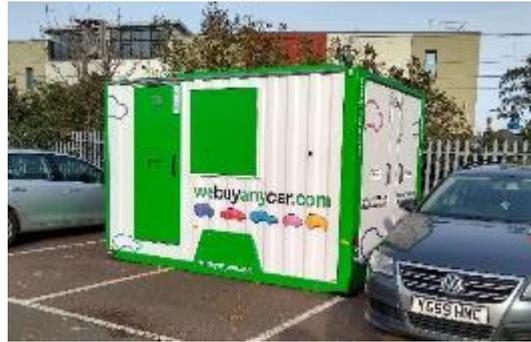
A small metal shipping container was present on site and in current use as an office space (Plate 4.17). The building had a metal roof and sealed doors and windows. No features were identified which could be utilised as ingress points or roosting locations for bats and no evidence of bats was recorded.

Plate 4.17 Metal Shipping Container Office

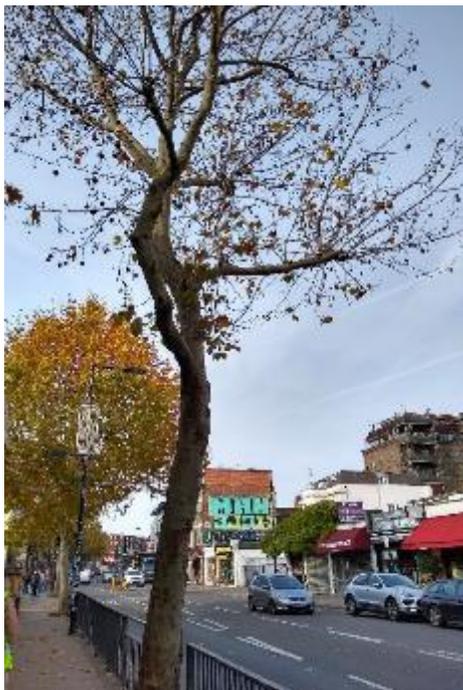
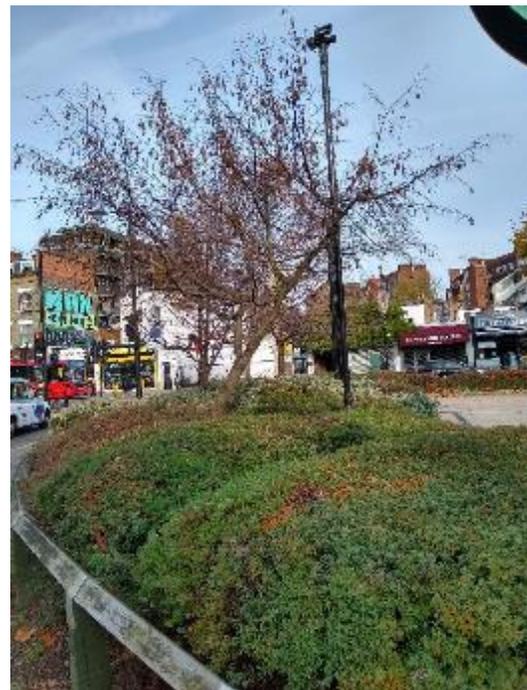
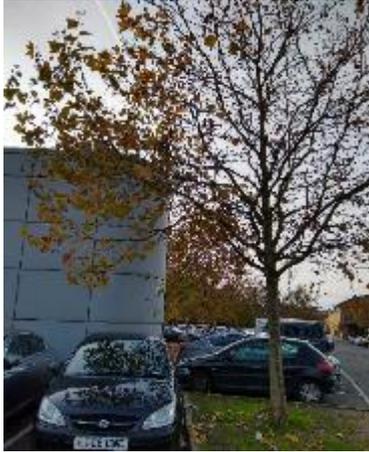
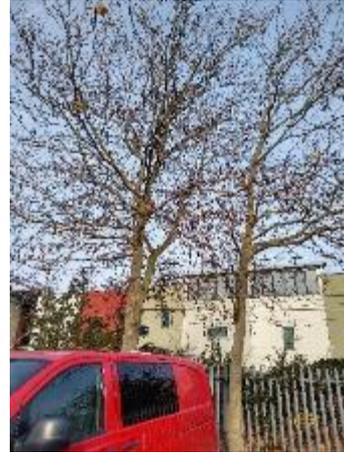
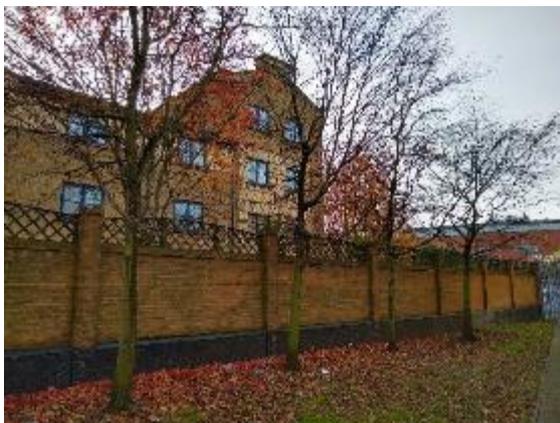
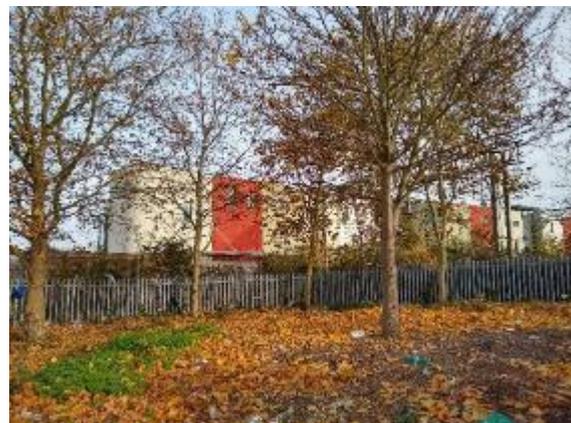
No potential features were identified on any of the trees on site and all trees on site were classified as having negligible potential to support roosting bats. Example photographs of the scattered trees around the Morrison's supermarket and Morrison's petrol station are presented in Plates 4.18-4.23.

Plate 4.18 Negligible Potential

Plate 4.19 Negligible Potential

Plate 4.20 Negligible Potential

Plate 4.21 Negligible Potential

Plate 4.22 Negligible Potential

Plate 4.23 Negligible Potential
