Project  
65 Kingsway - Base Scheme

Title  
Typical Replacement Window Details

Drawing No.  
**1914-BG-01-ZZ-DR-A-33.601**

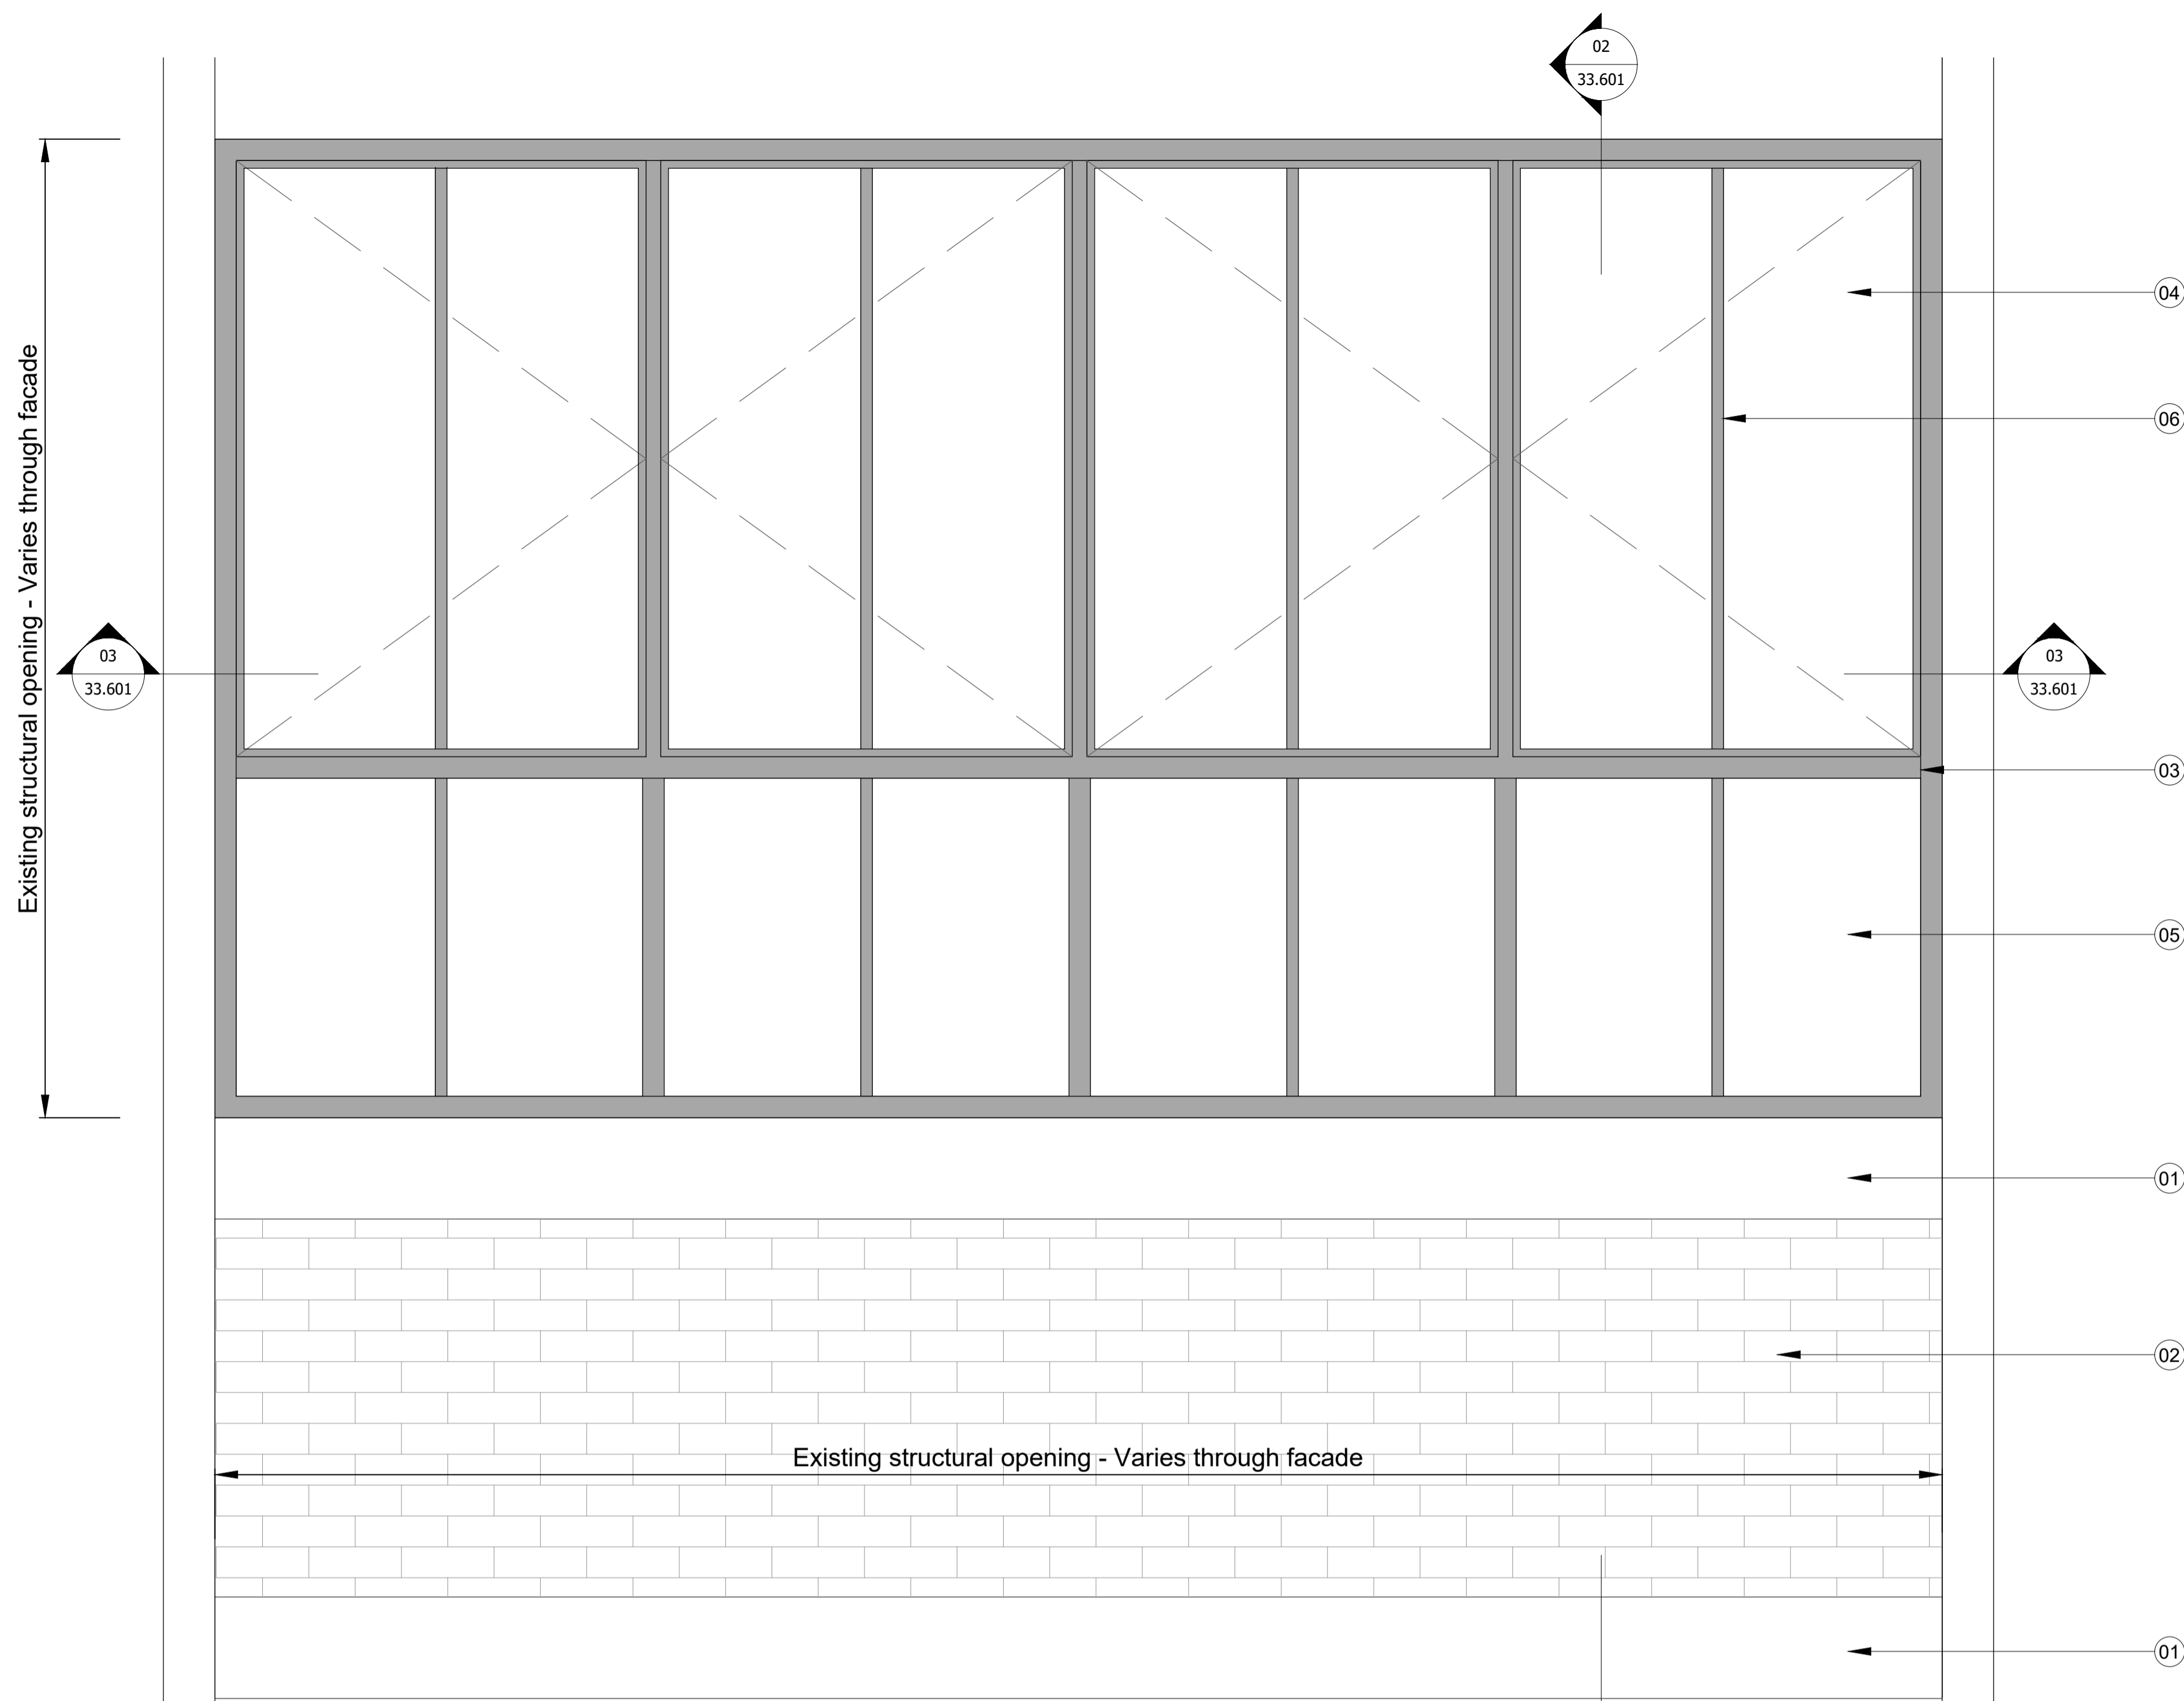
01  
20.271  
Typical Replacement Window - Elevation  
1:10@A1, 1:20@A3

1. Existing portland stone cill cleaned and repaired.
2. Existing red brick facade repaired and cleaned. Material below window varies through facades - bronze panel/brickwork/white glazed brickwork.
3. New thermal break double glazed crittal style steel frame window to match original design. Black colour.
4. Inward opening vent.
5. Fixed pane.
6. Steel false divider. Black colour.
7. Hardwood painted cill.
8. Single point safety anchorage for cleaning/maintenance.
