23 MARQUIS ROAD
DESIGN AND ACCESS STATEMENT

1.0.1 This Design and Access statement has been prepared as part of a planning application to replace a number of non original windows to 23 Marquis Road. It also covers reinstatement of an original rear access door opening, minor enlargement of an upper window opening, replacement of ground and lower ground front doors, installation of 3 conservation rooflights and works to the front garden.

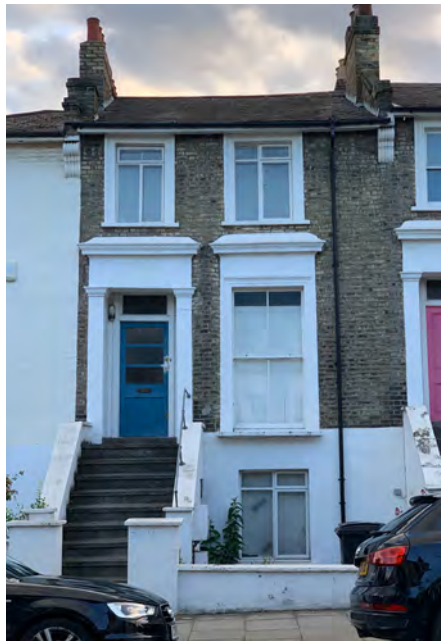
23 Marquis Road front elevation

3.1 The house has lost all its original windows to the front and rear elevation but retains the original window surrounds and window openings. To the rear the former garden access door has been infilled to create a window. Both front doors have been replaced and the front garden has been covered with a concrete slab.

4.5 On the front elevation, the front area is currently paved with concrete that is set at a high level against the front wall of the house, bridges the DPC and is creating internal damp problems. This slab will be broken out and a new natural stone front garden and steps installed with a french drain against the front of the house to address the damp issues.

4.6 Both front doors are of tired, modern design and will be replaced with a traditional Victorian four panel door more closely matching the original configuration with some glazed elements.

4.8 The missing cast iron decorative rail on the front bay window would be reinstated to match the original design.

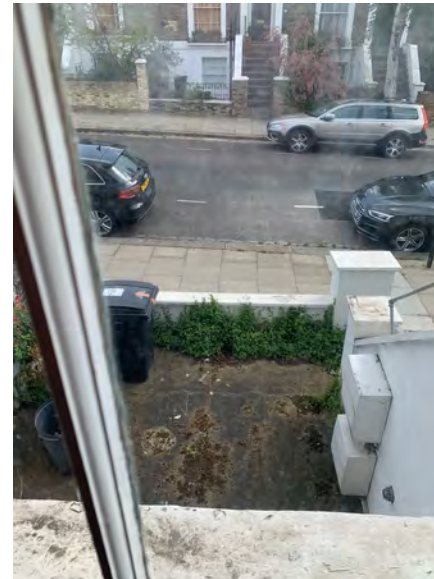
Concrete front garden

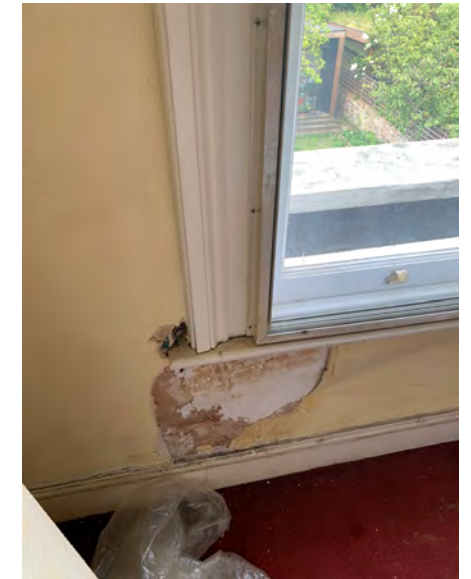
Rear window to top floor to be enlarged

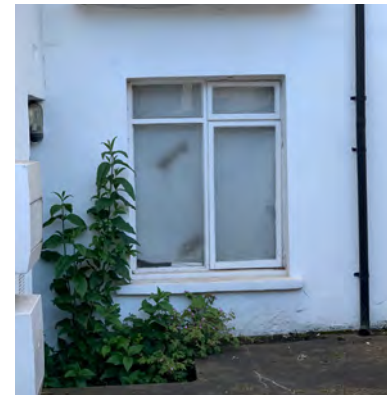
Typical replacement casement window

4.3 All the existing modern windows throughout the house will be replaced with sliding sash windows with glazing divisions that match the original configuration. The windows to the front of the house will be single glazed with the exception of the lower ground floor which will be micro doubled glazed to improve security. The windows and doors to the rear of the property will be micro double glazed to improve thermal performance and improve security.

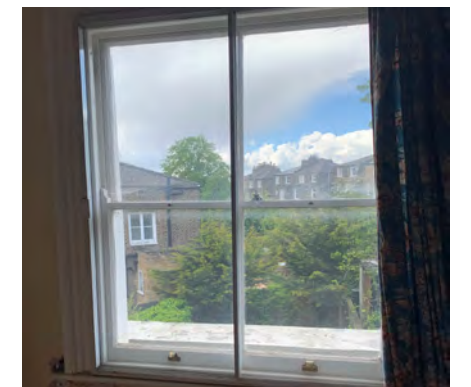
Modern windowreplacement to rear

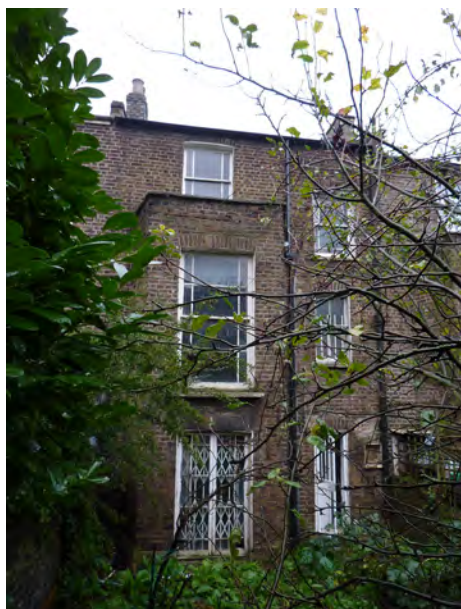
Original rear elevation at 6 St Pauls Crescent

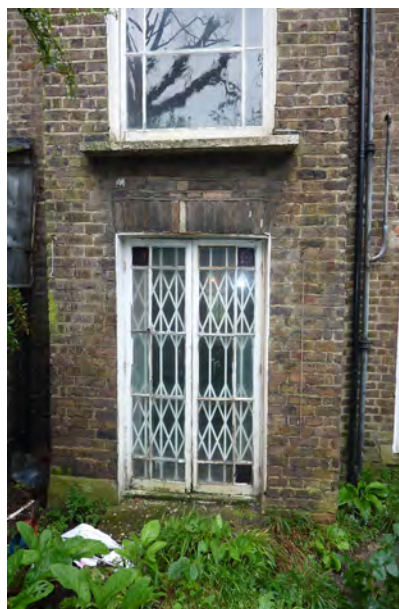
Original french doors to the garden at 6 St Pauls Crescent

4.4 The original rear access door opening will be reinstated and a new fixed timber window installed in the position of the door. The window is designed to look like an original window. The existing french doors will be replaced with a new double glazed set which more closely match the original configuration.

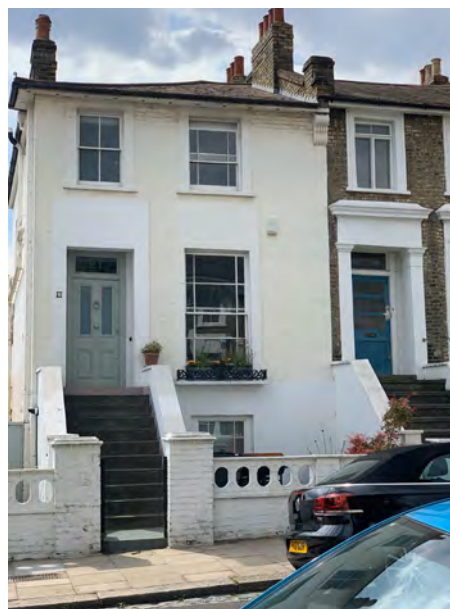
Original configuration of front windows to neighbouring building and original capped squat columns either side of entrance.

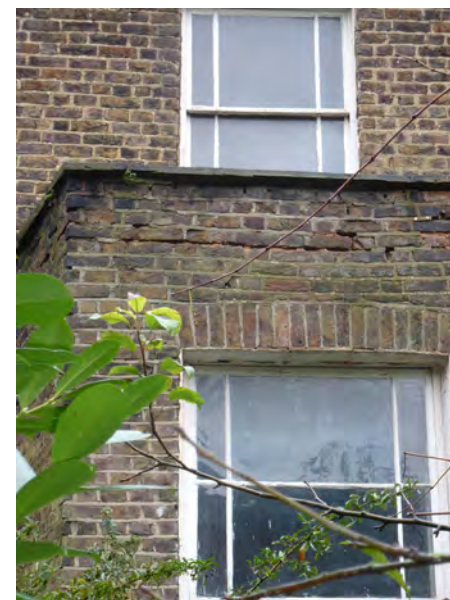
Original stone capped balcony to bay window.

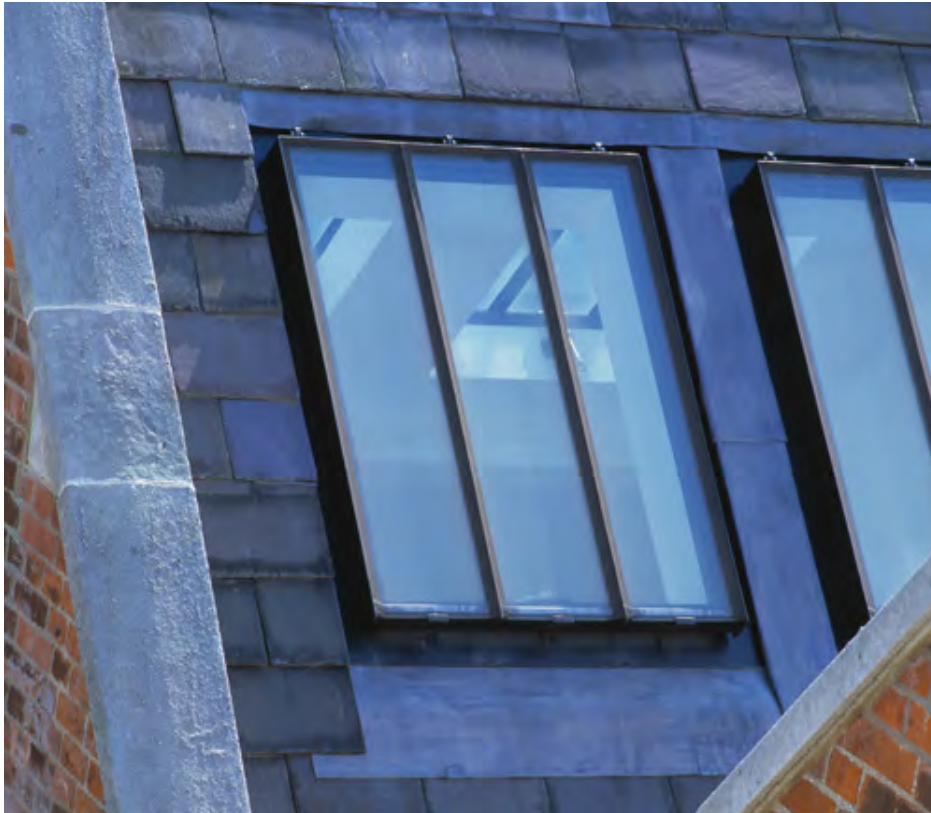
Conservation rooflights flush with roof finishes.

4.2 At roof level we are proposing introducing three conservation rooflights to the rear roof pitch laid flush with the surrounding roof finish to bring more light into the top floor bedrooms.

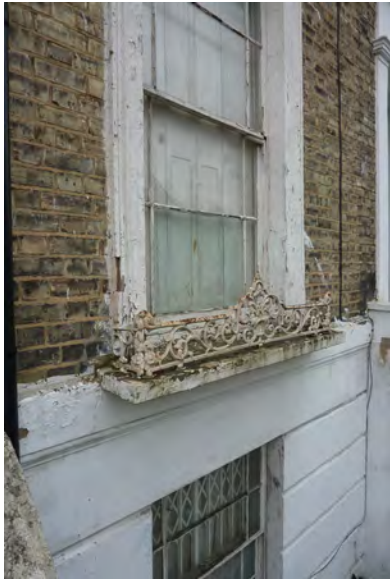
Example of original decorative baluster

4.10 The image on the left above shows an original decorative cast iron railing to a front window which would be replaced and reinstated. The image on the right shows a 'conservation range' micro double glazed sliding sash window with waxed cords and weights and shows how sympathetic this type of window can be.

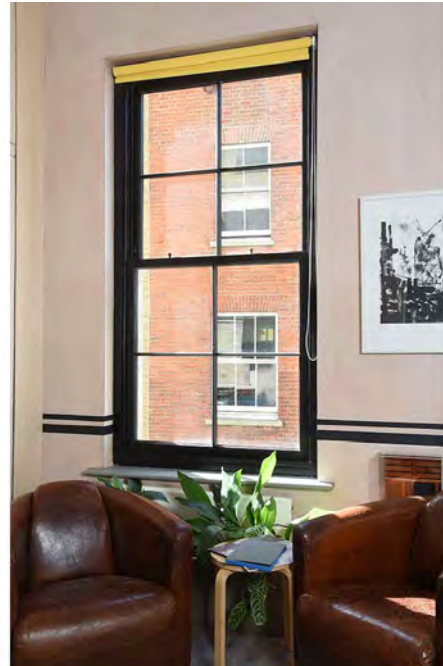
Example double glazed sliding sash window

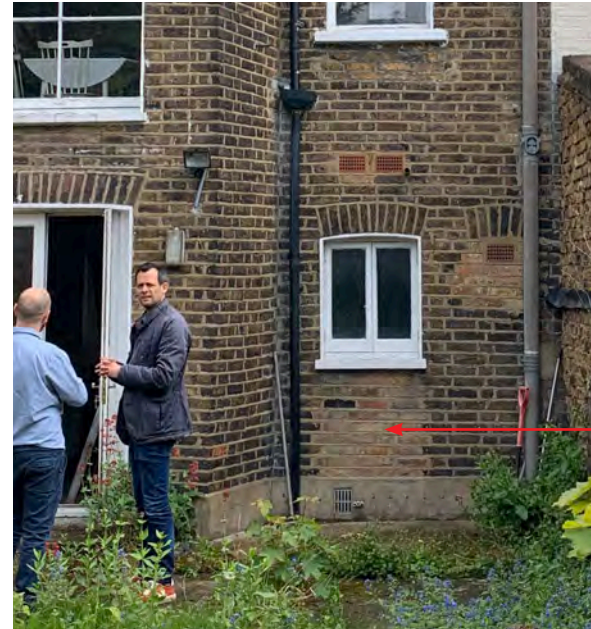
Modern brickwork removed to form new opening

4.11 The third image clearly shows the infill area to the lower ground floor rear access door that will be removed to create a new, tall opening.
