Drawing No: CCL 10395 / TCP Rev: 1
 Title: Tree Constraints Plan (Existing Layout)
 Site: 40 Orman Road NW3 4QB
 Scale: 1:100 Paper Size: A1

Drawing No:	CCL 10395 / IAP Rev: 1
Title:	Impact Assessment Plan (Existing Layout with Proposals Overlaid)
Site:	40 Orman Road NW3 4QB
Scale:	1:100
Paper Size:	A1

Trail excavation carried out on Thursday 19th September 2019.
Attendees: Emma Hoyle from Crown Tree Consultancy, Sara Dei from J&L Gibbons and two labourers.

Trial Excavation Plan
(Existing Layout)

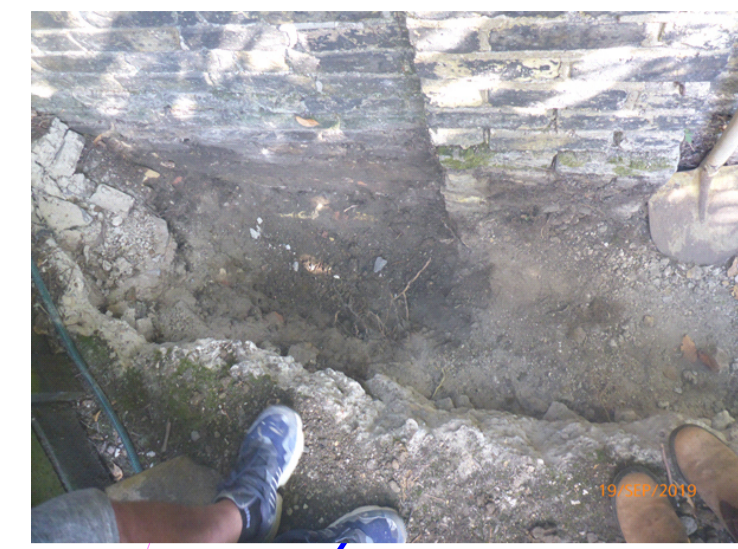
Trench 7
Depth: 0.6-0.8m
Width: 0.65m
Length: 1.2m

Trench 7:
No significant roots found.

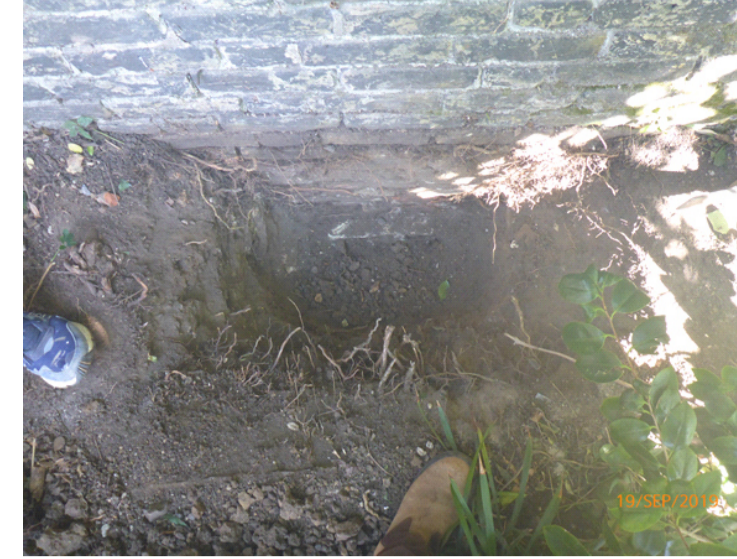
Trench 5
Depth: 0.7m
Width: 0.5m
Length: 1m

Trench 5:
No significant roots found.

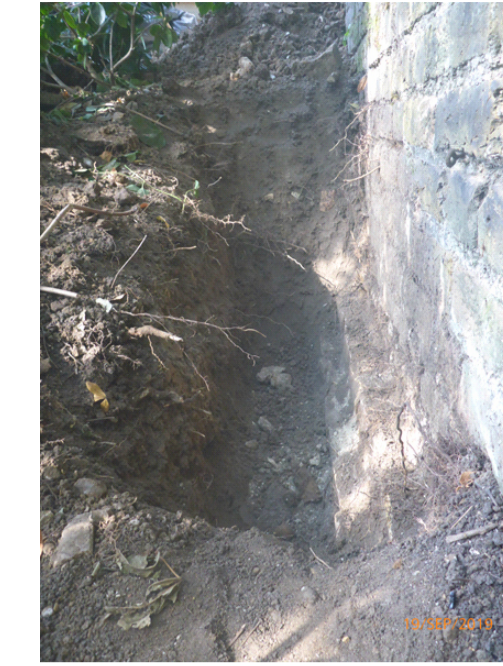
Trench 4
Depth: 0.55m
Width: 0.4m
Length: 1.4m

Trench 4:
No significant roots found.

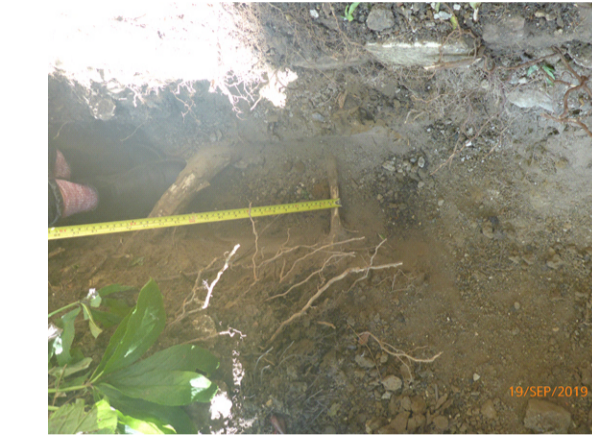
Trench 3
Depth: 0.55m
Width: 0.5m
Length: 1.1m

Trench 3:
Root 1: Diameter of 25mm at a depth of 0.5m below the existing ground level.
Root 2: Diameter of 45mm at a depth of 0.38m below the existing ground level.
One root of 10mm also encountered

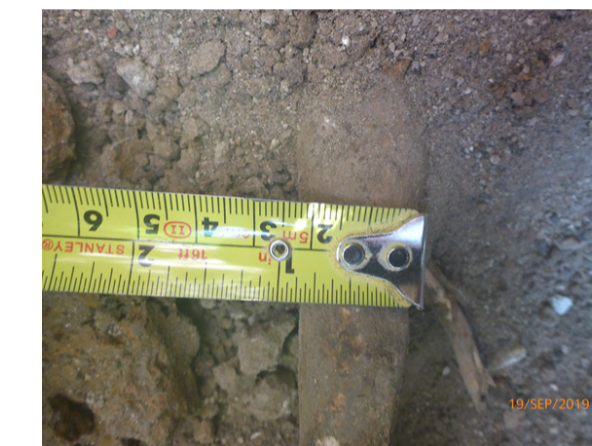
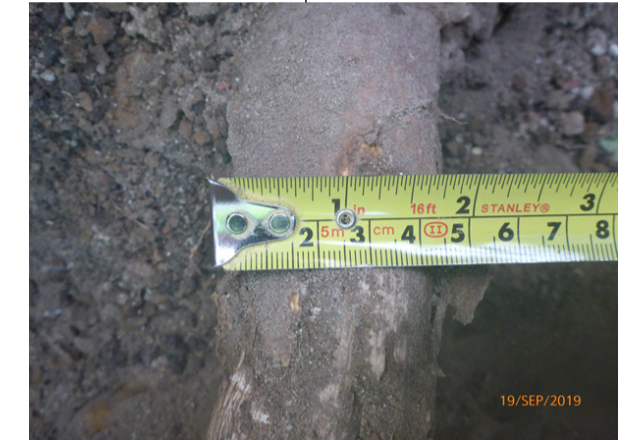
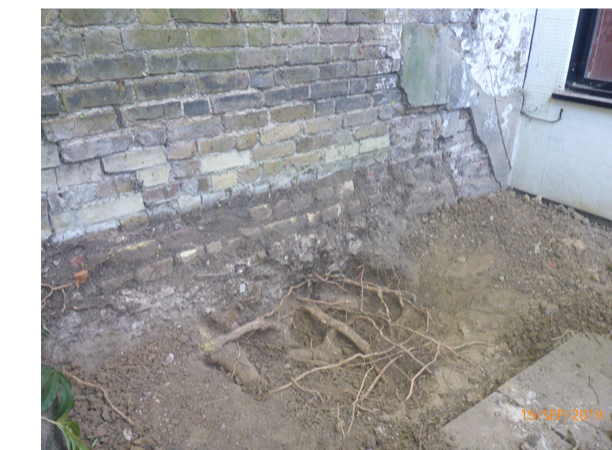
Trench 2
Depth: 0.3m
Width: 0.7m
Length: 1.1m

Trench 2: Significant rooting activity encountered.
Root 1: Diameter of 30mm at a depth of 0.11m below the existing ground level.
Root 2: Diameter of 100mm at a depth of 0.2m below the existing ground level.
Root 3: Diameter of 45mm at a depth of 0.12m below the existing ground level.
Root 4: Diameter of 80mm at a depth of 0.2m below the existing ground level.
Root 5: Diameter of 75mm at a depth of 0.11m below the existing ground level.
Root 6: Diameter of 30mm at the existing ground level.
Several other roots encountered with a diameter of up to circa 25mm.

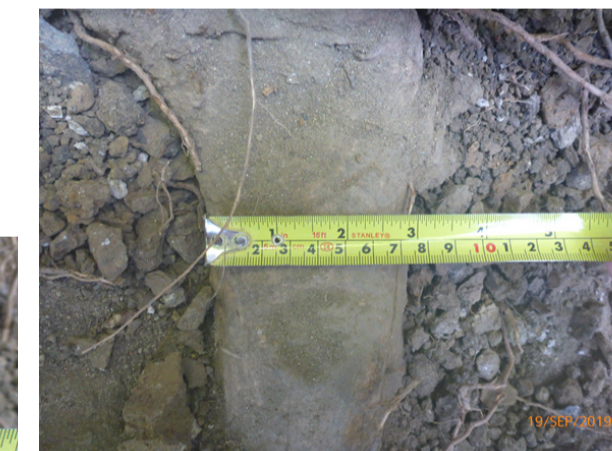
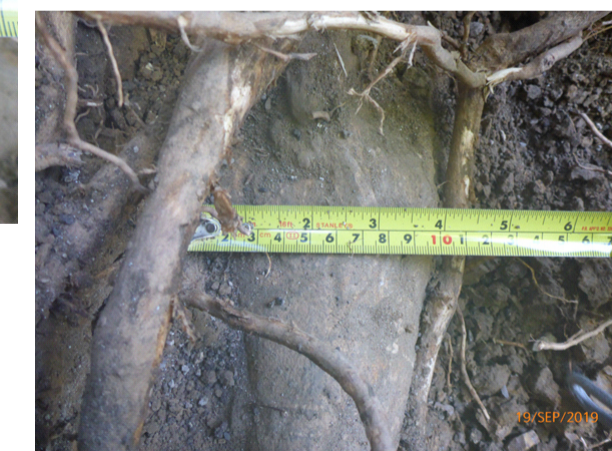
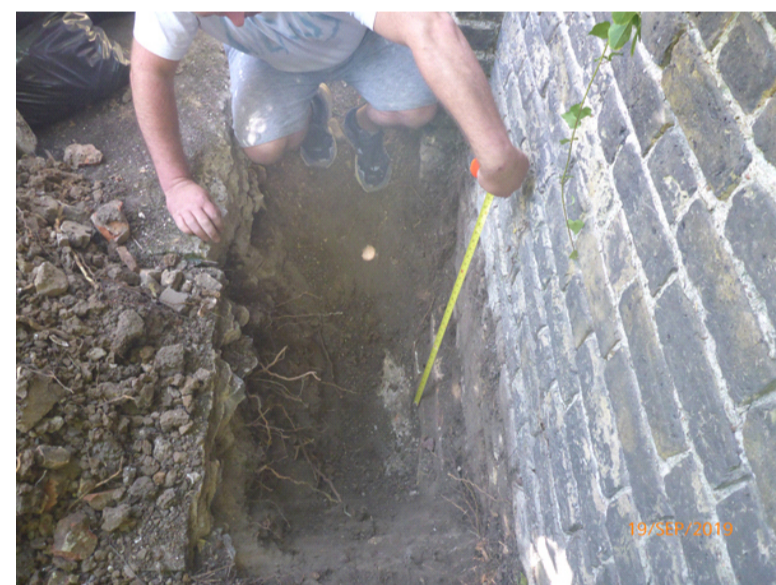
Trench 6
Depth: 0.75m
Width: 0.6m
Length: 1.2m

Trench 6:
No significant roots found.

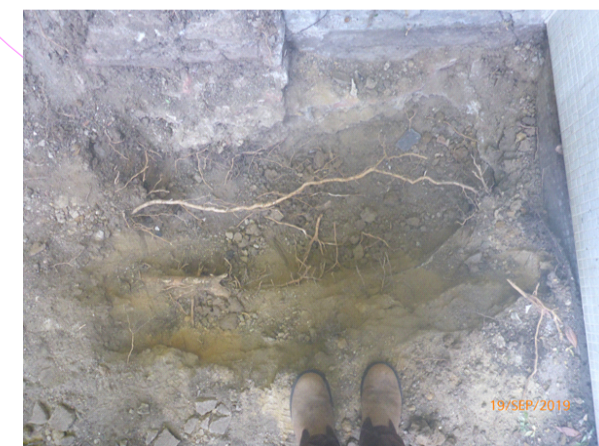
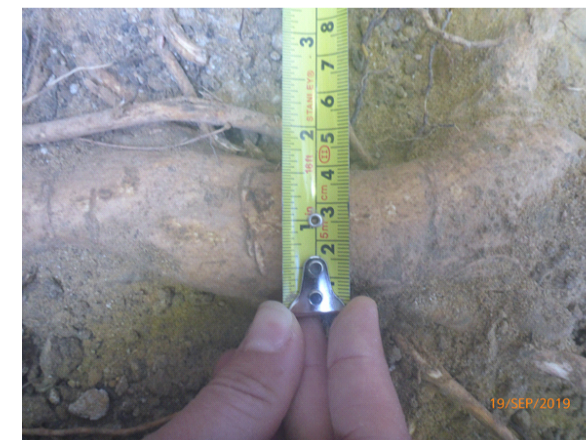
Trench 1
Depth: 0.7m
Width: 0.6m
Length: 1.3m

Trench 1:
Root 1: Diameter of 40mm at a depth of 0.18m below the existing ground level.
Root 2: Diameter of 0.14mm at a depth of 0.2m below the existing ground level.
