# BS 5837 Arboricultural Report & Impact Assessment

**40 Ornan Road  
London  
NW3 4QB**

**Dated  
6<sup>th</sup> December 2019**

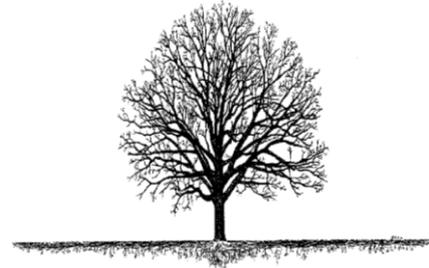
4.5.23. The majority of tree roots lie within the upper soil horizons. This is because the availability of oxygen decreases with depth and roots need to breathe to stay alive. In addition, nutrients are more readily available in the form of organic matter close to the soil surface.

4.5.24. Healthy soils contain about 25% air space between solid particles. Increased loading of the soils caused by construction activity causes air to be squeezed out as the soil becomes compacted preventing roots from breathing. Even an increase in pedestrian activity may cause some soil compaction.

4.5.25. It is important therefore that ground compaction and soil disturbance over Root Protection Areas should be avoided during the construction phase. This may be done by installing protective fencing and ground protection measures which should be approved and conditioned by the local authority.

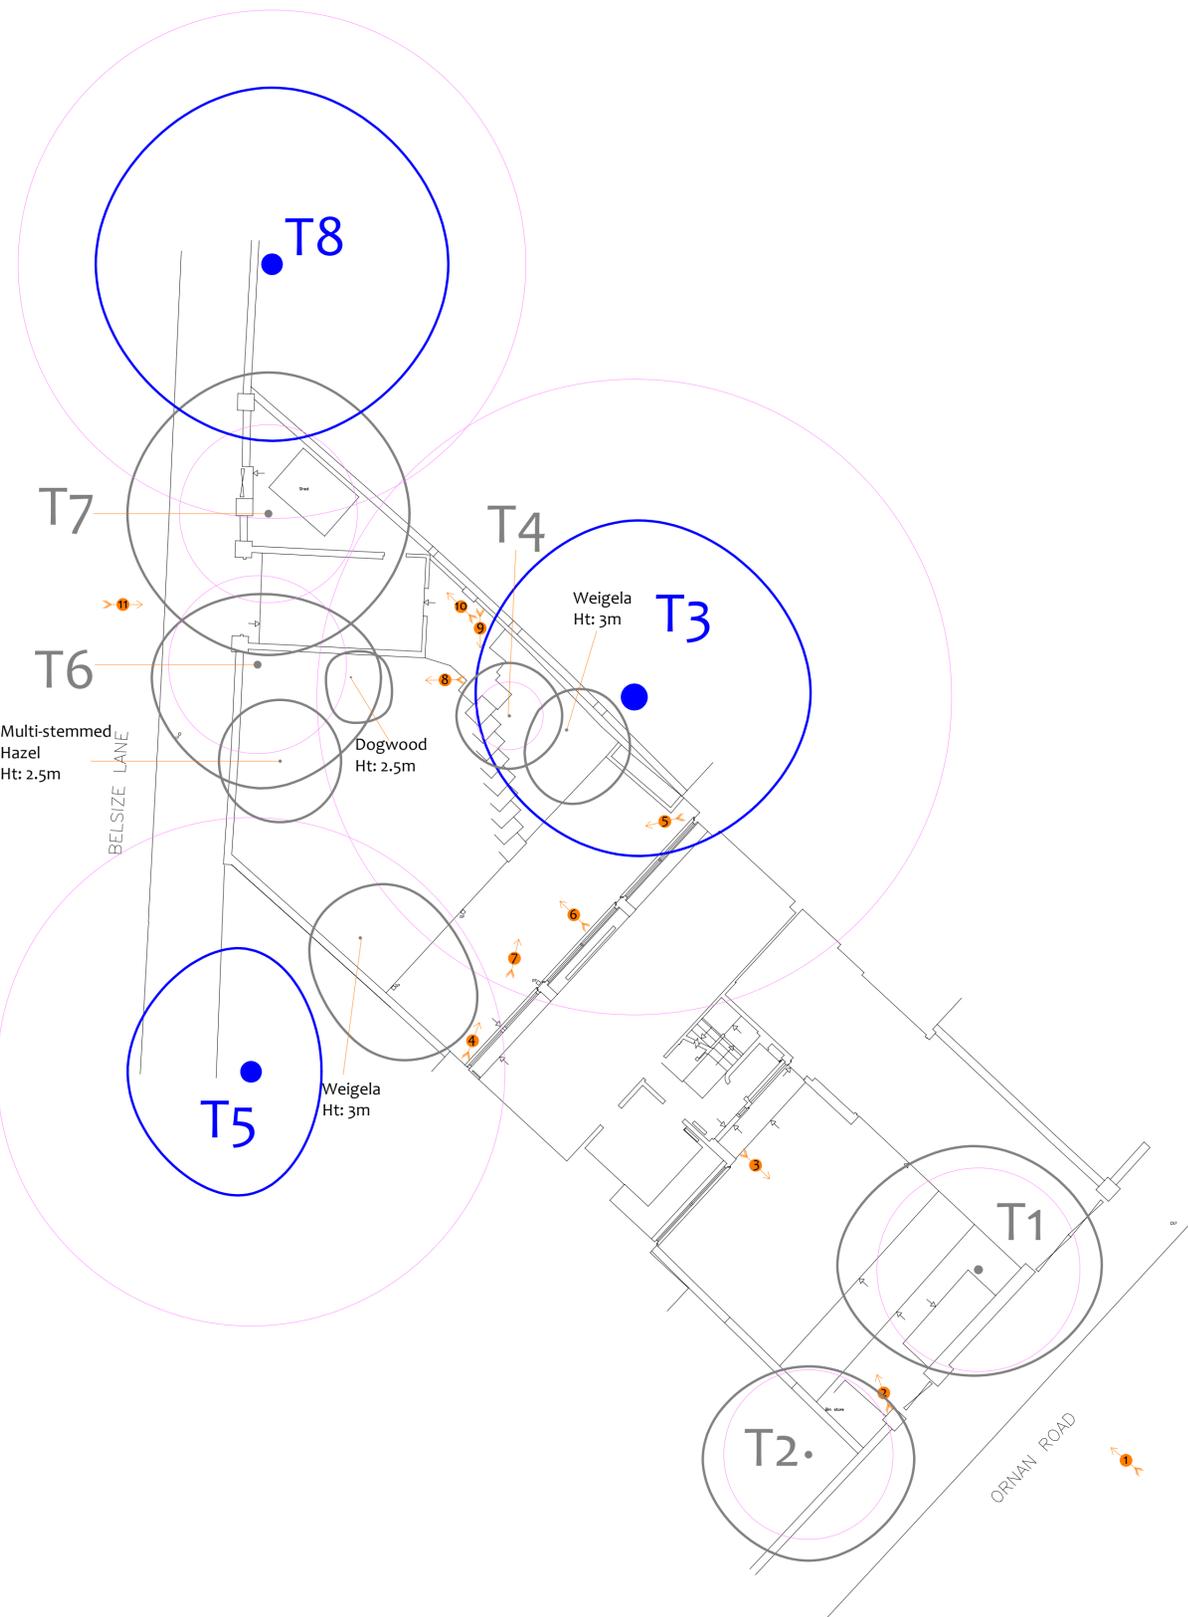
# Tree Constraints Plan

B5 s837 Root Protection Area (radius = 1xstem diameter)  
  Root Protection Area needing amendment due to site conditions, e.g. presence of existing road or building.  
  Root Protection Area having been amended to account for site conditions

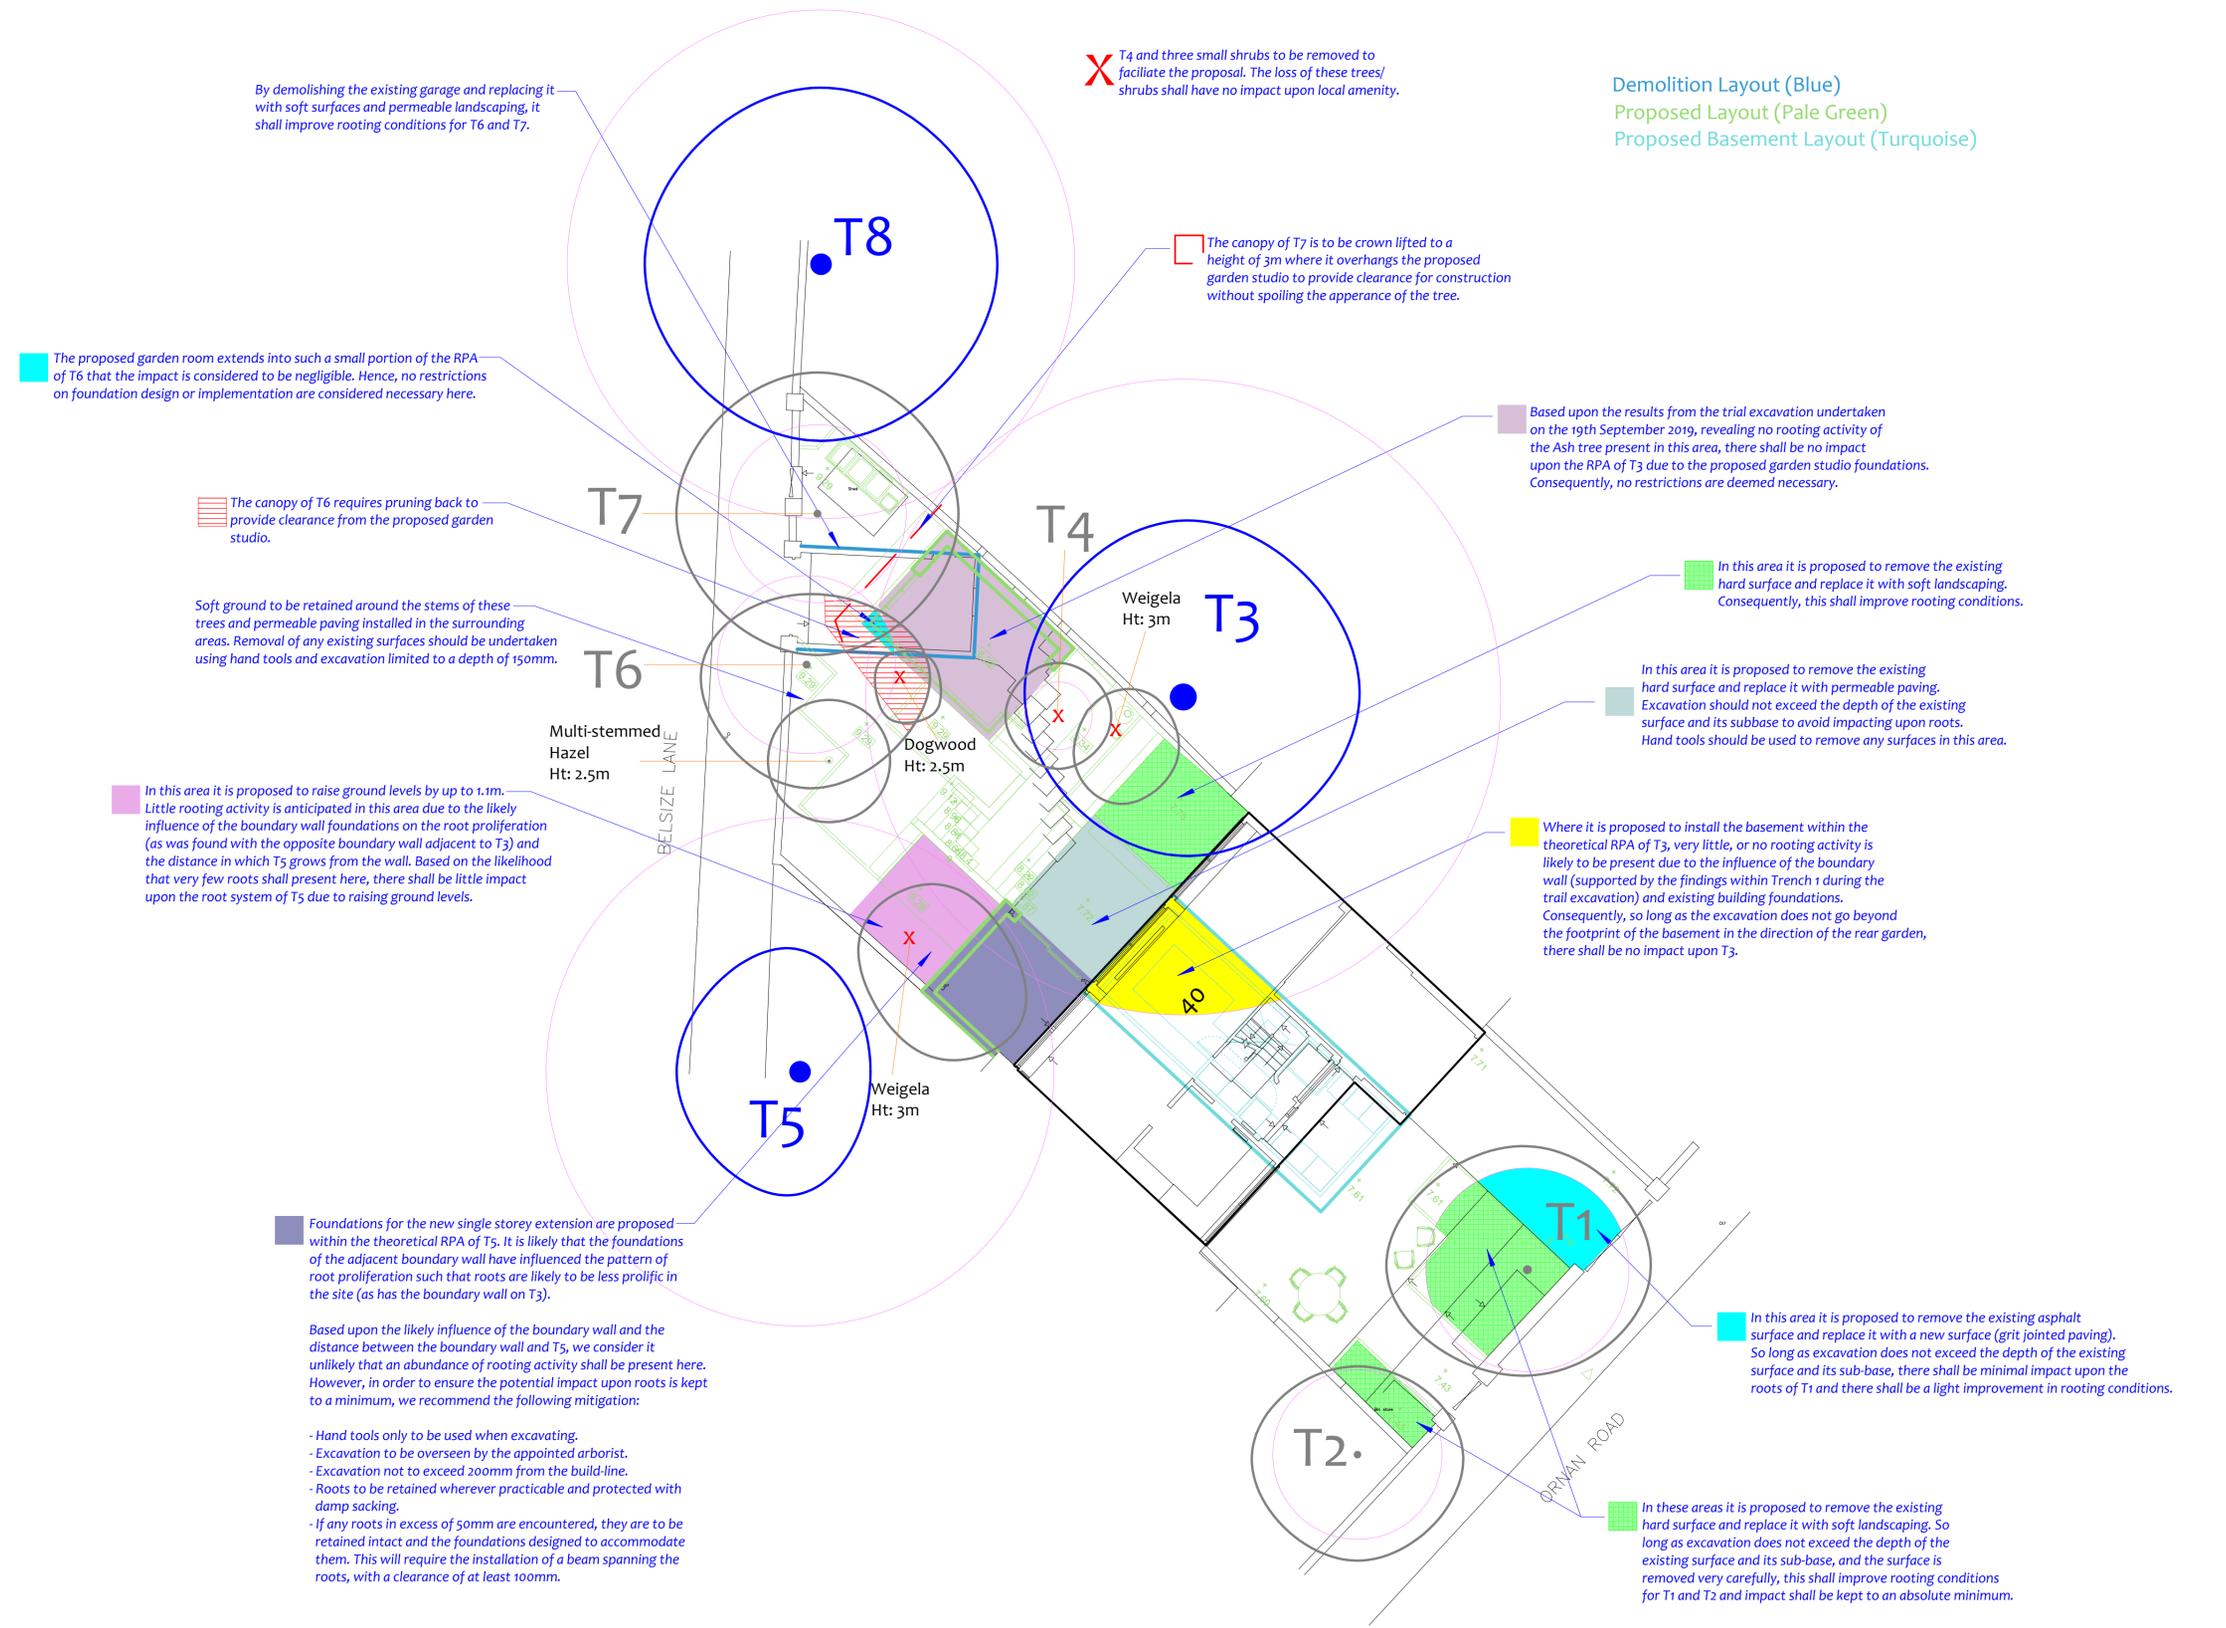
- Hand tools only to be used when excavating.
- Excavation to be overseen by the appointed arborist.
- Excavation not to exceed 200mm from the build-line.
- Roots to be retained wherever practicable and protected with damp sacking.
- If any roots in excess of 50mm are encountered, they are to be retained intact and the foundations designed to accommodate them. This will require the installation of a beam spanning the roots, with a clearance of at least 100mm.

The proposed garden room extends into such a small portion of the RPA of T6 that the impact is considered to be negligible. Hence, no restrictions on foundation design or implementation are considered necessary here.

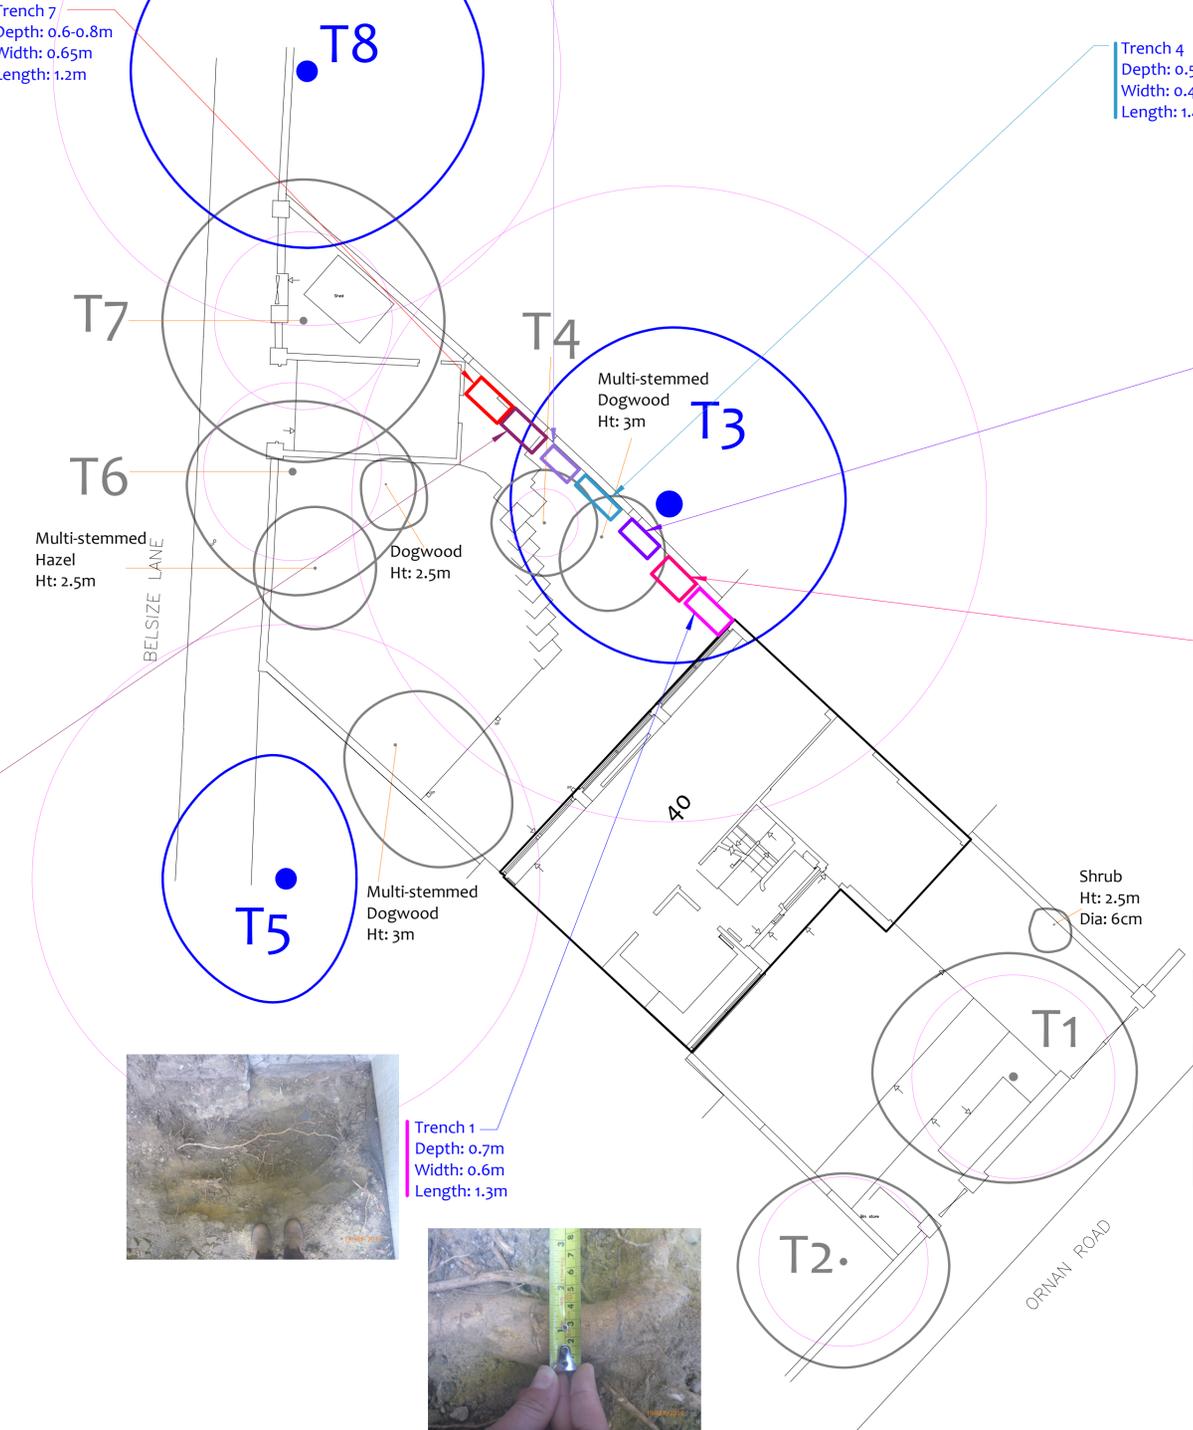
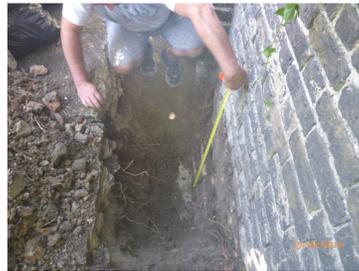
**Trial Excavation Plan**  
(Existing Layout)

Trench 1  
Depth: 0.7m  
Width: 0.6m  
Length: 1.3m

Trench 6  
Depth: 0.75m  
Width: 0.6m  
Length: 1.2m

Drawing No: CCL 10395 / TCP Rev: 1  
Title: Trial Excavation Plan (Existing Layout)  
Site: 40 Ornnan Road NW3 4ZB  
Scale: 1:100 Paper Size: A1

- 4.5.2. Boundary walls separate T3 and T5 from the site. The foundations of these walls shall influence the pattern of root proliferation such that roots are likely to be less prolific in the site.
- 4.5.3. On the 19<sup>th</sup> September 2019, a trial trench excavation was undertaken along the boundary wall adjacent to T3 to assess the rooting activity within the site. The results from the trial excavation found no roots of the Ash tree present at a distance of 1m from the stem to the north-west, extending to the rear boundary of the garden. Consequently, the boundary wall has influenced the roots of the Ash tree, T3. Please see the Trial Trench Excavation Plan in Appendix 6.
