vPPR Architects

Project : 092 – 133-137 Brecknock Road

Date: 6th of January 2020

Document: Site photos showing no tree root to proposed ramp location

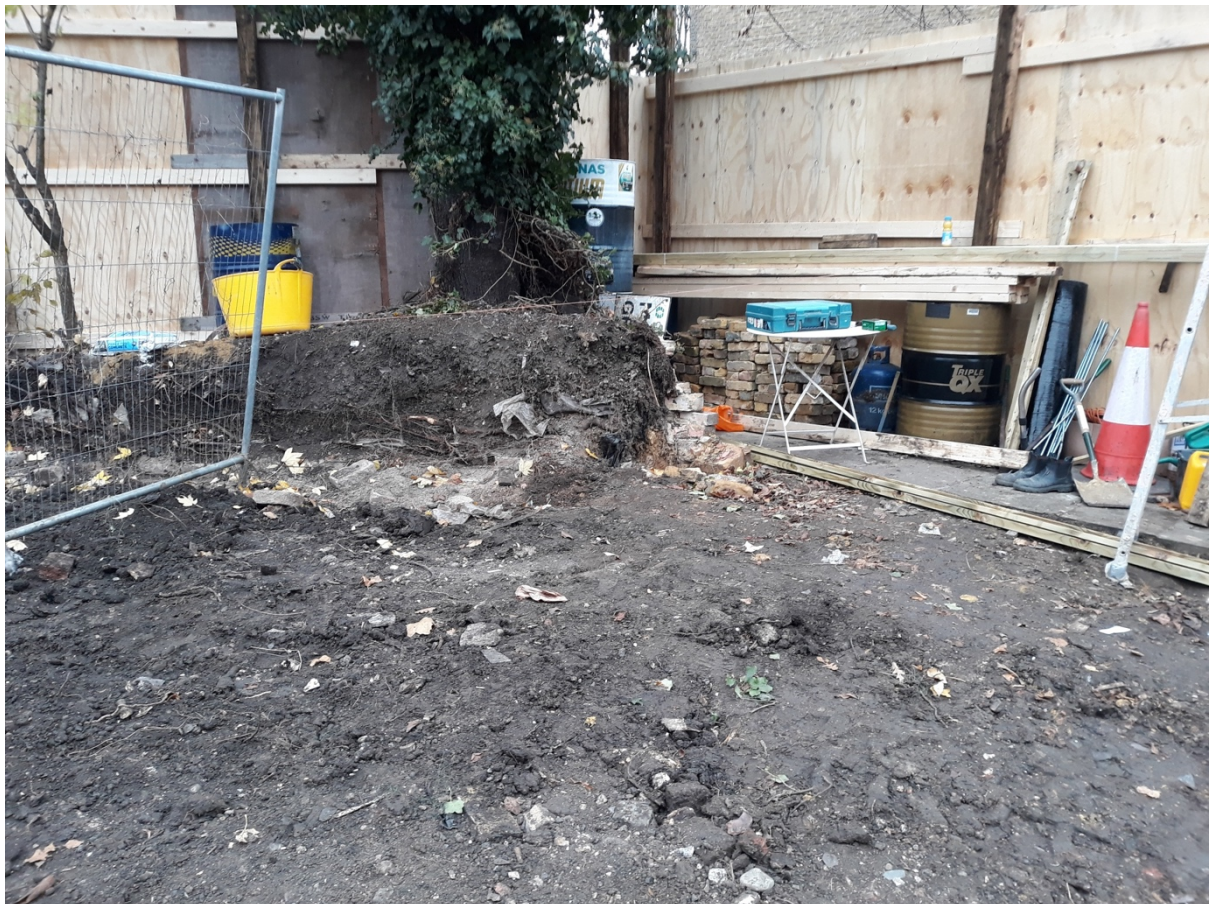
Site photo 01:

This photo shows the removal of existing of brick boundary wall. The contractor has not done any excavation, only has removed the existing concrete paving slabs in the garden. As evident from this site photo, the existing boundary wall has retained most of the tree root and the existing street level is above the adjacent garden level within the site. (our original survey indicates the existing street level is below garden level on site, but it has proved to be inaccurate when contractor has started to mobilize and investigate this area of site.)

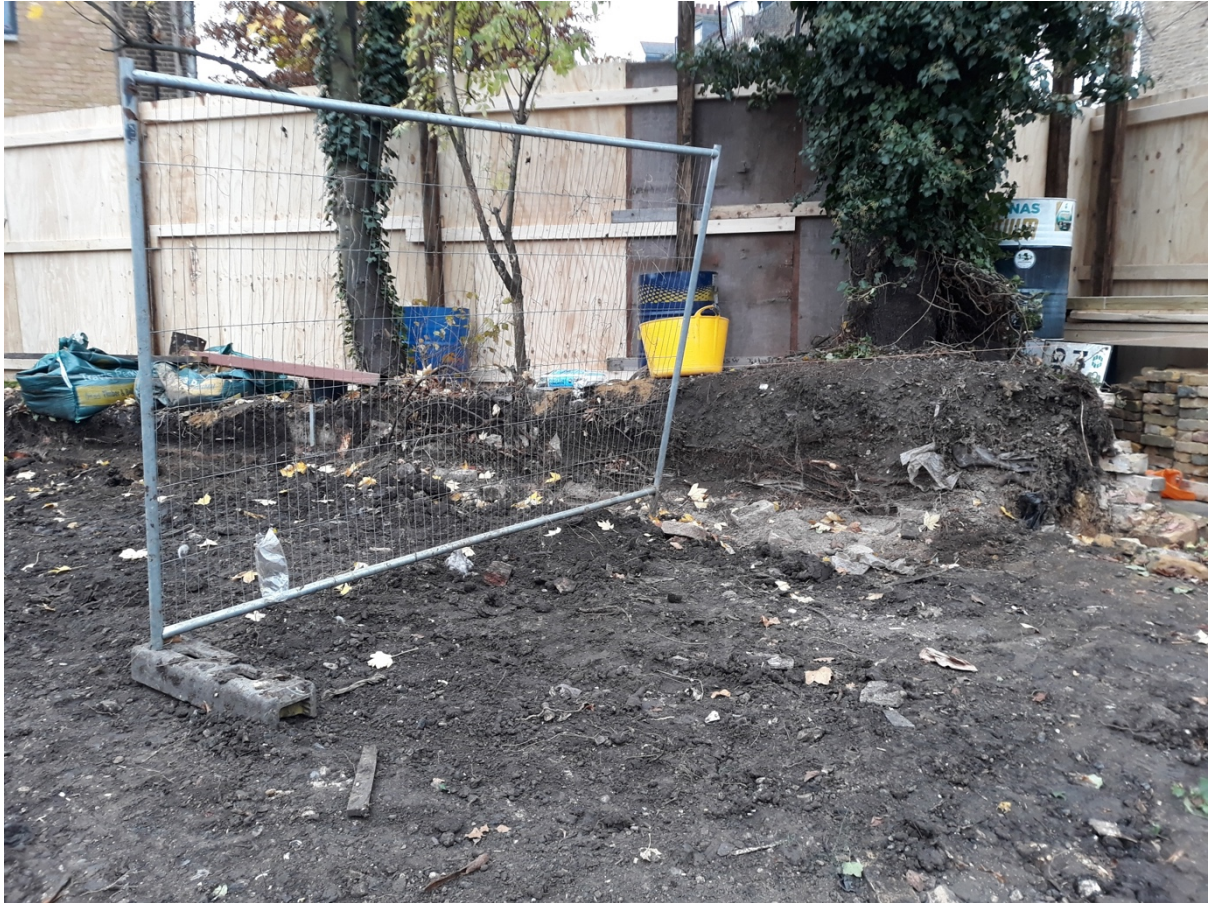
Site Photo 02: A close up of the lime tree root area after removal of existing brick boundary wall.
