Basement Impact Assessment

at
12 Platt's Lane, London NW3 7NR

Reference: 15655/BIA/Rev1.06
December 2016

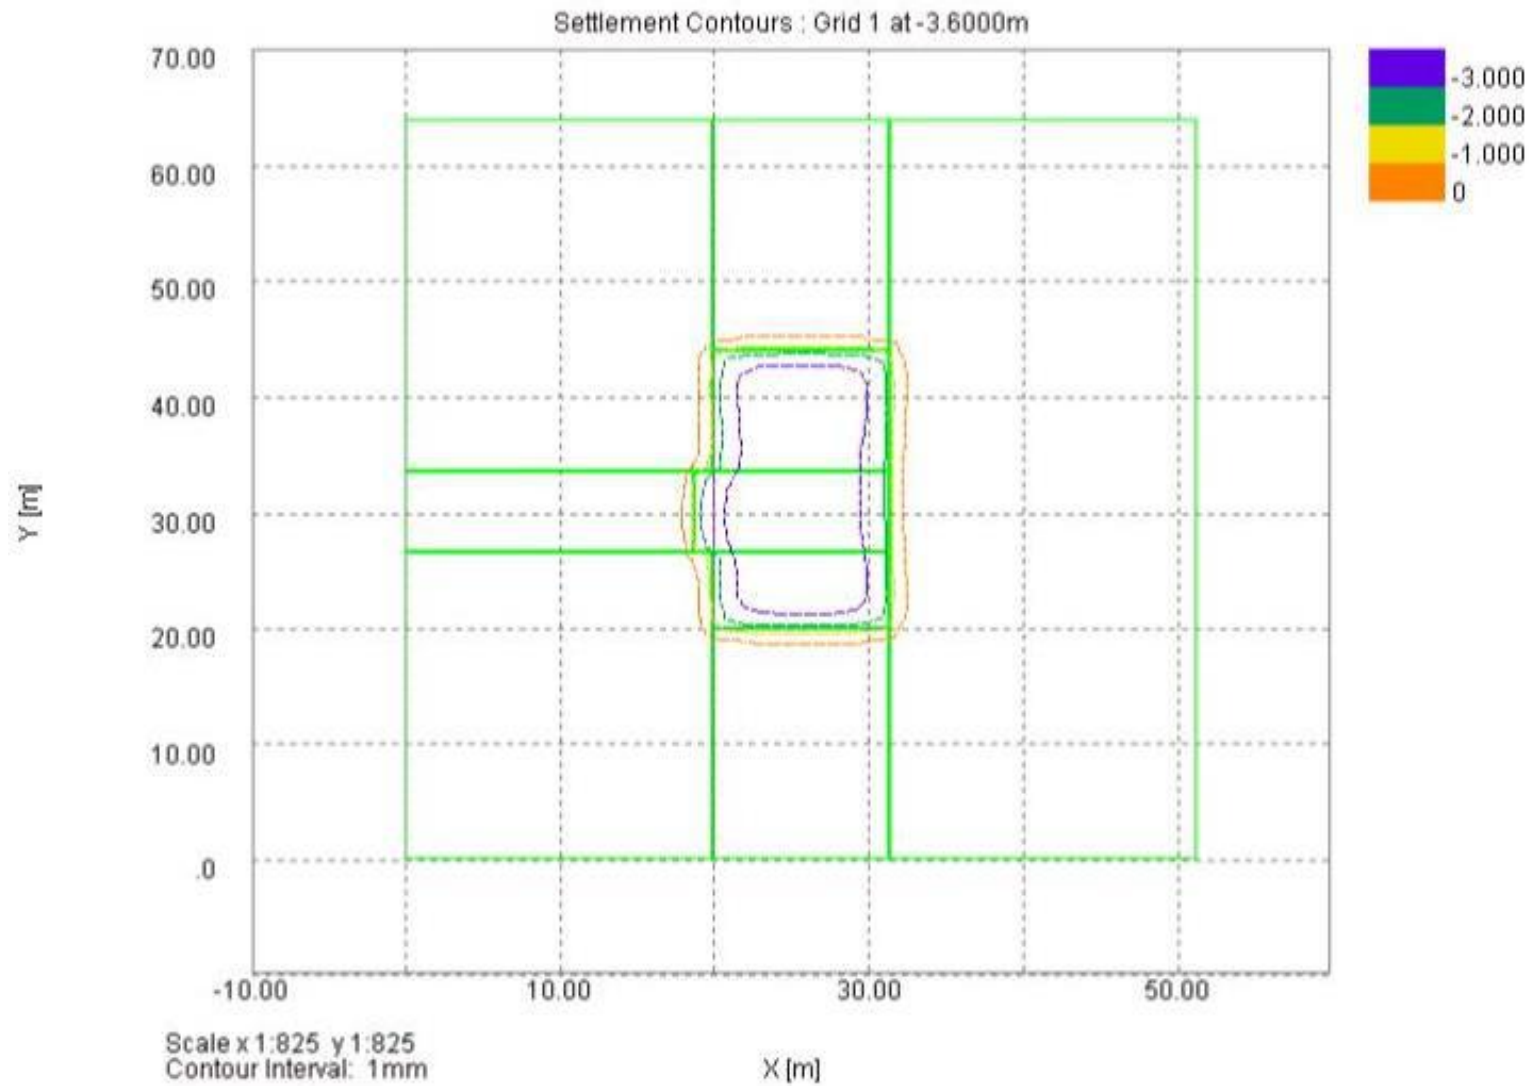
**Figure 5 – Undrained Heave****Project**

The excavation will unload the Claygate Member and the London Clay Formation and will cause a degree of heave, and/or settlement after construction.
