Factual Report

Site	Flats 3 19 Woodchurch Road London NW6 3PL
Client	Wates
Date	02.02.17
Our Ref	[REDACTED]

FACTUAL REPORT CONTENT

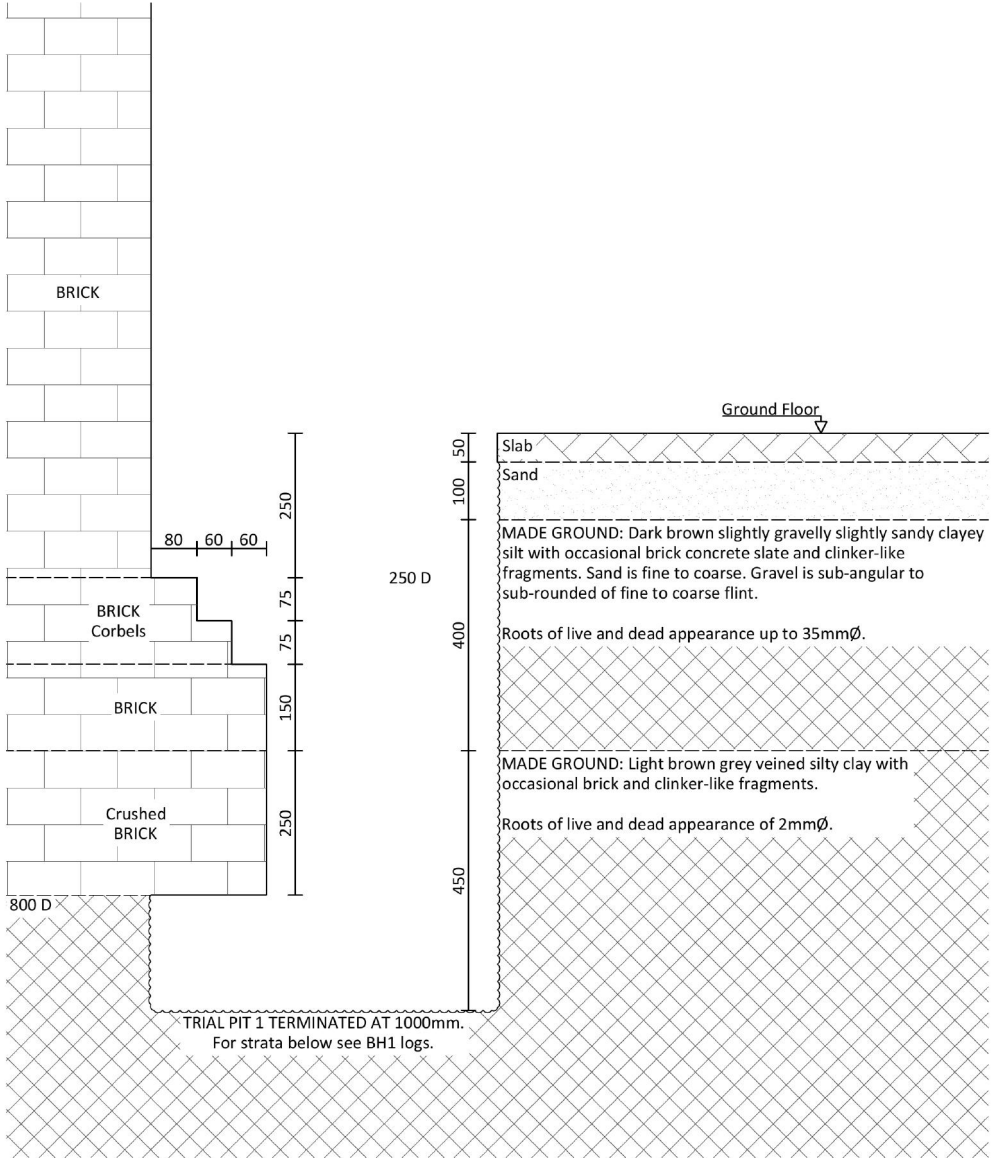
Site:		Client:		Trial Pit ID:	
	Flat 3 19 Woodchurch, London NW6 3PL		Wates		TP1	
	Contract Number:	Date:	Logged By:	Checked by:	Weather:	
		02/02/17	D.B.	J.H.	Wet	Sheet 1 of 1
	Easting:	Northing:	Ground Level:	Excavation Method:	Scale:	
Trial Pit Log	N.D.	N.D.	N.D.	Hand Tools	N.T.S.	
	<div>

</div>					
Remarks:			Key:			
All dimensions in millimetres.
