HERITAGE STATEMENT

Vine House, Hampstead Square, Hampstead, NW3 1AB

Grade II Listed Building (List Entry Number 1378721)

Report title: Heritage Statement
6 Hampstead Square
Hampstead
London
NW3 1AB

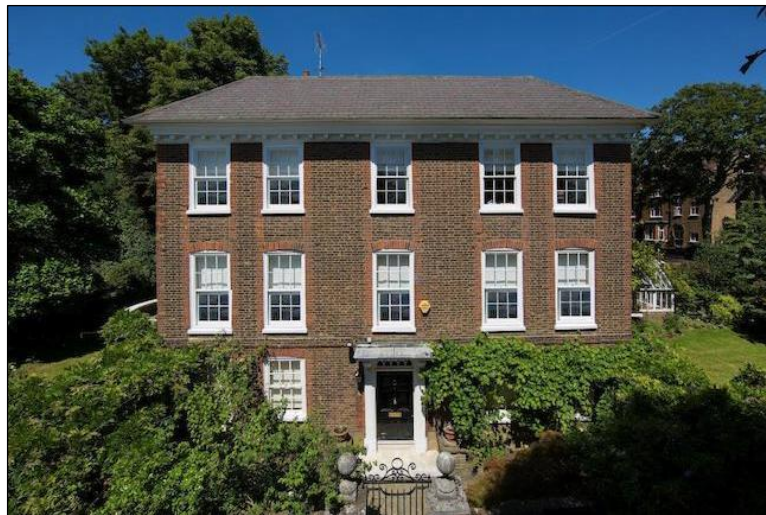
Plate 2 South (principal elevation) of Vine House, looking north

- 2.2.3 The south front (Plate 2) is the principal elevation facing Hampstead Square from which it is separated by a small patio and 3m high brick garden wall. This elevation represents the original façade to the 18th century Queen Anne house, although the original brickwork was refaced and repointed in the 19th century. The five bays of windows have early Georgian flush sashes with moulded frames in a six over six arrangement with a plain brick band above the ground floor windows. The ground and first floor windows have segmental brick arches with square headed sashes on the second floor. The front door is central, of painted softwood and six-panel construction set in a wooden door case with a rectangular over-light with intersecting tracery. Above the door is a straight hood supported by ornate console brackets. The hipped roof is slate hung with a low pitch and a plain modillion eaves cornice on this elevation. All elements of this façade, save for the low pitched roof, are contemporary with the earliest phase of the house.

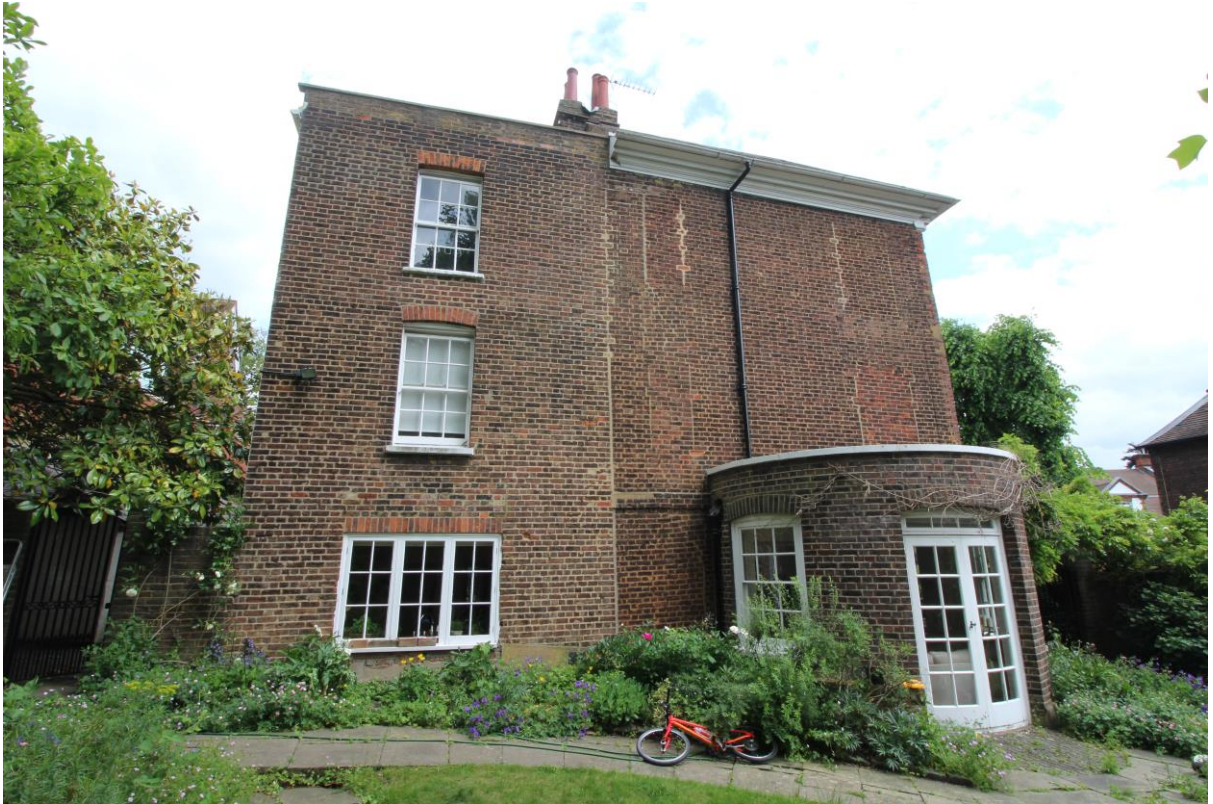
Plate 3 - West elevation, the extension (left) has a flat roof looking east

- 2.2.4 The upper portion of the west elevation is visible from the road on the approach from Heath Street. The front half is of repointed early 18th century brown brick with four blind windows, with a full-sized pair towards the front and a narrow pair towards the rear (Plate 3). A plain brick band continues from the main façade at first floor height. The roofline is of low pitch with corniced eaves and brick chimney stack. A later (1930s) single storey bow window with French doors gives access from the garden.

- 2.2.5 The rear half of the elevation represents a later extension to rear of the Queen Anne house (Plate 3). At ground level is a wide casement window with a straight brick head. The first and second floor windows are concealed box sashes with six over six arrangements with a segmented brick arch and straight brick head, respectively, and appear to date to the late 18th/early-19th century. The roof on this half of the elevation is a flat roof with a parapet constructed from 20th century bricks.
- 2.2.6 At least four phases of structural development can be observed on this elevation; the Queen Anne house being extended to the rear, its windows blocked up, a later early 20th century addition of a bow window being inserted on the ground floor, and a later still amendment to the roof of the extension to create a flat roof with parapet.

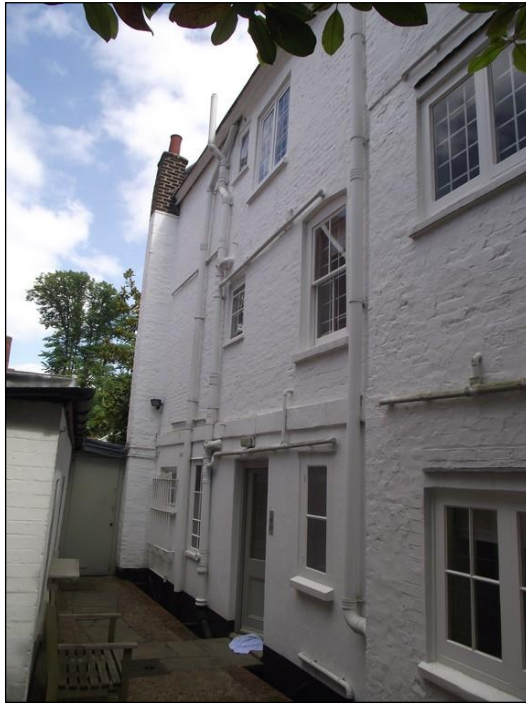
Plate 4 - North elevation with painted brick work and window insertions, looking east

- 2.2.7 This is the rear of the house. During the early 17th century when the house was first built this would likely have been a yard area used for storage and carrying out the daily services of washing etc. There may have been a few informal buildings here; it was not unknown for kitchens to be located in separate buildings to the rear of the main property. Today this yard area is taken up with two ranges which extend from the main house. The whole elevation is of painted brick with a mixture of modern wooden and plastic casement and sash lights on all floors (Plate 4). The random window insertions for ancillary rooms and bathrooms and a number of drainpipes give this side of the house an informal feel in keeping with its hidden aspect at the rear of the property. To the left is a double-pitched range with wide plain brick banding at first floor level. To the right is a separate bay with only two windows (ground and first floor). This bay is flat roofed, although it did once have two narrow pitches (see below). Together the two halves of the elevation represent two separate phases of rear extensions to the main 18th century house.

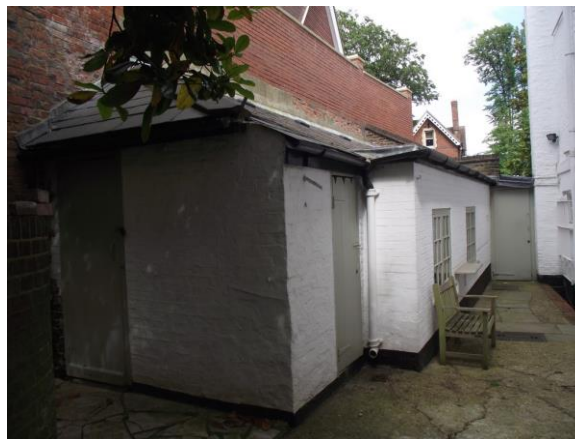
Plate 5 - mid 19th century brick built outbuilding with later additions, looking east

- 2.2.16 To the rear of the property there is a single-story painted brick-built building currently in use as a garage (Plate 5). The first phase of the structure dates to the mid-19th century when it was likely built as a wash house and outhouse to service the main house. The small flat roofed extension with timber casement windows was added in 1928 (see below) by which time it was in use as a garage. It is currently used for parking and storage and is in good repair.

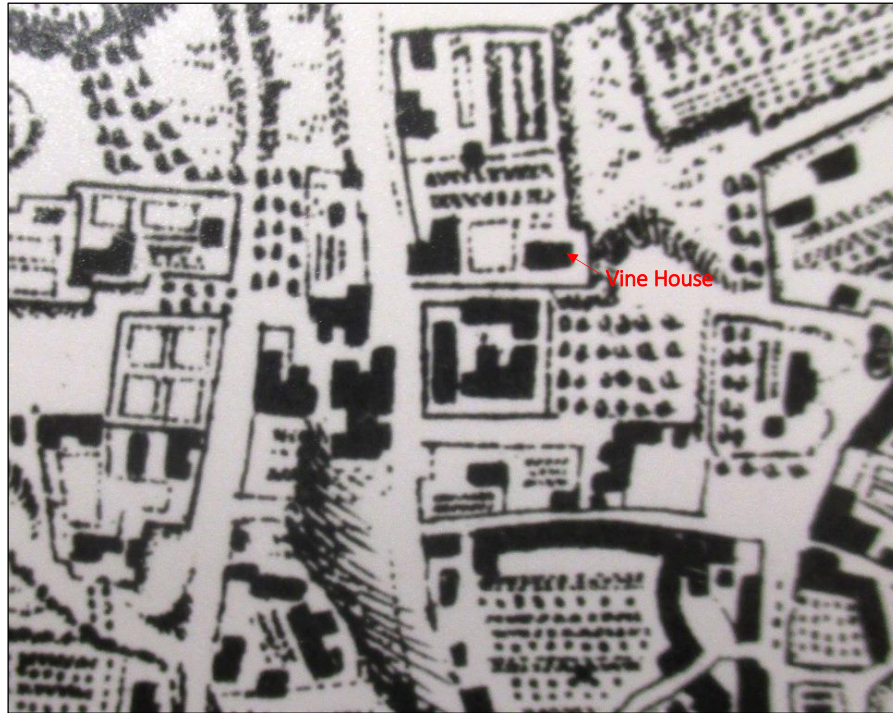
Plate 6 - 1746 John Rocque - *The Country Ten Miles Round London*

- 3.2.4 The earliest depiction of Vine House in any detail is the 1746 Rocque Map of *The Country Ten Miles Round London* (Plate 6). To the south the burgeoning settlement of Hampstead is laid out around its historic core of the High Street.

- 3.2.5 By the time the Rocque map was drawn Vine House was approximately 30 years old. The map shows it as being set back from the main northwards thoroughfare of Heath Street, effectively positioned behind the street front property (now Northcote House) with which it shared a large, roughly square plot. There was

- 3.2.9 Whilst cartography of this date is taken to be illustrative rather than empirical, Rocque does appear to have shown the plan form of Vine House as a rectangle, rather than the square that it is today.

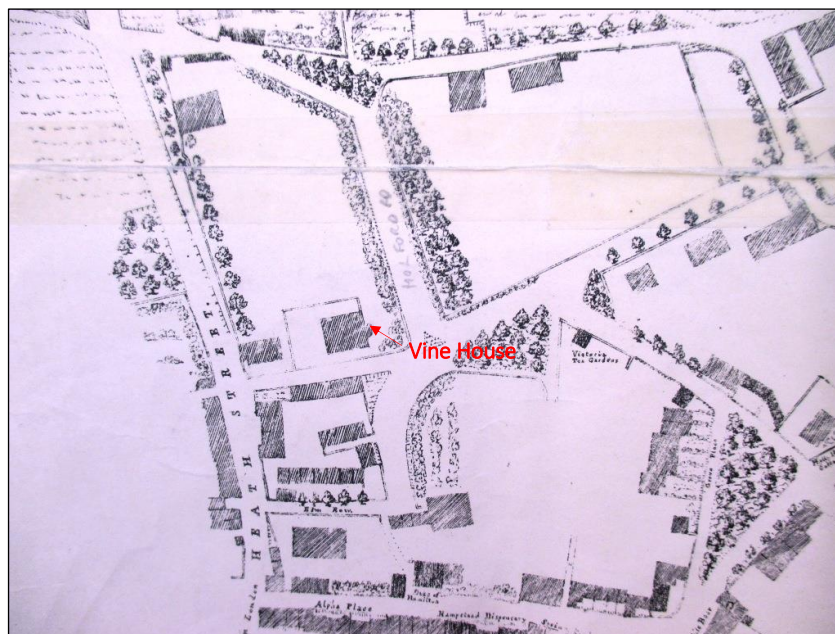
Plate 8 - 1847 *Plan of the Parish of St John* (LBCALSC)

- 3.2.14 Whilst this area of Hampstead was covered by the first tranche of Ordnance Survey cartographers in the early 1800s (British Library OSD 152, 1807), the earliest 19th century depiction of Vine House at a large enough scale is the 1847 *Plan of the Parish of St John* (Plate 8). By this time the line of Holford Road, to the east of Vine House had been formalised. The plan is a basic sketch showing the outline of buildings but no other real details appear within the plots, save for boundary walls and trees/shrubs. The plan of Vine House is square but with the addition of the canted, semi-circular bay window to the east elevation.

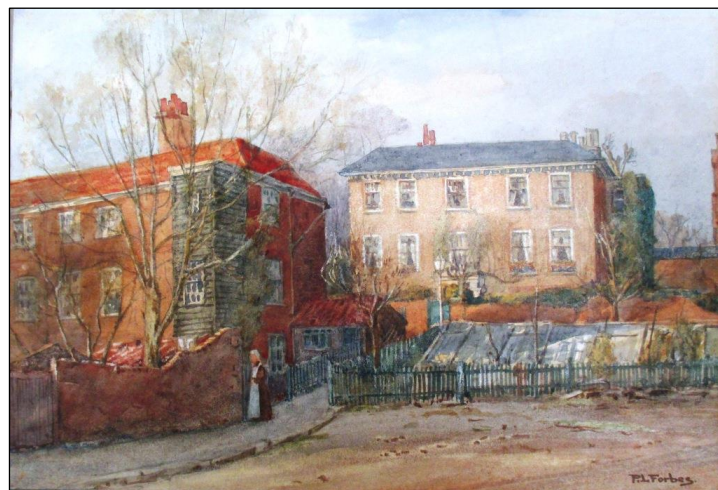
Plate 10 - Vine House painted by P.L Forbes in 1904 - 'The Home of Newman Hall' (reproduced with the permission of LBCALSC), looking north

- 3.2.23 The earliest complete visual representation of Vine House is a watercolour by local artist Patrick Lewis Forbes (1860-1939) dating to 1904, painted as 'The Home of Newman Hall' (Plate 10). In this painting the main south front of the property is depicted in relative detail and appears nearly identical to its appearance today.

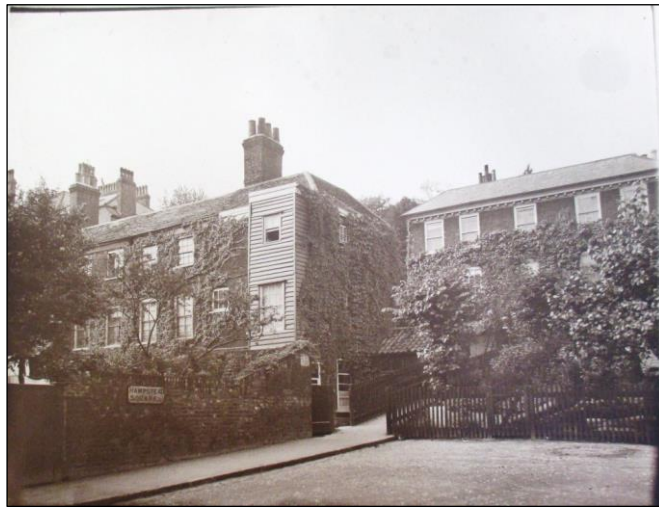
Plate 11 - Early photograph dating to 1910 of Hampstead Square showing Vine House (reproduced with the permission of LBCALSC), looking north-west

- 3.2.24 The earliest photograph located of Vine House dates to 1910 where a part of its south front is captured in a photograph of '*Hampstead Square*' (Plate 11). Apart from the ivy which in the intervening years since it was painted by Forbes has encroached on the façade, the frontage looks very similar to today. The general lack of trees in the square emphasises the height and prominence of the front of the house on the higher ground.

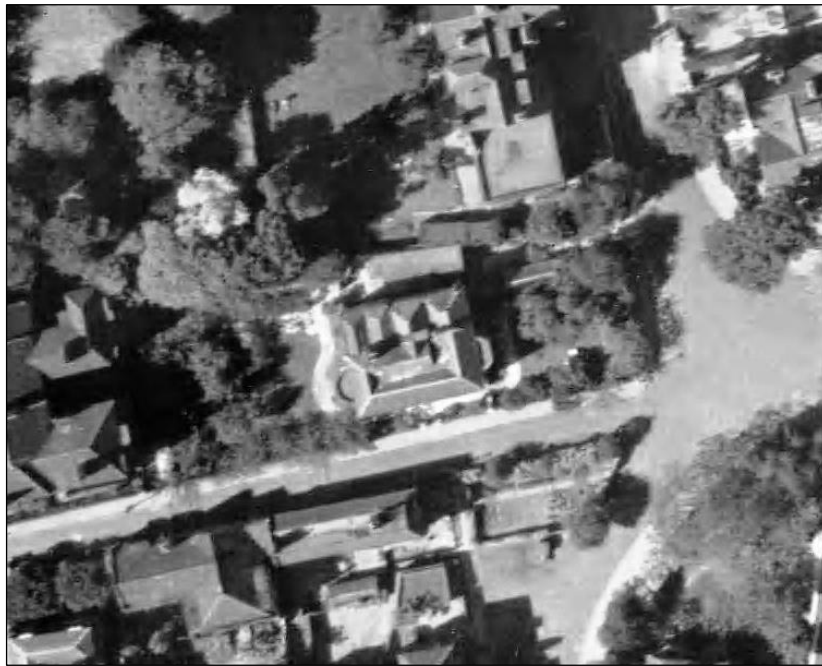
Plate 13 - 1944 aerial photograph of Vine House showing roof layout (Getmapping 2015)

- 3.2.29 The final significant documented change to the fabric of the house took place in 1952 when extensive works to the roof were undertaken by the owner, a Mr George William Augustine Burnside (*Hampstead and Highgate Express* 11 January 1952). A comparison of the roof layout shown on a 1944 aerial photograph of the house with that of a modern aerial photo show the extent of the works (Plate 13 and Plate 14). Whilst from the ground the changes did not affect the roofline, behind the ridge the entire central gully, including a possible dormer window have been removed and replaced with a shallow pitched slate slope. The flat roof of the rear extension was likely also created at this time with the removal of the two narrow pitches seen on the 1944 photo. In real terms this work resulted in the almost total replacement of the late Georgian roof on the oldest part of the house. This roof in itself was a replacement of a likely steeper-pitched tile hung roof more typical of early 18th century design.
