## APPENDIX A

8 Daleham Gardens							Borehole No: WS1	
Site & Location: London, NW3 5DA								
Client: Lee & Gina Marks				Coordinates: 526712E, 184815N		Sheet 1 of 1		
Engineer: Michael Barclay Partnership LLP				Ground Level: +9.80mOD		Report No: 10409/JRCB		
Progress & Observations	Samples & Tests		Field Test Results	Strata		Legend	Strata Descriptions	Backfill / Installation
	Type	Depth (m)		Depth (m)	Level (m)			
BH carried out: 03/09/19	D	0.20					Dark brown TOPSOIL with occasional gravel, brick fragments and roots.	
BH dia: 90mm reducing with depth	D	0.40		0.50	9.30			
	D	0.60					MADE GROUND: soft to firm orange brown/brown mottled grey slightly silty slightly gravelly clay. Gravel is fine to coarse angular brick and flint. Rare ash. Rare live roots and rootlets.	
	HV	0.60	30					
	D	0.80						
	HV	0.80	50					
	D	0.90						
	D	1.00						
	HV	1.00	50					
	D	1.20						
	HV	1.20	50					
	D	1.40						
	HV	1.40	60

## **DETS Report No: 19-13003**

Site & Location	8 Daleham Gardens, London NW3 5DA	Report No: 10409/JRCB
Site photographs

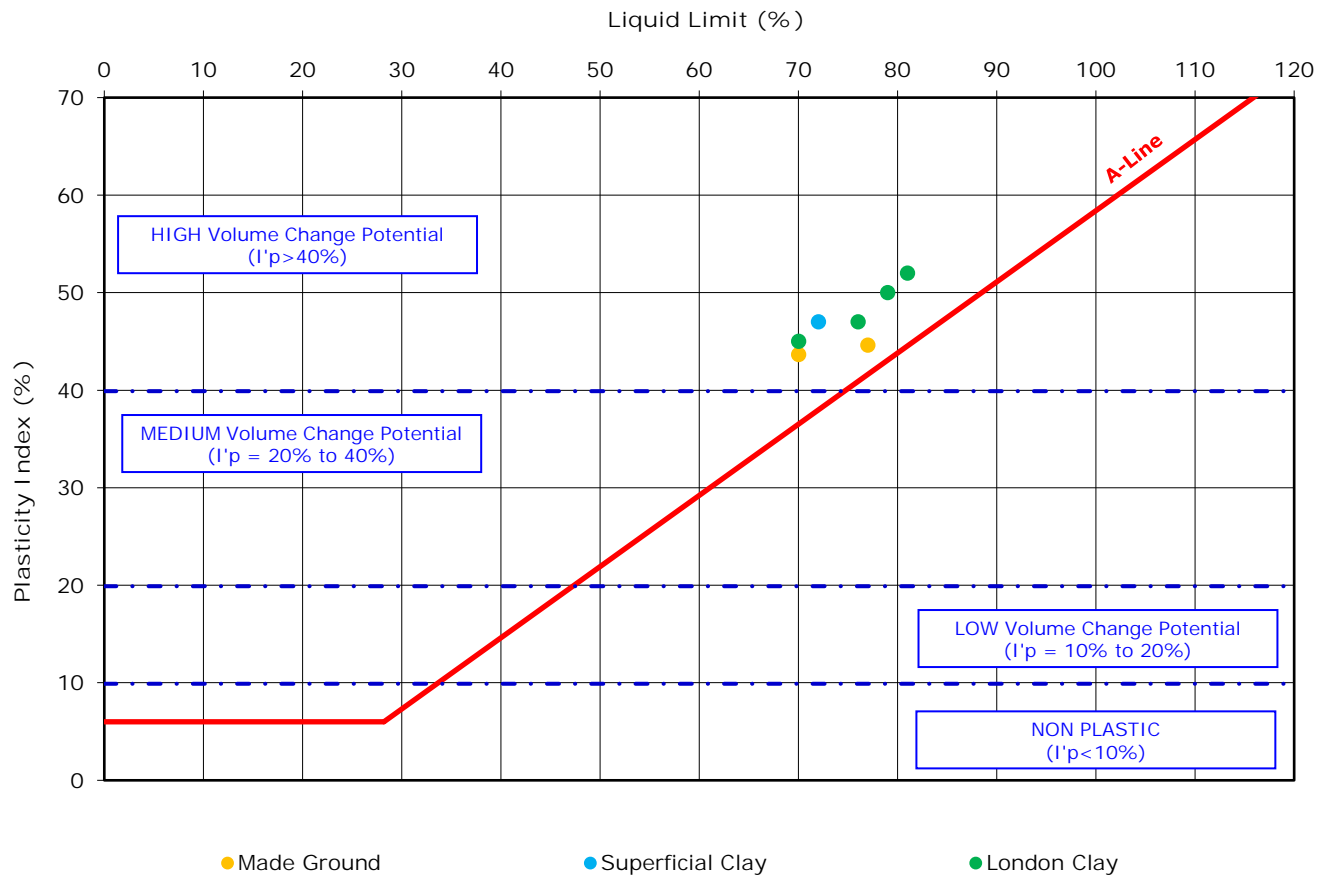
### Plasticity Chart

Modified Plasticity Index,  $I'p$ :

$$I'p = \frac{I_p \times (\% \text{ passing } 425\text{mm})}{100\%} \quad (\text{where } I_p = \text{Plasticity Index})$$

Classification in accordance with NHBC Standards, Part 4 'Foundations', Chapter 4.2 'Building near trees'

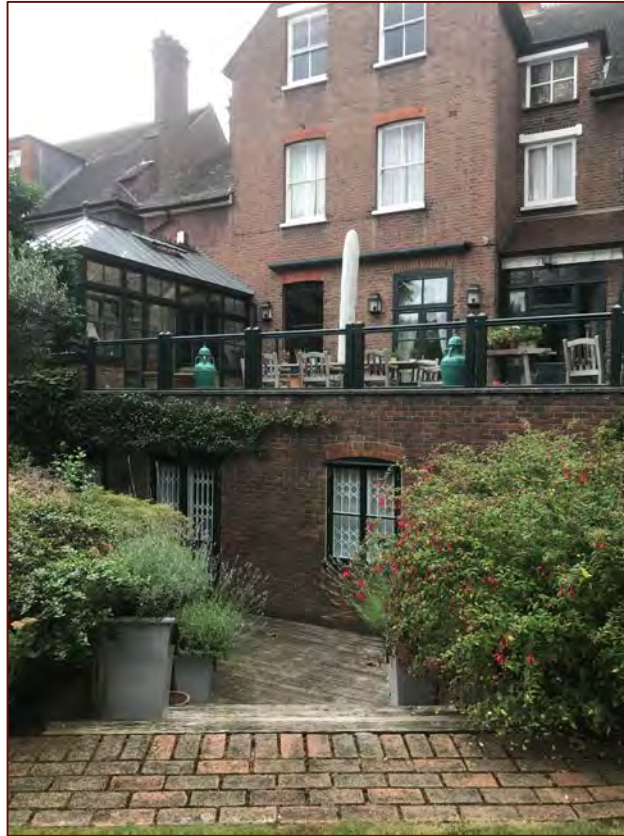
Photo No 13

General view of the lower ground floor/ basement. Area landscaped with localised wooden retaining walls.
